Strawberry Run Downstream Forensic Investigation

JUNE 27, 2022

Environmental Policy Commission

Presented by: Troy Biggs, PE, PH, D.WRE

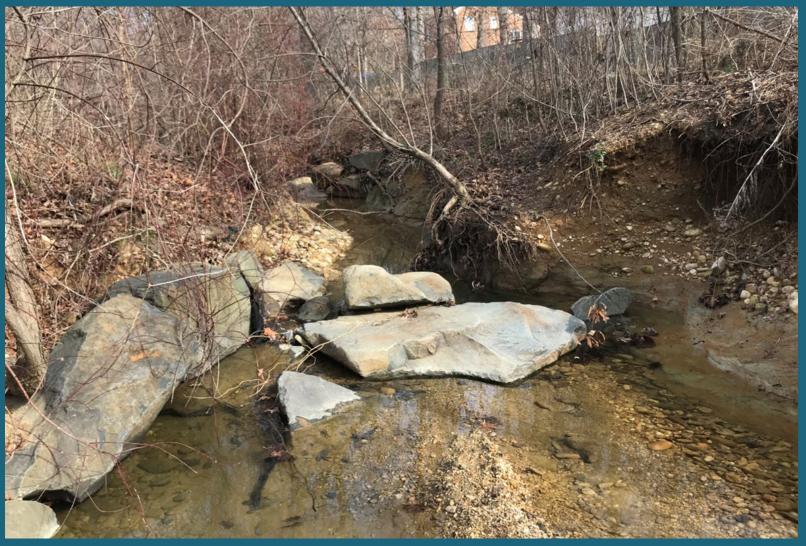
Scour Of J-Hook #2

November 2021; Looking Upstream

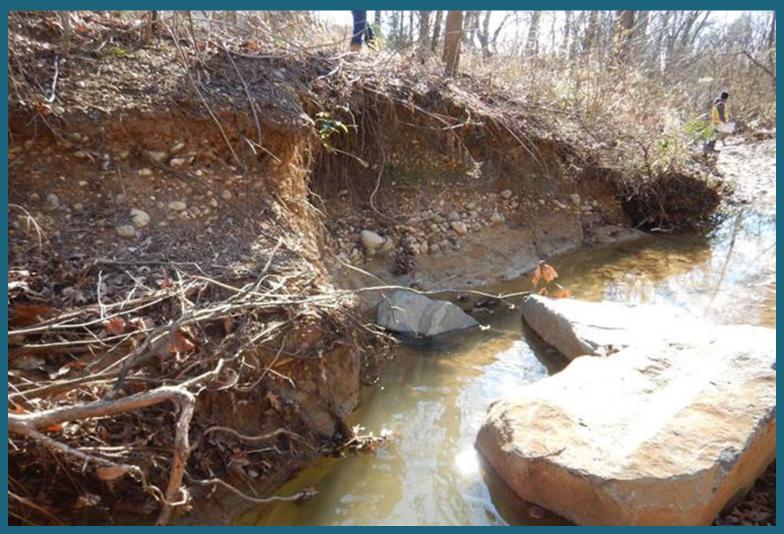
Scour Of J-Hook #2

November 2021; Looking Downstream

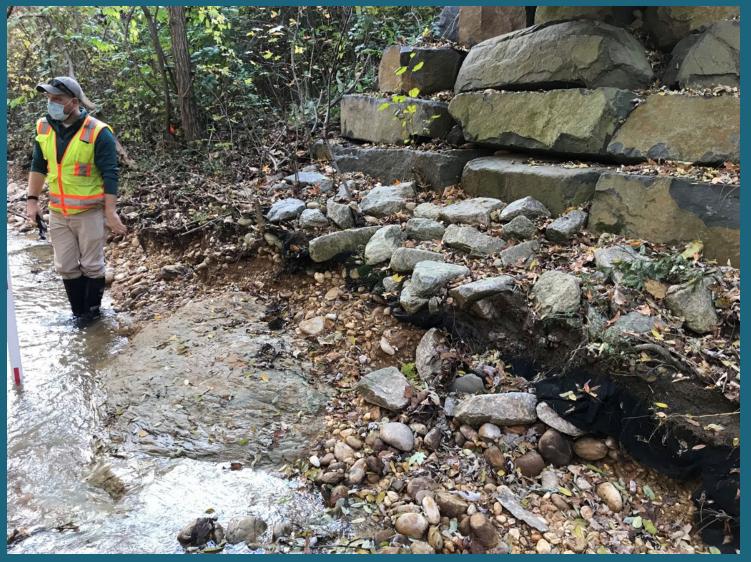
Failure Or Collapse Of Bank Protection Measures

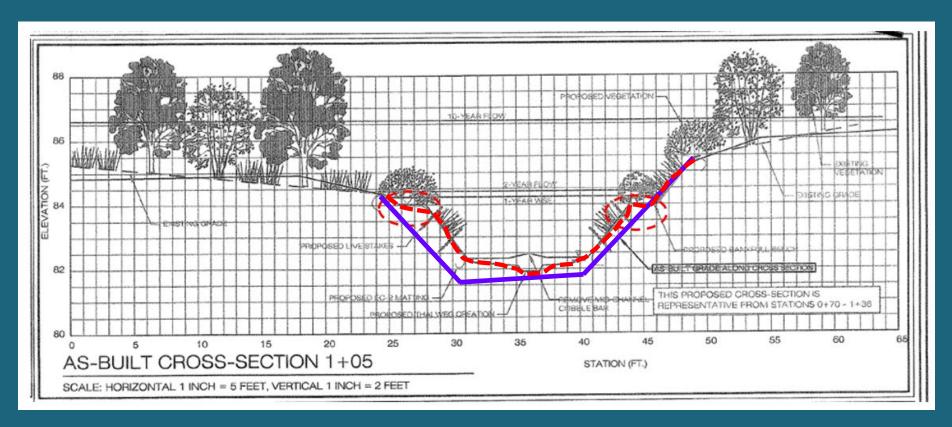
Construction As-built

- Constructed channel elevations not matching the design profile (structure elevations too high)
- Constructed cross sections not matching the design sections (no bankfull bench)

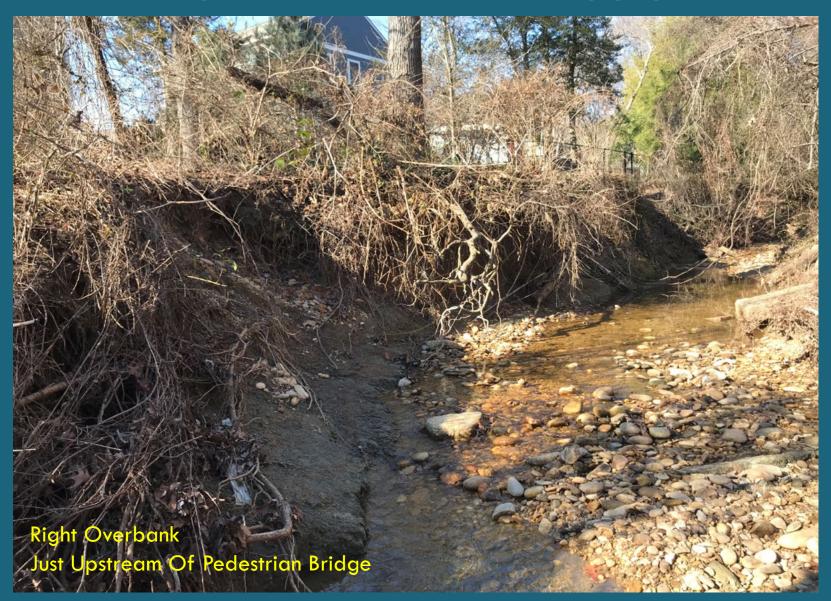
Upstream Bedload Supply

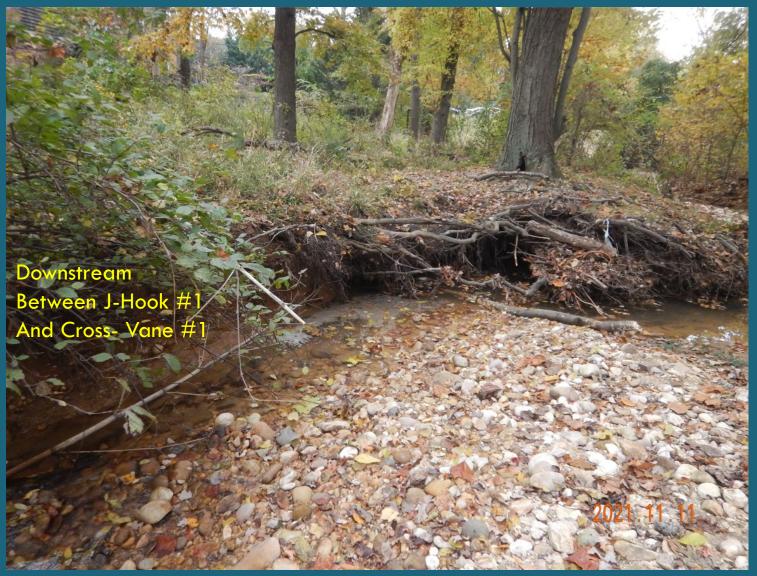
November 2021; S2 Area

Aggradation

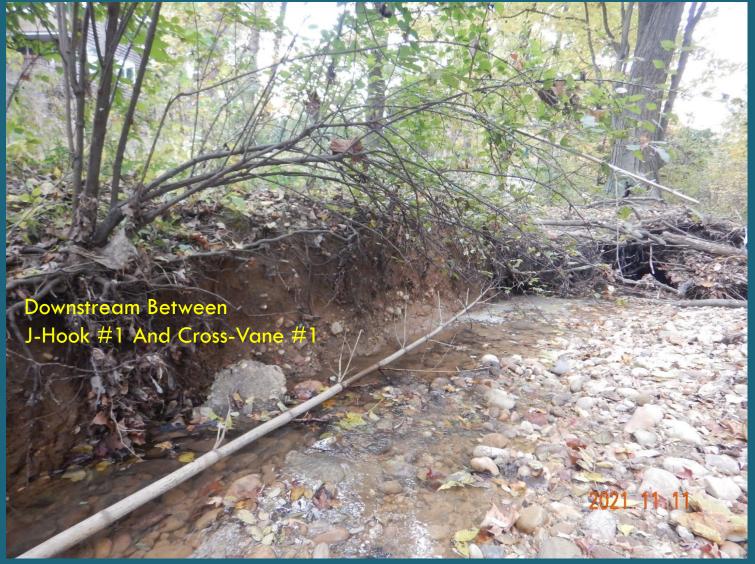
Lack Of Rock Toe Protection

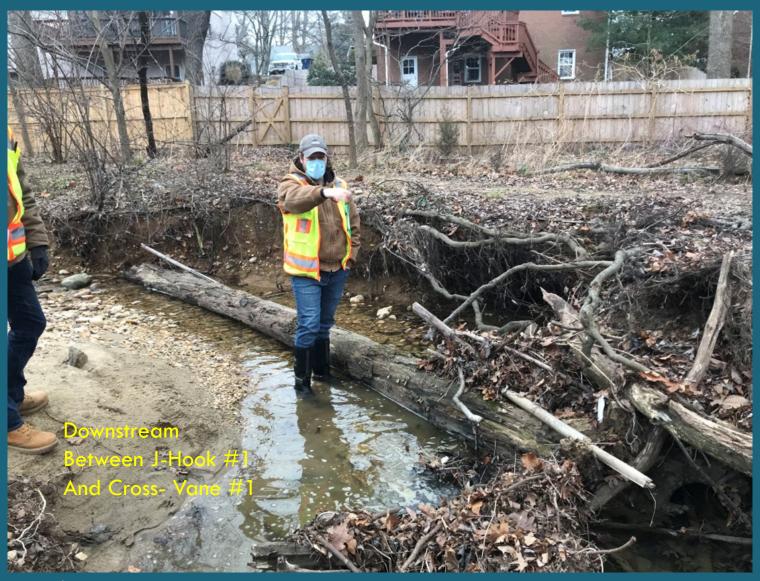
November 2021; S2 Area

Downed Trees / Channel Blockages
