Taylor Run Sanitary Sewer Crossings

November 15, 2022

Taylor Run Stream Crossings

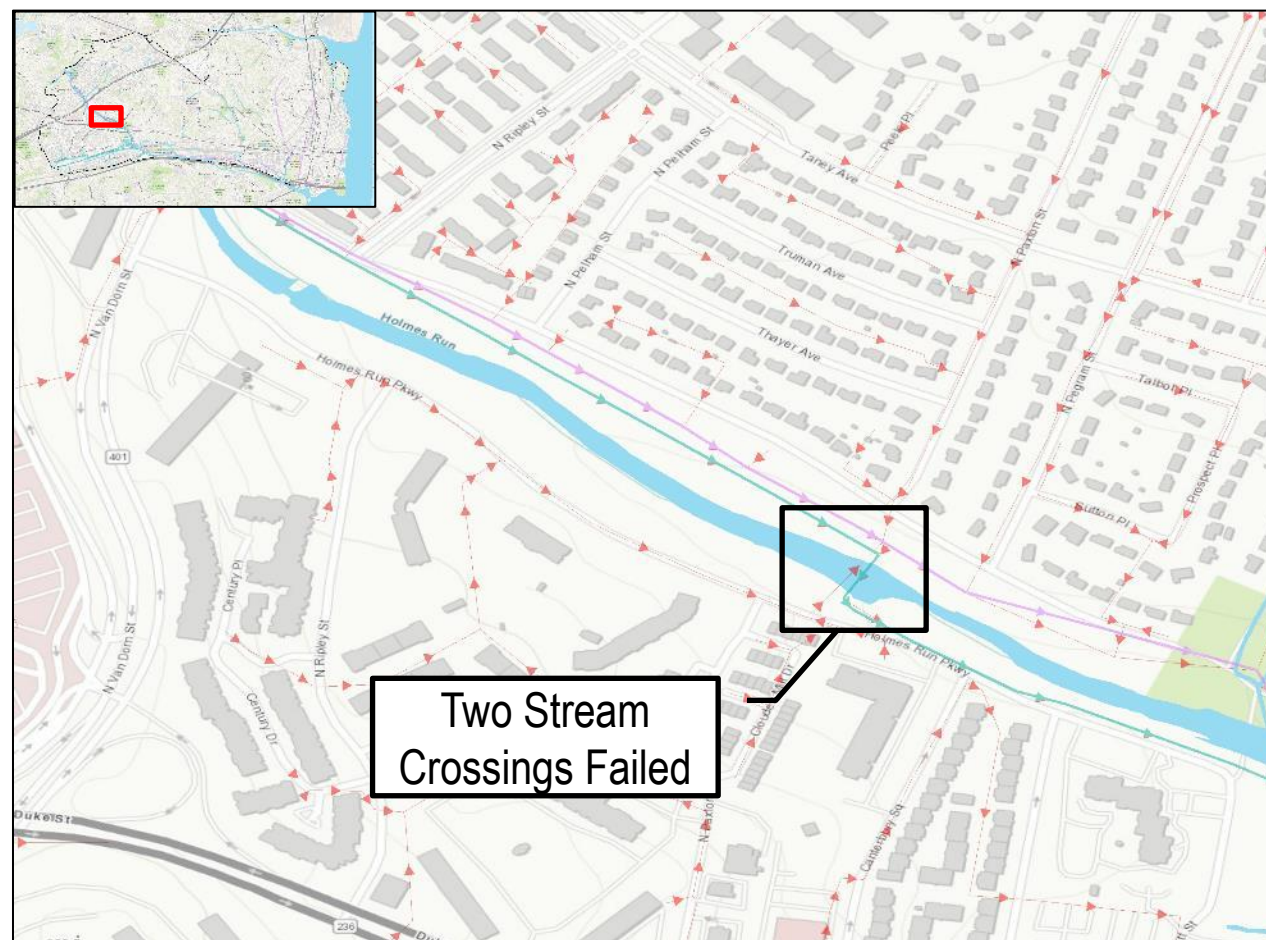
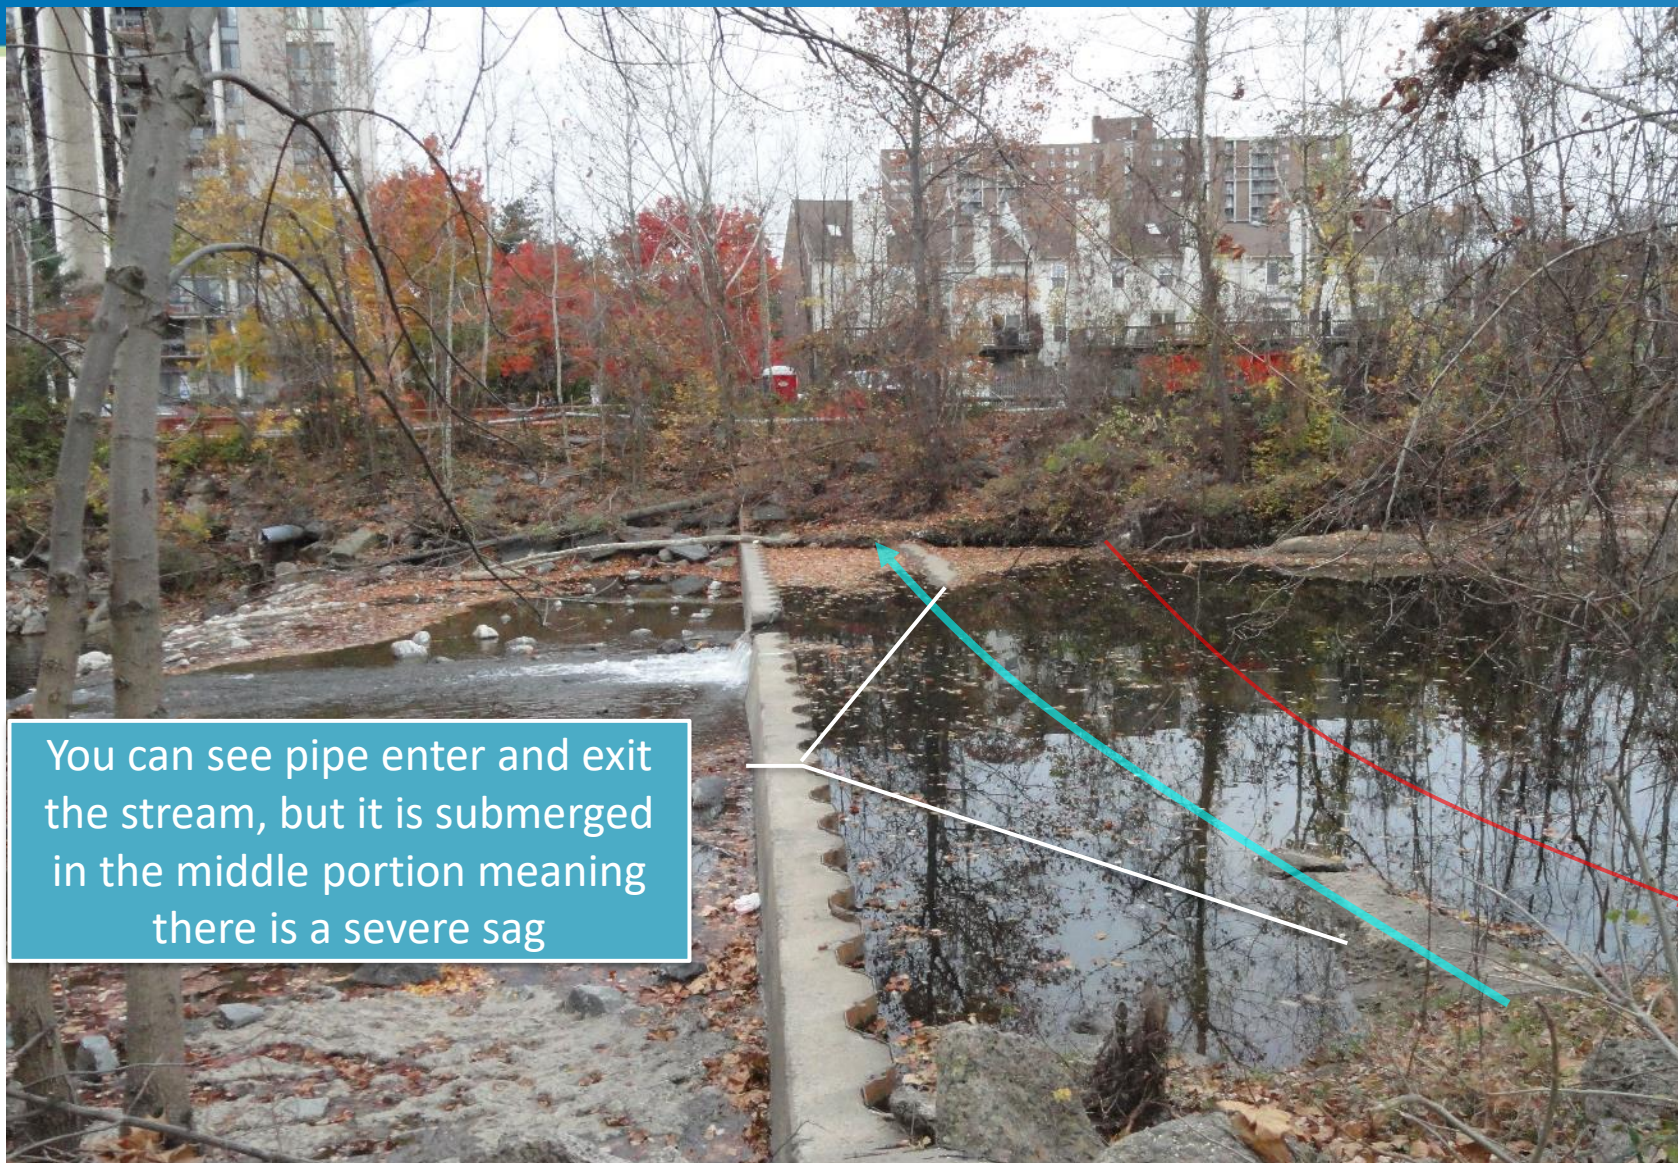
Holmes Run Sanitary Sewer Crossings

- Sewers as a result of a flood event during Tropical Storm Lee in 2011
 - Two sewers were undercut by high water velocities
 - Also impacted by debris
- Emergency construction was required to prevent further sewage in the stream

- Two sewers that failed were a 30-inch diameter Fairfax County pipe and a 12-inch diameter City pipe

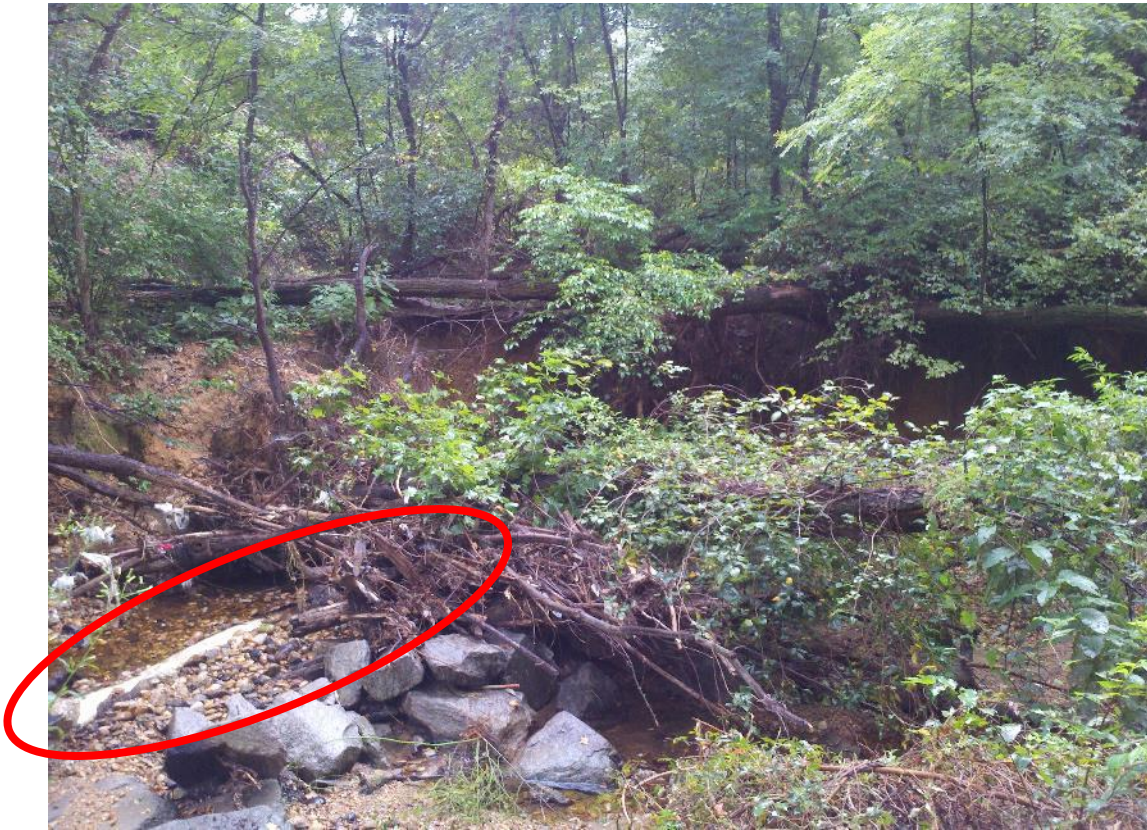
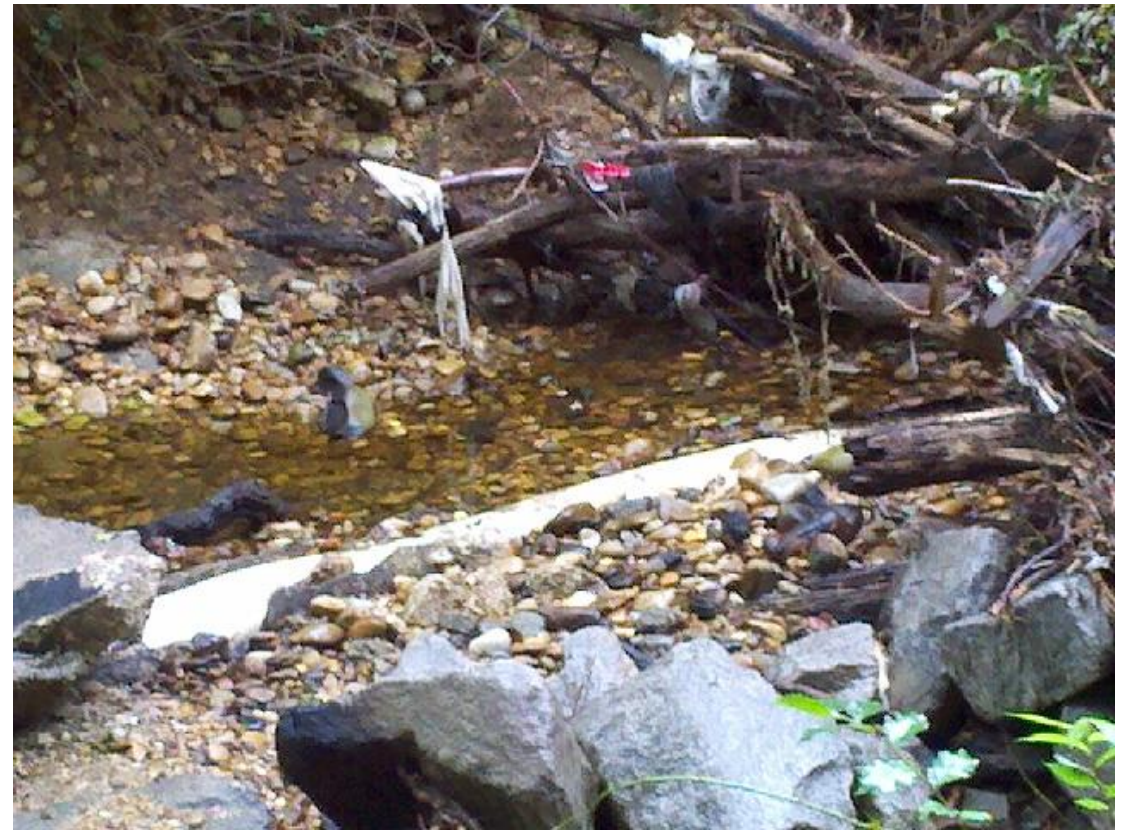
2014 Taylor Run Sanitary Sewer Crossing Failure

Concrete pipe broken and Cured-In-Place Pipe (CIPP) lining exposed

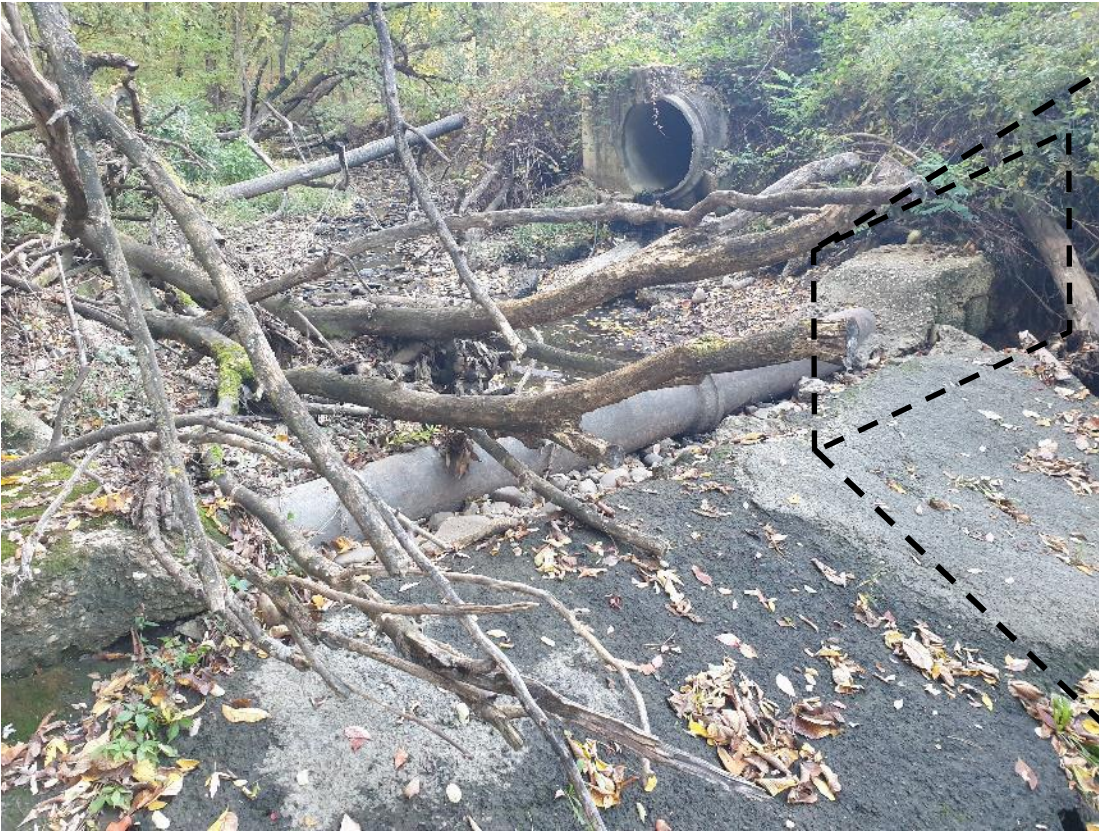
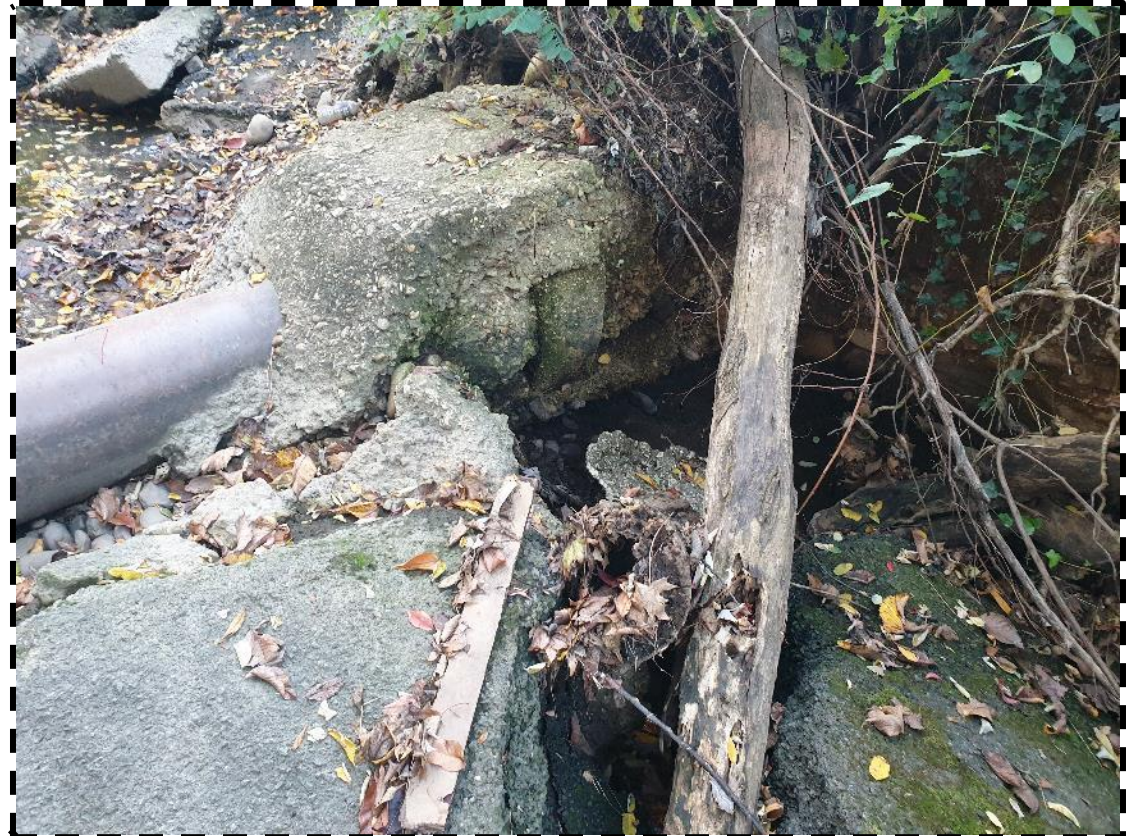
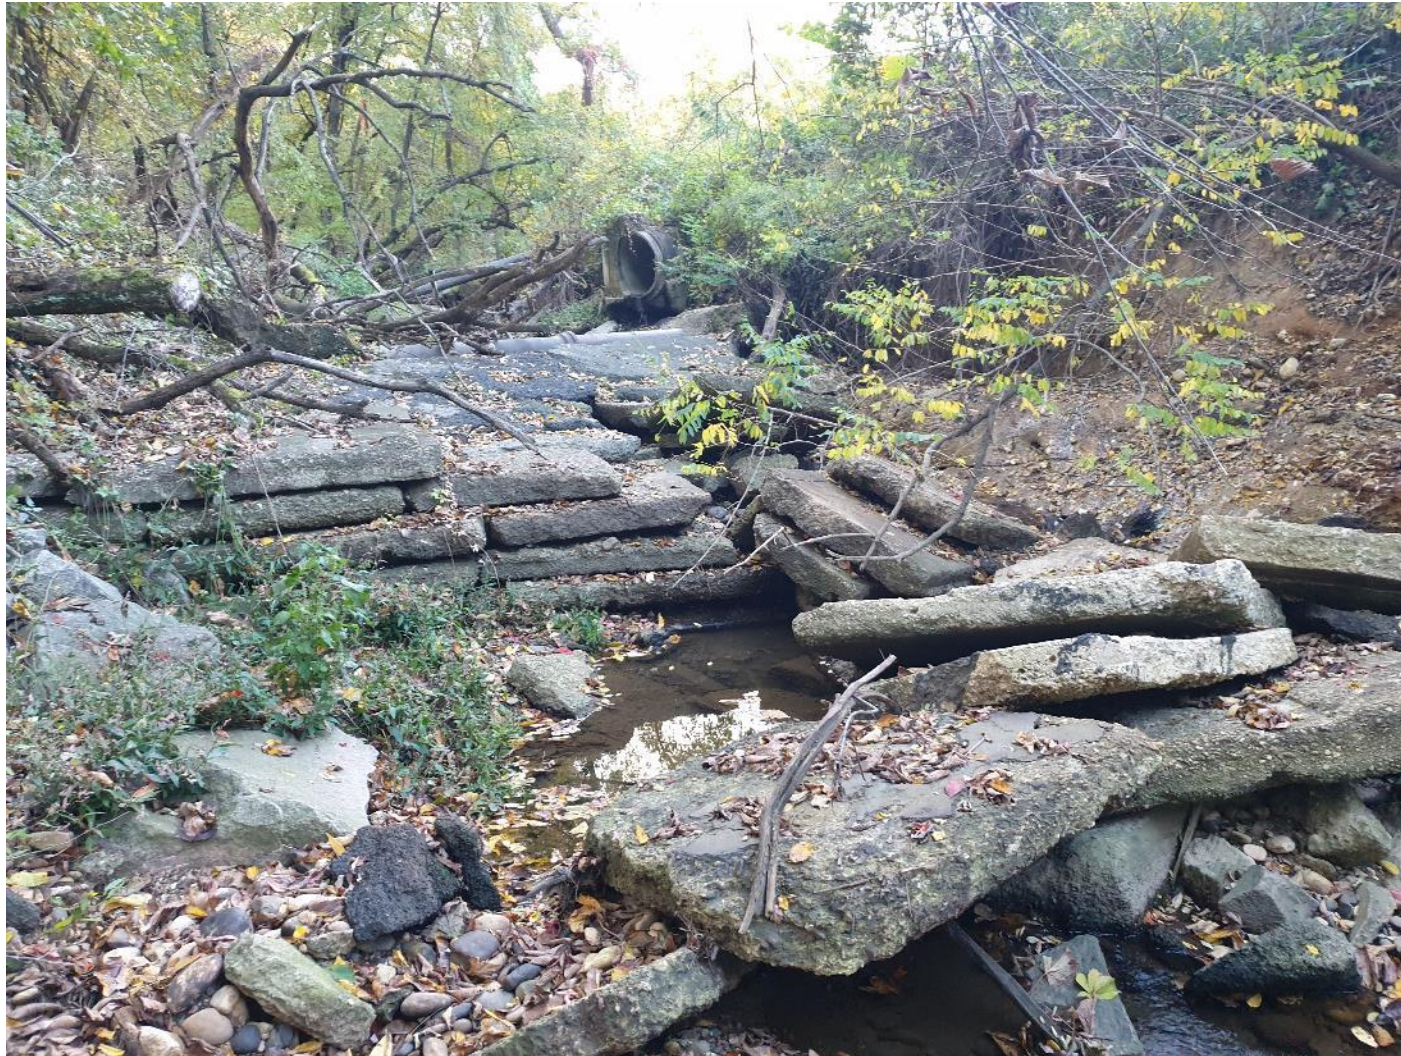
000040SEWP – Upstream Pipe

- There is a joint in the middle of the pipe which is a weak point. Could be a point of failure if struck by debris.
- Support at the north end is eroded and water is now flowing underneath the support. Further erosion may cause the support to fail.
- Concrete and asphalt intended to protect the crossing is beginning to wash out. This is no longer protecting the crossing and shows the power of the stream against the pipe.

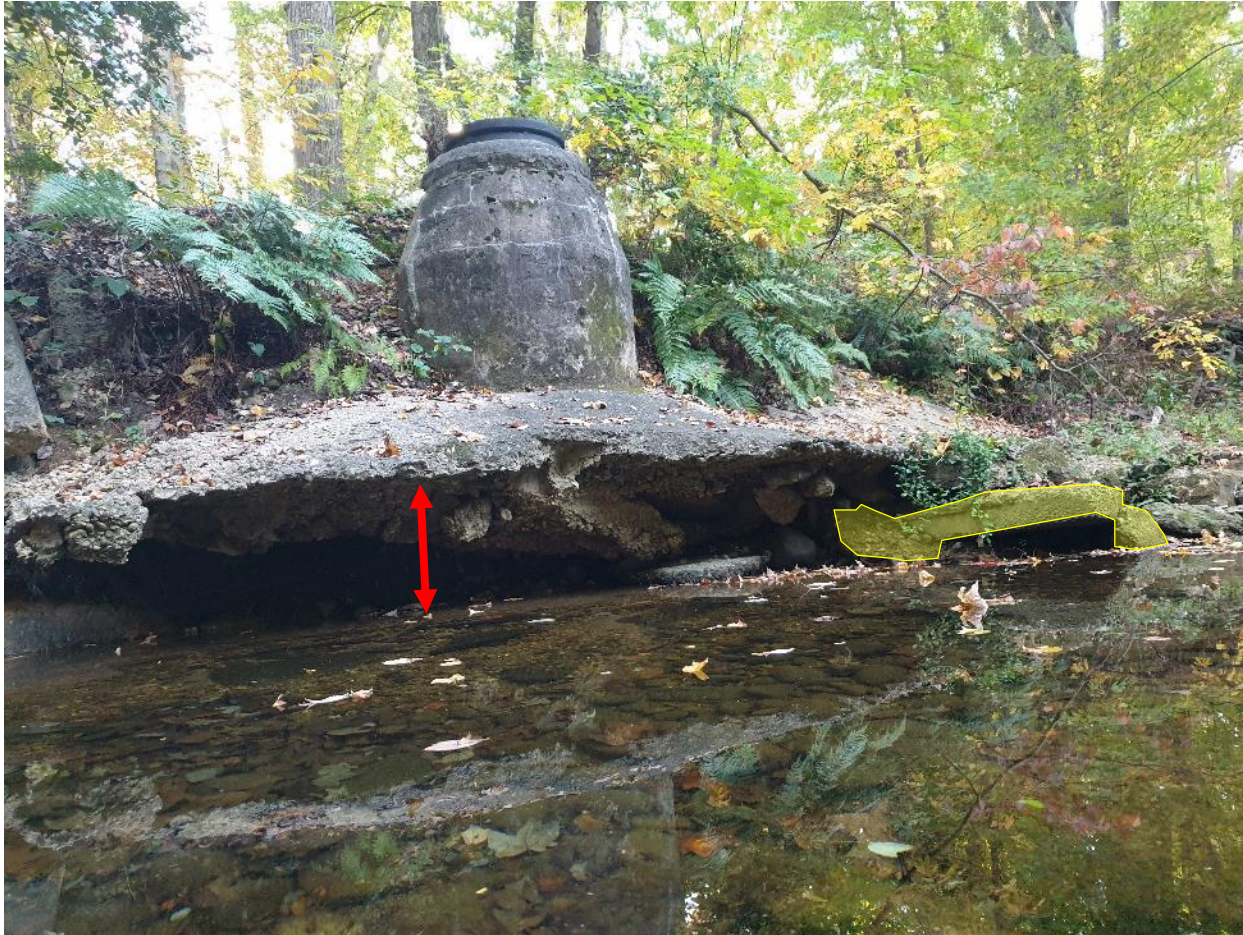
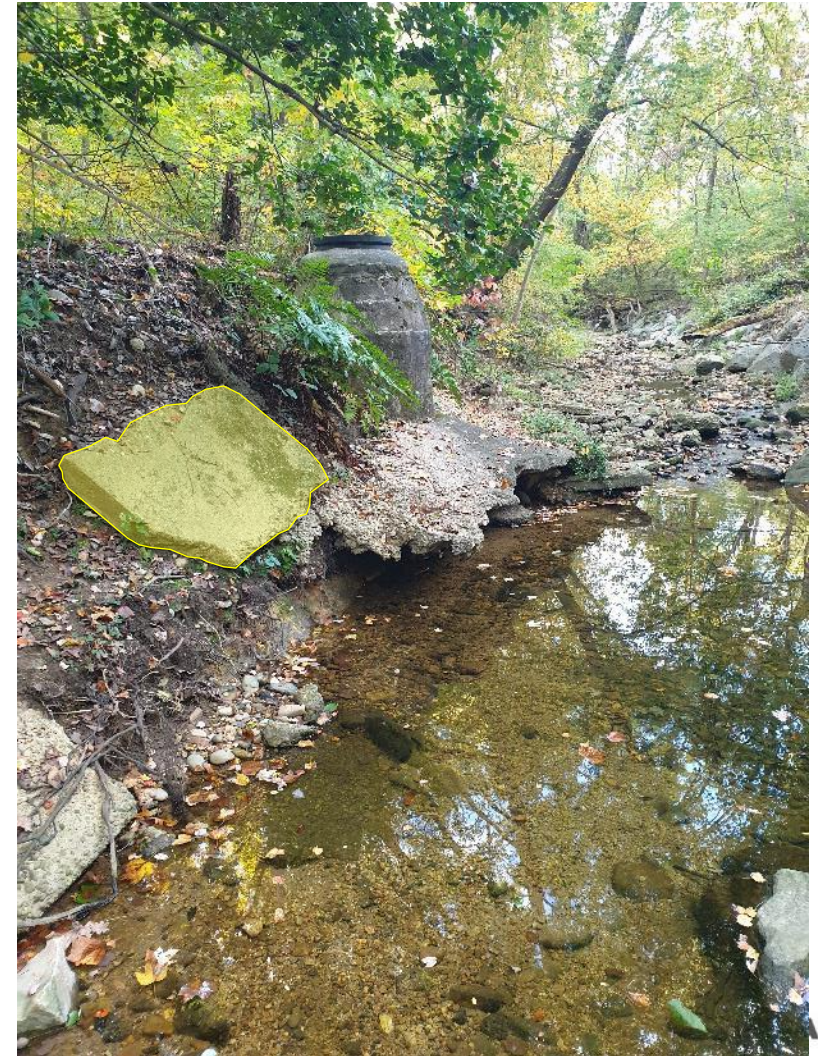
007529SSMH - Manhole

- Manhole is severely undercut. It seems to only be supported by the popes connected to it. As the stream continues to erode the banks, the manhole will fall into the stream
- Large pieces of debris around the manhole show the strength of the stream during wet weather. A large piece of debris striking the manhole could cause it to fail.
