City of Alexandria's Semi-Annual Report ATG-Oronoco Site Summary January 1, 2025 to June 30, 2025

This Semi-Annual Report summarizes site remedial activities for the former Alexandria Town Gas – Oronoco manufactured gas plant site (ATG-Oronoco) as described in Appendices A, B, and C of the Consent Decree between Potomac Riverkeeper Network and the City of Alexandria, Virginia, as filed January 9, 2024 in the U.S. District Court for the Eastern District of Virginia (Case No. 1:22-cv-00506-CMH-WEF).

August 29, 2025

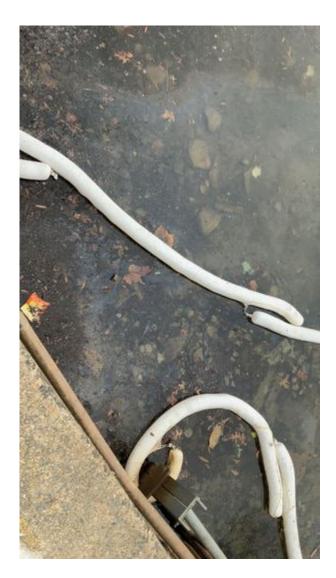
Outfall Photo #3:

January 16, 2025 10:22 AM
Personnel:
Shelby Dyer, RP Meredith
Weather and Tide Conditions
Outfall Boom Material:
Good, no action
Outfall Water Conditions:
NO sheen
Outfall Odors:
NO odor
Additional Outfall Notes: Outfall partly frozen.

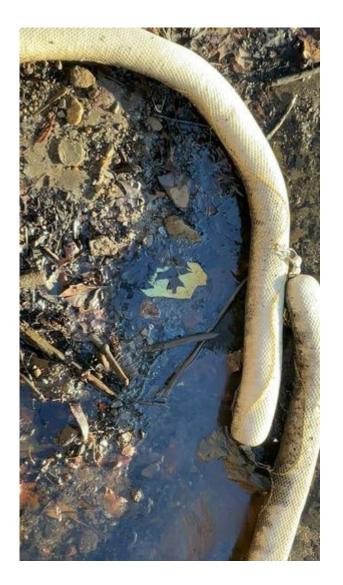
Outfall Photo #3:

February 7, 2025 9:21 AM
Personnel:
Shelby Dyer, Dane Anderson
Weather and Tide Conditions:
Outfall Boom Material:
Good, no action
Outfall Water Conditions:
SLIGHT sheen
Outfall Odors:
SLIGHT odor
Additional Outfall Notes:
Sheen spotted near first layer of boom next to mouth of outfall.

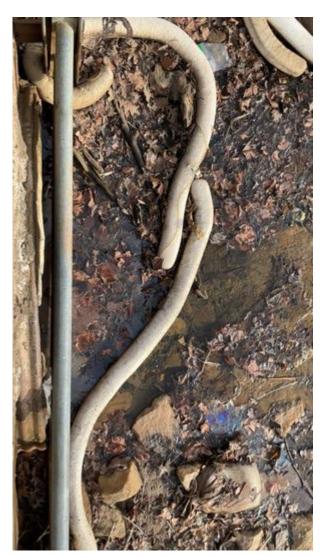
Outfall Photo #3:

Date:
February 20, 2025 10:14 AM
Personnel:
Shelby Dyer, Damian Murphy
Weather and Tide Conditions:
Outfall Boom Material:
Replacement needed
Outfall Water Conditions:

MODERATE sheen

Sheen spotted around inner boom area.

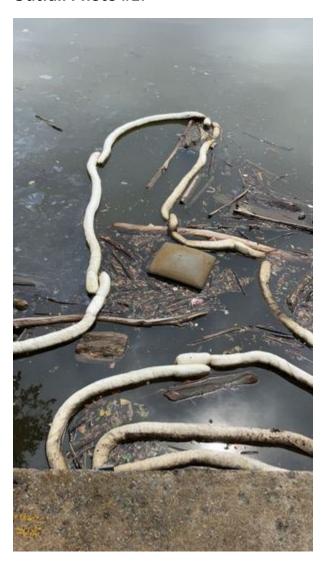
Outfall Photo #1:

Date:
May 22, 2025 10:34 AM
Personnel:
RP Meredith, Damian Murphy
Weather and Tide Conditions:
Outfall Boom Material:
Good, no action
Outfall Water Conditions:
Outfall Odors:
NO odor
Additional Outfall Notes:
Additional Outlan Notes.

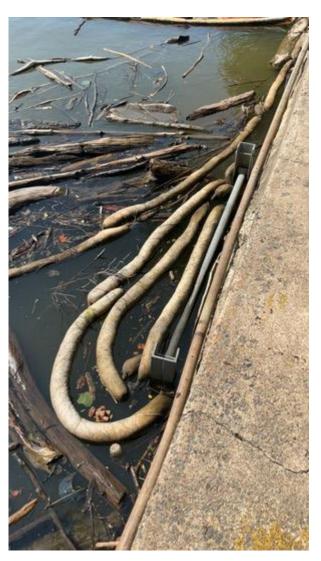
Outfall Photo #4:

June 12, 2025 10:12 AM
Personnel:
RP Meredith
Weather and Tide Conditions:
Outfall Boom Material:
Good, no action
Outfall Water Conditions:
NO sheen
Outfall Odors:
NO odor
Additional Outfall Notes: No sheen observed
