STRUCTURAL ASSESSMENT

Full Metal Jacket Building 0 Prince Street, Alexandria, VA

ALPHA CORPORATION (Alpha)
1850 S. Loudoun Street, Suite 200
Winchester, VA 22601

September 22, 2010

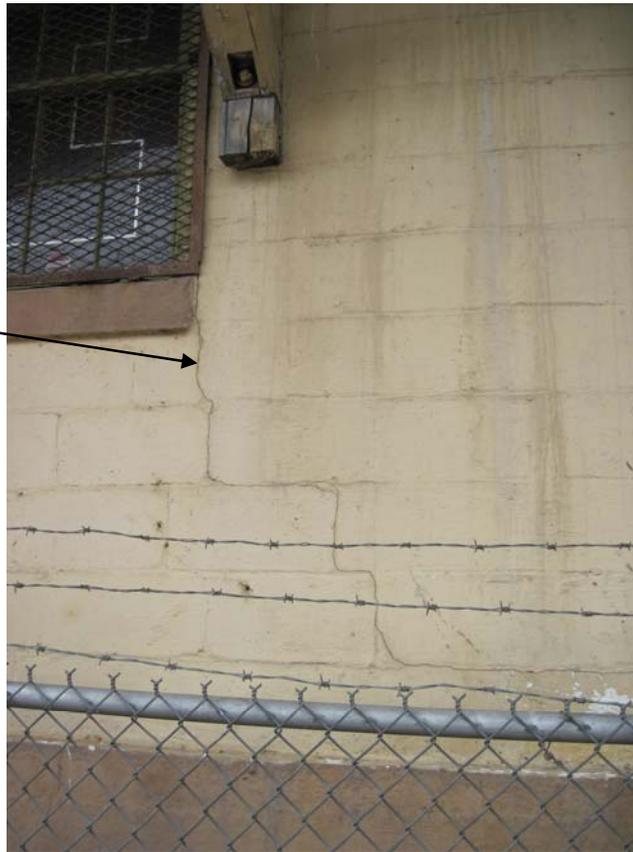
Photograph 3

**Vertical cracking
through CMU**

The exterior CMU bearing walls show significant signs of cracking and likely indicate foundation differential settlement. Once foundation repairs as described above have been completed, we recommend that all walls be repointed with new mortar and vertical control joints be added at a maximum of 40' to help alleviate and control any future cracking. Estimated costs for repointing and control joint installation are \$40,000.
