HAZARDOUS MATERIALS SURVEY

BEACHCOMBER BUILDING (Currently Vacant)

**1 – 3 PRINCE STREET
ALEXANDRIA, VIRGINIA 22314**

**SUBJECT: Limited Scope Hazardous Materials Survey for Identification
Of "Suspect" Lead in Paint, "Suspect" Asbestos,
And Miscellaneous Materials**

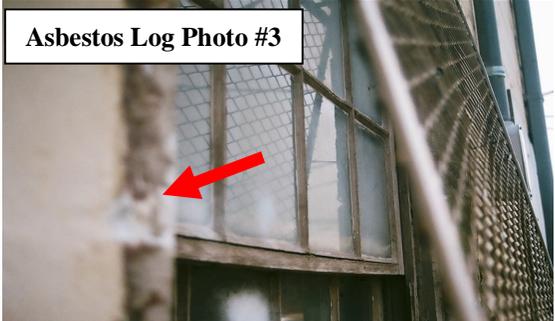
Sample	Building Location / Description of Material	Asbestos Content	Comment(s)
3	Exterior: Exterior Rear Window Caulking at Garage Door	35% Chrysotile	<p data-bbox="976 331 1247 365">Asbestos Log Photo #3</p>

- 2.1. Window Caulking Materials:** Asbestos bulk sampling results confirm exterior window caulking material contains 35% chrysotile asbestos (see Sample #3, Asbestos Table 1 and Attachment 1; Asbestos Log Photo #3).

<p data-bbox="961 642 1539 701">Comment: Assume all window caulking ACM-type.</p>
8 Floor Tile	Interior: First Floor – 9” X 9” Vinyl Asbestos Floor Tile (VAT) Beneath Carpet in Small Shelved Room at FT	12% Chrysotile	<p data-bbox="976 730 1256 764">Asbestos Log Photo #8</p>

13.1.1 **Exterior:** Removal all window caulking as asbestos containing.

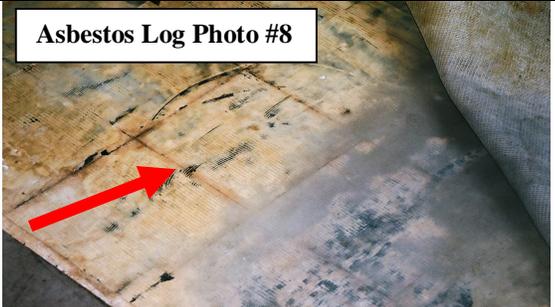
- 2.2. Vinyl Floor Tiles (First Floor):** Interior first floor 9" X 9" vinyl floor tile(s) located beneath carpeting in small-shelved room contains 12% chrysotile (see Sample #8, Asbestos Table 1 and Attachment 1; Asbestos Log Photo #8).

<p data-bbox="961 1020 1390 1052">Comment: Estimated 40 Square Feet</p>
14 Floor Tile & Mastic	Interior: Second Floor – Gray 9” X 9” VAT – 2 Rear Rooms	10% Chrysotile In both tile and mastic	<p data-bbox="976 1081 1268 1115">Asbestos Log Photo #14</p>

13.1.2 **Interior: First Floor** – Remove all 9” X 9” vinyl floor tiles in small first floor room (shelving area) as asbestos containing.

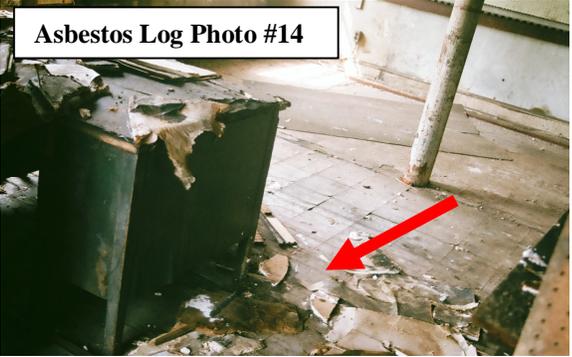
- 2.3. Vinyl Floor Tiles (Second Floor):** Interior second floor gray colored 9" X 9" vinyl floor tile(s) in two rear rooms contains 10% chrysotile asbestos in floor tile and associated adhesive mastic (see Sample #14, Asbestos Table 1; Asbestos Log Photo #14).

<p data-bbox="961 1419 1403 1444">Comment: Estimated 400 Square Feet</p>
15 Floor Tile	Interior: Second Floor – 12” X 12” VAT – Gray Bathroom	12% Chrysotile	<p data-bbox="976 1474 1268 1507">Asbestos Log Photo #15</p>

13.1.3 **Interior: Second Floor** -- (1) Remove 9” X 9” VAT (gray type) and associated adhesive mastic in 2 rear rooms and (2)12” X 12” vinyl floor tile in bathroom as asbestos-containing materials.

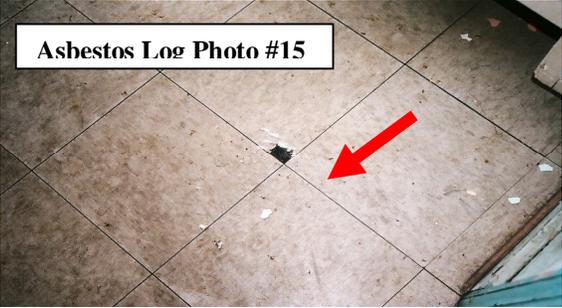
- 2.4. Vinyl Floor Tiles (Second Floor – Bathroom):** Additionally, second floor bathroom gray colored 12" X 12" floor tiles contain 12% chrysotile in tile (see Sample #15, Asbestos Table 1; Asbestos Log Photo #15).

<p data-bbox="961 1764 1390 1789">Comment: Estimated 70 Square Feet</p>

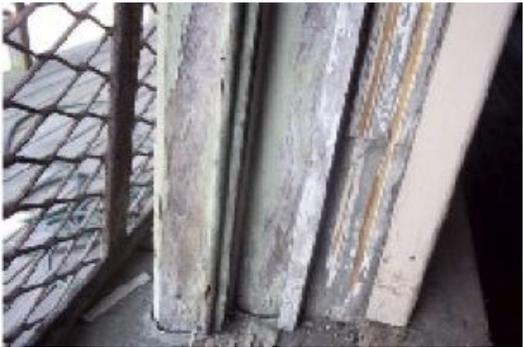
Sample # Sample Date	Material Description / Area Sample Location	XRF Lead Concentration	OSE LBP Source File Photo #
XRF-010 July 5, 2012	Second Floor – Window Jamb Area: Second Floor (Main Area)	1.8 mg/cm ²	OSE LBP SOURCE FILE PHOTO #2

13.2.2 **Interior Components:** Windows, doors throughout and metal structural support.

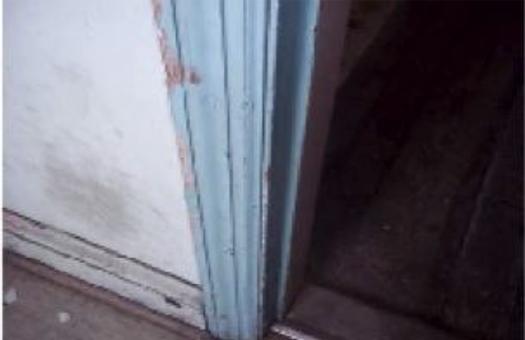
XRF-018 XRF-017 July 5, 2012	Second Floor – Bathroom Door Casing and Jamb Area: Second Floor (Bathroom)	1.3 mg/cm ² (Casing) 1.2 mg/cm ² (Jamb)	OSE LBP SOURCE FILE PHOTO #3

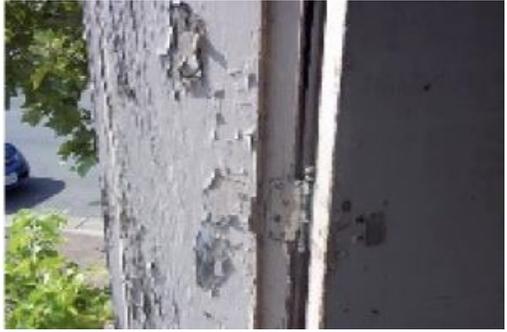
Sample # Sample Date	Material Description / Area Sample Location	XRF Lead Concentration	OSE LBP Source File Photo #
XRF-024 July 5, 2012	First Floor – Door Jamb Area: First Floor/Main	2.3 mg/cm ²	<p>OSE LBP SOURCE FILE PHOTO #4</p>

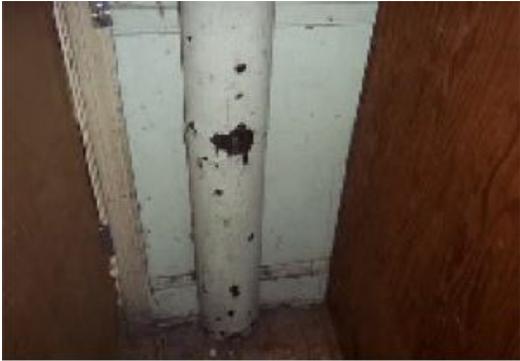
XRF-029 July 5, 2012	First Floor – Support Posts Area: First Floor/Storage	1.3 mg/cm ²	<p>OSE LBP SOURCE FILE PHOTO #5</p>

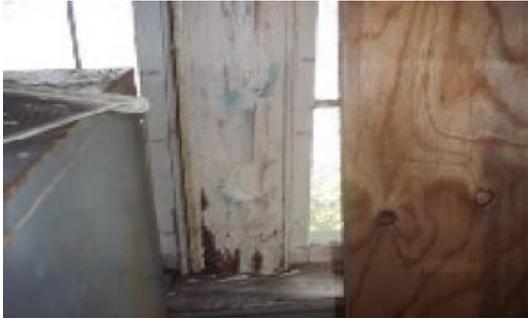
XRF-039 July 5, 2012	First Floor – Window Partition Bead/Office Area: First Floor	5.2 mg/cm ²	<p>OSE LBP SOURCE FILE PHOTO #6</p>

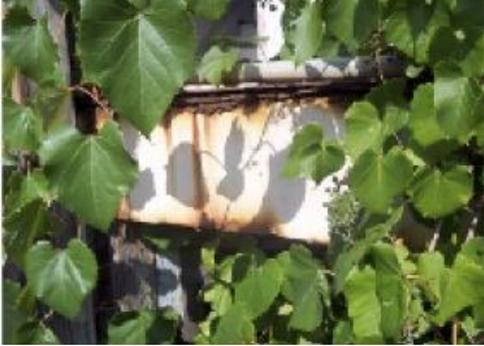
Sample # Sample Date	Material Description / Area Sample Location	XRF Lead Concentration	OSE LBP Source File Photo #
XRF-050 July 5, 2012	Exterior – Skirt Board Area: Exterior	3.3 mg/cm ²	<p align="center">OSE LBP SOURCE FILE PHOTO #7</p>

13.2.1 **Exterior Components:** White skirt and door (plus jamb)

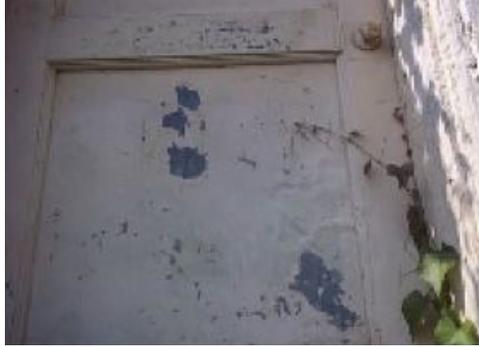
XRF-053 July 5, 2012	Exterior – Exterior White Door (Rear) Area: Exterior	3.3 mg/cm ²	<p align="center">OSE LBP SOURCE FILE PHOTO #8</p>

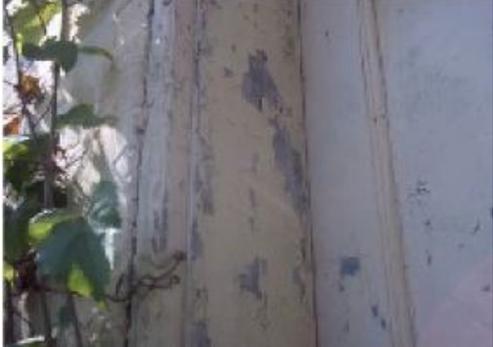
XRF-054 July 5, 2012	Exterior – Door Jamb Area: Exterior	2.2 mg/cm ²	<p align="center">OSE LBP SOURCE FILE PHOTO #9</p>

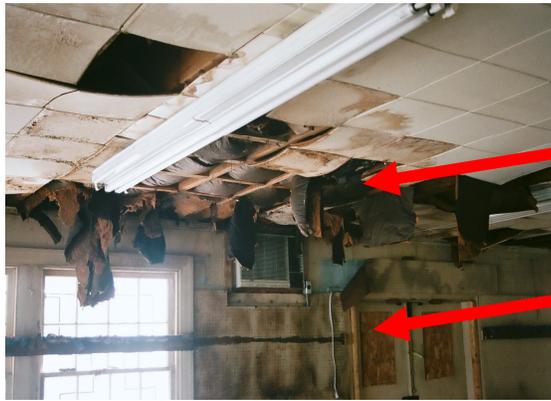
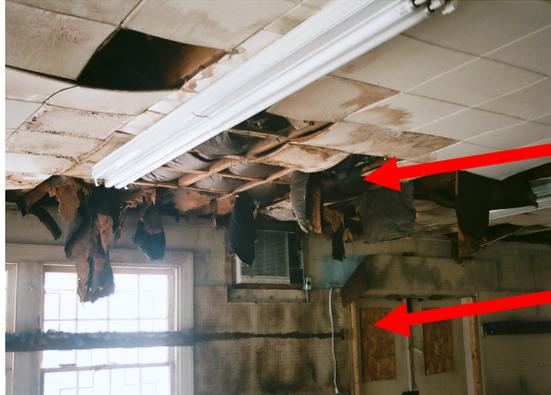
MISC. PHOTO #1

- **Thermostats** – Based on age of building and onsite equipment, all thermostats assumed mercury-type. Remove thermostats and dispose as hazardous waste.
- **Fluorescent Light Fixtures** – Based on age of building (pre-1976), all fluorescent light ballasts should be treated as PCB-type. Dispose of fluorescent light ballast as PCB-containing hazardous waste.
- **Mold** – Roof leak has damaged interior ceiling and acoustical ceiling tiles throughout interior of building. Wood flooring is swollen/decayed on both second floor and first floor. Drywall, acoustical ceiling tiles, and plaster walls are mold filmed (see Miscellaneous Log Photo # 1).

13.5.1 Mold: All interior components (i.e., wall/ceiling plaster, etc.) mold damaged. Wood flooring moldy/decaying throughout building site. Roof leak damaged interior ceiling and acoustical ceiling tiles throughout interior of structure. Wood flooring swollen/decaying and plaster walls are mold filmed throughout due to constant moisture conditions. Mold remediation required throughout.

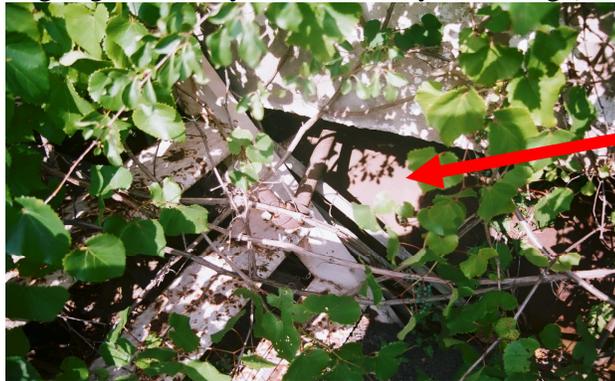
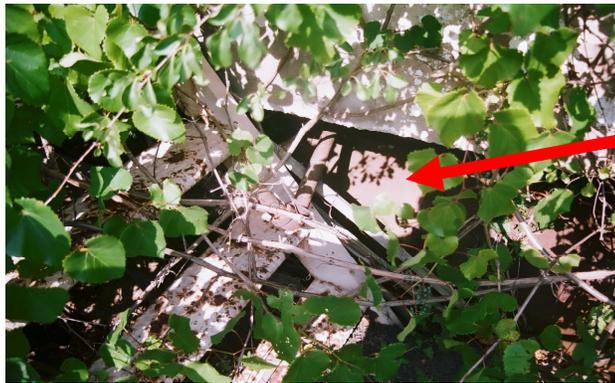
MISC. PHOTO #2

- **Oil Storage Tank** – Old rusted oil storage tank (estimated 250-gallon size) located beneath skirt/stairwell near garage door entry. This tank may be leaking (see Photo #2).

13.6.1 Oil Storage Tank: Assess and evaluate above ground tank for oil leak. Remove or replace as deemed necessary. Rusted old (estimated 250 gallon) oil storage tank located beneath stairwell/skirt area near garage door entry.

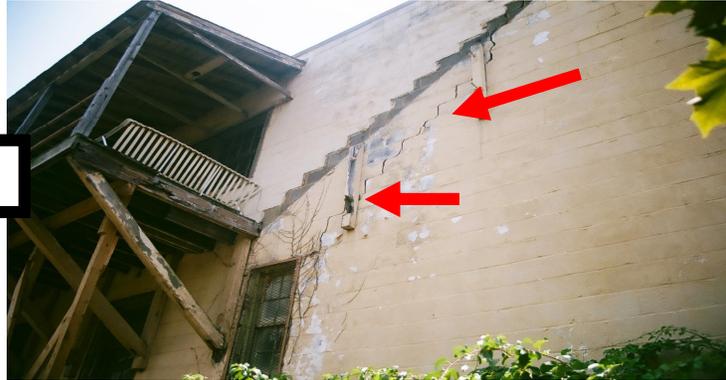
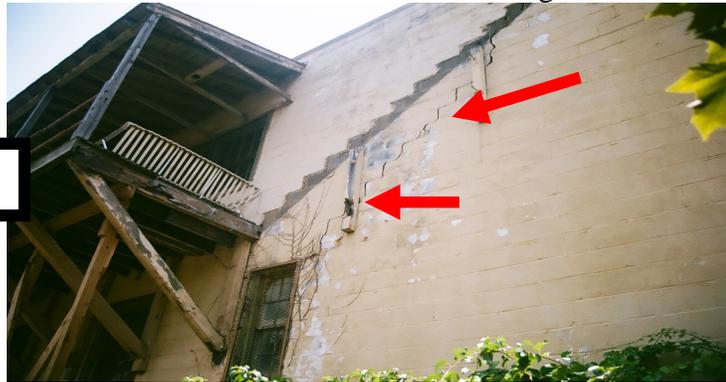
MISC. PHOTO #3

- **Structural** – Large crack exists in concrete wall extending from second Floor to first Floor (see Photo #3).

- 13.7.1 **Structural:** Repair large crack in west side area of building. Large crack exists in concrete wall extending for second floor to first floor.

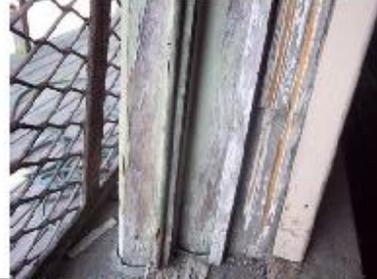
Photo #2: Peeling LBP on Window Jamb 2nd Floor

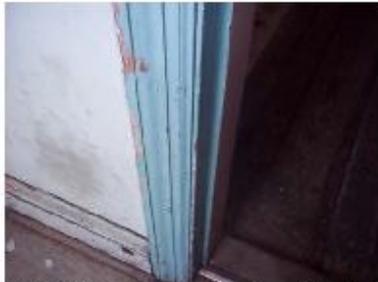
Photo #3: Peeling LBP on Door Casing and Jamb 2nd Floor

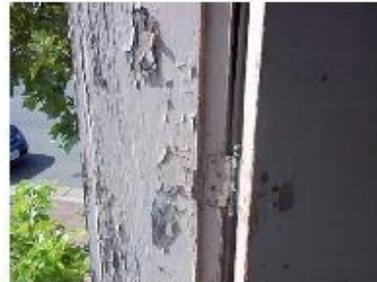
Photo #4: Peeling LBP on Door Jamb 1st Floor

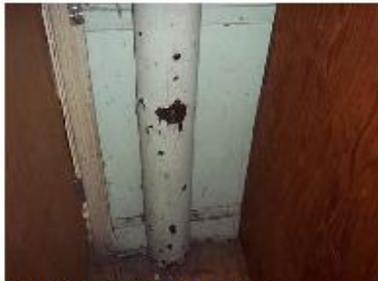
Photo #5: Peeling LBP on Support Posts 1st Floor

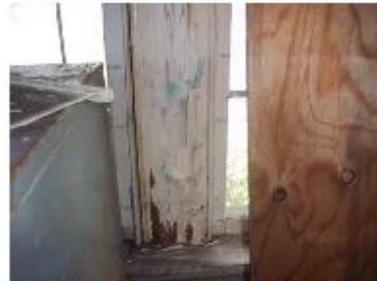
Photo #6: Peeling LBP on Window Partition Bead 1st Floor

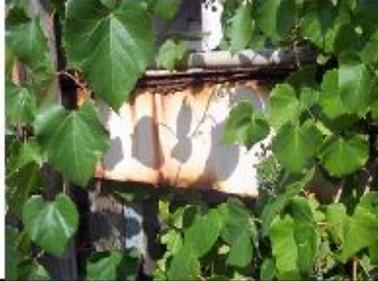
Photo #7:	Peeling LBP on Skirt Board Exterior
-----------	--

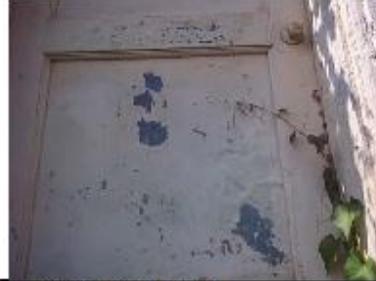
Photo #8:	Peeling LBP on Door Exterior Rear
-----------	--------------------------------------

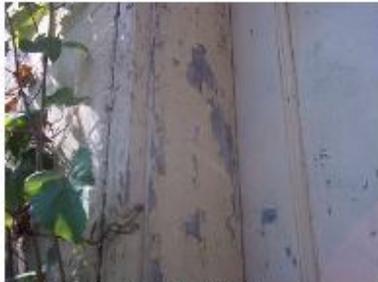
Photo #9:	Peeling LBP on Door Jamb Exterior Rear
-----------	---
