Re: Lead-Based Paint Screening Inspection
0 Prince Street
Alexandria, VA 22314

One Source Environmental Project Number: 76-005

LEAD PAINT INSPECTION REPORT

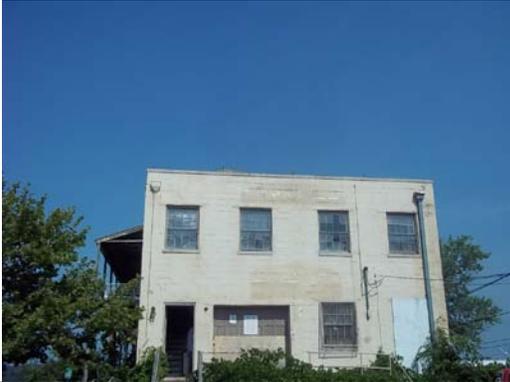
Photo #1:	Front of Site
-----------	---------------

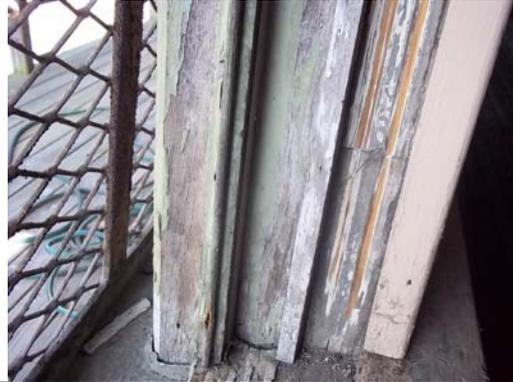
Photo #2:	Peeling LBP on Window Jamb 2 nd Floor
-----------	---

At a minimum the deteriorated paint classified in poor (P) condition in the attached xrf report and the tables above should be stabilized with specialized cleaning by certified personnel and cleared by a certified risk assessor. The owner may choose to permanently abate the LBP and/or leaded components by stripping or replacing such components.

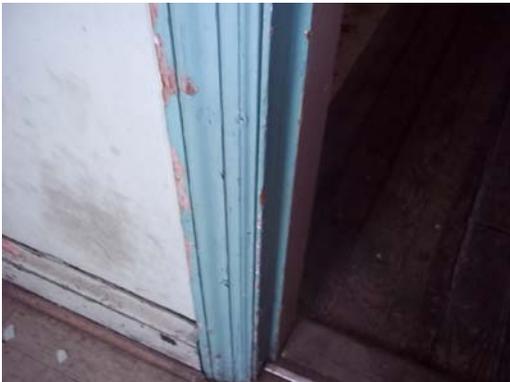
Photo #3:	Peeling LBP on Door Casing and Jamb 2 nd Floor
-----------	--

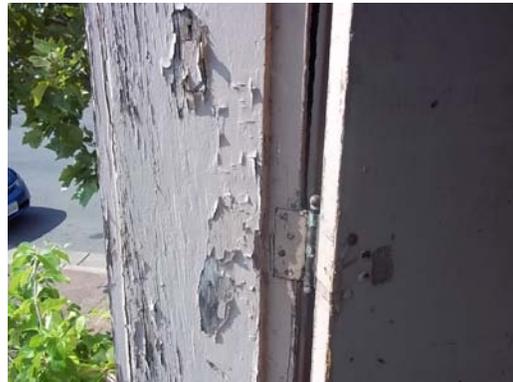
Photo #4:	Peeling LBP on Door Jamb 1 st Floor
-----------	---

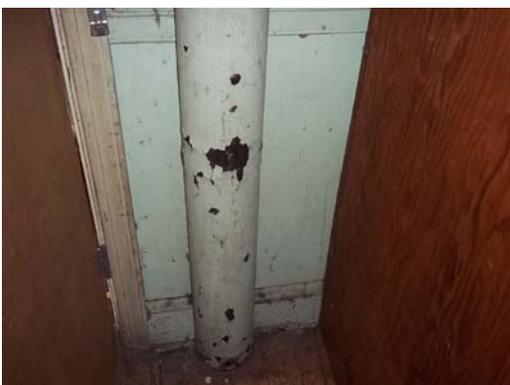
Photo #5:	Peeling LBP on Support Posts 1 st Floor
-----------	---

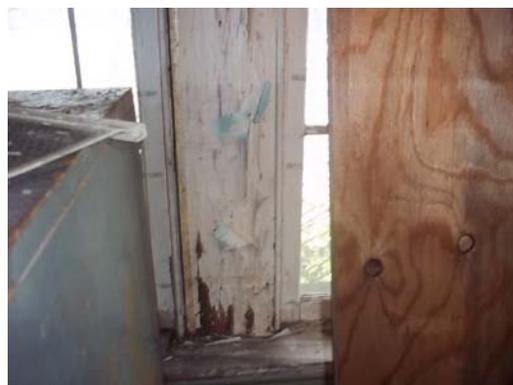
Photo #6:	Peeling LBP on Window Partition Bead 1 st Floor
-----------	---

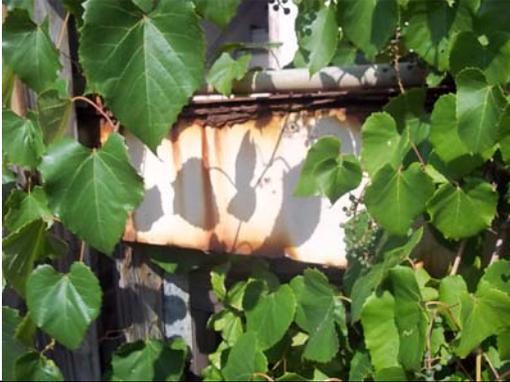
Photo #7:	Peeling LBP on Skirt Board Exterior
-----------	--

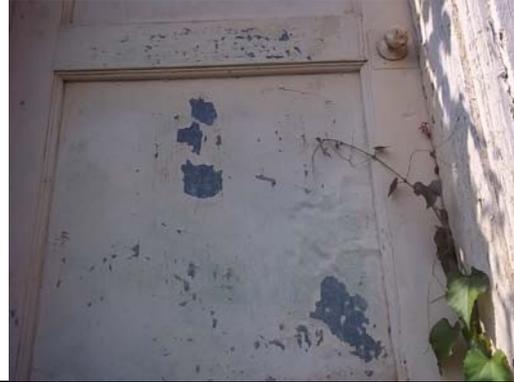
Photo #8:	Peeling LBP on Door Exterior Rear
-----------	--------------------------------------

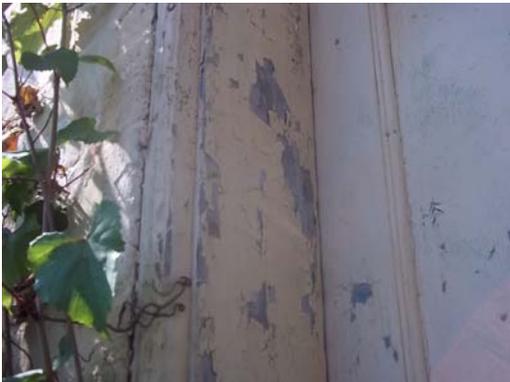
Photo #9:	Peeling LBP on Door Jamb Exterior Rear
-----------	---
