**Seminary Road / Beauregard Street  
Corridor(s) Traffic Study**

**Final Report**

Prepared for:  
**City of Alexandria, Virginia**

**January 19, 2007**

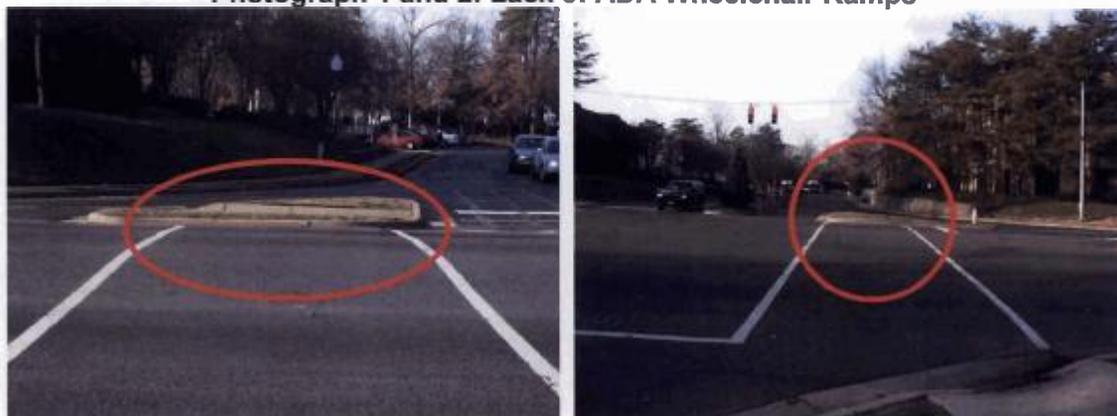
Most intersections along the corridor have ADA wheelchair ramps to provide access for disabled pedestrians. However, ADA wheelchair ramps do not exist at crosswalk termini in two locations on the west side of Beauregard Street at Highview Lane. Photographs 1 and 2 show the existing crosswalks crossing Beauregard Street that lack ADA ramps. All other crosswalks at this intersection have ADA ramps.

**Photograph 1 and 2: Lack of ADA Wheelchair Ramps**

- Add the missing ADA wheelchair ramps on the west side of the intersection.
- Add missing pedestrian signal heads at the intersection of Seminary Road and Beauregard Street and replace sidewalks in poor condition to improve pedestrian safety and mobility at this intersection.

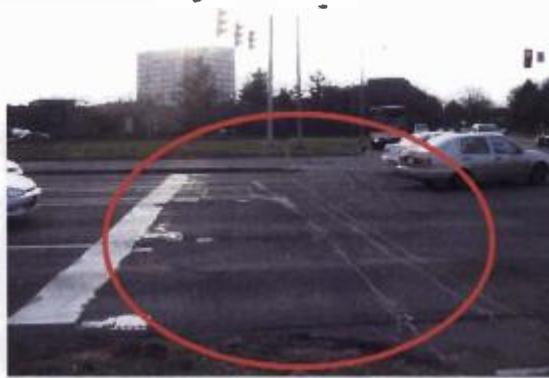
Further north, the sidewalk on the east side of Beauregard traverses alongside the Mark Center property to the intersection of Seminary and Mark Center Drive and does not provide access across the channelization island at the intersection with Seminary Road. In addition, on the east leg of Seminary Road at Beauregard Street, a crosswalk does not exist for pedestrians to cross Beauregard Street at this location, as shown by Photograph 3.

**Photograph 3: Lack of a Marked Crosswalk at Seminary Road / Beauregard Street Intersection**

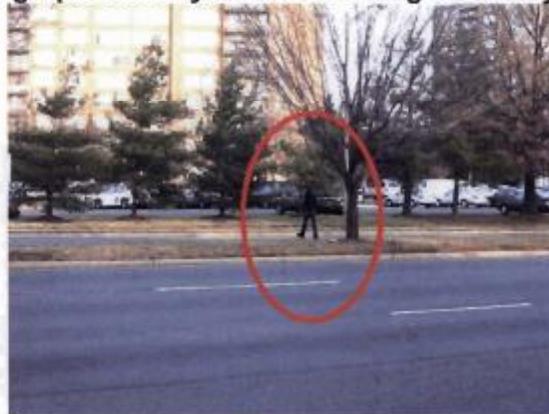
Pedestrians, traversing along the east side of Beauregard Street, must instead cross Beauregard at Mark Center Drive and travel along the west side of Beauregard to cross Seminary Road, then must cross Beauregard again if their final destination is on the east side of Beauregard. The lack of a crosswalk on the east leg of this intersection can encourage jaywalking, as shown in Photograph 4.

**Photograph 4: A Jaywalker Crossing Seminary Road**

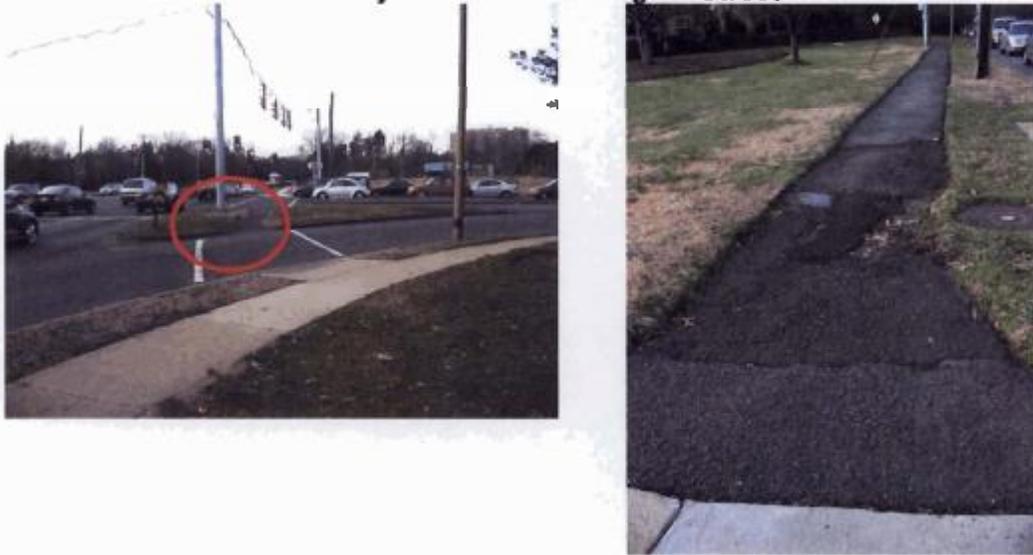
Along Seminary Road, the sidewalk is continuous; however, there exist locations where the width is substandard or the sidewalk is in poor condition. In the northeast quadrant of the intersection with Beauregard, the sidewalk in the channelized island is asphalt and in poor condition, not to mention less than four feet wide, as shown in Photograph 5. This could pose some mobility constraints for the disabled. Photograph 6 shows the poor condition of the sidewalk in the southwest quadrant of the same intersection.

**Photograph 5 and 6: Poor Condition of Sidewalk in the Intersection of Seminary Road and Beauregard Street**

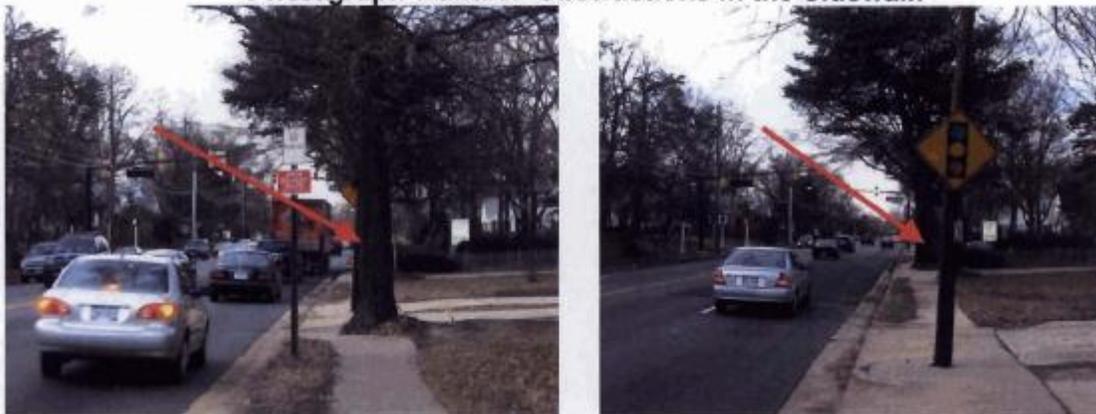
Continuing westward from Beauregard, there are locations along the north side of Seminary at which the sidewalk curves around mature trees, or there is a pole in the middle of the sidewalk. In both cases, the effective width of the sidewalk is less than four feet, which could cause difficulty for disabled pedestrians. Photographs 7 and 8 present several samples of obstructions for pedestrians along the sidewalk on the north side of Seminary Road.

**Photograph 7 and 8: Obstructions in the Sidewalk**

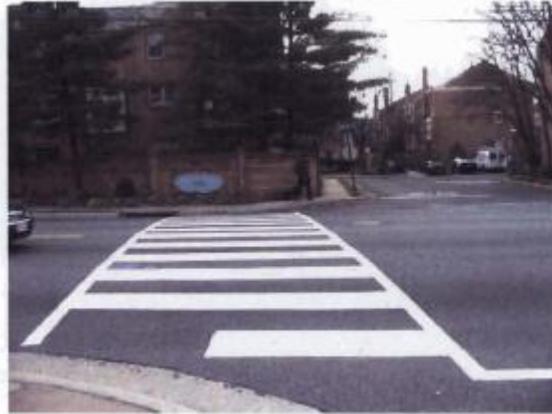
An unsignalized crosswalk, marked with high visibility markings, exists on Seminary Road at the intersection with Fairbanks Avenue. The crosswalk is signed in advance with pedestrian crosswalk signs in both directions on Seminary Road. Photograph 9 shows the crosswalk markings at this location.

**Photograph 9: Marked Crosswalk at  
Fairbanks Avenue**

- Install pedestrian-actuated flashers for the crosswalk on Seminary Road at Fairbanks Avenue activated by pedestrian pushbuttons.
- Install missing crosswalk markings for the pedestrians crossing Seminary Road at Echols Avenue.

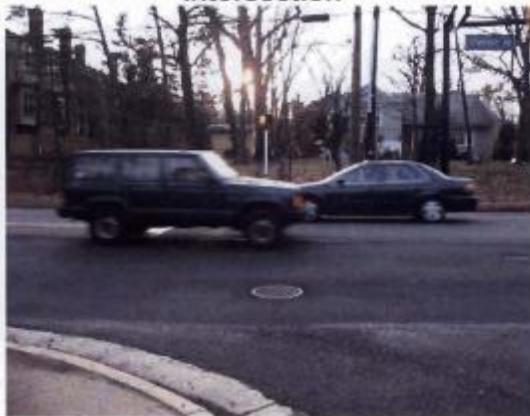
At the intersection of Seminary Road and Echols Avenue, pedestrian signal heads exist for pedestrians crossing Seminary Road on the east side of the intersection, however; a marked crosswalk does not currently exist, as shown in Photograph 10. The signal was recently reconfigured, and the old crosswalk markings were eradicated, but new crosswalk markings were not installed. In addition, the Echols Avenue crosswalk on the north side of the intersection is marked only halfway across the roadway. It is possible that both the lack of a crosswalk across Seminary Road and the partial removal of the Echols Avenue crosswalk are due to utility work which included excavation within the roadway. Once all utility work is completed in this section of roadway, the pedestrian crosswalk markings should be installed as necessary.

**Photograph 10: Unmarked Crosswalk  
at the Seminary Rd / Echols Ave  
Intersection**

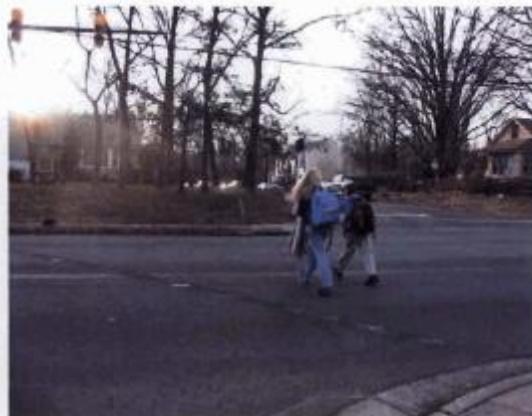
**Photograph 11: Students Crossing  
Seminary Road at Echols Avenue**

Currently a crosswalk does not exist across Seminary Road on the west side of this intersection. However, Metrobus stops exist along both eastbound and westbound Seminary Road on the west side of this intersection. A westbound school bus was also observed stopping and discharging students between the Echols Avenue legs of the intersection. As a result of the lack of a crosswalk, Metrobus riders and school children cross Seminary Road in locations other than where the crosswalks are currently located.

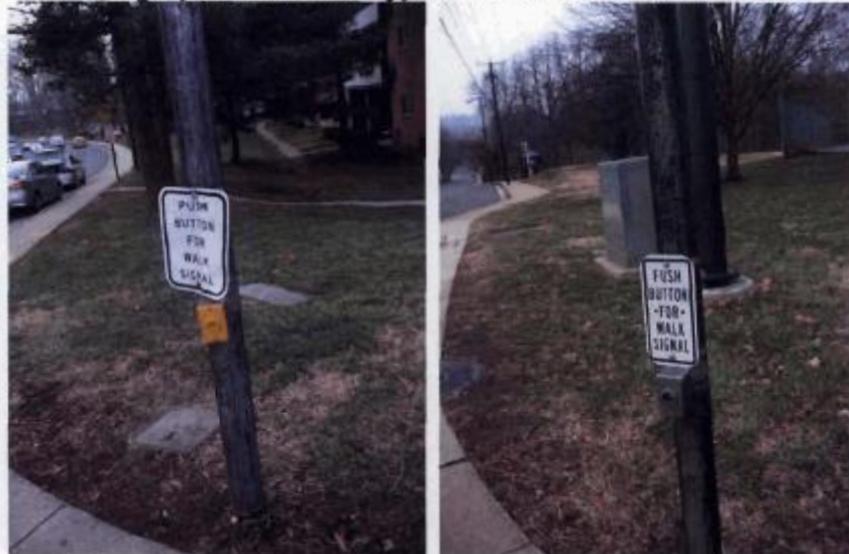
Pedestrian signal heads exist at most signalized intersections within the study area where crosswalks are present. In most instances where there are pedestrian signal heads, there are pedestrian pushbuttons. The pedestrian pushbuttons present throughout the corridor are typically not compliant with current ADA standards.

**Photograph 12 and 13: Typical Pedestrian Push Buttons**

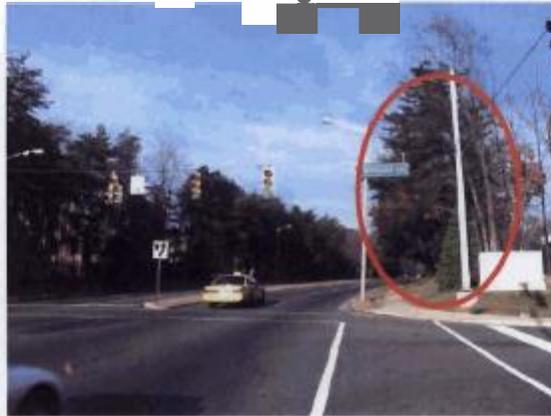
There are some locations along Beauregard at which pedestrian signal heads do not exist. As shown in Photograph 14, the crosswalk across the east leg of Beauregard and Rayburn Avenue does not have pedestrian signal heads. Pedestrians crossing at this location must rely on the traffic signal heads to determine when it is safe to cross.

**Photograph 14: Lack of Pedestrian Signal Heads**

- Relocate pedestrian pushbuttons on Beauregard Street at Rayburn Avenue onto a pushbutton pole so that mobility-impaired pedestrians may be able to access the buttons, and install missing pedestrian signal heads to provide a safe crossing for pedestrians.

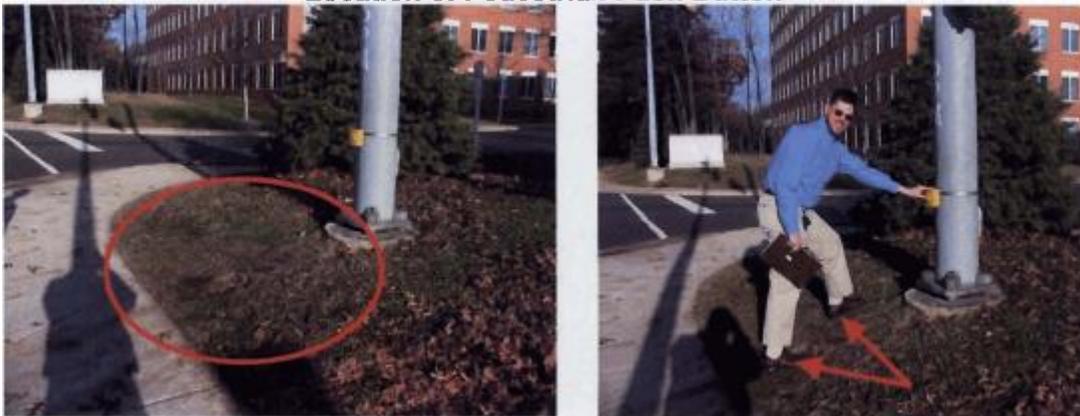
At the same intersection, the pushbutton in the southeast quadrant is located on the traffic signal pole. Pedestrians must step up a small hill to reach this push button, as demonstrated in Photographs 15 and 16. Pedestrians with mobility impairments may not be able to reach the pushbutton.

**Photographs 15 and 16: Pedestrian Impedance Due to Poor Location of Pedestrian Push Button**

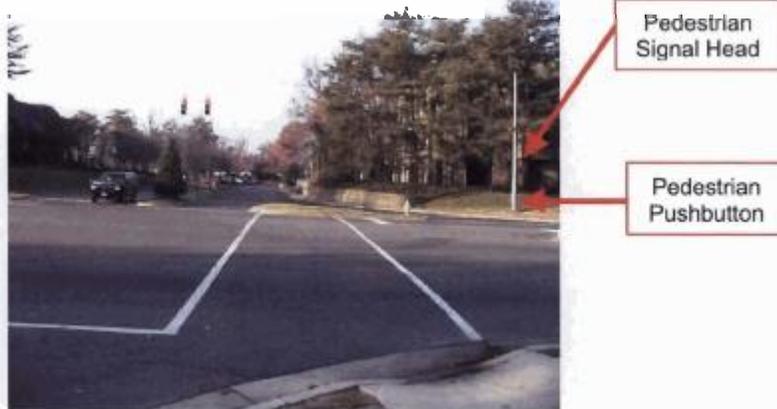
Although pedestrian signal heads exist at the intersection of Beauregard Street and Highview Lane, they are not located near the crosswalks on the west side of the intersection. Pedestrians have to look at an angle away from the intersection to see the pedestrian signal heads on the signal pole, as shown in Photograph 17. Also, the pedestrian push buttons on the west side of the intersection are not located adjacent to the crosswalk, but rather across the channelized right turn lanes, as shown in the same photograph. This means that a pedestrian has to push the button and cross the channelized turn lane to reach the channelization island and the crosswalk.

**Photograph 17: Poorly Placed  
Pedestrian Signal Head and Pushbutton**

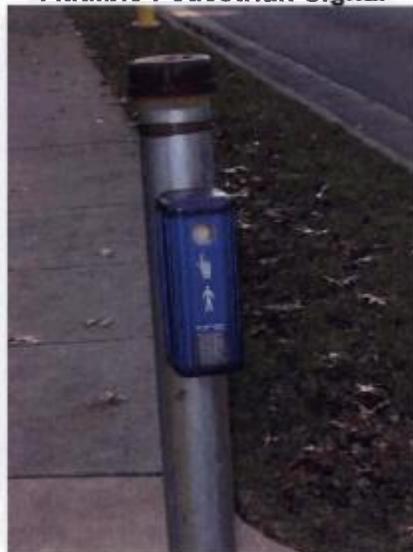
The pedestrian push buttons at Beauregard Street and Mark Center Drive include audible pedestrian signals, shown in Photograph 18, for pedestrians crossing the south and east legs of the intersections.

**Photograph 18:  
Audible Pedestrian Signal**

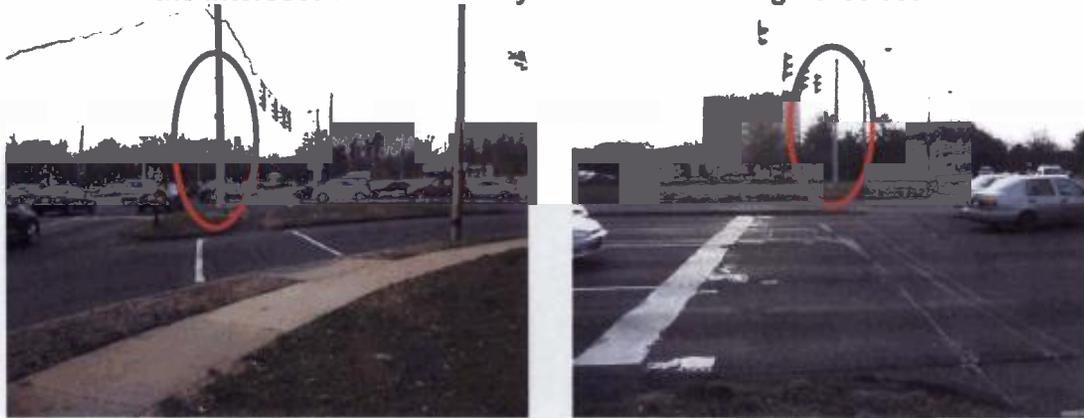
At the intersection of Seminary Road and Beauregard Street, pedestrian signal heads do not exist, as shown in Photographs 19 through 22. This is the only signalized intersection within the study area that does not have any pedestrian signal heads. The current proposed signal modification will added pedestrian signal heads only on the north and west legs of the intersection.

**Photographs 19 and 20: Lack of Pedestrian Signal Heads at the Intersection of Seminary Road and Beauregard Street**

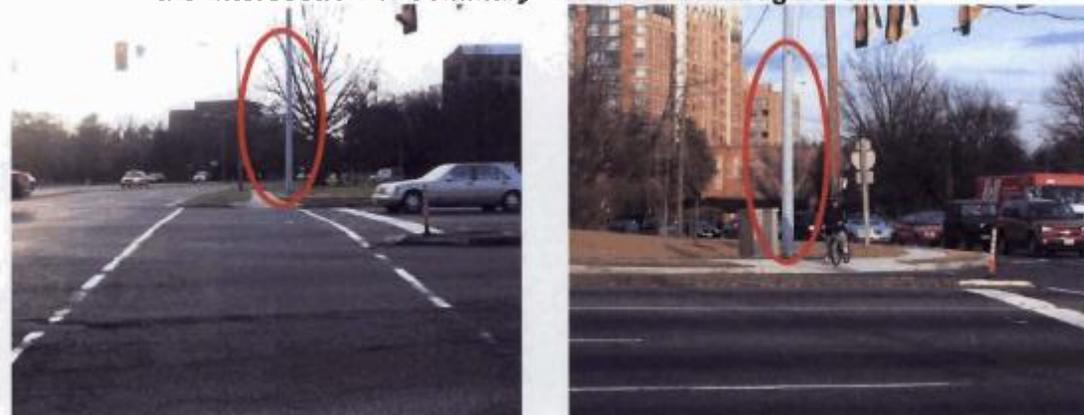
**Photographs 21 and 22: Lack of Pedestrian Signal Heads at the Intersection of Seminary Road and Beauregard Street**

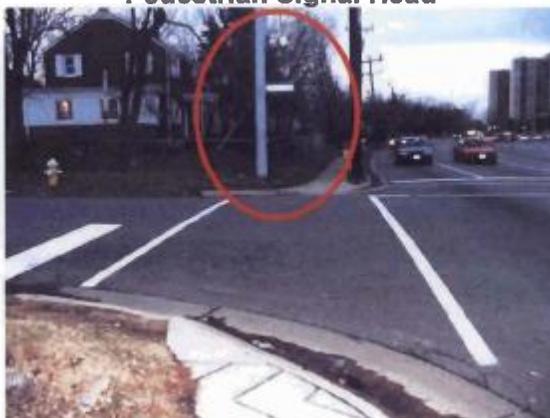
Three marked crosswalks exist at the intersection of Seminary Road and Dawes Avenue; however, the south leg does not have pedestrian signal heads, as shown in Photograph 23.

**Photograph 23: Lack of  
Pedestrian Signal Head**

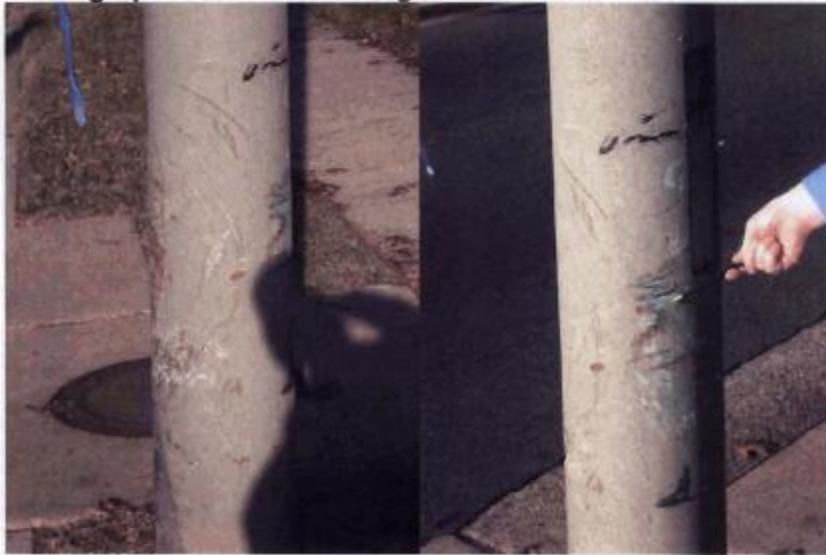
The concept of a Clear Zone is to provide enough distance between the edge of the traveled way and an object to allow a vehicle that leaves the roadway the ability to recover without hitting the object. The Virginia Department of Transportation (VDOT) has identified 7.5 feet as the desirable, and 1.5 feet as the absolute minimum, clear zone behind a curb. There are several locations along Beauregard Street in which there are street light poles that are within the absolute minimum requirements. Most of these light poles seem to have not caused any safety issues. But the pole located in the northeast quadrant of the intersection with Rayburn Avenue has paint scraps from where it has been struck by more than one vehicle, as illustrated in photographs 24 and 25.

**Photographs 24 and 25: A Light Pole Which Has Been Struck**

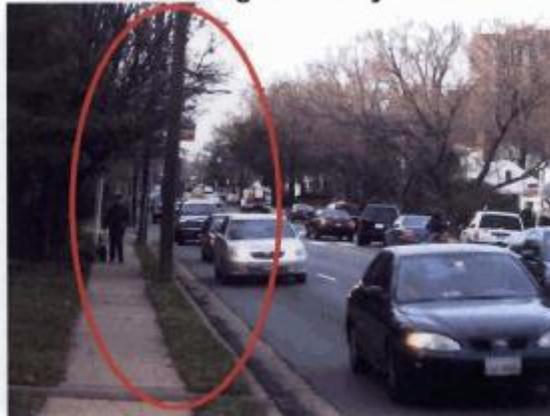
Seminary Road also has poles (power and communications) in the streetscape area along the south side of the roadway, between the back of curb and the sidewalk, from Beauregard Street to Colfax Street, as shown in Photograph 26. In this area, the narrow right-of-way leaves little room for the poles and signs, necessitating their placement within the Clear Zone. During the field reconnaissance, no pole or sign was observed to have been struck by a vehicle.

**Photograph 26: Narrow Streetscape  
Zone along Seminary Road**

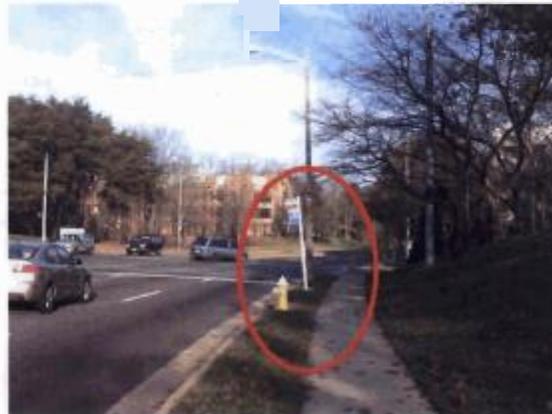
Access to transit service is good, as stops are distributed fairly evenly throughout the corridor. Access is not an issue in the study area, but rather the conditions of several stops, as well as the specific location of stops in relationship to the crosswalks. Several locations along Beauregard Street do not have a concrete pad between the sidewalk and curb; transit users currently step onto the grass streetscape area. This could cause some problems as people step out of the bus onto the grass to reach the sidewalk, as they could lose their footing. Photograph 27 shows a typical location on Beauregard Street which would need a concrete pad.

**Photograph 27: Typical Location Lacking a Concrete Pad for Transit**

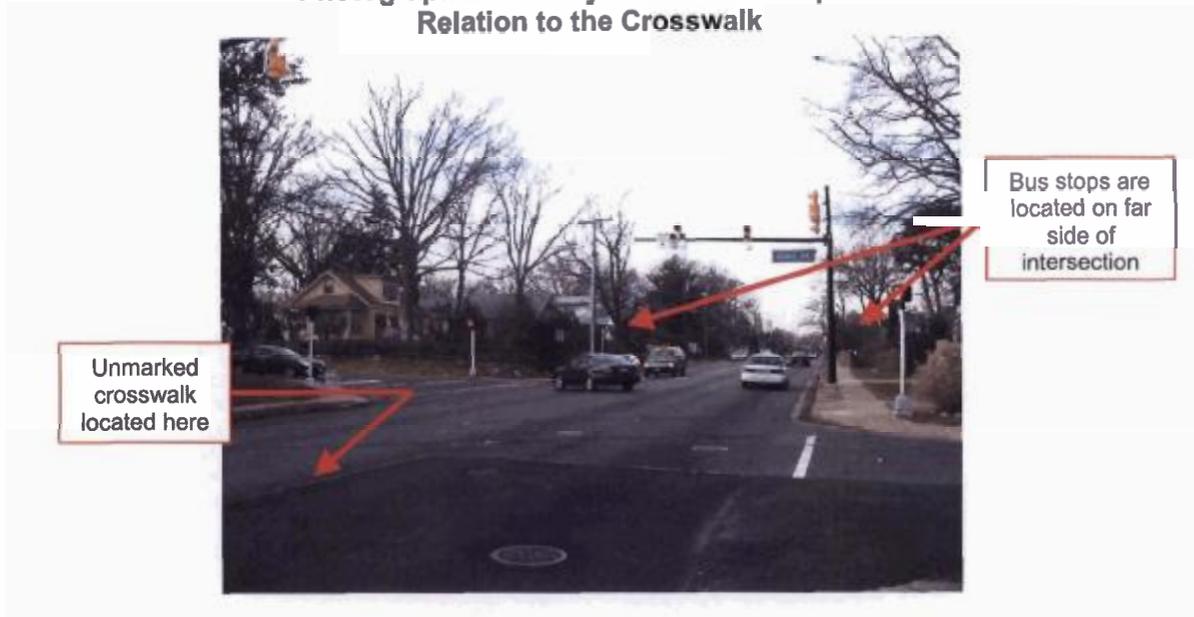
Several locations also exist along Seminary Road at which a concrete pad is needed for the same reason. The locations of some bus stops along Seminary Road should be relocated, such as the stops adjacent to the intersections with Echols and Dawes Avenue, so they are on the same side of the intersection as the crosswalks. There is one crosswalk across Seminary Road at Echols Avenue but the bus stops for both directions on Seminary Road are located on the other side of the intersection. These stops should be relocated to the same side of the intersection as the crosswalk to minimized pedestrian movements through the intersection. Photograph 28 illustrates this fact.

**Photograph 28: Poorly Placed Bus Stops in Relation to the Crosswalk**

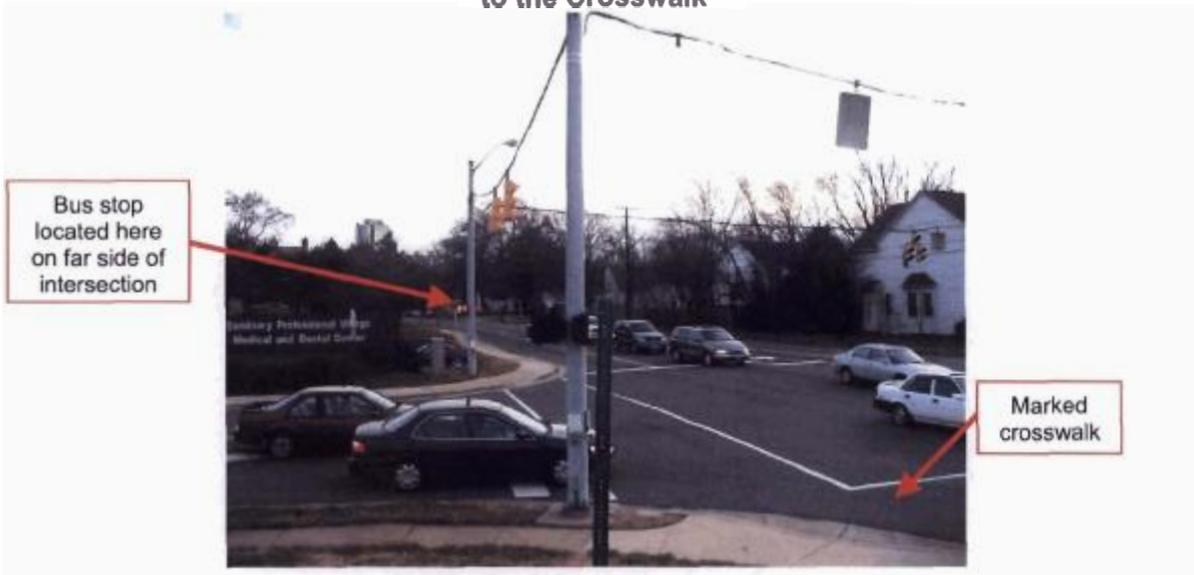
This also occurs at one of the bus stops at the intersection of Seminary road and Dawes Avenue, as illustrated in Photograph 29. The bus stop should be relocated to the same side of the intersection as the crosswalk, or a new crosswalk and pedestrian signal heads should be installed.

**Photograph 29: Poorly Placed Bus Stop in Relation to the Crosswalk**
