# TECHNICAL MEMORANDUM

RE: **SITE RECONNAISSANCE AND INVENTORY**

This memorandum documents the site reconnaissance and existing conditions assessment in support of the City of Alexandria waterfront planning efforts. The purpose of this investigation was to obtain an initial understanding of the material type, extent and condition of the shoreline treatment (e.g. steel and timber bulkheads, rip-rap, pavement, “natural” vegetation, etc.) and structures (e.g. piers, wharfs, etc.) along the waterfront. The preliminary observations of existing conditions were based on review of existing data and site investigations performed during the week of May 17 – 23, 2009. This reconnaissance-based rating should not be construed as a structural condition assessment, but rather as a preliminary evaluation.

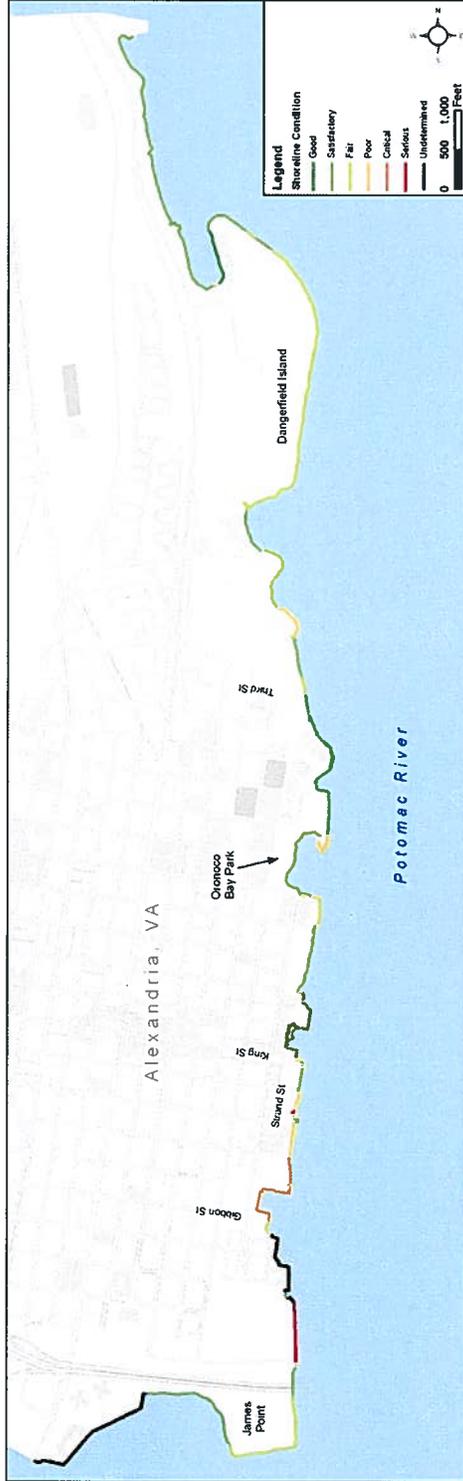
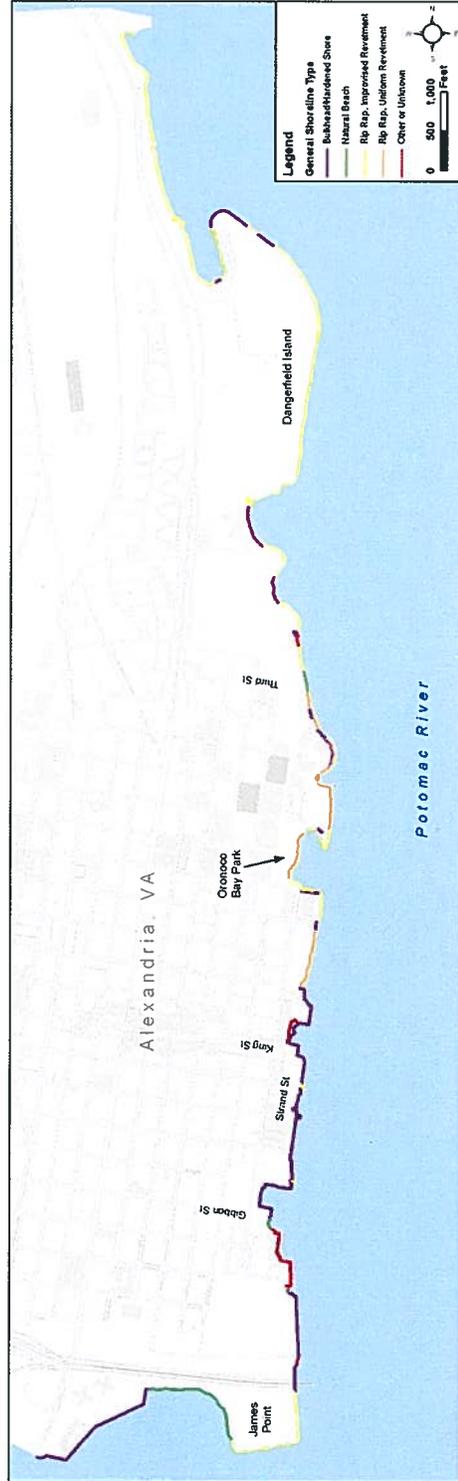
Figure 2. General Shoreline Treatment and Preliminary Condition

A summary of the existing condition assessment of the shoreline is compiled in **Table 6** and illustrated in **Figure 2**. Approximately 75% of the shoreline stabilization is characterized as fair or better and appears to be meeting its intended use without any repairs needed.

Less than 15% of the shoreline was identified to be in poor to critical condition. There were four shoreline reaches (250 feet or less) categorized as being in poor condition that are distributed along the City shoreline from south of Mirant energy to south of “the Strand” (Figure 2). Figure 3 illustrates one of the reaches with poor conditions; a concrete paved revetment fronting the parking area adjacent to Nina’s Dandy has been undermined.

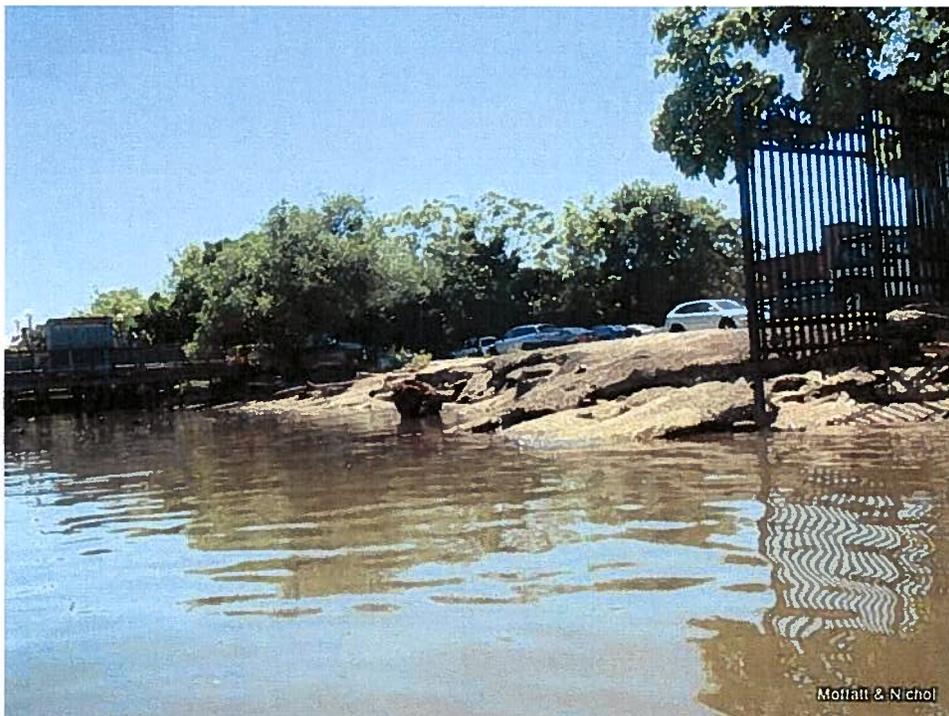
**Figure 3 View of the concrete revetment shoreline in front of the parking lot at the Strand.**

As identified above, the majority of the existing shoreline treatment and structures were classified based on the preliminary observations as meeting intended structural use. Specific reaches of the public shoreline (e.g. parking area fronting the Strand, bulkhead at Windmill Hill Park) categorized as being in poor or critical condition as well as those areas of concern identified by the city staff (December 1, EDAW/AECOM), should be prioritized for further evaluation and improvement.

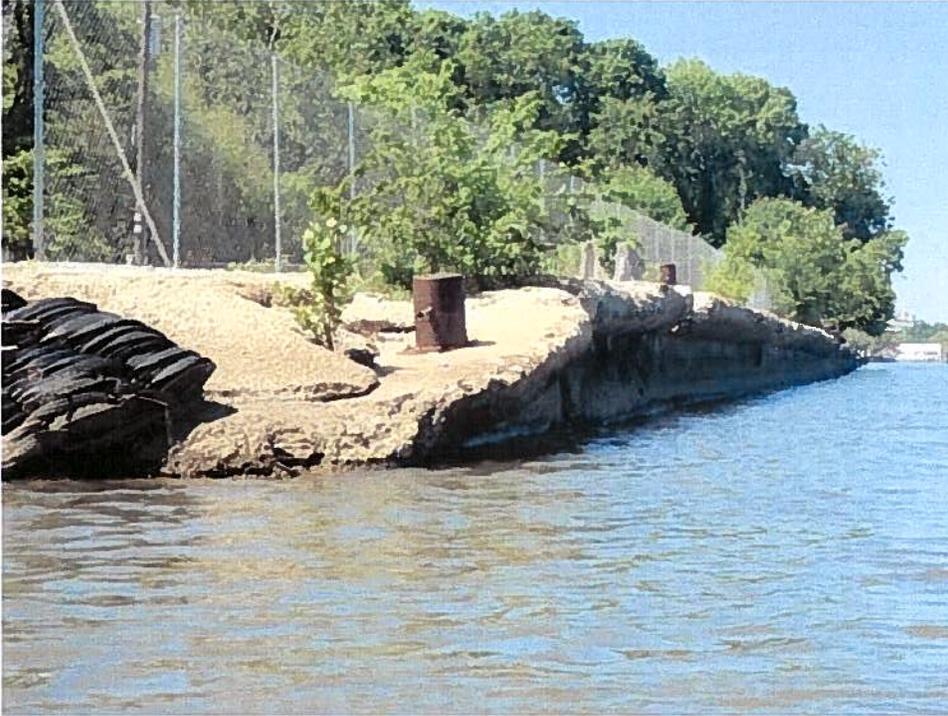
The shoreline which is considered to be in either serious or critical condition includes the bulkhead at Windmill Hill Park (approximately 956 linear feet) and the reach of concrete bulkhead north of the Woodrow Wilson Bridge (approximately 1,000 linear feet). Figure 4 and Figure 5 illustrate existing conditions of the shoreline at Windmill Hill Park and north of the Woodrow Wilson Bridge.

**Figure 4. View looking north of the concrete bulkhead north of the Woodrow Wilson Bridge**

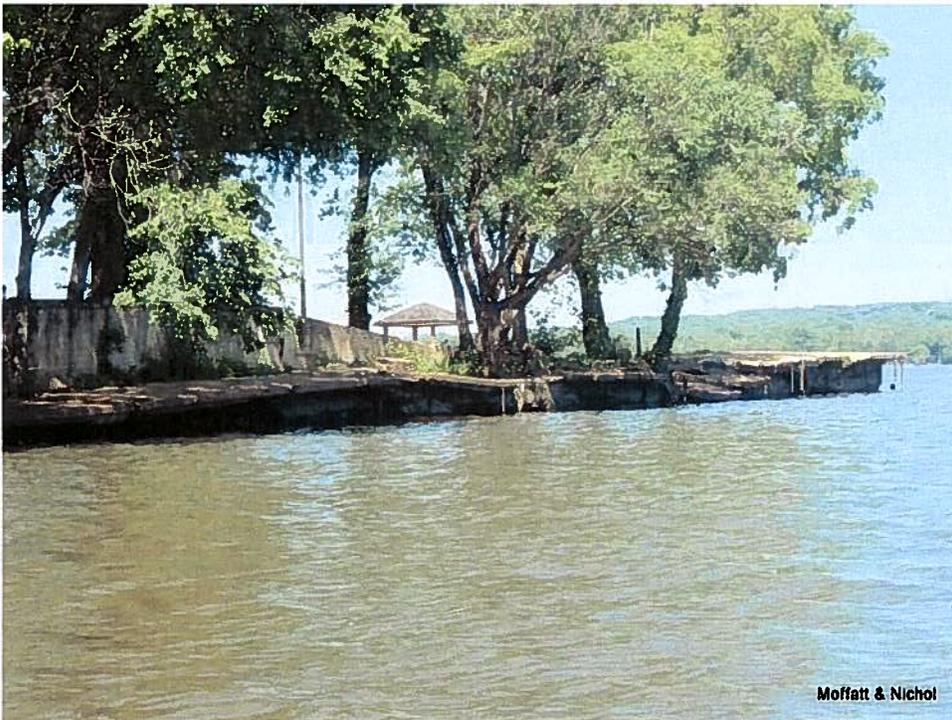
**Figure 5. View looking at the north shoreline of Windmill Hill Park**

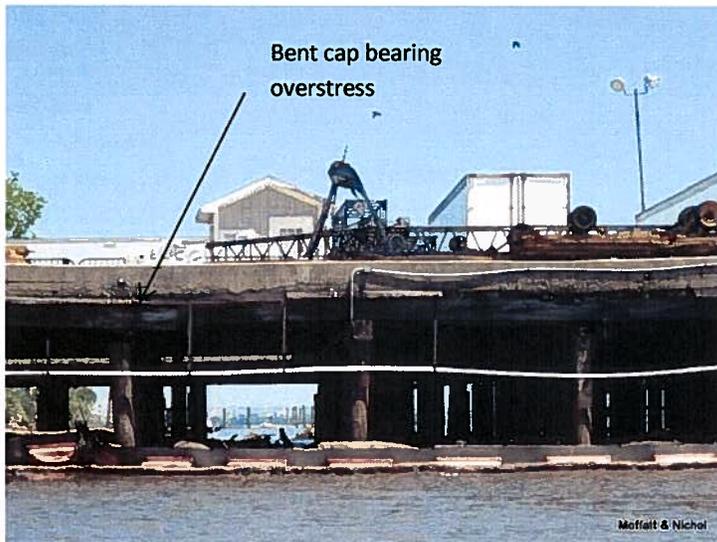
The timber piles in Area B are in satisfactory condition overall. The timber bent caps are rotten in many instances and may be susceptible to bearing overstress. Bearing overstress has already occurred in one location on the South Face of the structure. The concrete deck sags significantly in this location (**Figure 12**). The timber stringers show little visual indication of rot, but it is very possible that rotten stringers are present based on the observed condition of other timber members. Moderate corrosion is evident on the central steel stringer. Some instances of rot were noted on the timber decking under the concrete deck.

**Figure 12. View of approach looking north at Robinson Terminal North**

In a few locations the timber decking has collapsed exposing the underside of the concrete topping slab. The timber decking is likely susceptible to bearing overstress where they are supported by the timber stringers and central steel stringer. Based on the large section size of the timber decking it is possible that the designer may have accounted for composite action between the concrete deck and the timber decking or at least additional capacity provided by the timber decking. It is also possible that the timber decking was intended to be stay in place formwork. A more detailed inspection would be required to determine the intended purpose of the timber decking, but in either case settlement of the concrete topping slab due to rotten timber decking is possible overtime. The condition of the concrete topping slab was not determined due to limited site access. Overall, based on this preliminary assessment, Area B is classified as Poor.
