**Alexandria Commission for the Arts
Special Meeting**

VI. Condition Assessment

1. Presentation and Receiving of Report – The final report for the City's public art conservation assessment done this fall by Evergreene Architectural Arts was shared with the Commission. Diane Ruggiero gave a quick overview of the 76-page report and answered questions. See [Attachment 4](#).

Conservation Solutions, a division of EverGreene Architectural Arts (EverGreene) was contracted by the City of Alexandria, Virginia to carry out condition assessments of the City's public art collection. This survey builds upon a previous assessment completed by Conservation Solutions in 2013, which is part of the City's mandate to assess the collection within a 5-year cycle. The Alexandria Public Art Collection consists of a number of historically significant memorials and contemporary artworks.

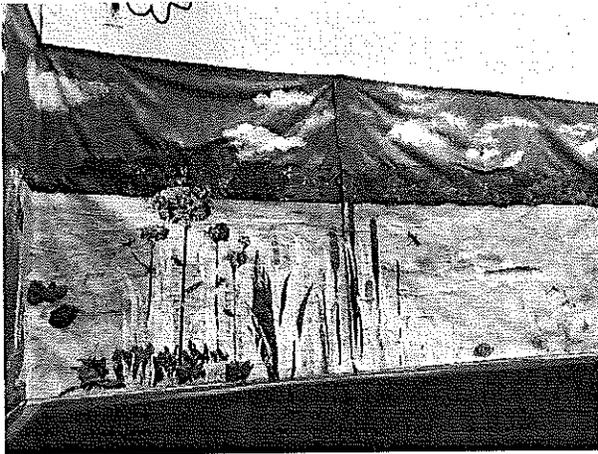
Figure 3: Typical section of canvas exhibiting uneven stretching and bowing due to a lack of structural framework.

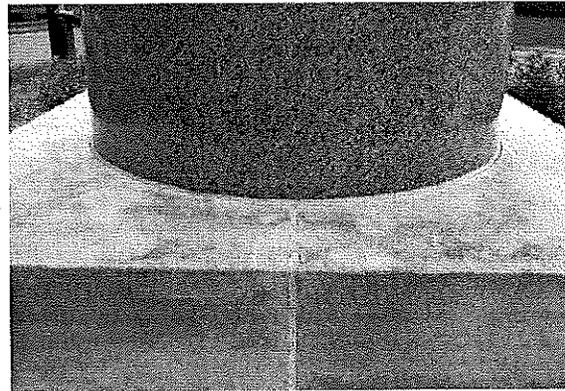
Figure 4. Detail of copper corrosion stains on the limestone base from the bronze plaque.

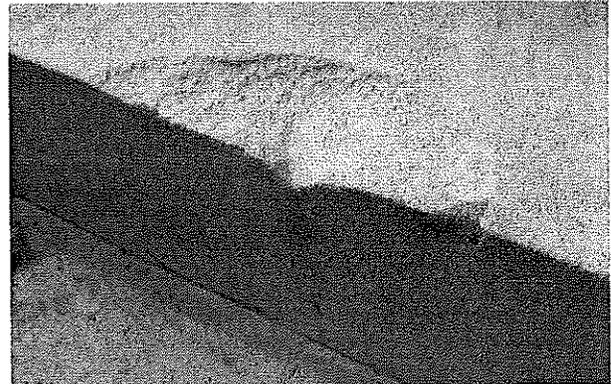
Figure 6. Limestone spall along the base.

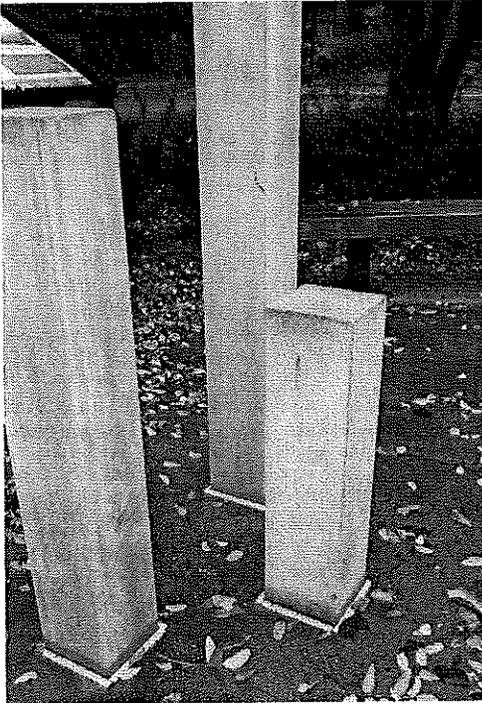
Figure 3. Detail of typical water run- off/streaking pattern down the face of the pillars

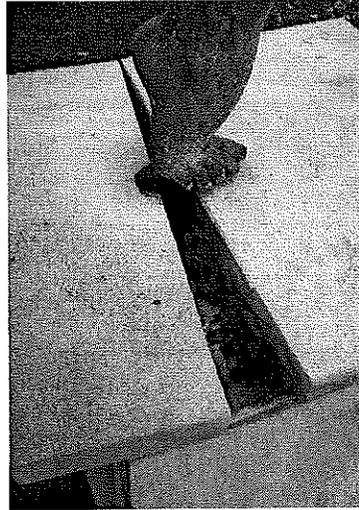
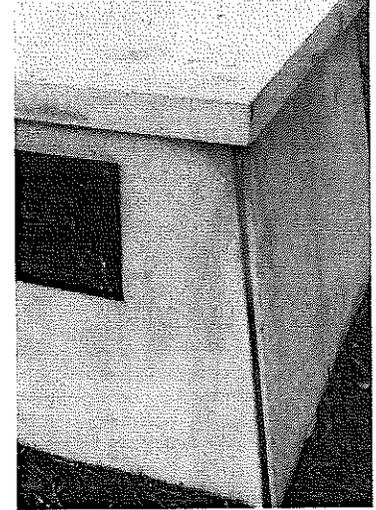
(Left to Right): **Figure 1.** *Brio* measures 8' in height including plinth. **Figure 2.** The cast stones of the pedestal have become displaced. **Figure 3.** Copper staining has discoloured the joints.

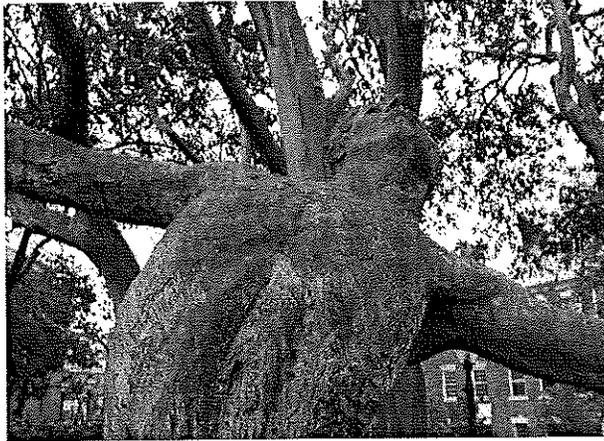
(Left) Figure 4. Detail of general discoloration and soiling on the head and torso of the figure.

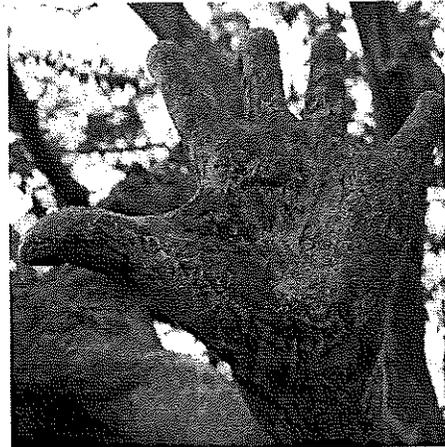
(Right) Figure 5. Detail of advanced corrosion and possible iron staining on the hand of the figure.

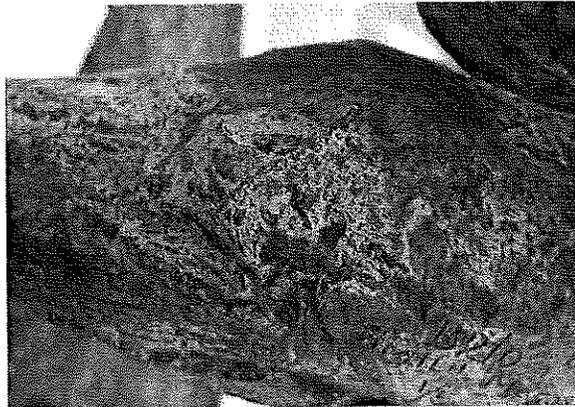
(Left) Figure 6. Detail of patina and additional surface staining.

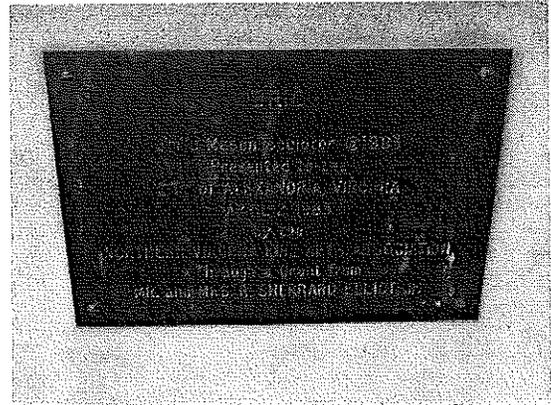
(Right) Figure 7. Dedicatory plaque with pervasive corrosion of the surface.

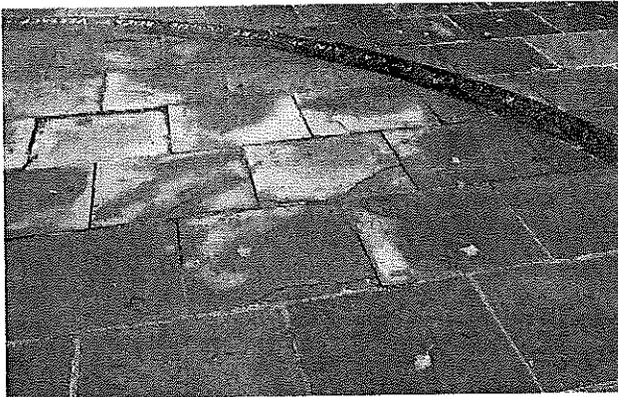
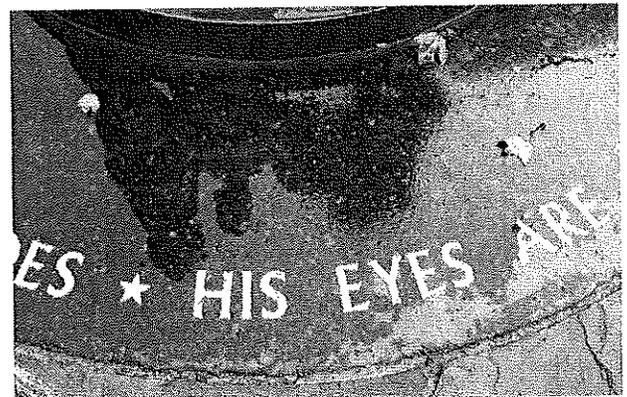
(Left) Figure 3. Slate pavers exhibit minor flaking and mortar loss typical to a highly-trafficked surface.
(Right) Figure 4. Paint is flaking from within the lettering on the inscribed granite pavers.

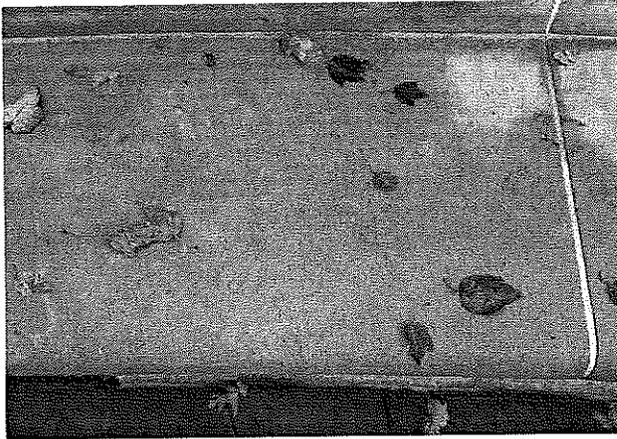
(Left) Figure 5. Localized graffiti on the limestone bench.

If any graffiti is observed, a conservator should be consulted for its removal. Graffiti should be addressed as soon as possible, as it will become more difficult to remove over time. Products and procedures should be tested to determine the safest and most efficient cleaning method. Less aggressive graffiti removal techniques should be attempted prior to the use of more interventive options.

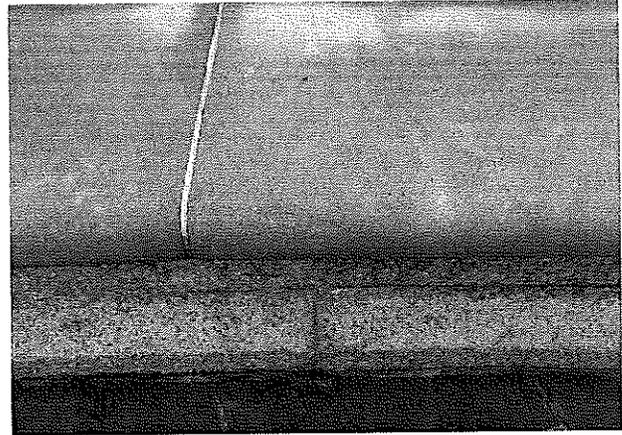
(Right) Figure 6. Staining and discoloration is typical on the granite blocks under the limestone bench.

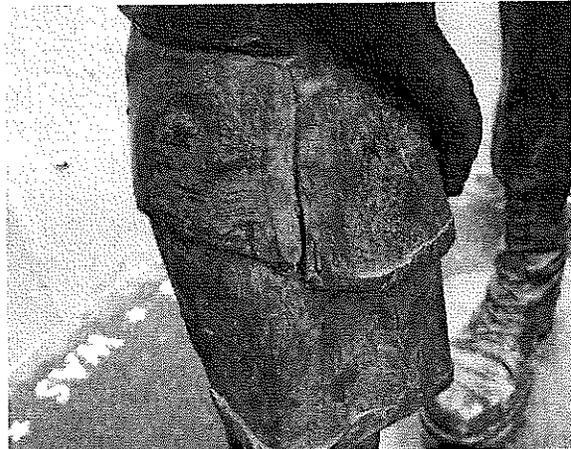
(Right) Figure 8. Minor corrosion has developed in the recesses and folds of the bronze figures. They catch and retain water.

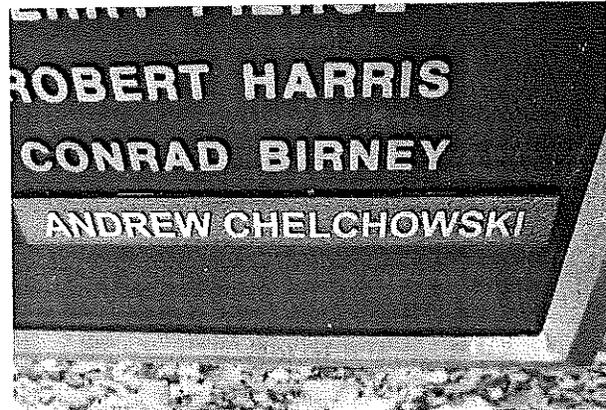
Figure 2. Plaque shows signs of corrosion.

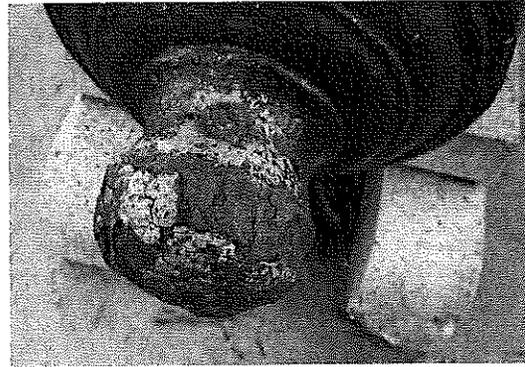
Figure 2. Detail of advanced corrosion.

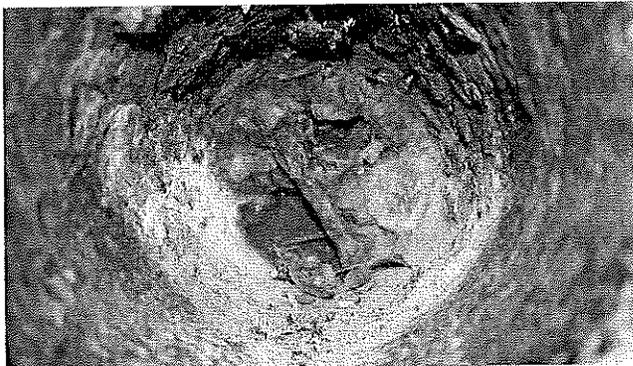
(Left) Figure 3. Interior of muzzle with debris and corrosion.

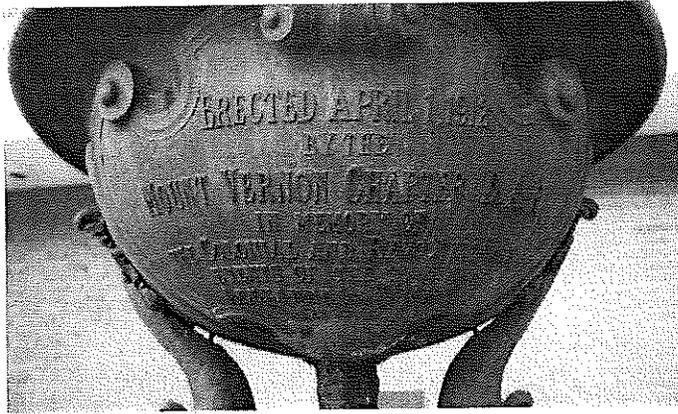
Figure 3. Corrosion on dedicatory inscription on the underside of the upper fountain basin.

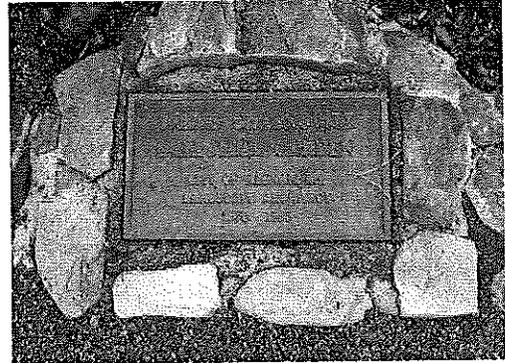
Figure 2. Detail of general soiling and deterioration of plaque.

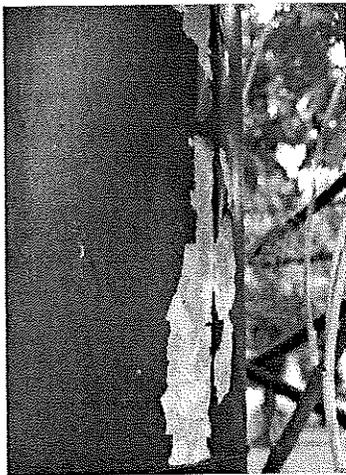
(Left) Figure 3. Detail of paint loss on a steel structural member revealing the galvanized surface below.

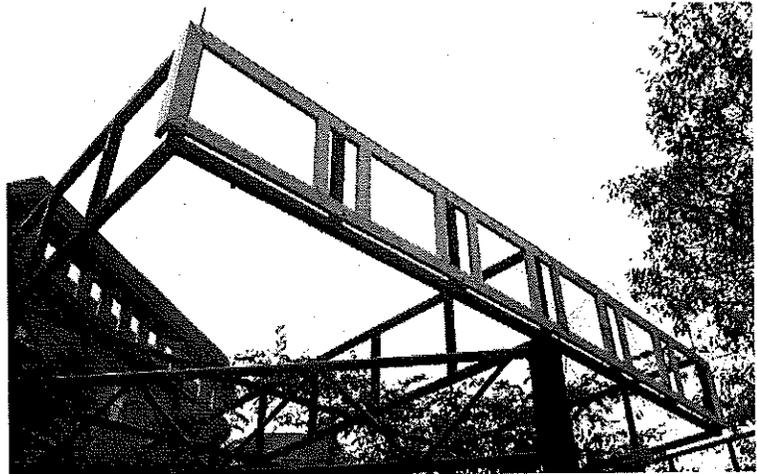
(Right) Figure 4. A secondary wood trellis, painted white is in poor condition.

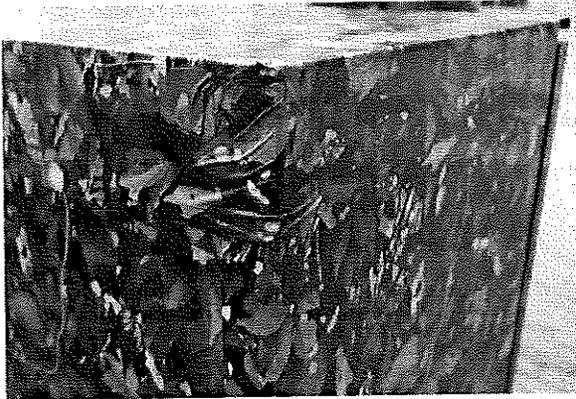
Figure 5. The vinyl wrap surface of the didactic plaque is bubbling in select locations.

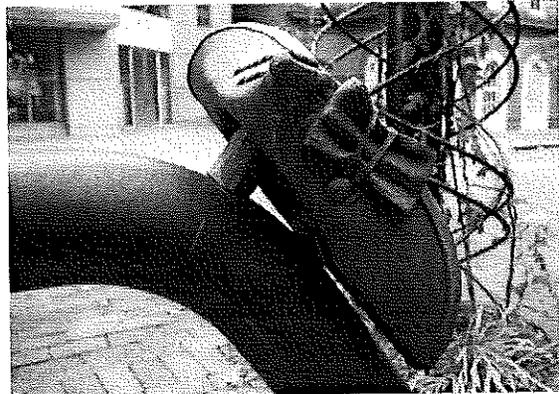
Figure 6. The steel and bronze water fountain exhibits surface deterioration including loss of protective coatings and corrosion.

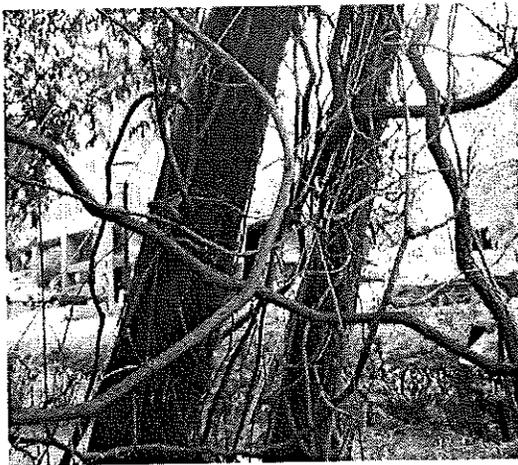
Figure 7. Vegetation on steel introduces water to the metal surface.

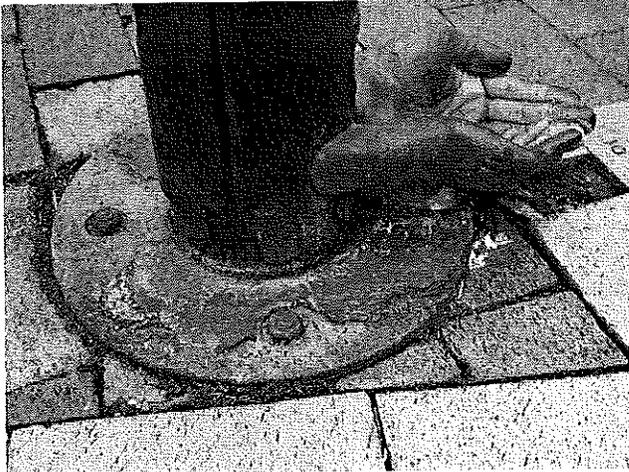
(Left) Figure 11. Detail of advanced corrosion on the steel base of the water fountain with bronze sculptural features.

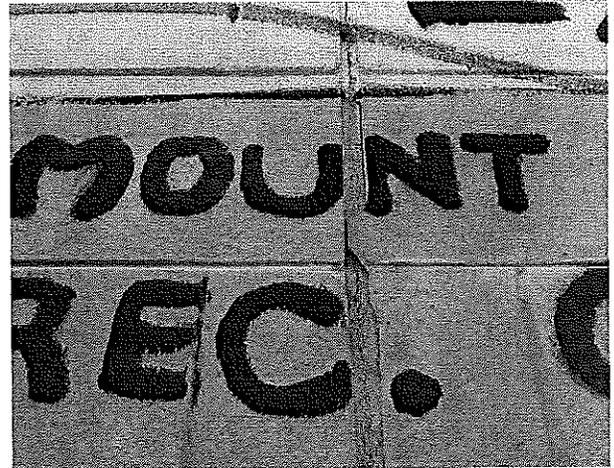
(Right) Figure 8. Paint is failing where it was applied over flexible sealant along the expansion joint.

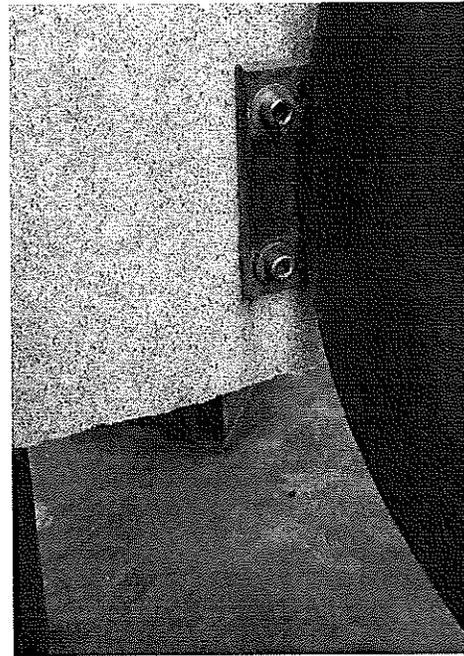
Figure 2. Detail of iron staining the granite.

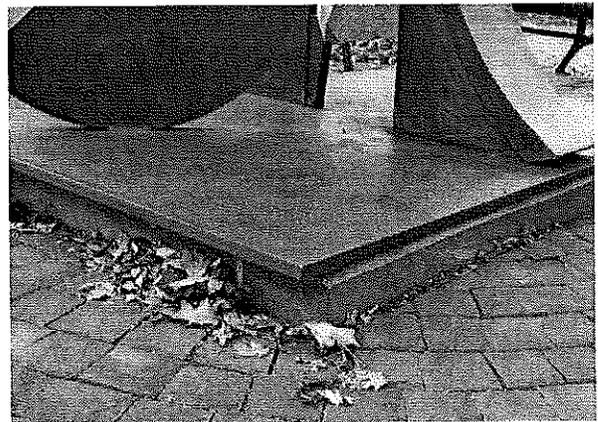
Figure 4. Iron staining of the granite base and vegetative growth in the pavers abutting the sculpture.

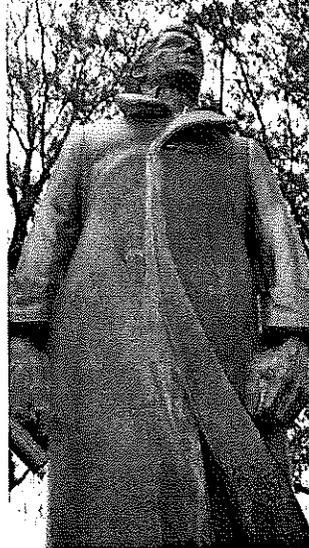
(Left to Right) **Figure 1.** General view of the *Shipbuilder* sculpture. **Figure 2.** Detail of surface corrosion and soiling. **Figure 3.** General view of decorative granite scroll.

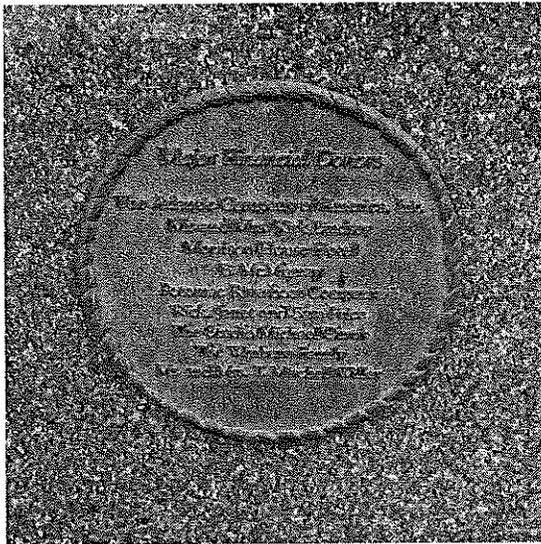
(Left) Figure 4. Two of the three circular plaques have little to no wax coating remaining and are corroded.

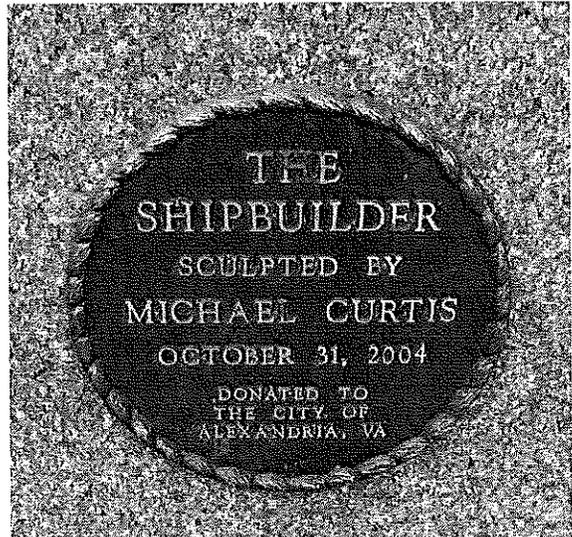
(Right) Figure 5. Front plaque displays little corrosion.

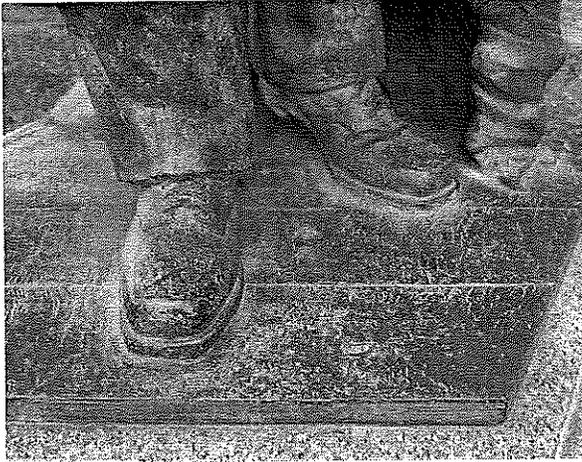
(Left) Figure 6. Minor pitting on edges of figure's shoes, may be an original casting flaw.

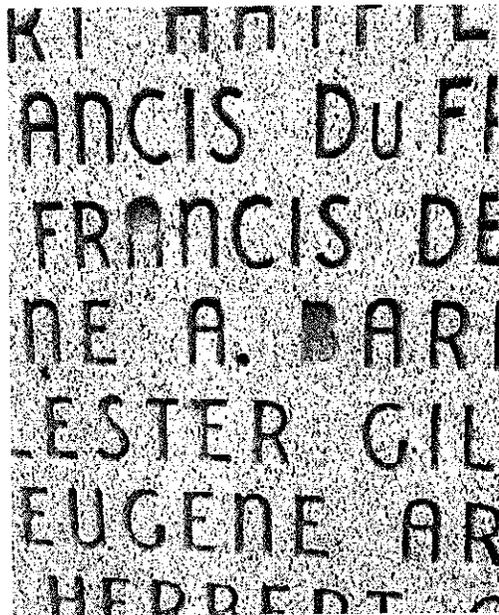
Figure 3. Small stone stubs from within "A"s and "B"s have begun to spall off.

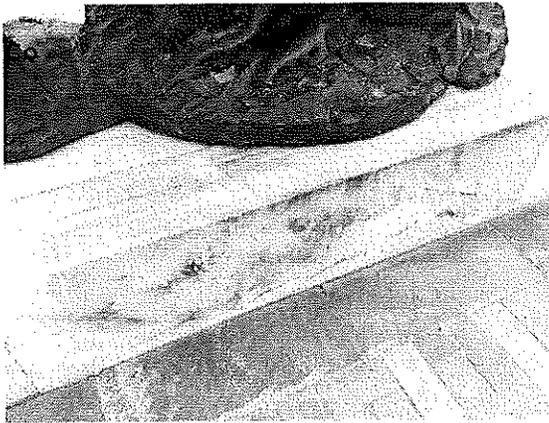
(Left) Figure 3. Sandstone wall exhibits iron and copper staining.

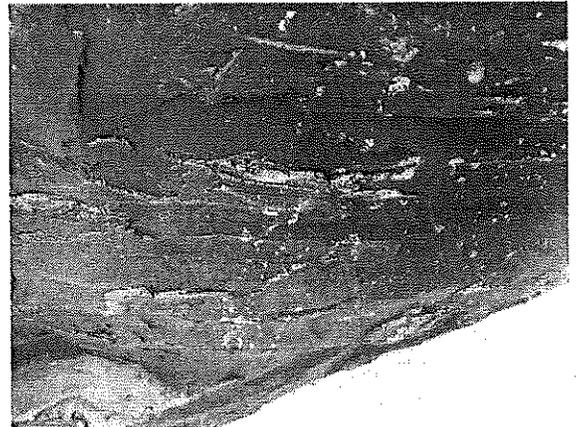
(Right) Figure 4. Bronze surface with pockets of corrosion.

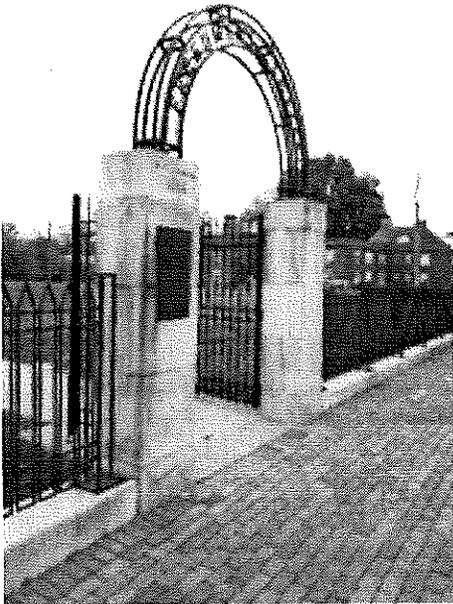
(Left) **Figure 5.** Cemetery entrance; the sandstone pier shows severe iron-staining from the ferrous bolts.
(Right) **Figure 6.** View of the north wall (interior facing) with bronze plaques.

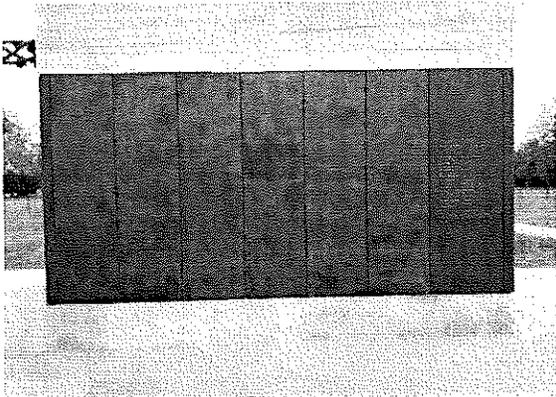
Figure 7. View of the north wall (exterior facing). Iron staining in this location is inherent to the stones.

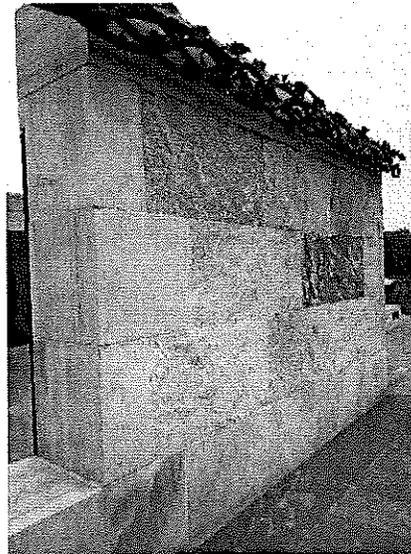
Figure 8. East wall (interior facing) with blanching and discolored patinated bronze plaques.

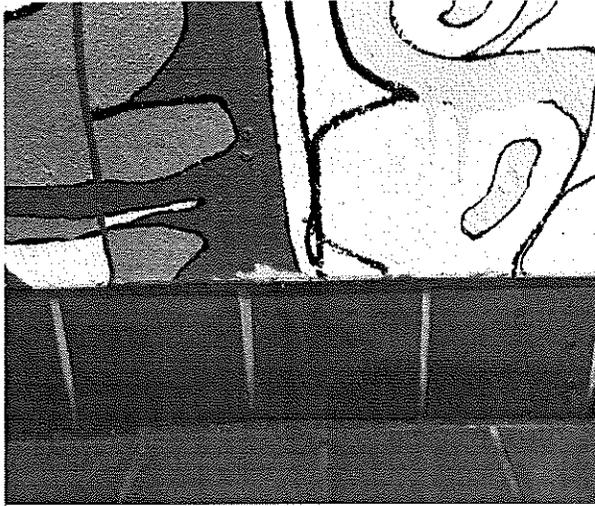
Figure 3. Detail of flaking paint along lower edge of wall.

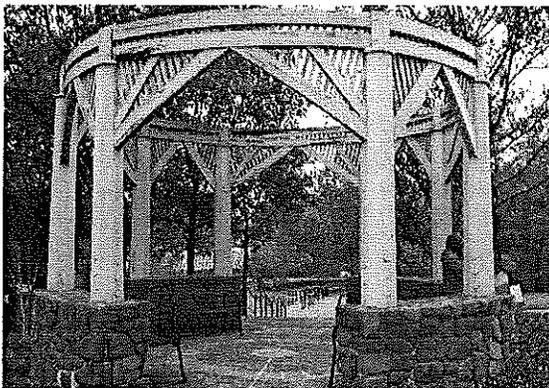
(Left) Figure 1. Part A, wooden trellis in poor condition.

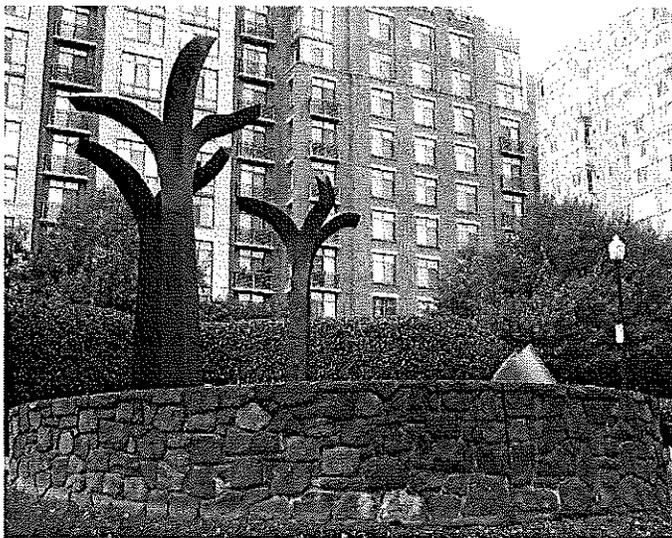
(Left) Figure 5. Overall view of Part C. Wall is exhibiting efflorescence and deteriorated mortar joints.

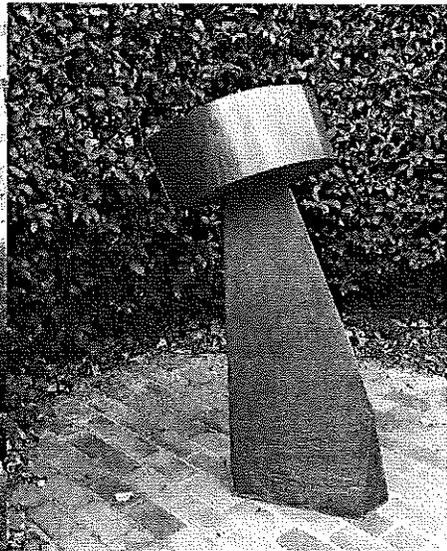
(Right) Figure 6. Bronze podium, Part C. Once integrated, it is no longer accessible because of the surrounding vegetation.

Additional lighting should be added to highlight the installation at night and to prevent vandalism in the park. Evaluate reinstating the book component of the lectern in Part C, with full access to the area.

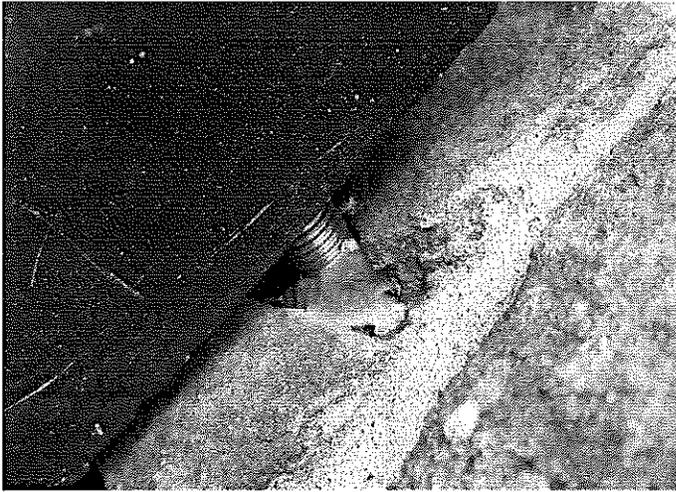
Figure 7. Detail of steel rods and epoxy securing bronze signage to brick, Part A.
