# ABOVE WATER INSPECTION OF EXISTING CONCRETE BULKHEAD ALONG THE WINDMILL HILL PARK

**DATE:** January 23, 2009

**LOCATION:** Windmill Hill Park Waterfront  
Alexandria, VA

**INSPECTION TEAM:** Bradford K. Hull, P.E (RK&K)  
Karl Stegmann, P.E. (RK&K)

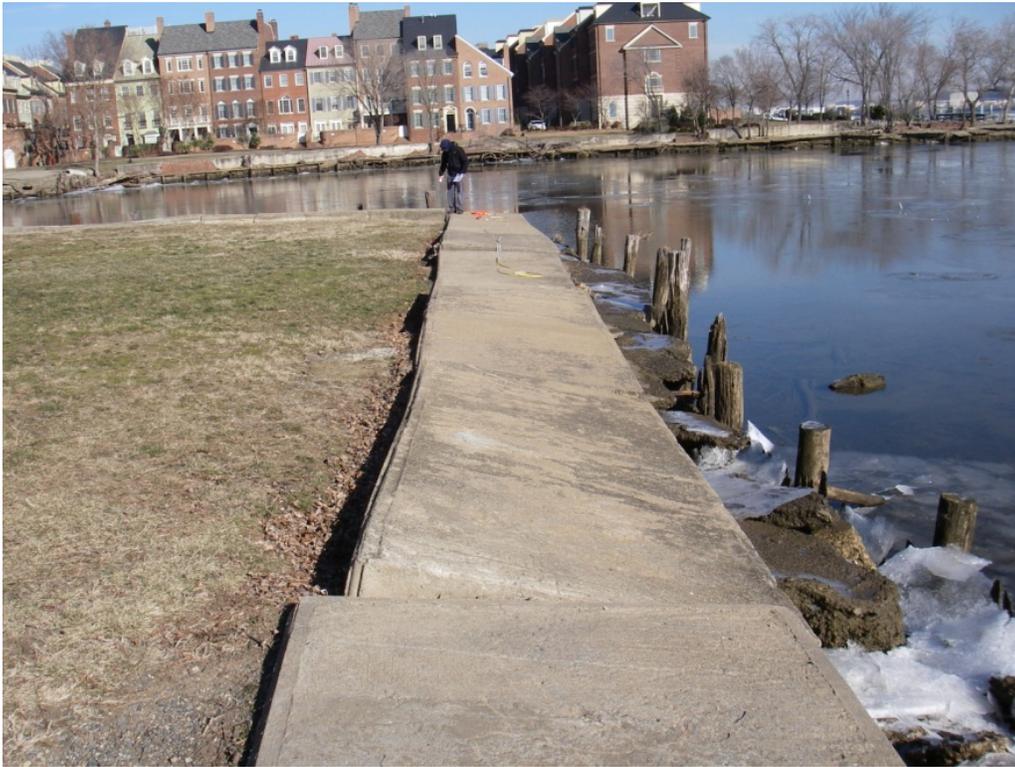
The West River Wall (Photo 1) portion of the bulkhead measured approximately 95 feet in length and supports seven 5'-10" wide concrete walkway slabs. The majority of concrete bulkhead in this section is severely deteriorated and provides minimal structural support.

Photo # 1 – West River Wall (Note: Uneven settlement of the slabs causing a tripping hazard)

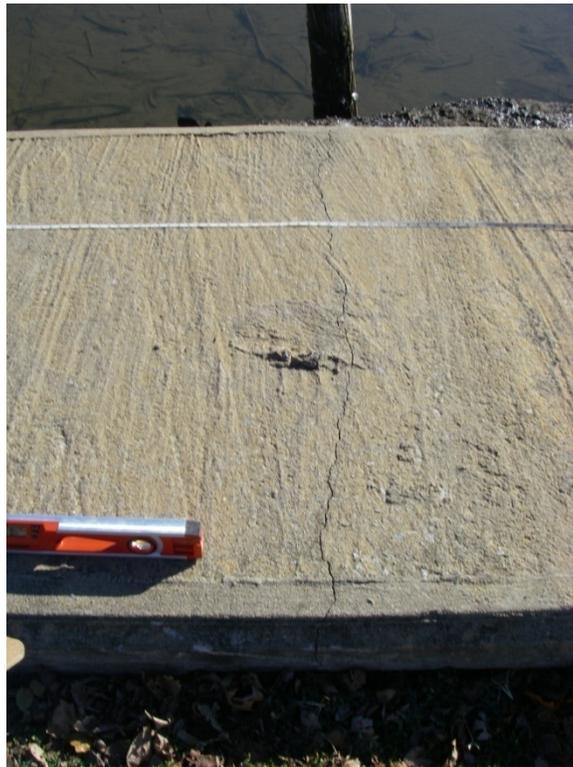
Two medium full-width cracks, measured at 26 inches and 22 inches long were observed in the first concrete slab. Another full width medium crack was located in Slab 6 (Photo 2). Two (2) shallow spalls without exposed rebar are present in Slab 3.

Photo # 2 – Full Width Medium Crack in Slab 6

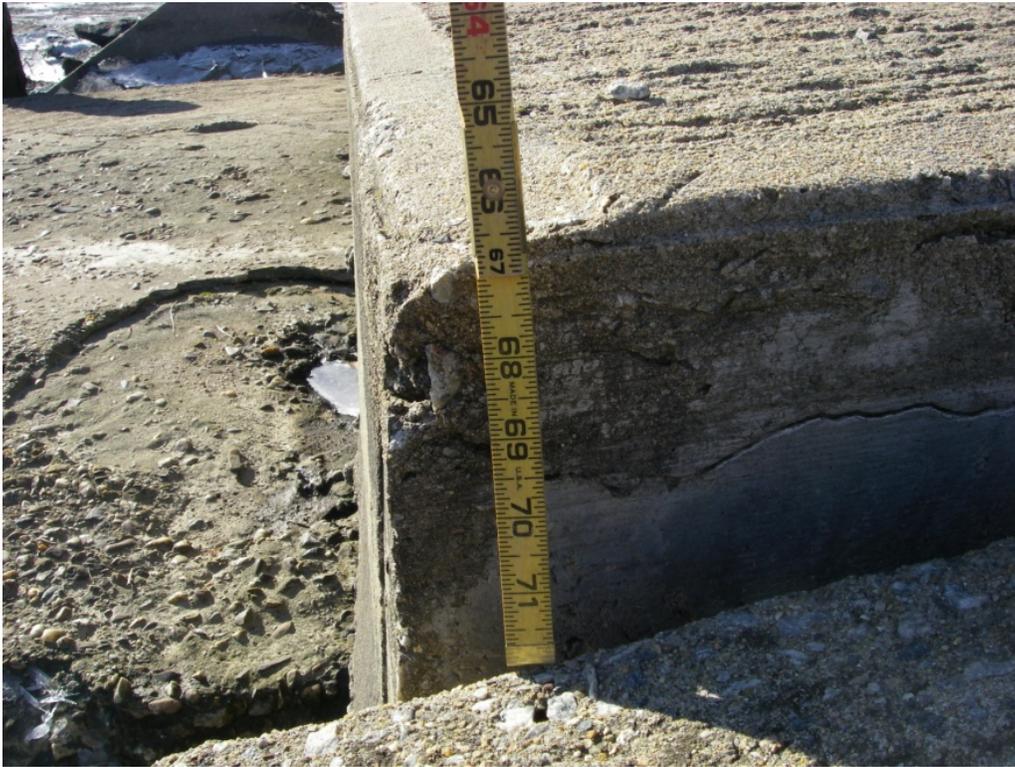
Differential movement between walkway slabs was observed at various locations along the West River Wall. Between Slabs 1 and 2, there was a 2¼ inch gap with a differential height of 5.5 inches (Photo 3), and a horizontal difference of 5.5 inches was observed along the front face of these slabs (Photo 4). A tree stub and a 1 inch gap were observed between Slabs 3 and 4. Slabs 4 and 5 are separated by a 3 inch horizontal gap with a vertical difference of 5 inches. The gap in the middle of Slabs 5 and 6 was measurable at 1 inch horizontally with no measureable vertical displacement.

Photo # 3 – 5.5 inch vertical displacement between Slabs 1 and 2

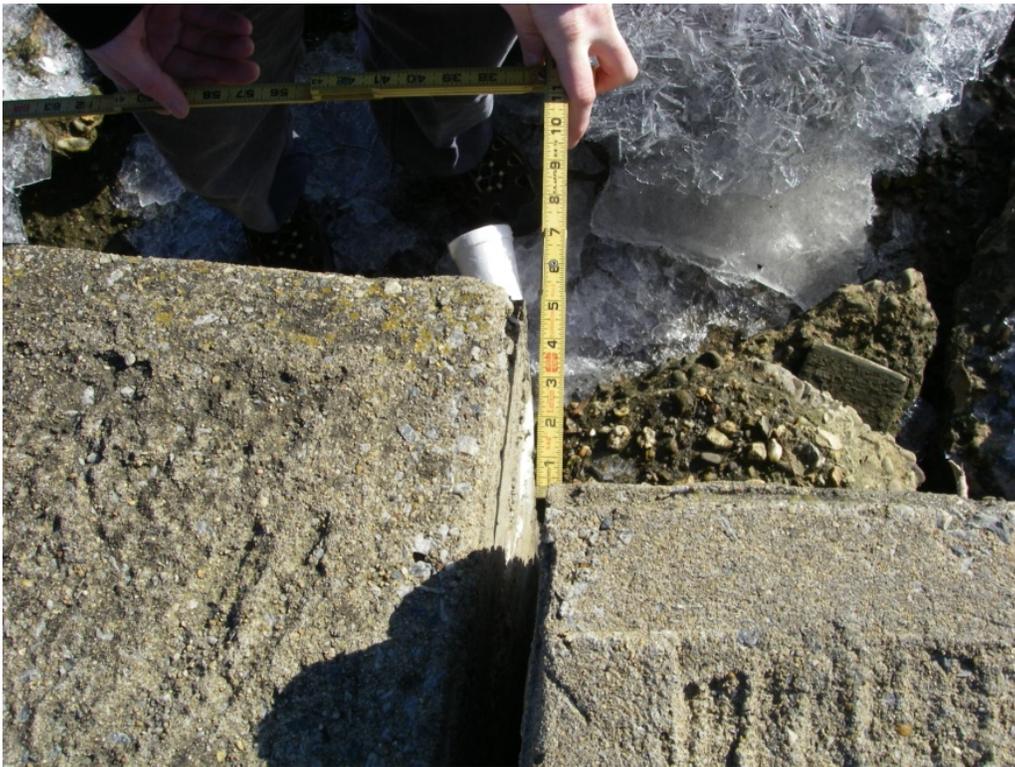
Photo # 4 – 5.5 inch horizontal displacement between Slabs 1 and 2

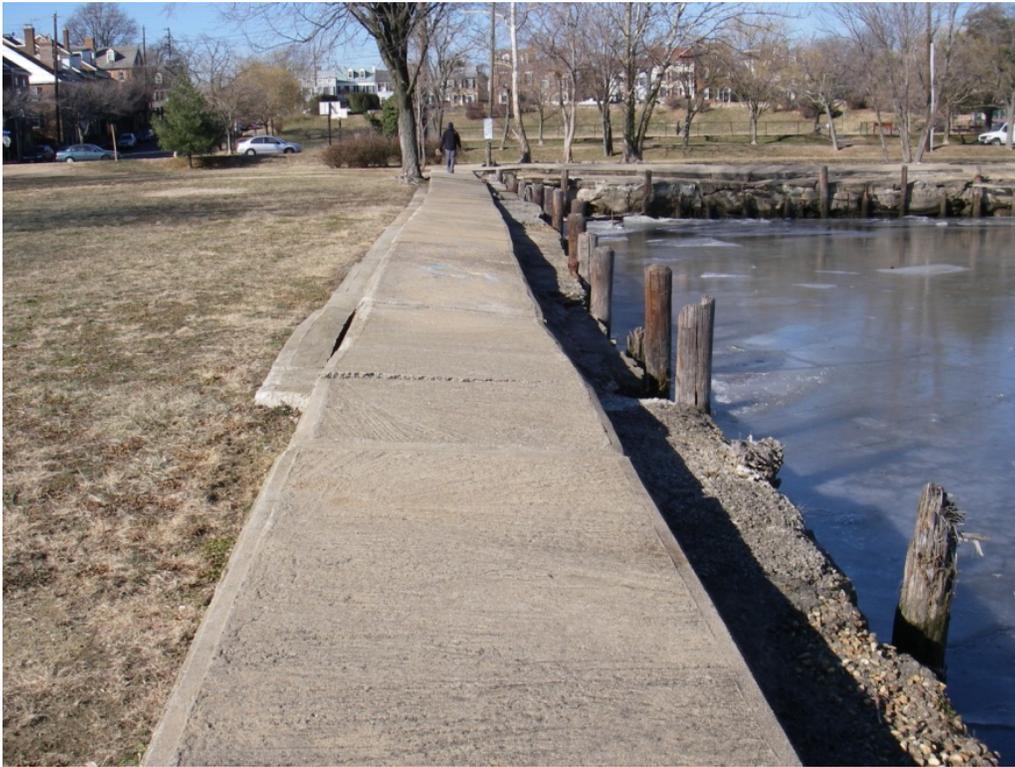
The south cove wall (Photo 5) portion of the bulkhead measured approximately 157 feet in length and eleven 5'-6" foot wide concrete walkway slabs are supported behind the wall. The majority of the concrete bulkhead in this section is severely deteriorated and provides minimal structural support.

Photo # 5 – South Cove Wall

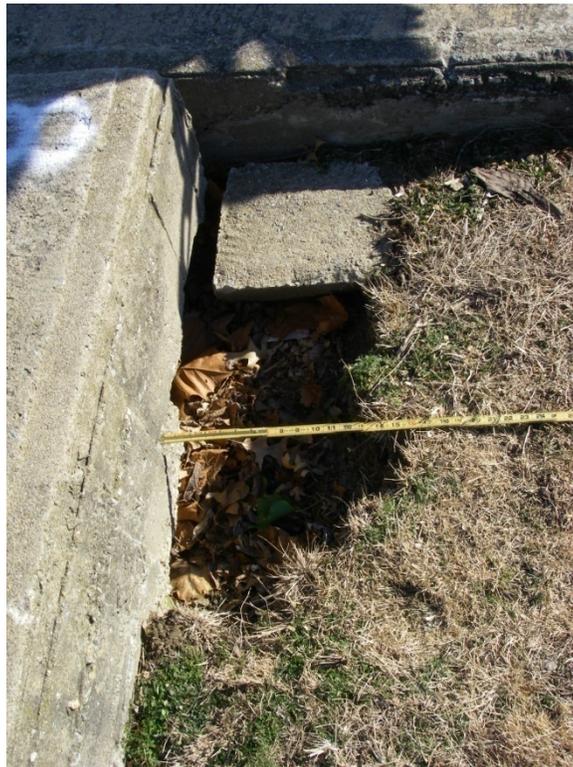
There is a 3'-4" by 1'-4" void in the existing ground behind the slabs at the corner where the South Cove Wall and the West River Wall intersect (Photo 6).

Photo # 6 – 3'-4" x 1'-4" void behind Slabs 7 and 8

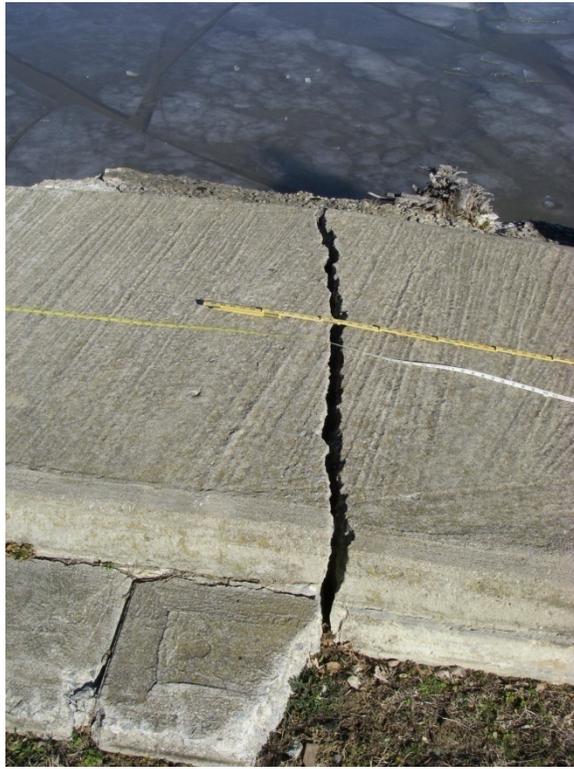
A majority of the concrete slabs behind the wall display large to medium full width cracks. There is a 1¼" wide crack with observable differential vertical and horizontal displacements in Slab 9 (Photo 7). A 15"x13" full depth triangular spall with full width crack was noted in Slab 10 (Photo 8). For a complete description of crack widths, lengths and locations see Appendix B.

Photo # 7 – 1¼" Wide Full Width Crack in Slab 9

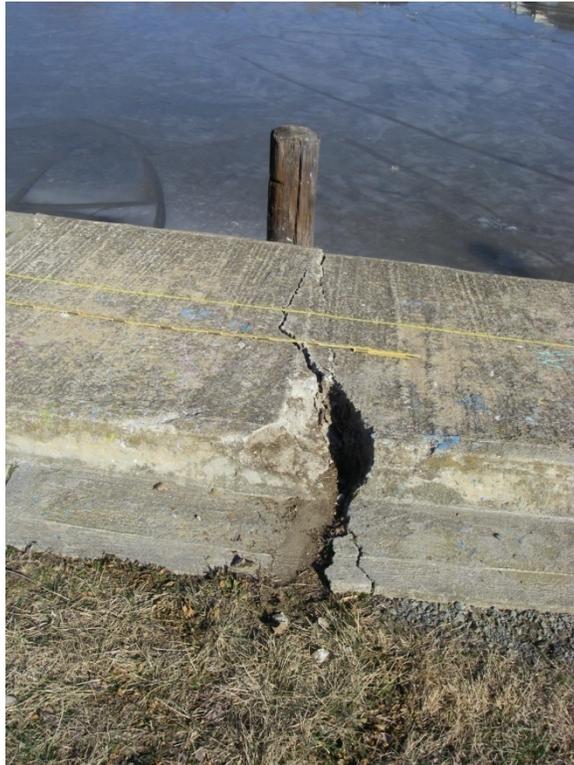
Photo # 8 – 15"x13" spall and wide crack in Slab 10

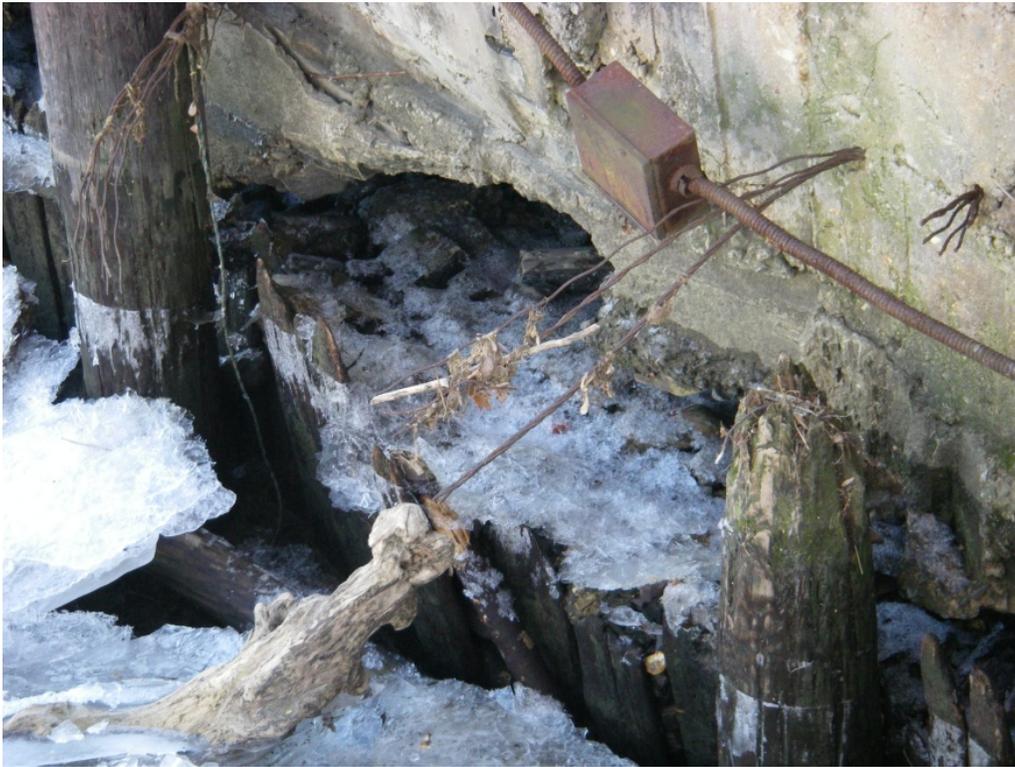
A void was observed under the bulkhead near the southwest corner, in front of Slab 16. The base of the concrete wall is heavily deteriorated and a void approximately 5 feet wide by 2 feet tall was observed (Photo 9). The distance the void extends under the bulkhead could not be determined, because access was not available from the top of the bulkhead, but was visually estimated to be 3 feet.

Photo # 9 – Approximate 5'x2' void under Concrete Bulkhead at Southwest Corner

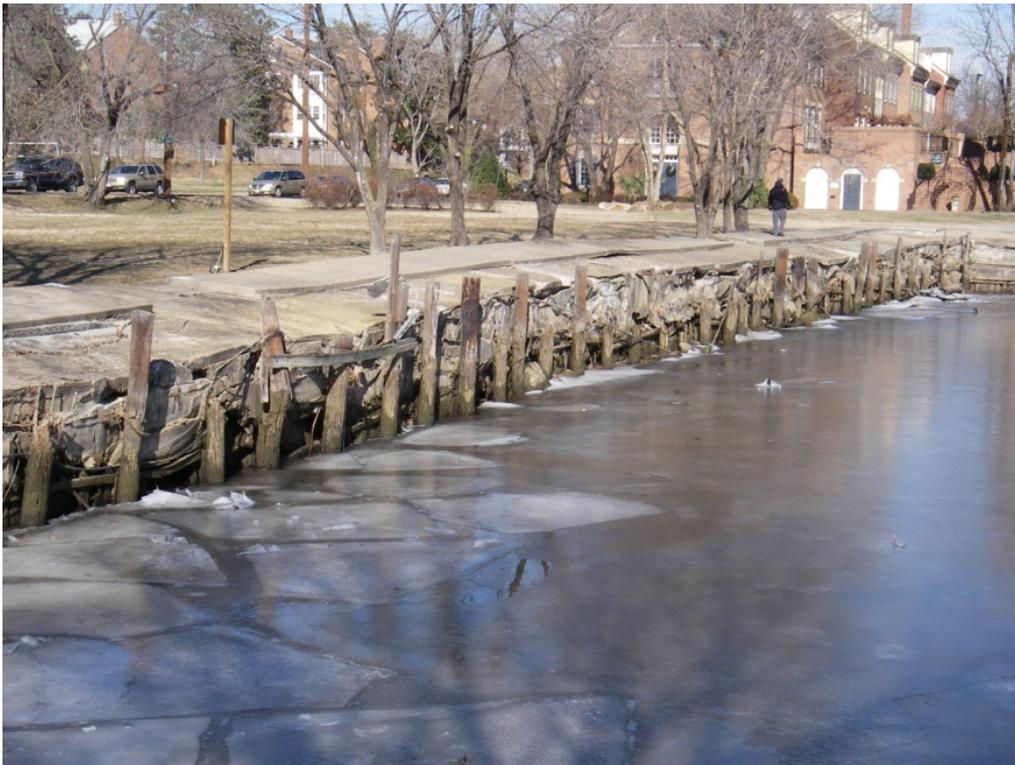
The West Cove Wall (Photo 10) portion of the bulkhead measured approximately 263 feet long. This portion of the wall consisted of the concrete bulkhead supporting walkway slabs with two ramps. The ramps sloped from the existing groundline to the top of the existing concrete bulkhead. The majority of concrete bulkhead in this section is severely deteriorated and provides minimal structural support. A void is located in the concrete bulkhead in front of walkway Slabs 21 and 22 (Photo 11). A 23' long x 7" wide crack is also noted at this location. The void measured approximately 42" deep through the crack. The void has caused the bulkhead to collapse inward on itself and creates a 1½" vertical displacement between Slabs 21 and 22.

Photo # 10 – West Cove Wall (Note: Several uneven slabs along the bulkhead causing a tripping hazard)

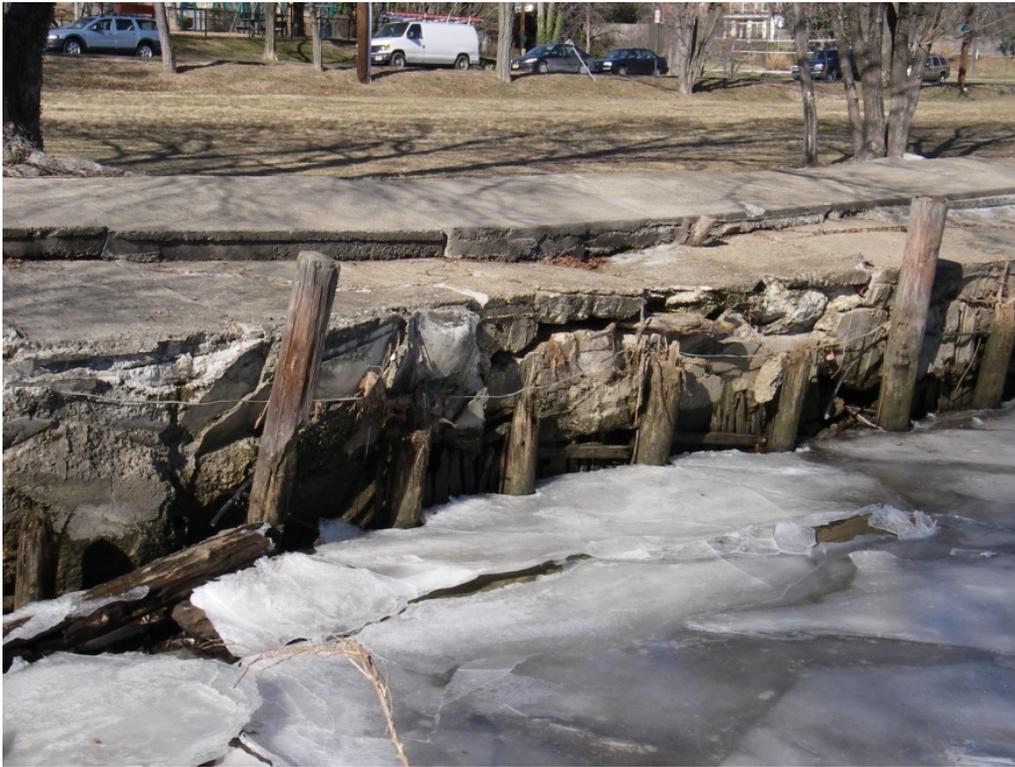
Photo # 11 – Void under Bulkhead in front of Slabs 21 and 22 (Note: Settlement of the bulkhead and the slabs above the void)

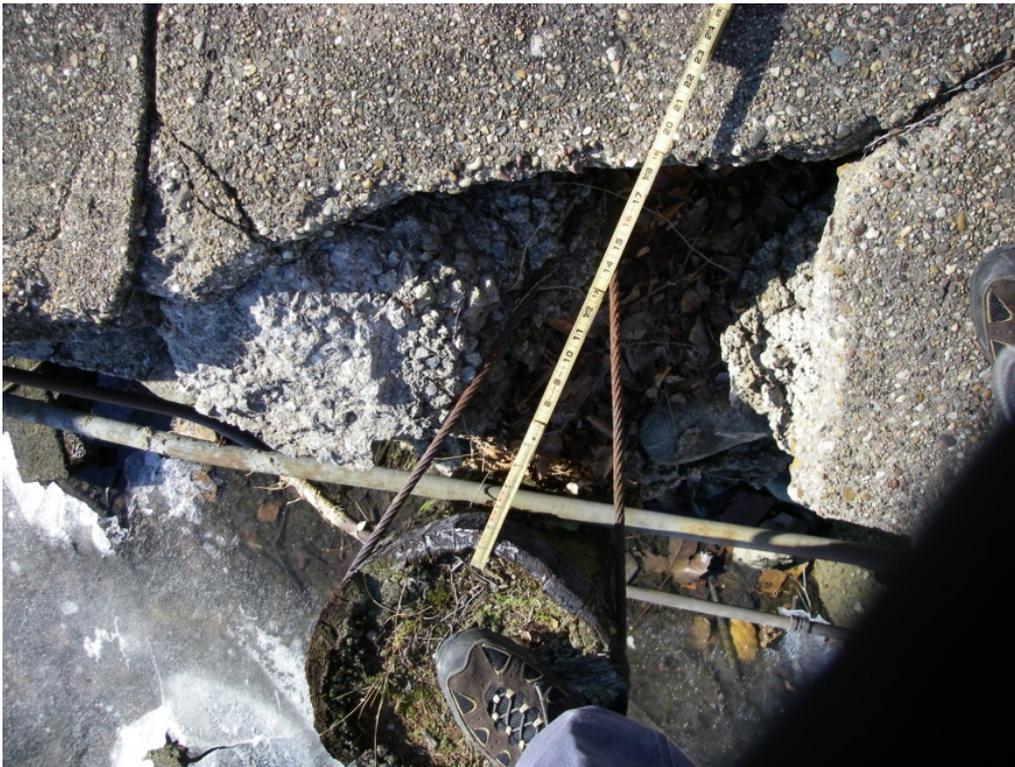
A second void (16" deep) was observed in front of Slabs 30 and 31, where multiple 3" to 4" wide cracks were present. Portions of the concrete bulkhead were missing where these wide cracks terminated along the water's edge. The missing portions of concrete bulkhead measured 15"x28" (Photo 12), 32"x18" (Photo 13) and 25"x20" (Photo 14). There is a 1 foot deep void behind Slab 30 that extends through the concrete bulkhead (Photo 15). A third void (22" deep) was found in front of walkway Slabs 32 and 33, where a 20' long x 3" wide crack was noted (Photo 16). The largest void observed measured 10' wide x 15' long x 3' deep and is located under the concrete slabs in the northwest corner of the cove. This void has caused the top slab to slide and tilt toward the water (Photo 17). Gaps measured between 4 to 5 inches between the slabs above the void. A large 9"x7" deep spall was measured in the bulkhead in front of Slab 26 (Photo 18).

Photo # 12 – 15'x28" Missing Portion of Concrete Bulkhead at Water's Edge in front of Slab 30

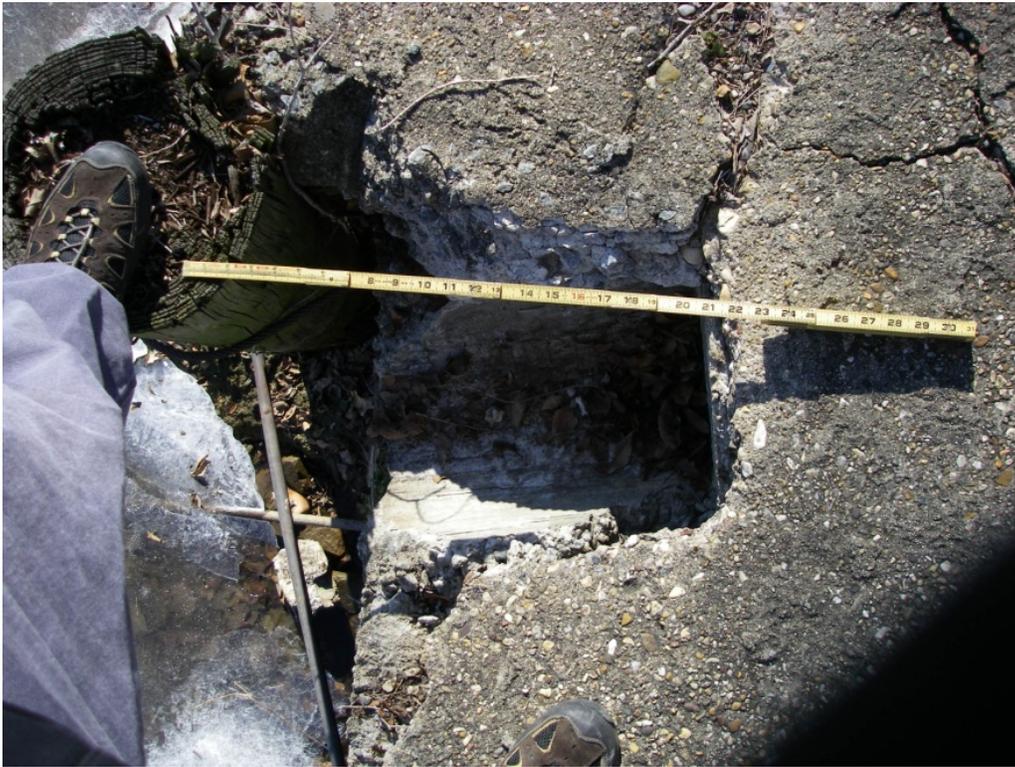
Photo # 13 – 32"x18" Missing Portion of Concrete Bulkhead at Water's Edge in front of Slab 30

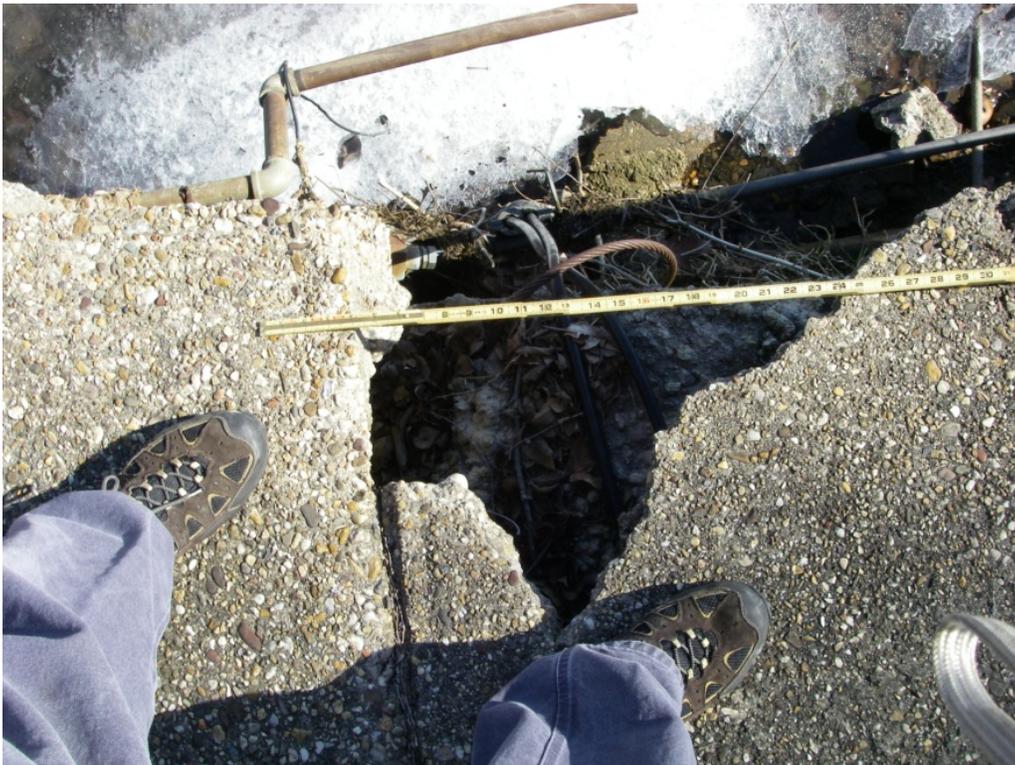
Photo # 14 – 25"x20" Missing Portion of Concrete Bulkhead at Water's Edge in front of Slab 31

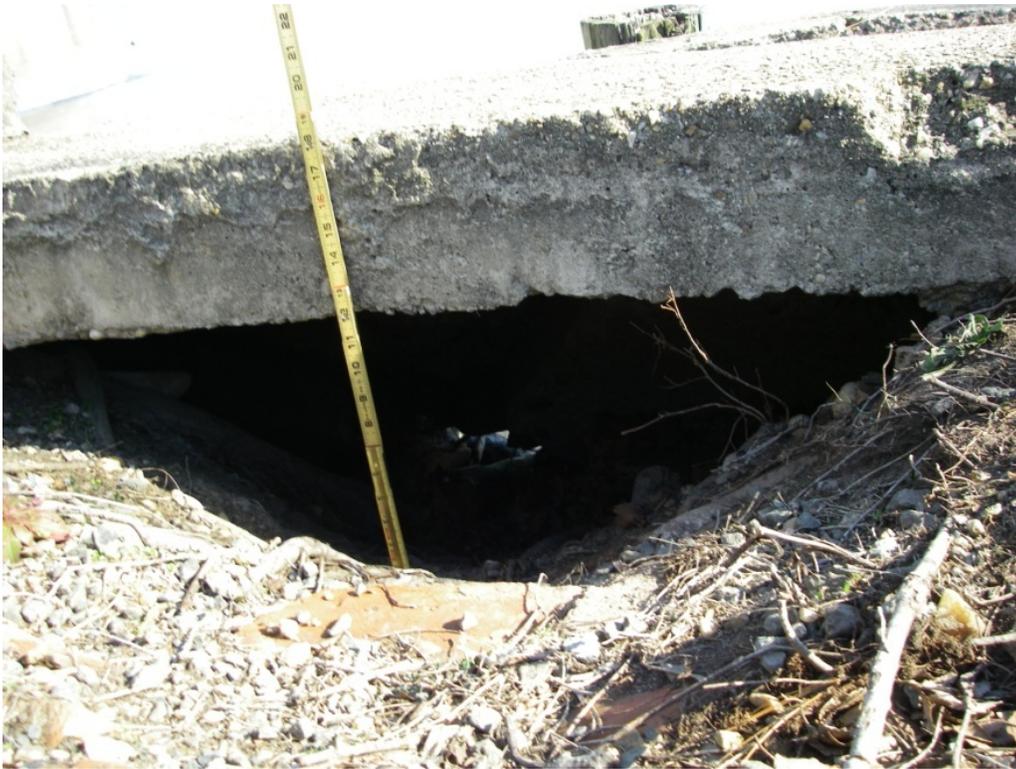
Photo # 15 – Void under Slab 30 (Note: Void extends through the bulkhead)

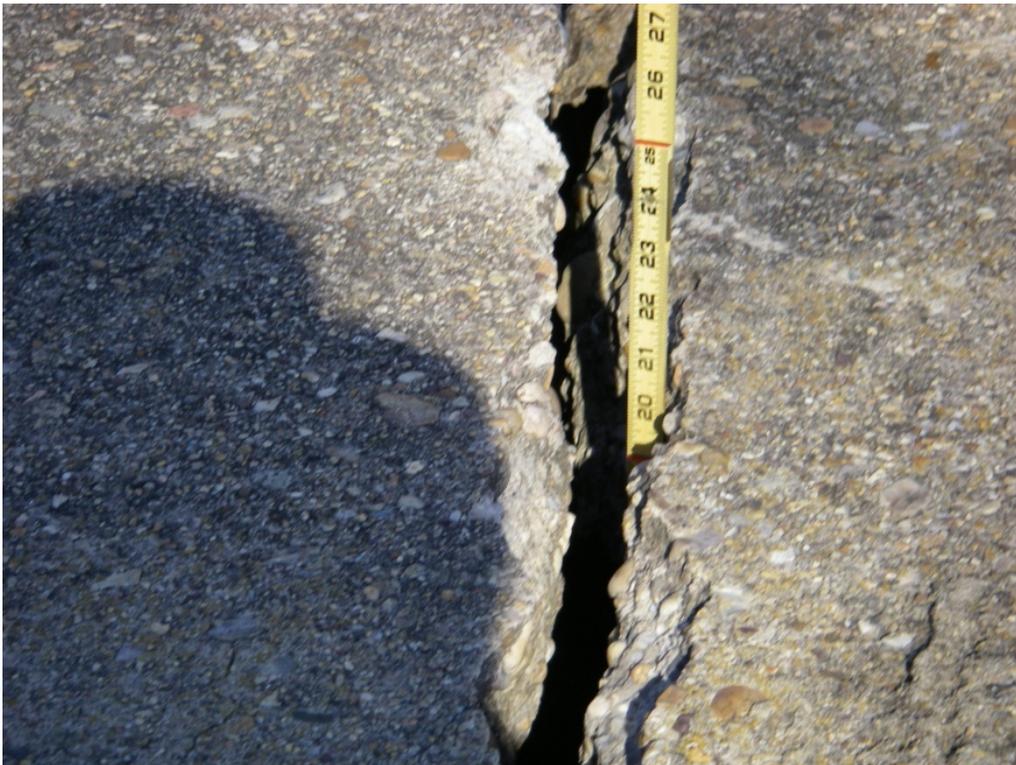
Photo # 16 – 3” Wide Crack located in front of Slabs 32 and 33

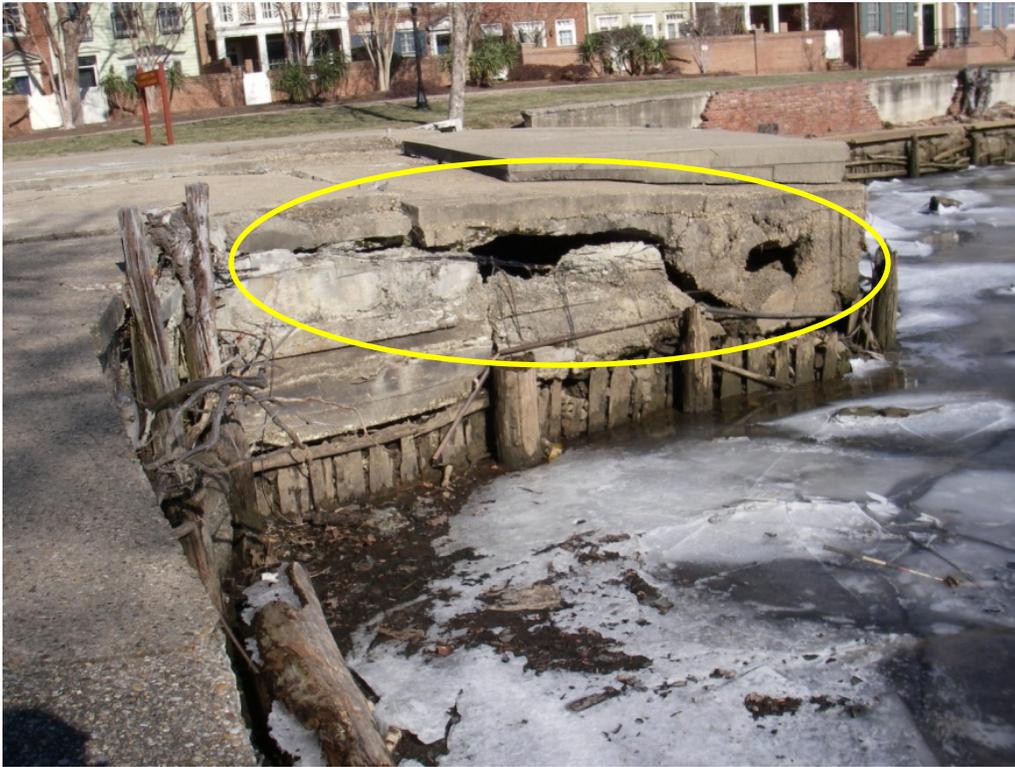
Photo # 17 – Northwest Corner (Note: 10' wide x 15' long x 3'deep void below the slab)

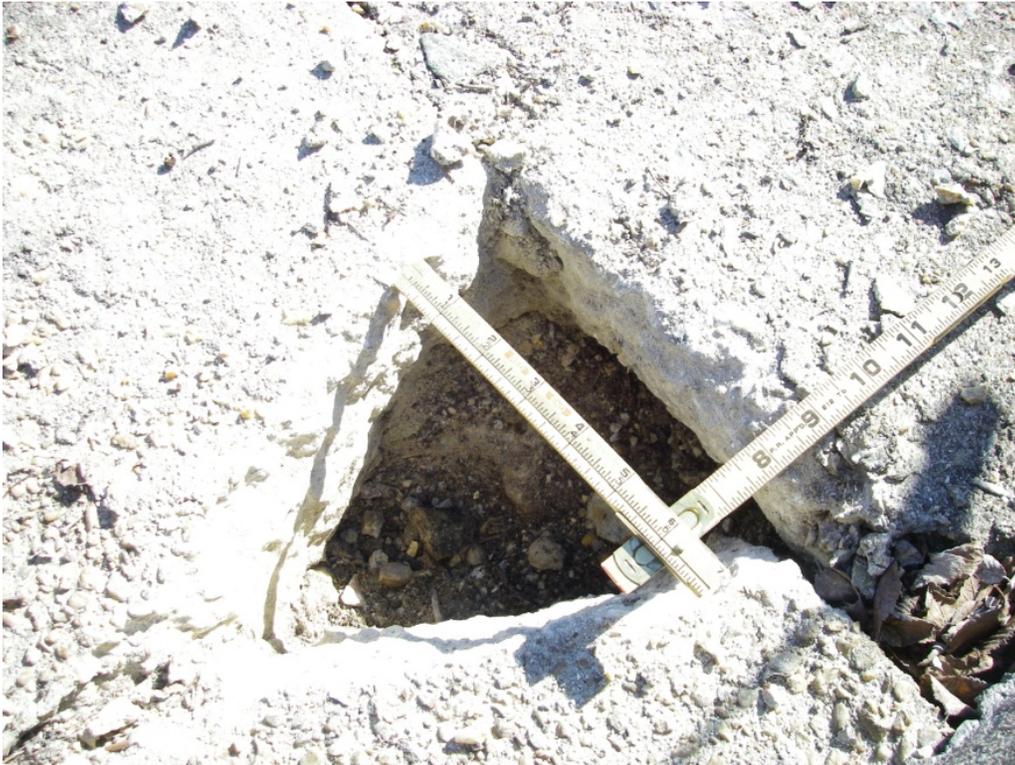
Photo # 18 – 9"x7" Deep Spall in front of Slab 26

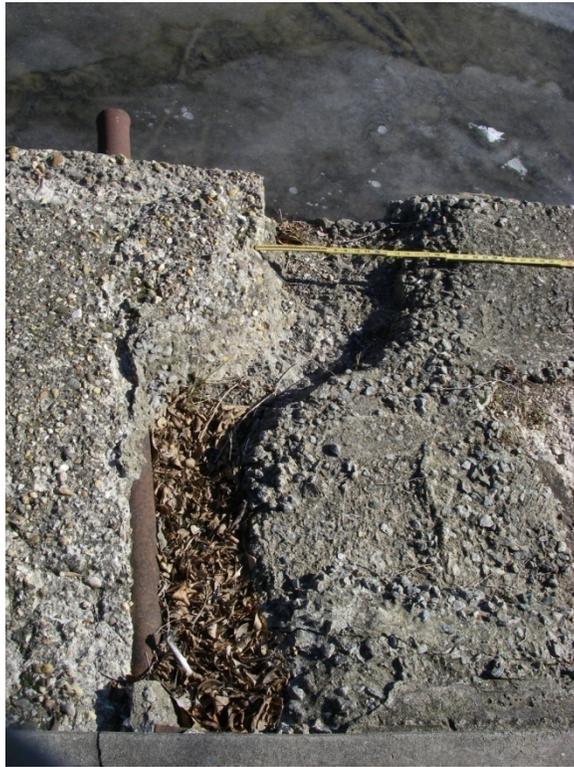
Multiple concrete slabs behind the concrete bulkhead wall displayed signs of distress with medium to large full width cracks and random large spalls. Slab 19 had a 17"x15" shallow spall with no exposed rebar in the southeast corner of the panel. A medium full width crack is present in Slab 20, this crack also measured 1" in vertical displacement. Two shallow spalls measuring 26"x12" and 14"x14" are located in slab panel 21 at the southwest corner and 4 feet south of the northeast corner of the slab, respectively. A 1" wide full width crack travels through Slab 27, and terminates in a large 6" deep spall at the front face of the concrete bulkhead (Photo 19).

Photo # 19 – Full Width Crack and Spall at Slab 27

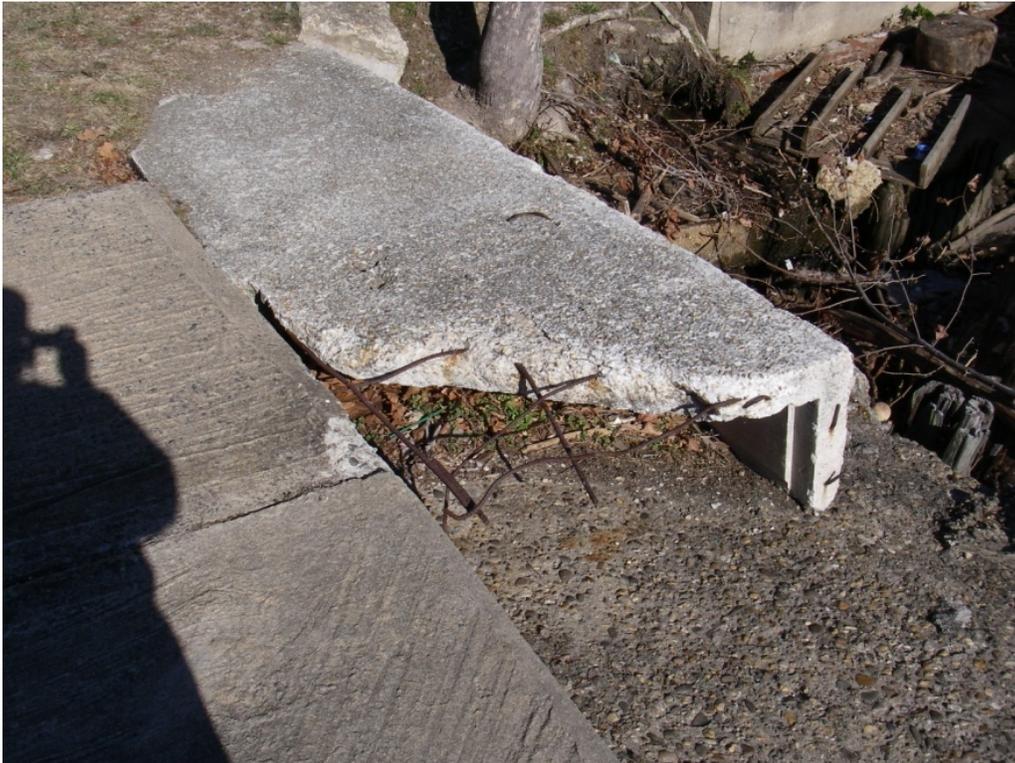
A concrete slab located on the northeast corner of the bulkhead has a large concrete spall with protruding rebar that creates a safety hazard (Photo 20).

Photo # 20 – Protruding Rebar located at Northwest Corner of Bulkhead creating a safety hazard

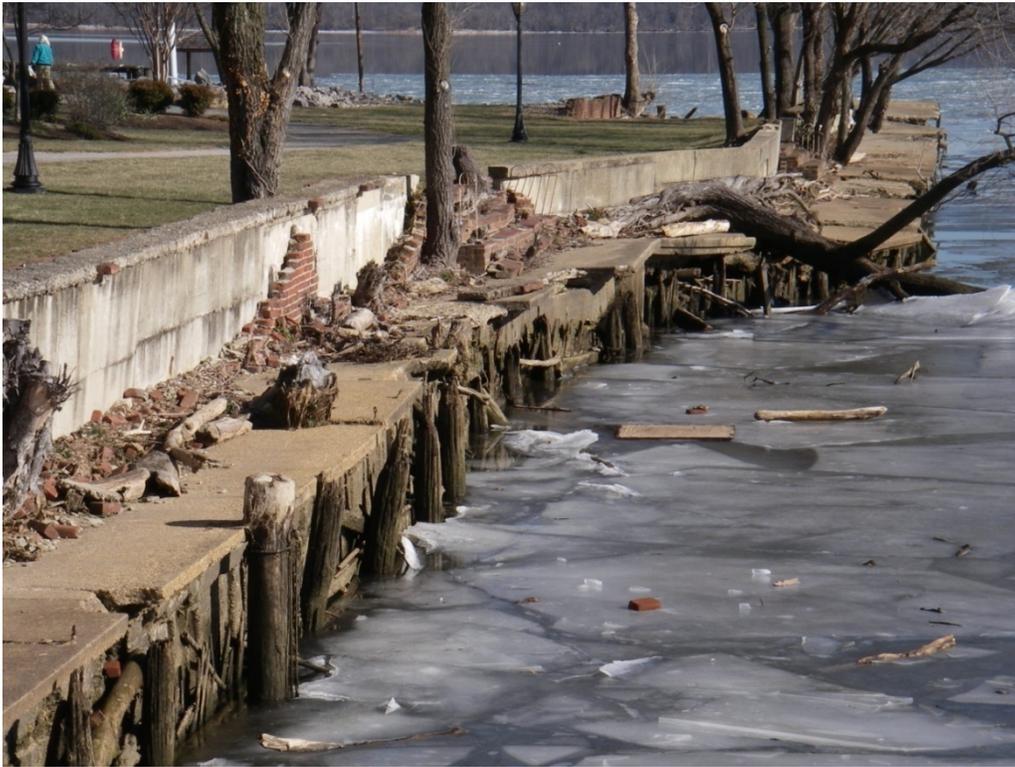
The bulkhead consists of two distinct structure types. The north bulkhead wall is approximately 285 feet long and consists of concrete walkway slabs supported by timber sheeting (Photo 21). The concrete walkway is located approximately 3 feet above the mean low water elevation. A concrete retaining wall with brick facing supports the remaining excavation. The second portion of the bulkhead is a full height concrete retaining wall with timber sheeting below the waterline (Photo 10). The top of wall was measured at 6.5 feet above the mudline on the western cove wall. Concrete walkway slabs are located 2 to 5 feet inshore of the top of the concrete bulkhead in this portion of the bulkhead. The structural foundation type of the existing bulkhead is unknown at the time of this inspection. The investigation and inspection of the foundation system was not part of the scope of this inspection.

The North Cove Wall (Photo 21) varies in construction compared to the other sections of the bulkhead. Along the North Cove Wall, the walkway slabs are located along the water's edge at approximately 3' feet above low tide. The slabs are supported on soil behind a timber sheeting. The majority of the slabs were severely cracked, uneven, and/or spalled with large voids below the slabs (Photo 22). Multiple full grown trees or tree stubs are present on the slab causing failure of the slabs (Photo 23).

Photo # 21 – North Cove Wall and Retaining Wall (Note: Slabs on bulkhead are uneven, cracked, and spalled)

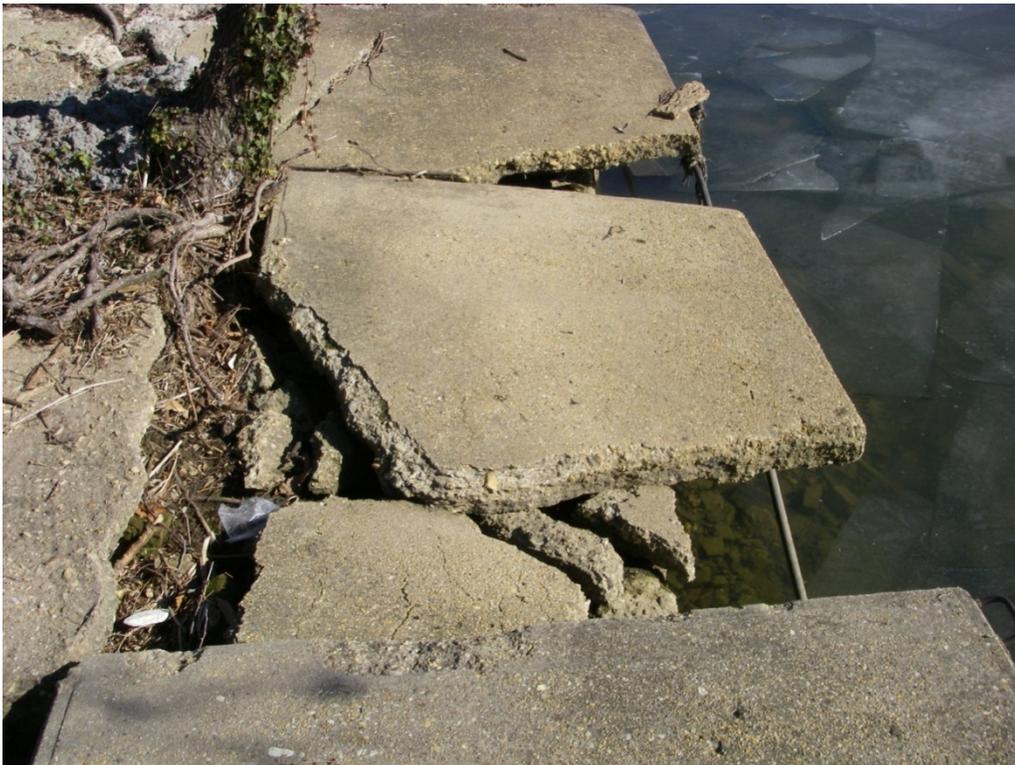
Photo # 22 – Typical Walkway Slab Panel on North Cove Wall (Note: Cracks and spalls are typical in the slabs)

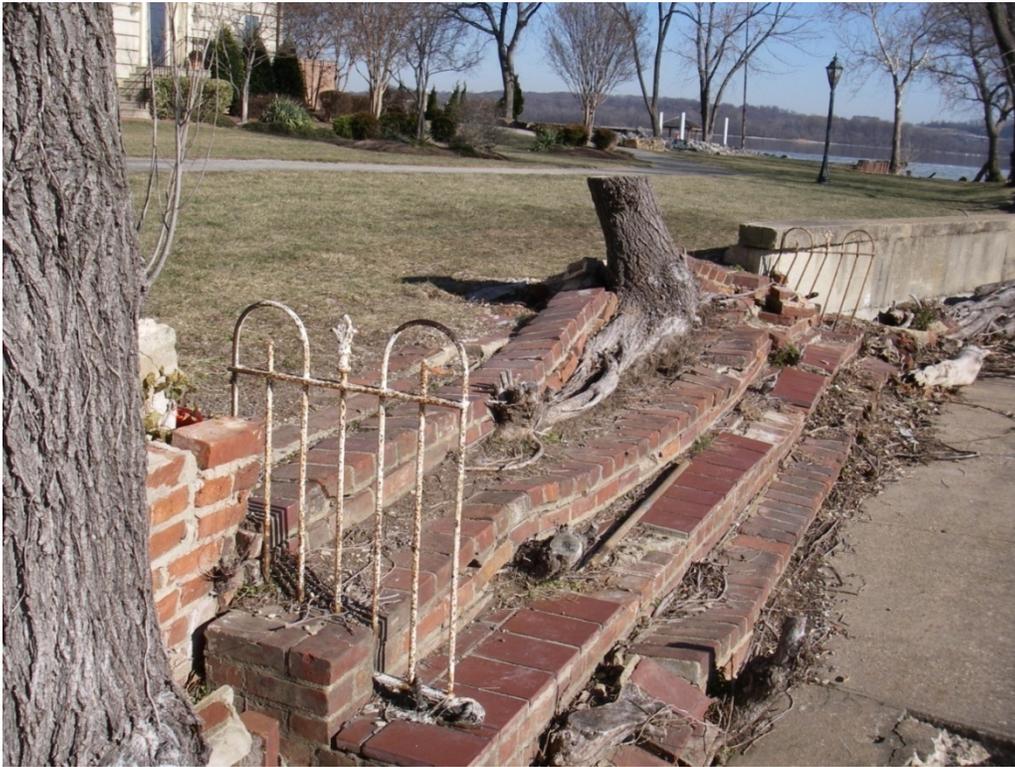
Photo # 23 – Typical Full Grown Trees and Tree Stubs growing out of North Cove Wall and staircase
