Fort Ward Park Master Drainage Plan *Prepared for the City of Alexandria*

Presented by URS Corporation

August 14, 2013

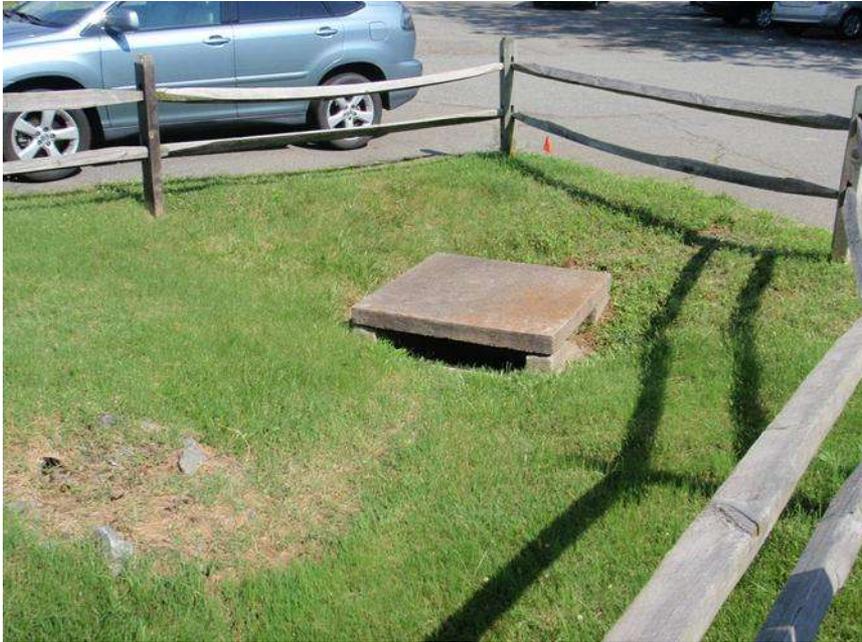
Upstream Inlet

- Shallow drop inlet near the museum and the parking lot. No major problems noted during the field trip.

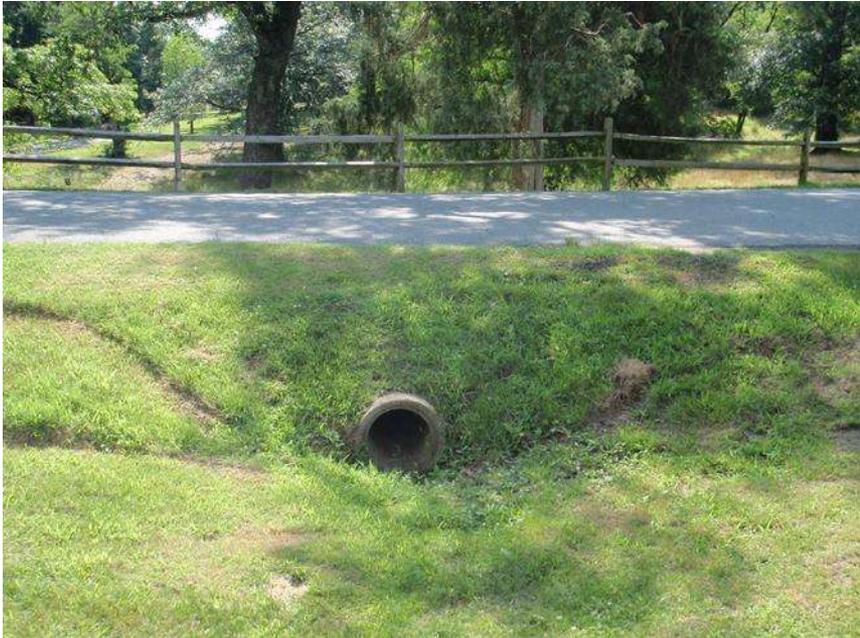
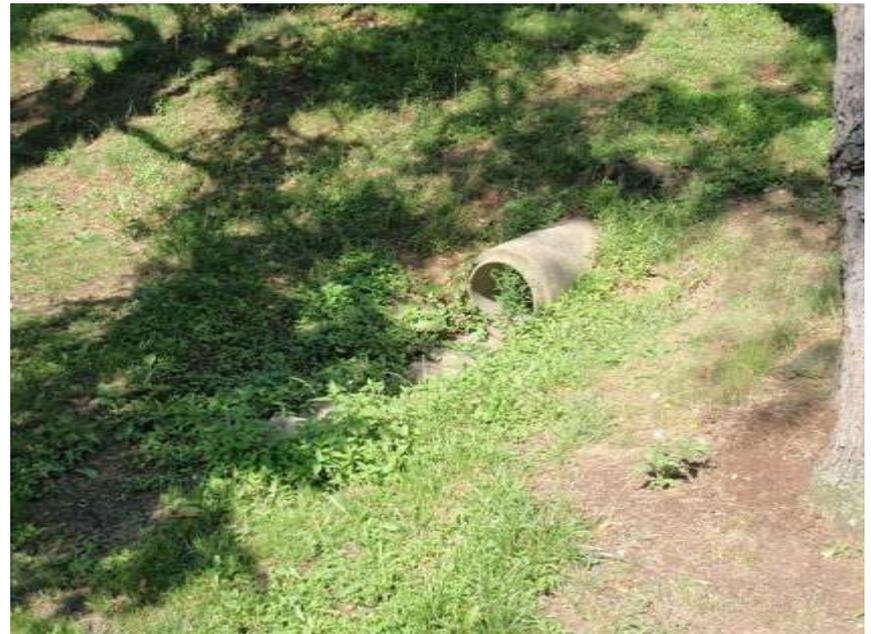
- 15" culvert crossing under the entrance road near bathrooms. A small ponding area was observed at the culvert inlet.

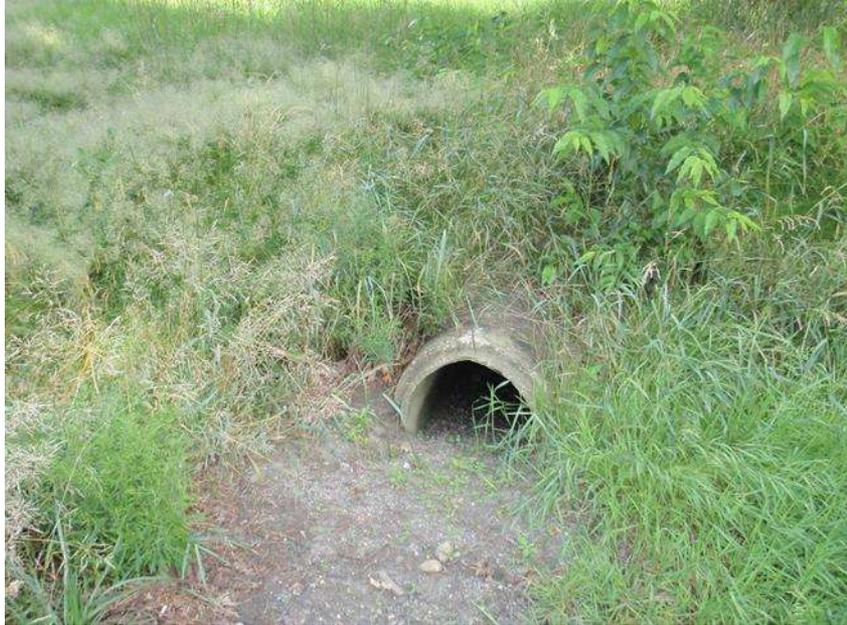
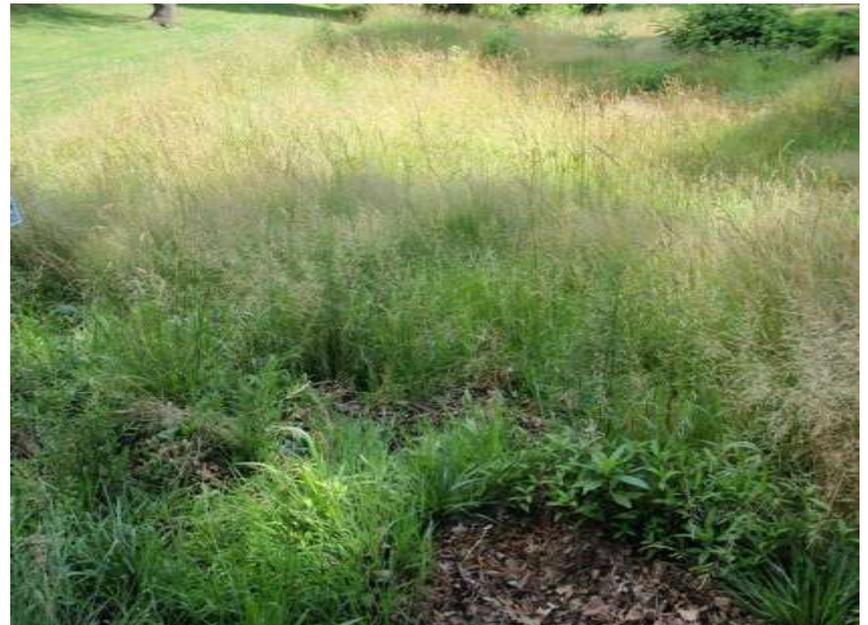
- Outlet of 18" pipe that collects runoff from upstream forested area and Braddock Road. Sediment and debris deposition was noted at the outfall.

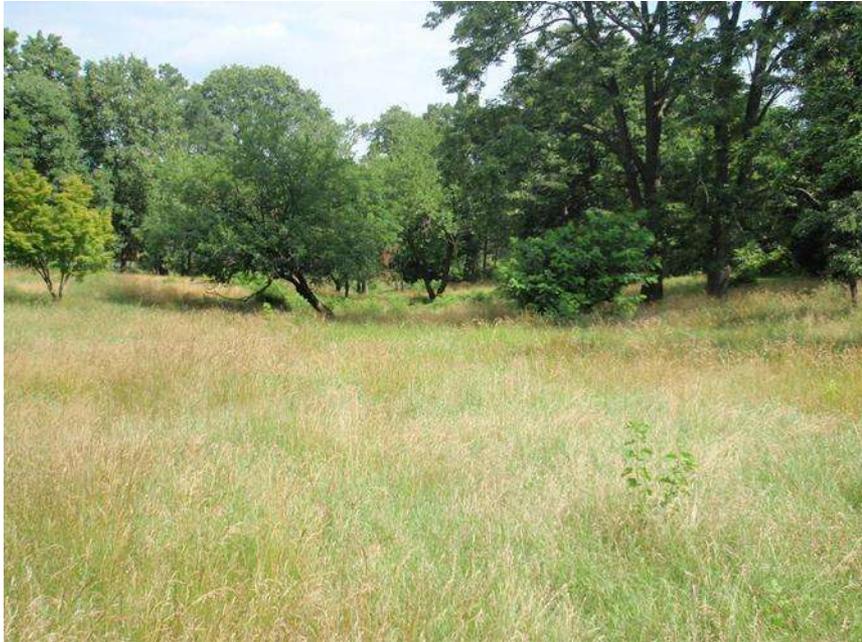
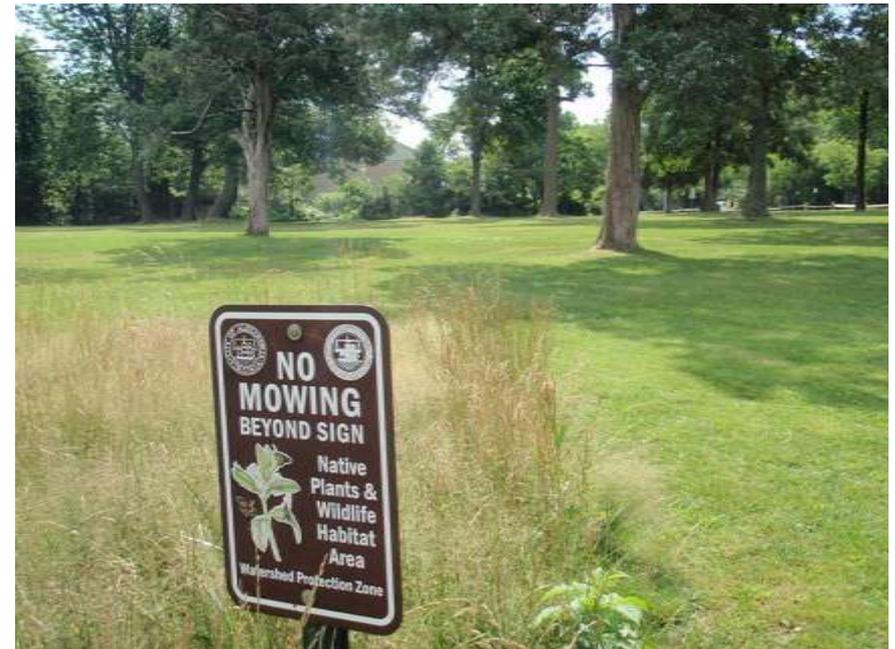
- Swale in the natural area with "No Mowing" sign nearby. No major problems noted during the field trip.

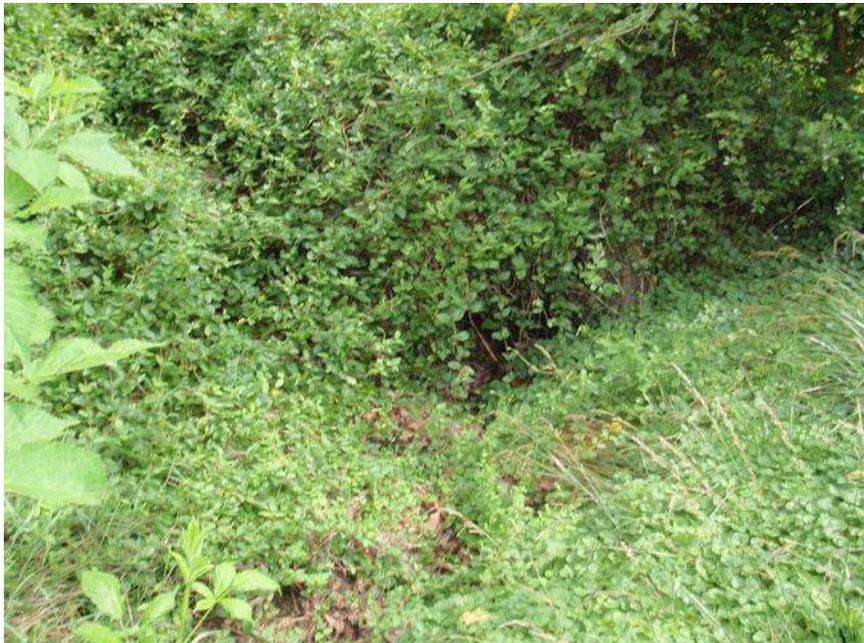
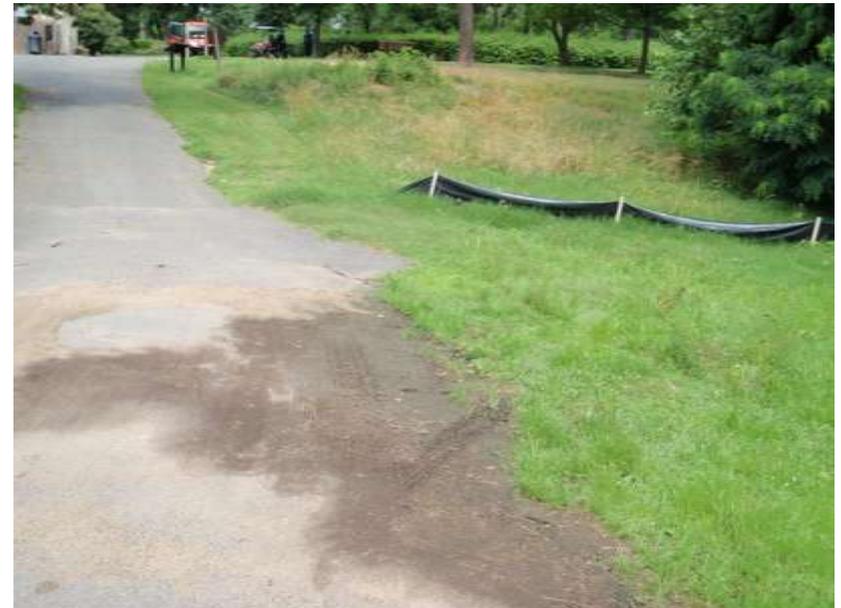
- The 36" culvert under the road that leads to the utility yard is partially blocked and vegetation was overgrown around the culvert. Observed sediment and debris build up at the 6" PVC underdrain pipe that located just upstream of the 36" culvert.

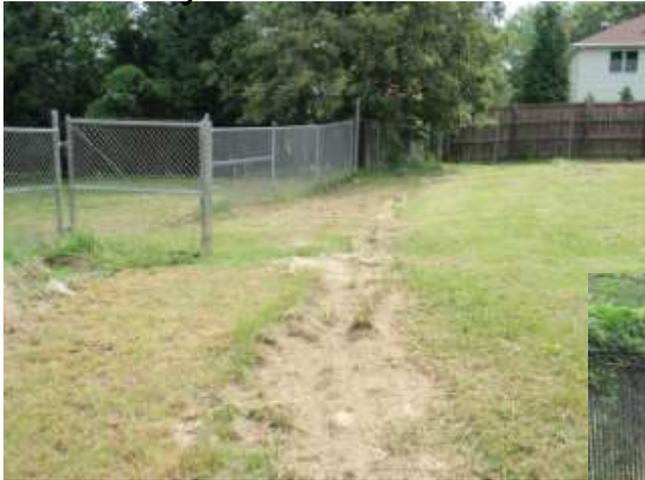
Infiltration Trenches

- Old Utility Yard. Several infiltration trenches have been installed to prevent runoff from reaching the cemetery. A temporary catch basin collects runoff from the small trench along the fence line which divides the park property from the neighborhood. The runoff from the catch basin drains to an area uphill of the road over the 36" culvert and downhill of the cemetery. Temporary hay bales have been setup up to prevent runoff from entering the cemetery.

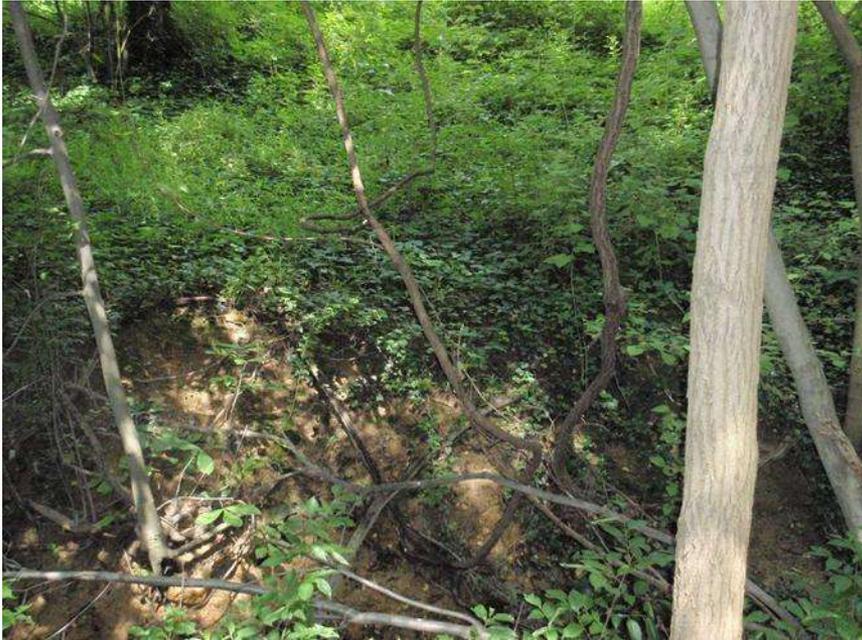
Stream Bed

- Main stream channel that runs through the park is eroded and there is concrete debris in the channel. A swale has formed from backyard drainage conveyance from residential property. In addition, there is a clogged inlet at downstream end of the natural stream channel.

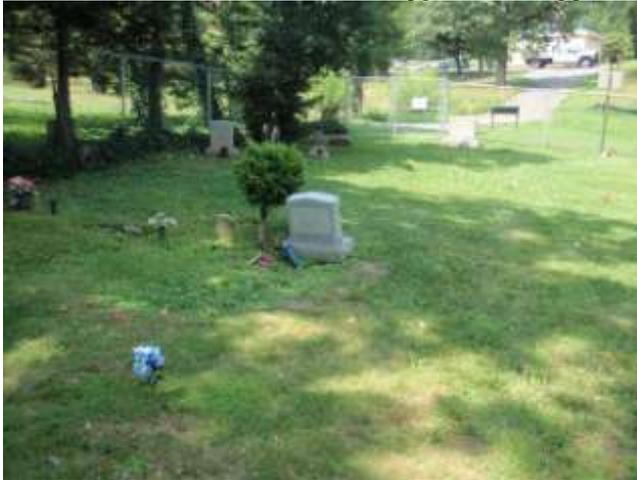
- The base areas are exposed on several gravestones in the cemetery. Depressions have formed in front of several graves from ponding during rain events. There are several areas of exposed, bare ground in the cemetery. A channel is forming through the cemetery where runoff flows during rain

Exposed Gravestone

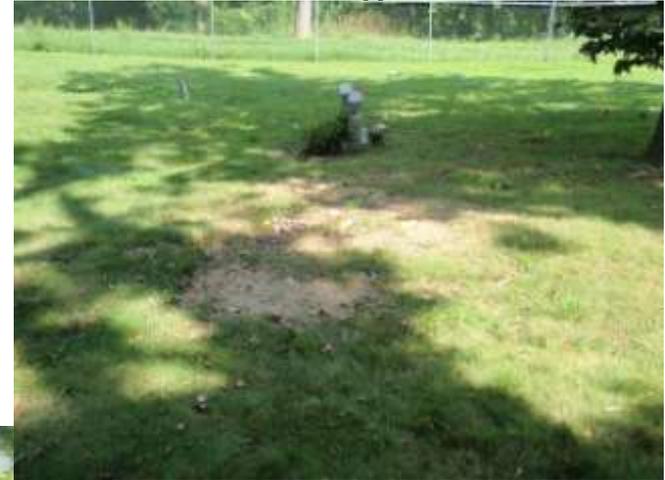
Exposed Bare Ground and Gravestone

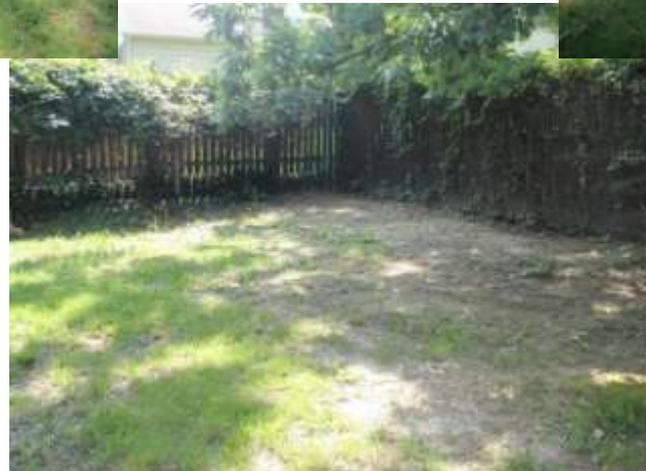
Exposed Bare Ground

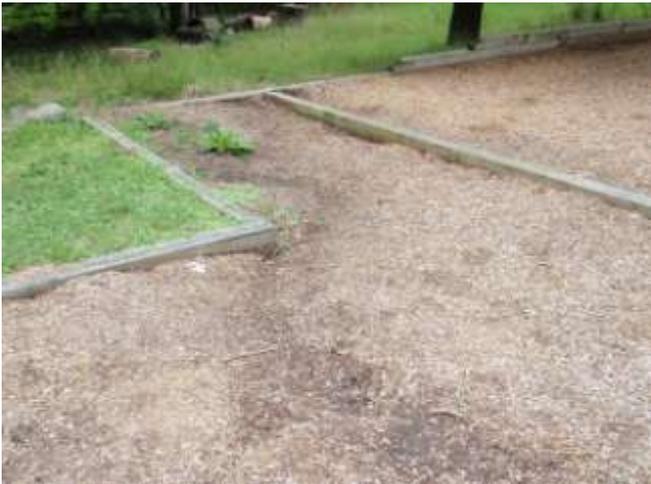
- A channel has formed on the hill adjacent to the playground. There are two yard inlets that collect drainage from the hill before it gets to the playground. One of these inlets is completely covered by sediment and leaves. A channel has formed through the playground. There is a rock outfall and filter fabric at the outfall of the channel through the playground. There are areas of bare ground on the hill upstream of the playground.

Channel in the playground

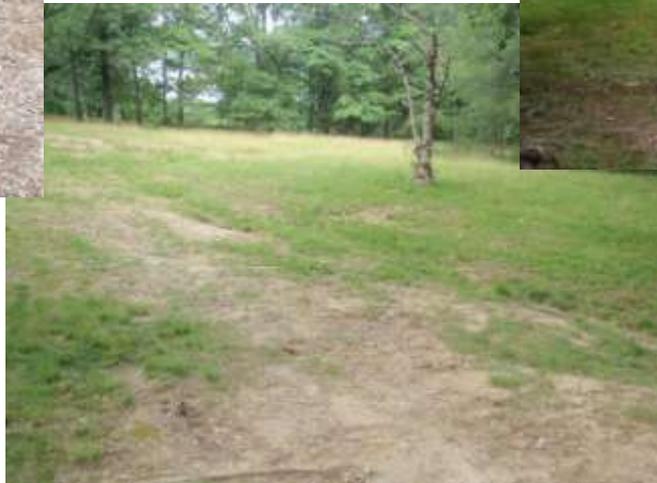
Exposed Bare Ground

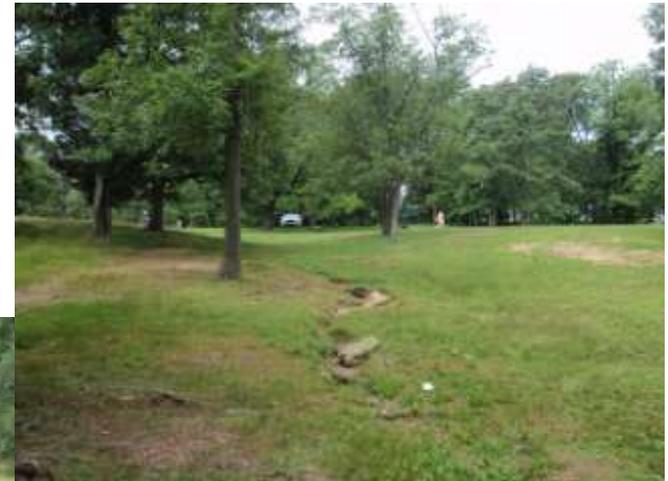
Channel upstream of the playground

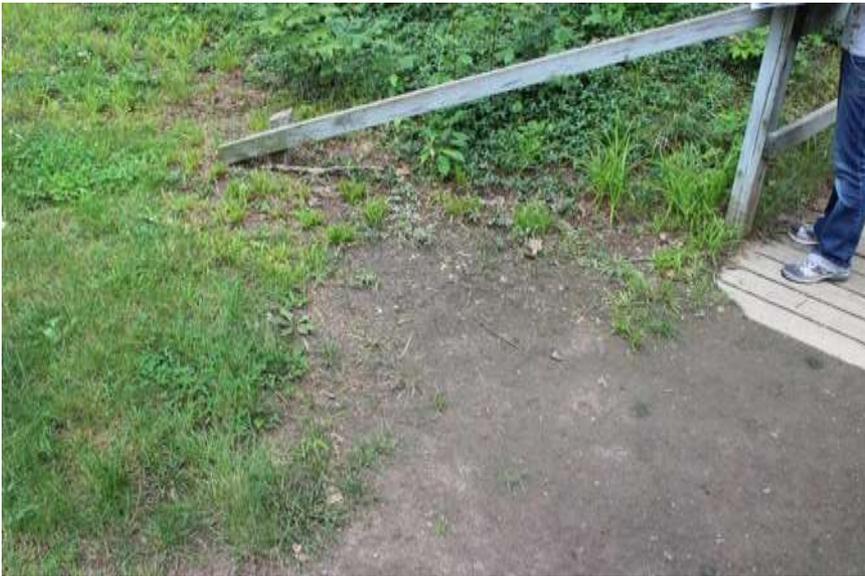
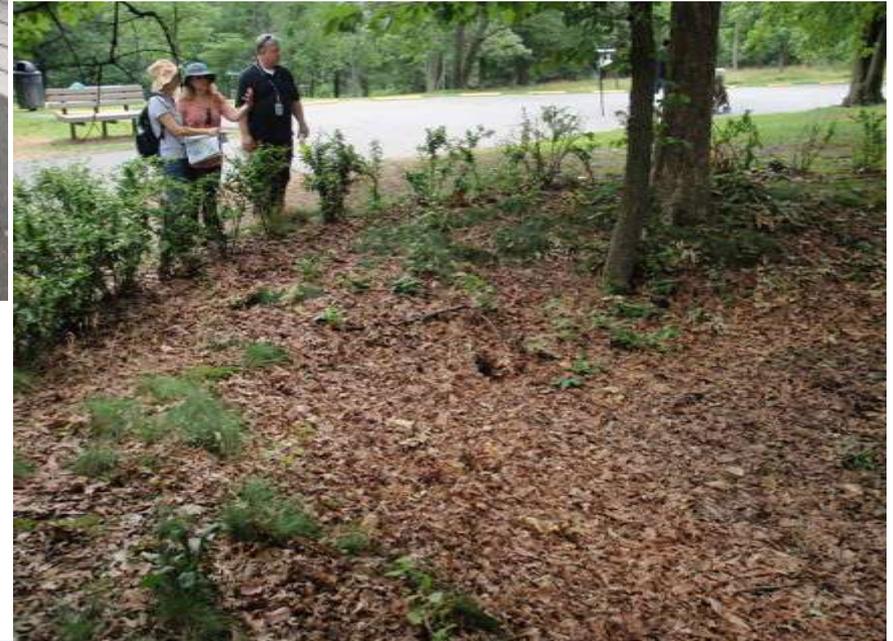
- There is a clogged yard inlet near the footbridge over the swale surrounding the Fort. The cross culvert inlet upstream from the rifle trench appeared to be clogged at the time of the field visit.

Clogged Inlet near Footbridge

Clogged Inlet

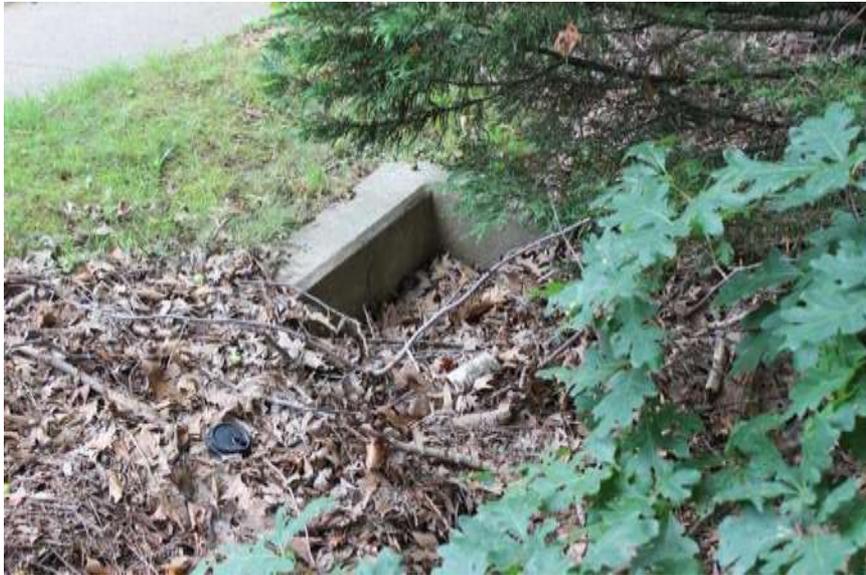
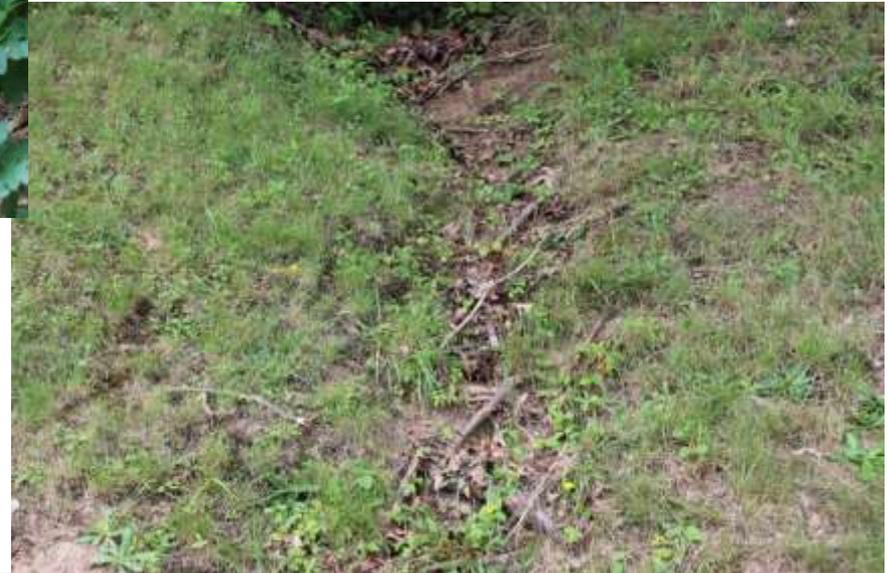
- Park outfalls along Van Dorn Street. Inlets collecting drainage from parks are clogged with debris. Channels have formed downstream of cross culverts discharging runoff

Clogged Inlet Outfall at the Park Property Line

Upstream Channel of the Outfall

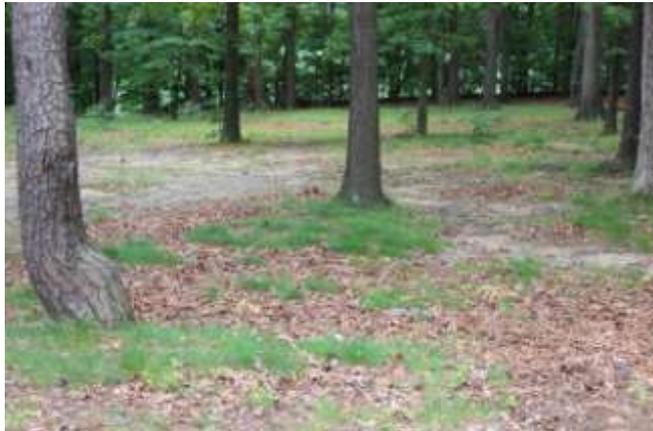
- There are bare spots on hill near the soccer field. An inlet at the base of the hill is clogged and a channel has formed upstream of the inlet.

Bare Ground

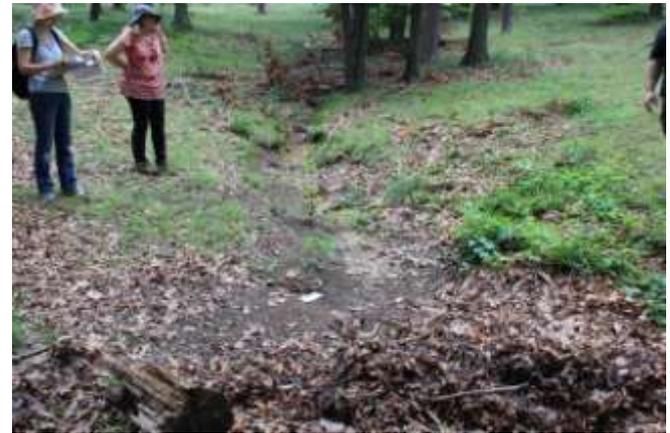
Channel Upstream

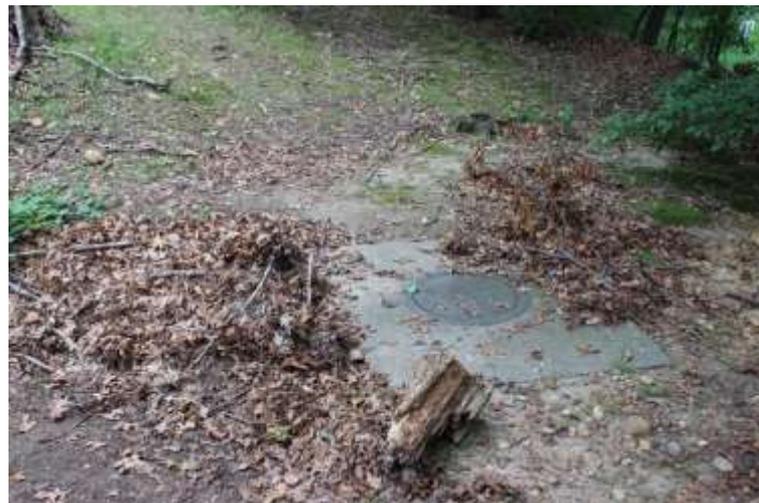
Clogged Inlet

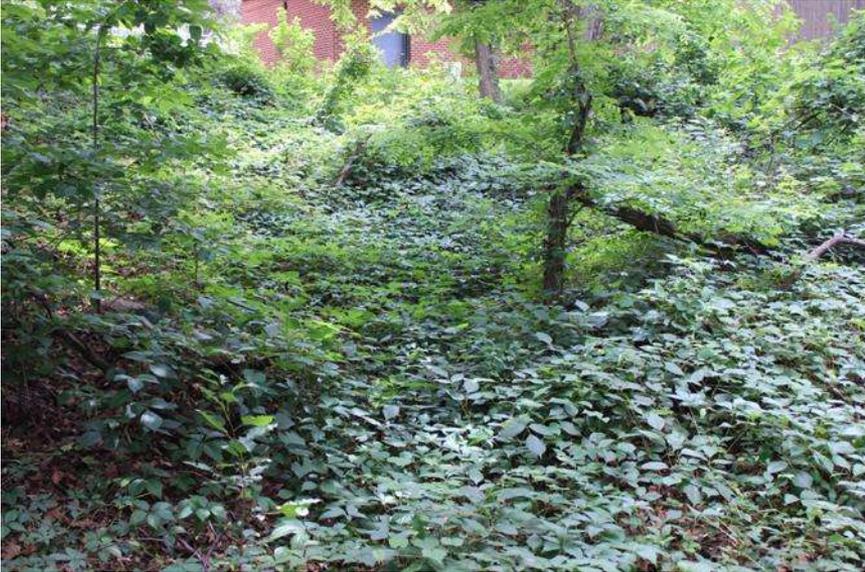
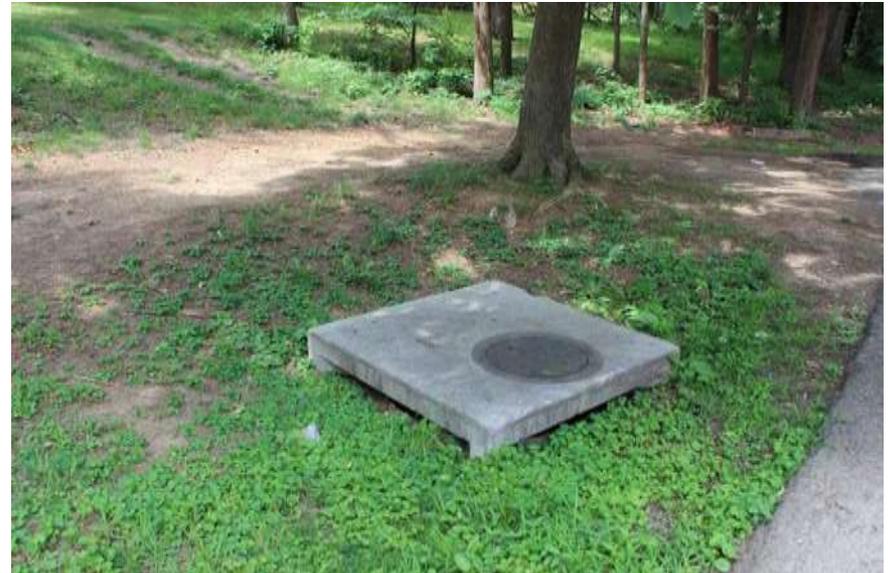
- No problems were observed near the manhole and inlets near soccer field and amphitheater.

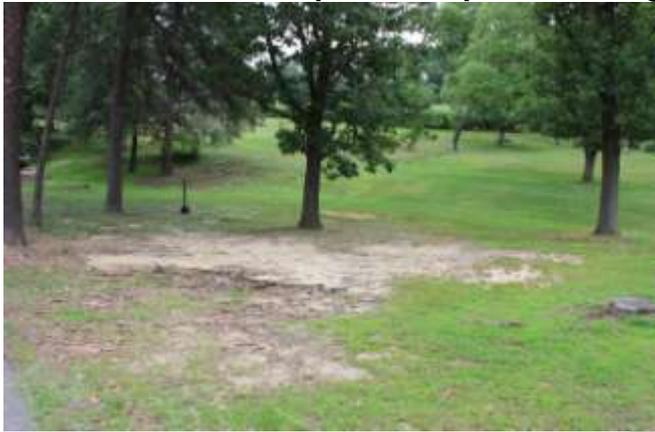
- There are areas of exposed, bare ground in the open areas near the parking lot near amphitheater and adjacent open area. The inlet adjacent to the west side of the Fort is clogged. There is a depression at 15" inlet to the cross culvert under the parking lot. Sedimentation in the parking lot due to blockage from telephone poll being used as a landscape timber.

Bare Ground

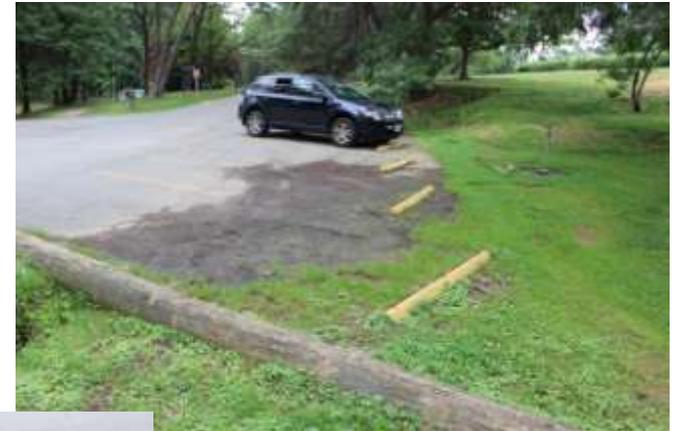
Sedimentation at the parking lot

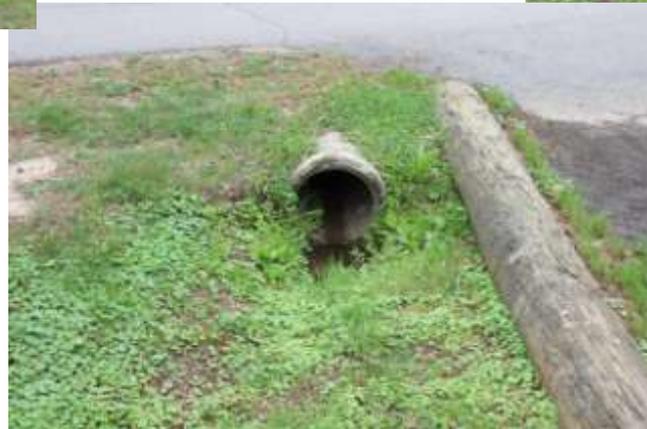
Depression at the inlet

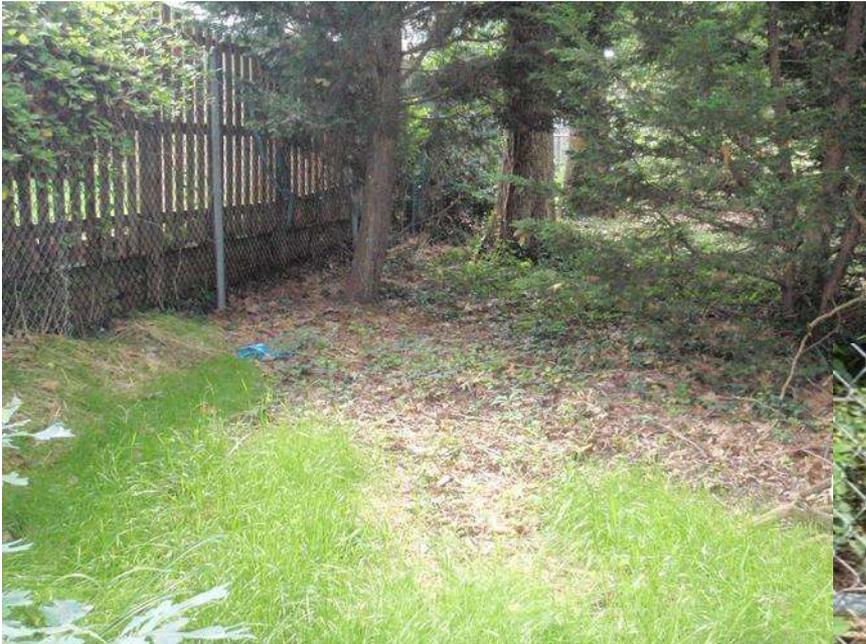
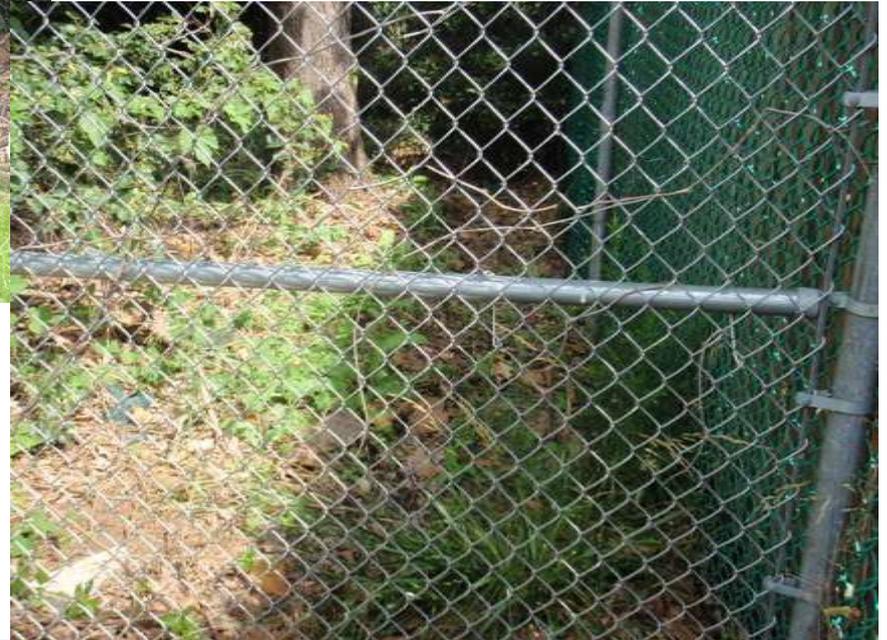
- Runoff from the properties in Marlboro Estates is draining onto Park property and contributing to drainage issues
