**HAZARDOUS MATERIAL SURVEY
ROBINSON TERMINAL/ALEXANDRIA MARINE SHOP
ALEXANDRIA, VIRGINIA**

ECS PROJECT NO. 01:21983-B

OCTOBER 4, 2013

Reference: Hazardous Material Survey
Robinson Terminal, 2 Duke Street, Alexandria, Virginia
Alexandria Marine Shop, 226 Strand Street, Alexandria, Virginia

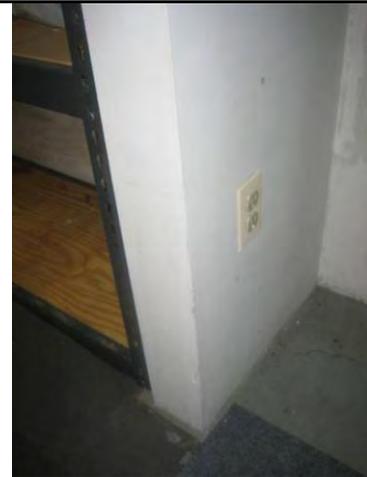
10. View of joint compound, Samples M4-M6, M10-M12.

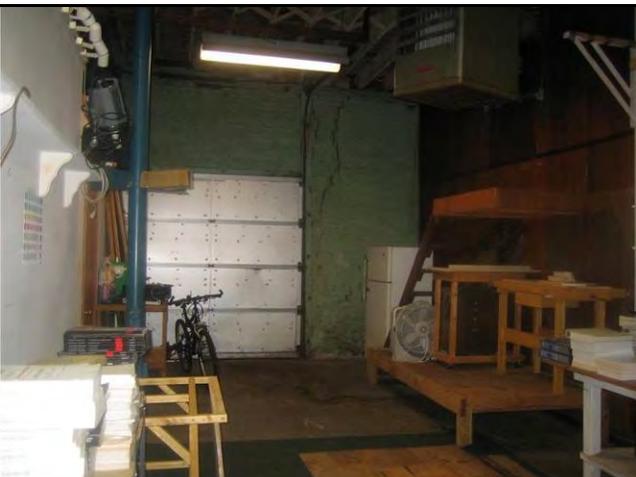
Surfaces throughout the structures appeared to have various painting histories with multiple layers and areas of deterioration. Paint within the warehouse areas, warehouse storage, welding shop, and in the marine shop were observed to be in poor condition.

11. View of rear storage room in Marine Shop with LBP on perimeter wall (green surface color).

At this time ECS recommends that all painted surfaces in the structure be assumed to have detectable levels of lead and are regulated under OSHA. The OSHA standard under 29 CFR 1926.1101 gives no guidance on acceptable levels of lead in paint at which no exposure to airborne lead (above the action or permissible exposure levels) would be

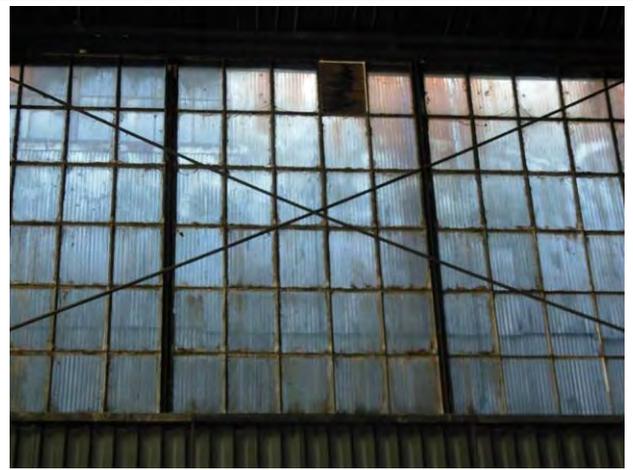
Interior and exterior window caulking throughout the warehouse, and welding shop were typical. The warehouses have upper windows that were inaccessible, but typical of lower windows. The window glazing throughout the structures was observed to be in poor condition (damaged) and in a friable state when touched. This material should be classified as Friable (Photograph Nos. 6 and 12).

12. View of the upper windows within the warehouse.
