REPORT OF ASBESTOS-CONTAINING MATERIALS SURVEY

**FORMER ROBINSON TERMINAL SOUTH
2 DUKE STREET & 226 STRAND STREET
ALEXANDRIA, VA**

ECS PROJECT NO. 01:21983-F

DECEMBER 16, 2015

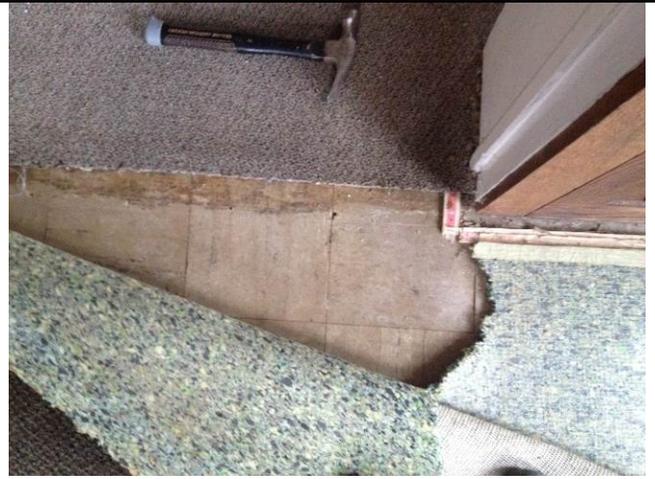
The asbestos containing floor tiles and associated mastics were observed beneath carpeting and layered floor tiles throughout the 1st and 2nd floor levels of the office building. Additionally, 12" x 12" white floor tiles on the 2nd floor rear hallway and offices of the office building were also detected as asbestos containing. Black asbestos containing floor mastics were also detected in the kitchen area of the office building associated with the off-white sheet flooring.

2. Office Bldg - View of the 9" x 9" tan floor tiles (ACM) with black mastic (ACM), Samples 16-17.

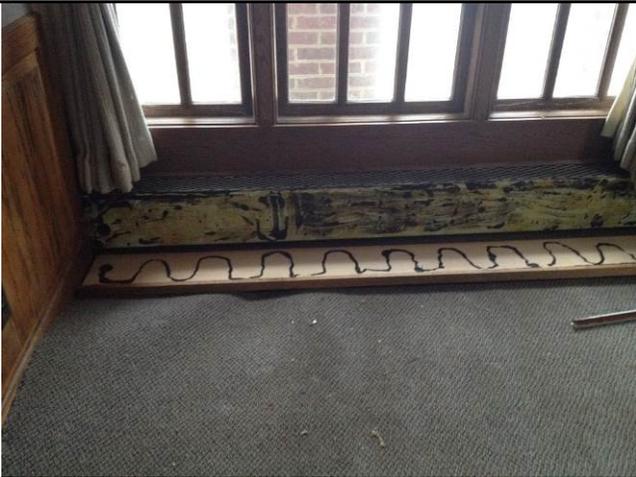
The asbestos-containing black mastic on the radiators in the Office Building was observed inside the wood panels and on the radiators. Additional black mastic may be associated with the wall mounted fan coil units and radiators that are built into the walls.

3. Office Bldg – View of the black mastic (ACM) on radiator, Samples 18-19.

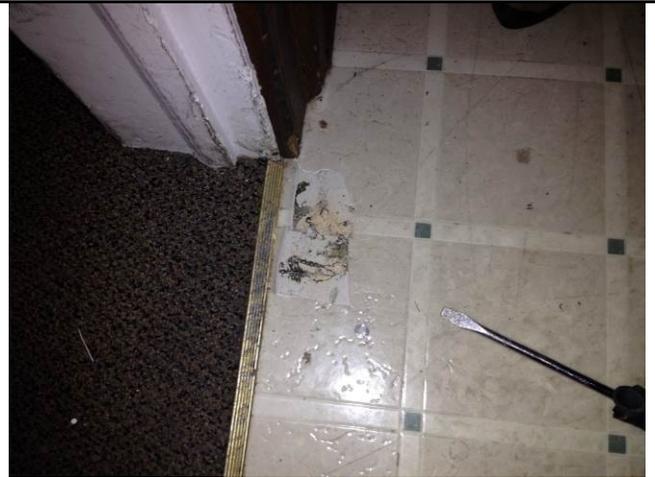
4. Office Bldg – View of the black mastic (ACM) of the off-white sheet flooring in the kitchen, Samples 20-21.

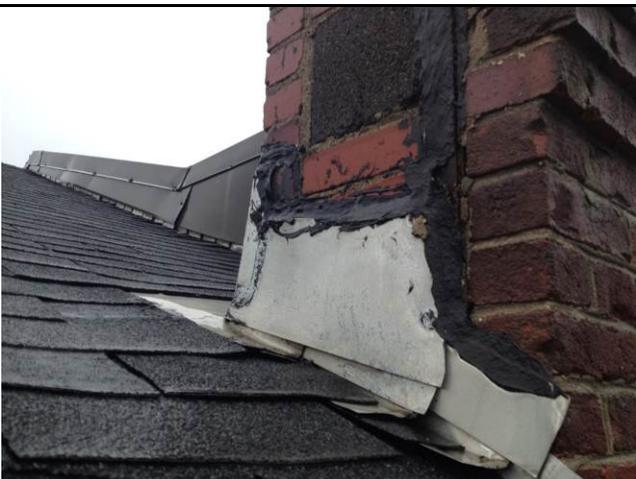
5. Office Bldg – View of black tar (ACM) and flashing (ACM), Samples 28-29.

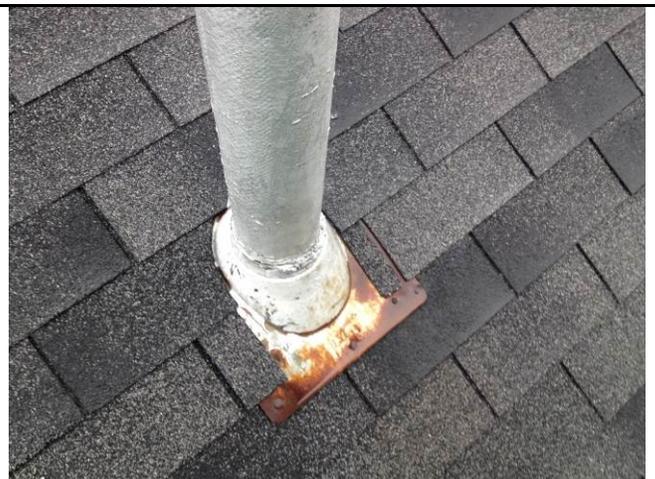
6. Office Bldg – View of the silver/black tar (ACM) on roof vent, Samples 30-31.

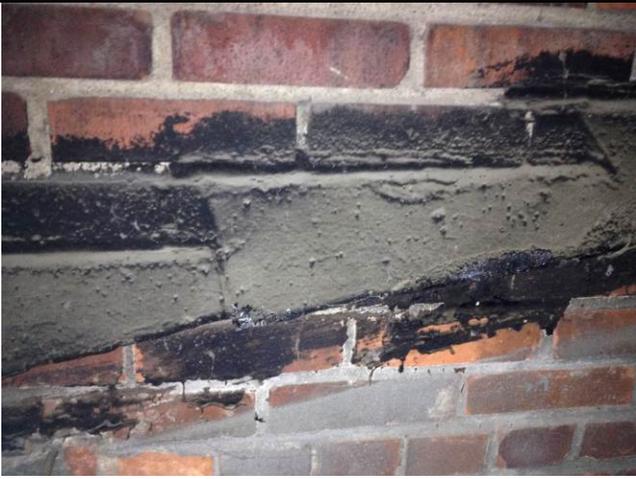
7. Office Bldg – View of the residual black tar (ACM) on the brick from former roof, Samples 34-35.

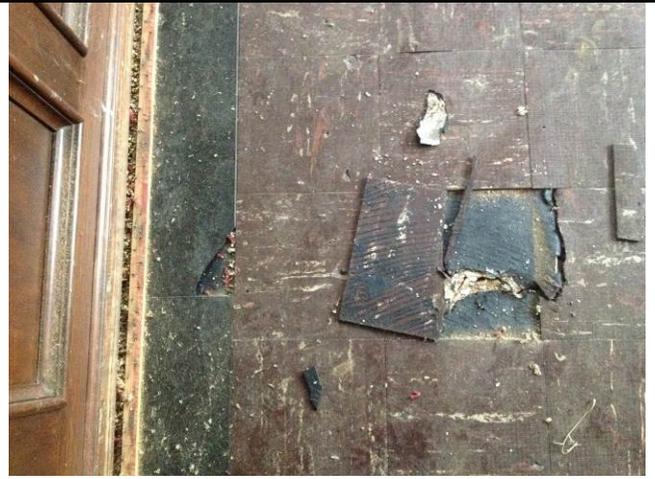
8. Office Bldg - View of the 9" x 9" black floor tiles (ACM), Samples 66-67.

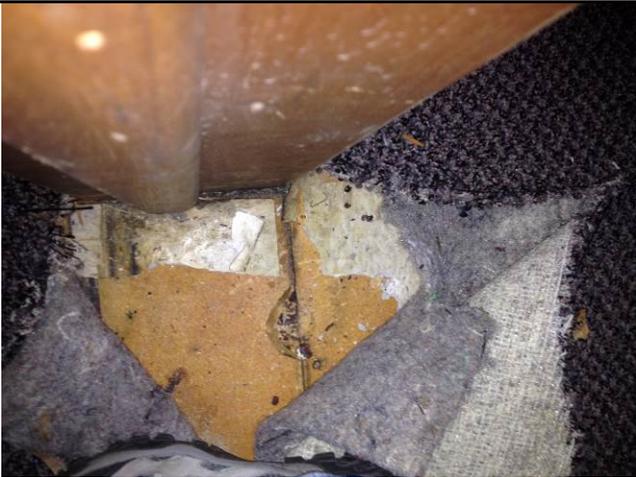
9. Office Bldg - View of 12" x 12" white feathered floor tiles (ACM) located beneath the carpet, Samples 72-73.

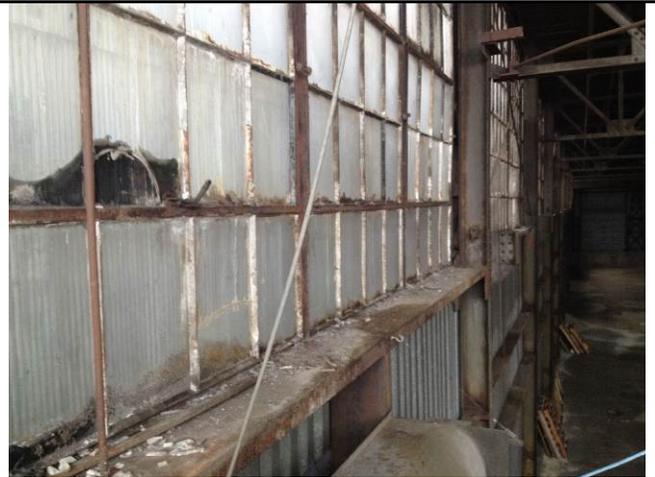
Interior and exterior white window glazing associated with the warehouse interior and exterior windows were detected to contain asbestos. Although a few samples were reported as non-detect, the material is not distinguishable from one window to another among the warehouses. Most of glazing was observed to be significantly damaged with asbestos containing debris on the floor or window sills. Therefore, this material is considered friable.

10. Typical view of the upper interior windows in the warehouse with damaged asbestos containing glazing.

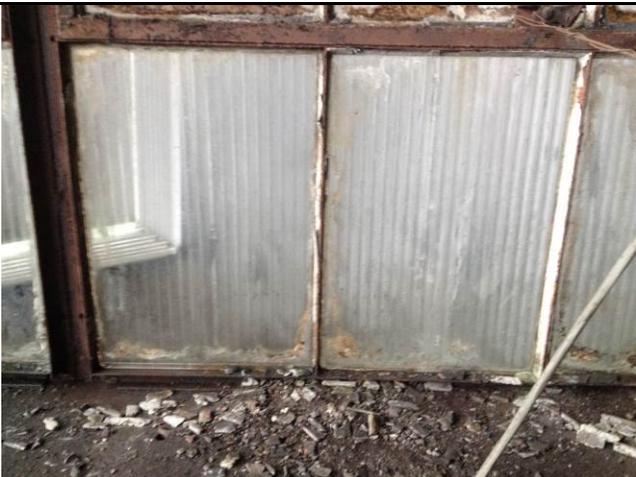
11. View of the damaged interior window glazing (ACM) in the warehouses.

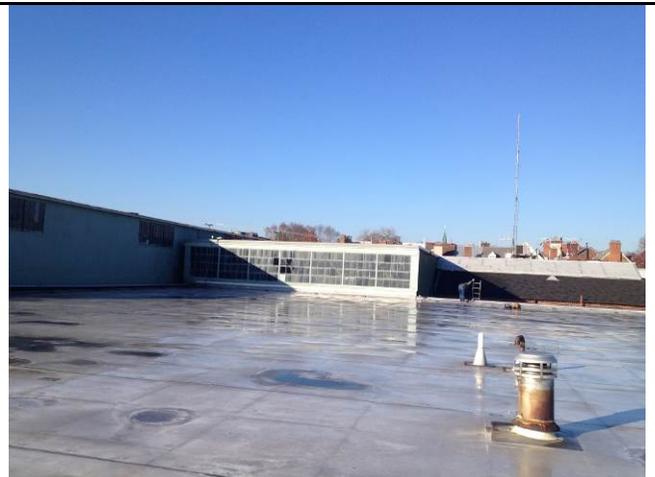
| <u>General Location</u> | <u>Material</u> | <u>Friability</u> |
|---|---|---|
| Warehouse 8 – Exterior Upper Windows | Exterior White Window Glazing | Friable (Damaged) |

12. View of the exterior windows of Warehouse 8 with asbestos containing glazing, Samples 116-117.

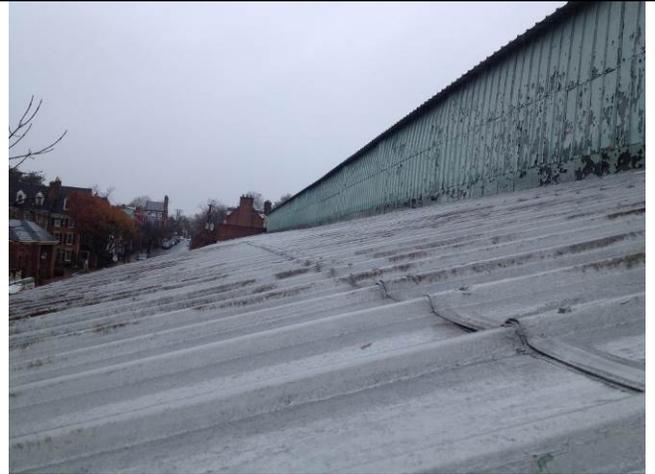
The metal roof of Warehouses 1 was coated with asbestos-containing silver paint (coating). A similar coating with a black tar underlayment was also detected as asbestos-containing on the tank structures and equipment on the roof of Warehouse 4. The flat roof section of Warehouse 1 was inaccessible due to power lines. This roof was observed to also be coated with the silver asbestos paint.

14. Warehouse 1 – View of the silver paint (coating) (ACM) on the metal roof.

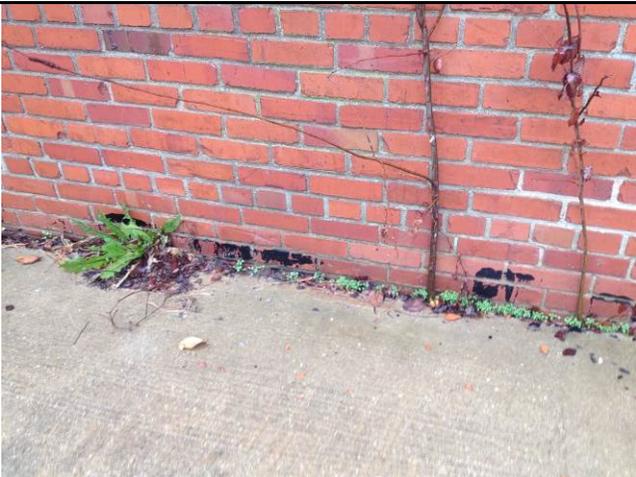
The exterior black subgrade waterproofing sealant was observed along the perimeter walls of Warehouse 4 and contains asbestos. The white caulk on the tank structures was also reported as asbestos containing. The caulk and adjoining surfaces of the roof structures were coated with the silver asbestos paint. The black roof tar on the HVAC pitch pockets and the gray roof vent sealants at Warehouse 4 roof were also reported as asbestos containing. The black mastic within the brick layered façade along the perimeter wall at the Sprinkler room of Warehouse 4 was detected to contain asbestos. The roofing middle layer membrane at Warehouse 2 was reported as asbestos containing.

15. Warehouse 4 – View of the black subgrade waterproofing sealant (ACM), Samples 58-59.

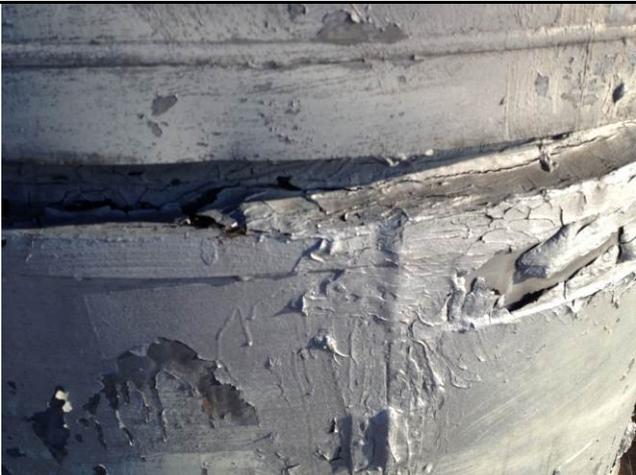
17. Warehouse 4 – View of silver/black tar (ACM) and white caulk (ACM) on tank structure, Samples 110-114.

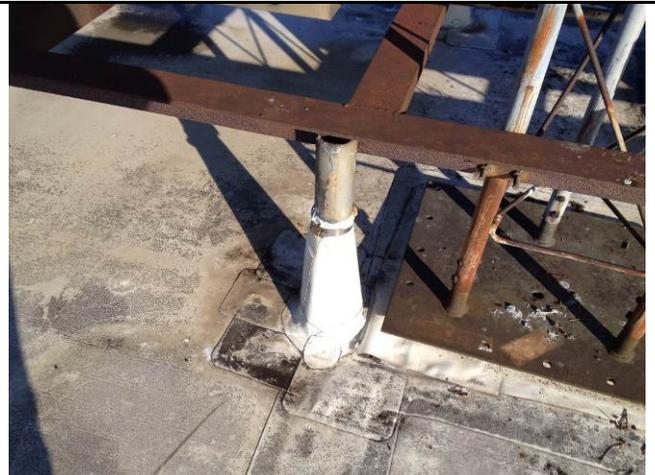
18. Warehouse 7 – View of black pitch pocket tar (ACM), Samples 120-121.

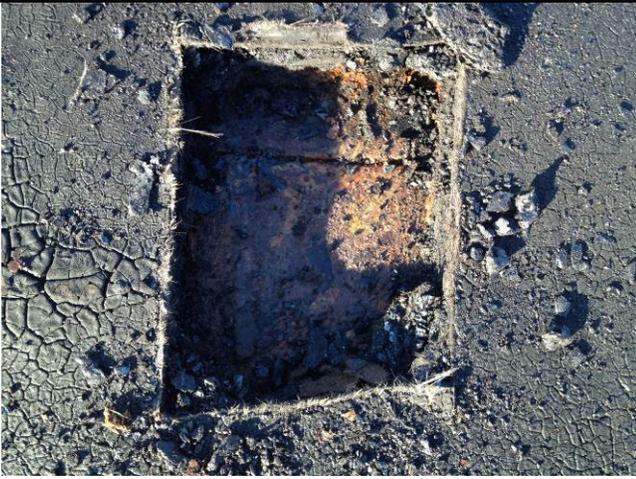
19. Warehouse 2 – View of the roof core, middle membrane (ACM), Samples 126-127.

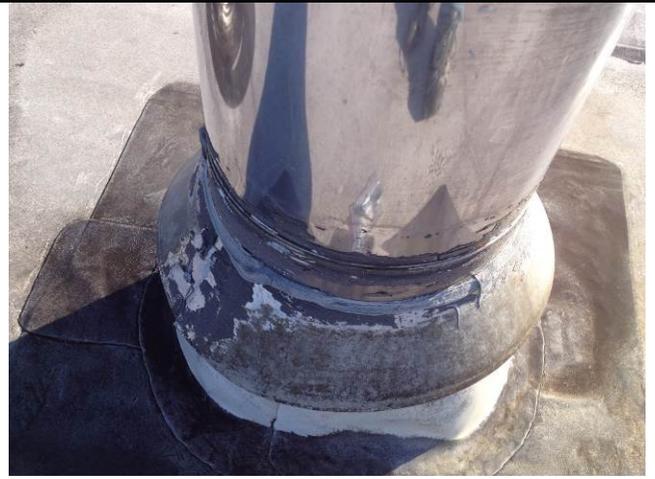
20. Warehouse 4 – View of gray vent sealant (ACM), Samples 134-135.

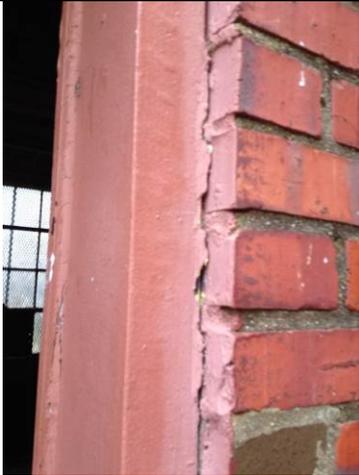
21. Welding Shop – View of exterior gray door caulk (ACM), Samples 86-87.

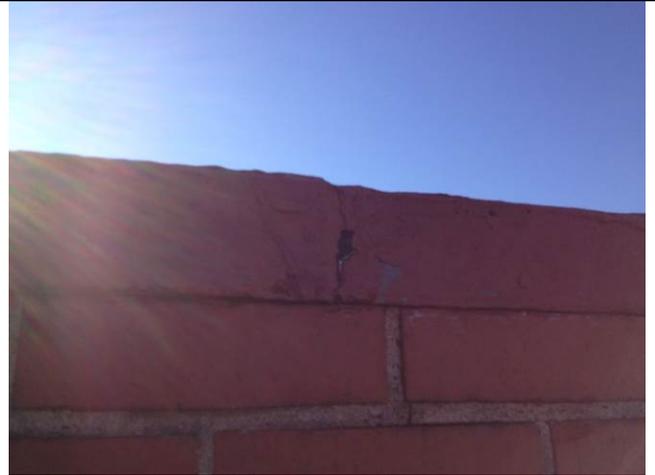
22. Welding Shop – View of black cement on coping (ACM), Samples 160-161.

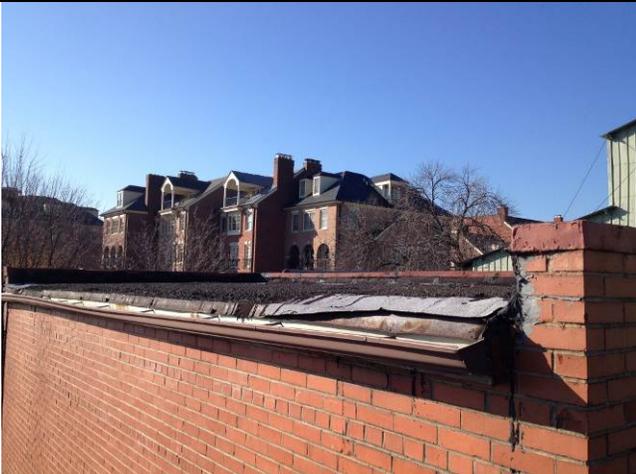
23. Welding Shop – View of gray caulk (ACM) on flashing, Samples 162-163.

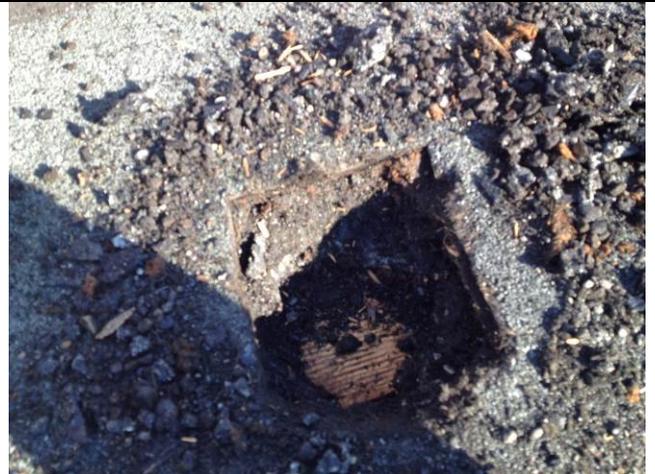
24. Marine Shop – View of roofing pitch (ACM), Samples 142-143.

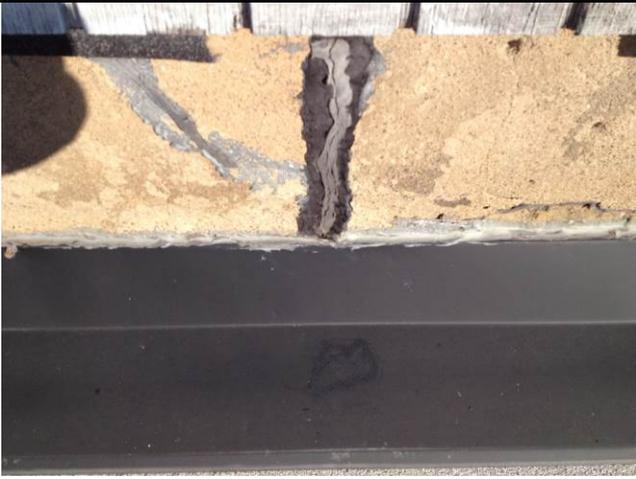
25. Marine Shop – View of black/gray sealant (ACM) on flashing, Samples 144-145.

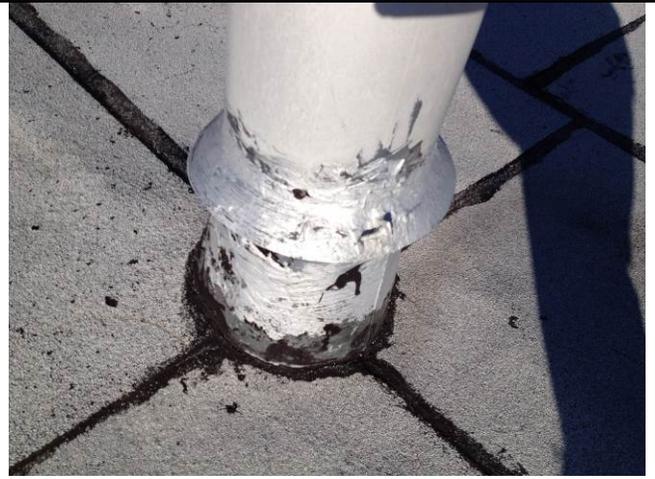
26. Marine Shop – View of silver/black tar (ACM) on roof vents, Samples 148-149.

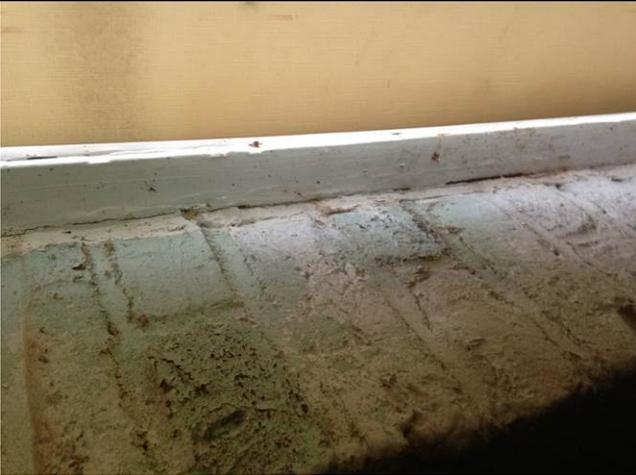
27. Marine Shop – View of interior white window caulk (ACM), Samples 101-102.

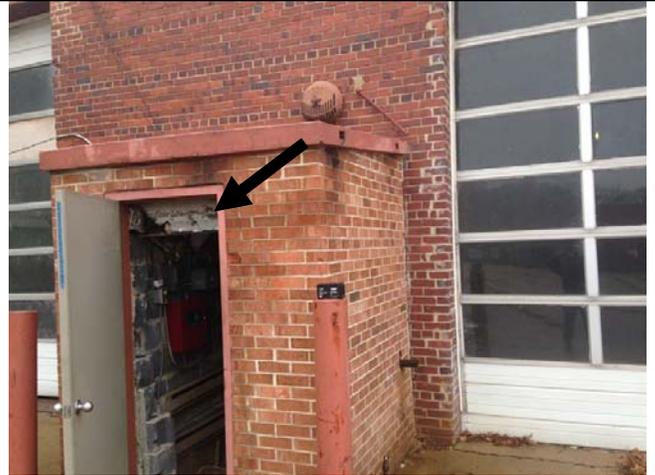
28. Warehouse 4 – View of black mastic on CMU blocks (ACM), Samples 60-61.
