APPENDIX B

FIELD FORMS

Alexandria Stream Assessment

Site Name	000109 Holmes Run
Project Type	Outfall
Site Latitude	38.83065
Site Longitude	-77.13487
Date	03/15/2018
Staff	<input checked="" type="checkbox"/> Troy Biggs <input checked="" type="checkbox"/> Mike Hepp <input checked="" type="checkbox"/> Alexandria Staff <input type="checkbox"/> Other
Watershed	Holmes Run
Drainage Area	49.5 ac.

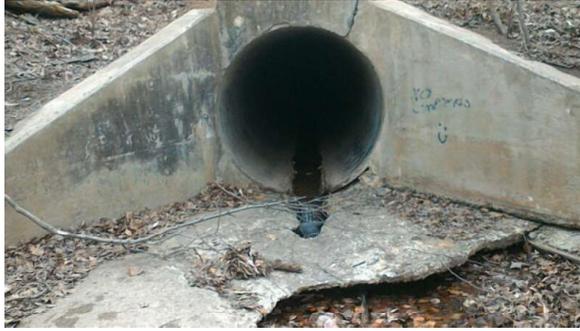
Image 2

Outfall

Infrastructure Details: Pipe outfall apron cut through concrete. Pipe scouring. Outfall channel side slope and bottom concrete broken

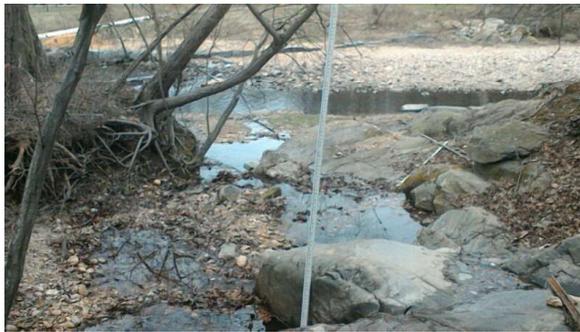
Image 3

Bedrock ds tie in

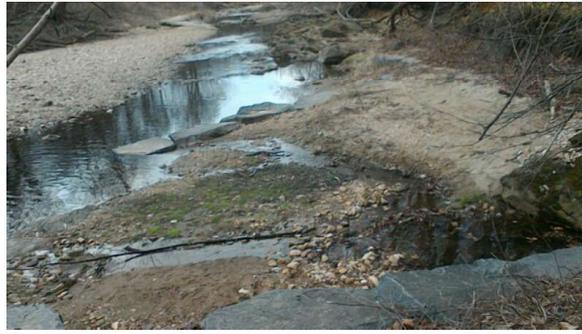
Image 5

Ds tie in at vane arm

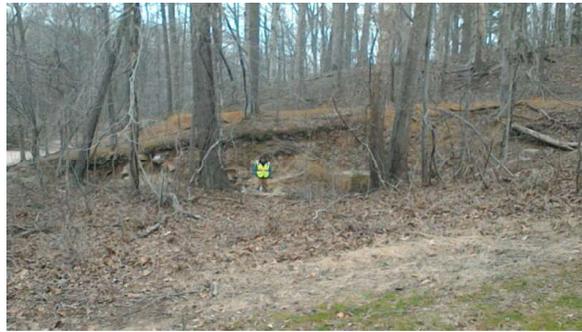
Image 6

Side view of outfall

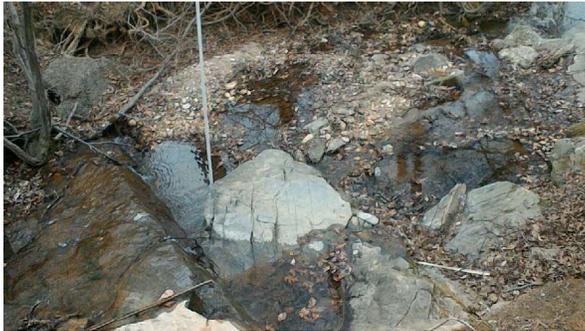
Image 10

Below concrete apron

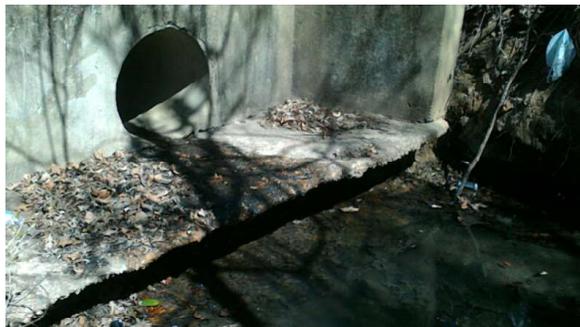
Image 2 Concrete apron

Infrastructure Details: 36" RCP outfall undermined

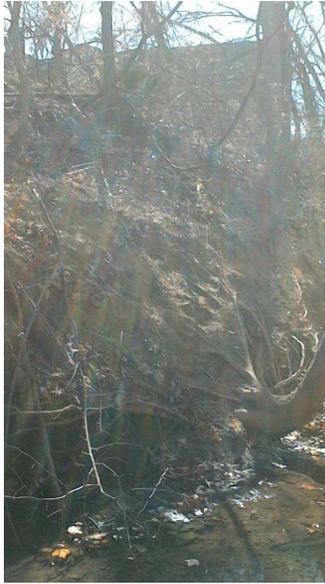
Image 3 Left eroded bank

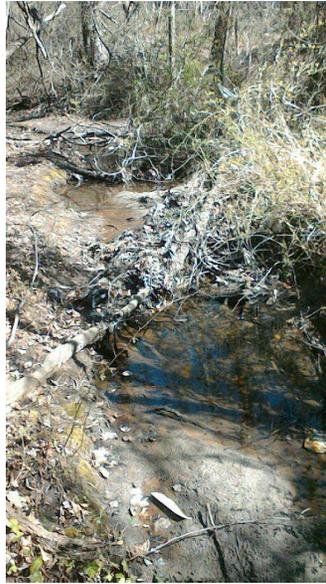
Image 6 Downstream headcut #1

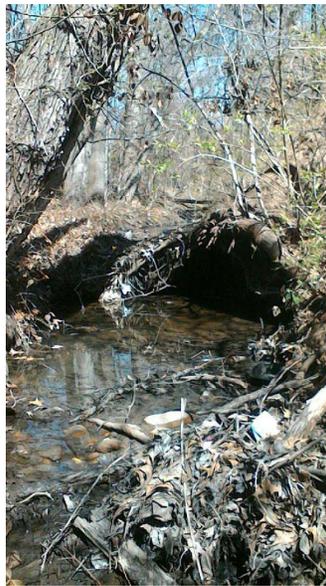
Image 7 Downstream headcut #2

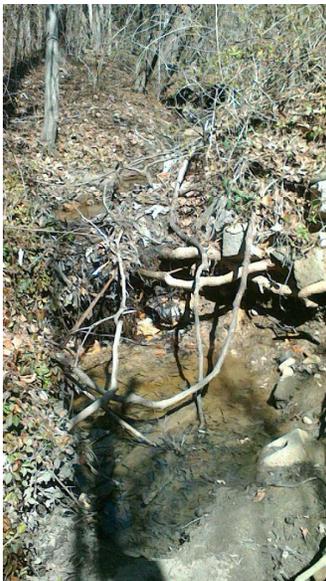
Image 8 Downstream headcut #3

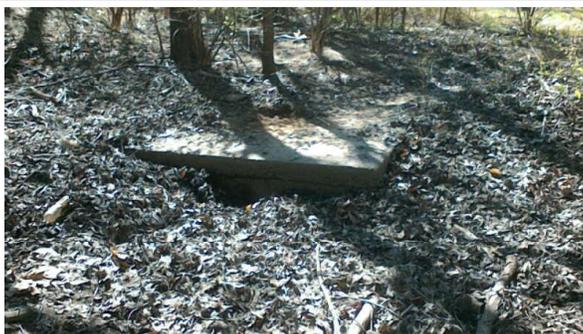
Image 9 Storm inlet covered with debris

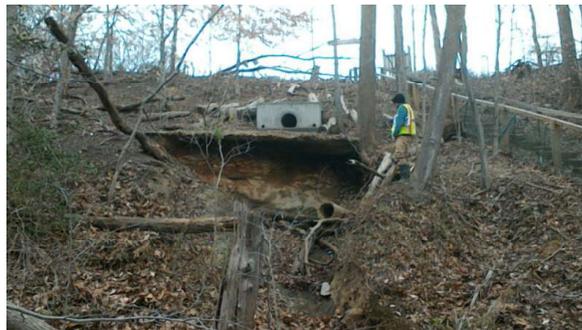
Image 4 Cantilevered outfall

Infrastructure Details: Outfall apron cracking and hanging over air

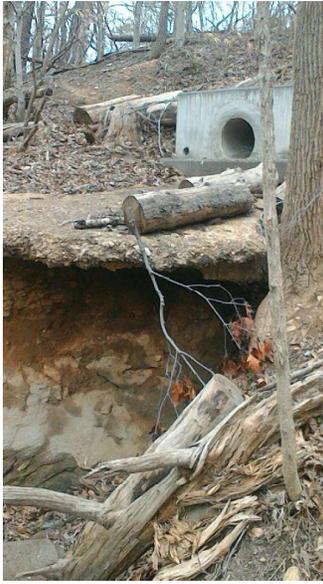
Image 5 Overhanging concrete apron

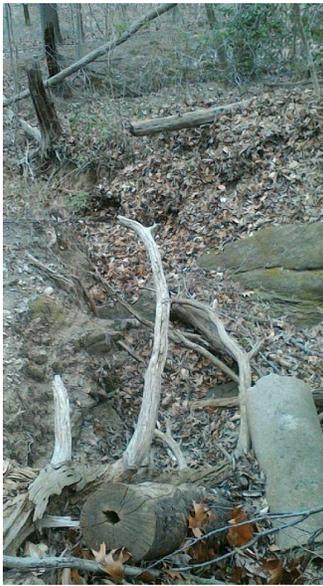
Image 6 Exposed bedrock

Bedrock Details: Cut down to bedrock at the end of the apron

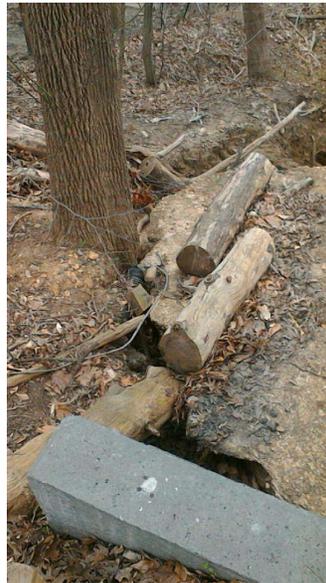
Image 9 Headwall apron interface

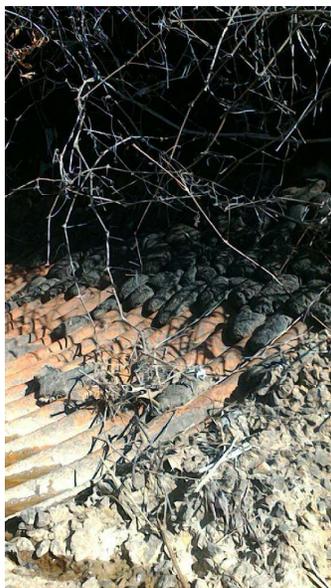
Image 4 Eroded CMP

Dual 90in cmp pipe hanging and beginning to undercut. Existing lining deteriorating

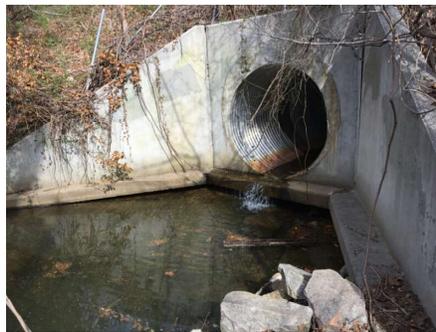
Image 1

Upstream storm sewer outfall. 6ft dai. CMP

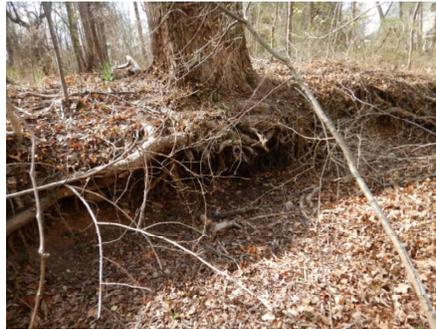
Image 3

Abandoned meander/floodplain. Evidence current channel has downcut approx. 4 ft.

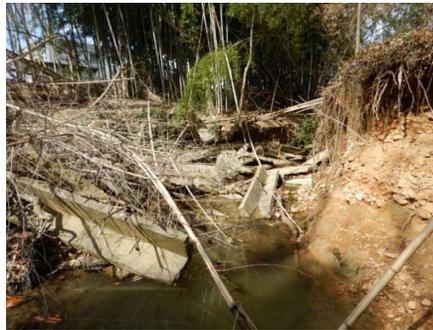
Image 4

Broken concrete pieces (appears to be old curb & gutter) in the channel.

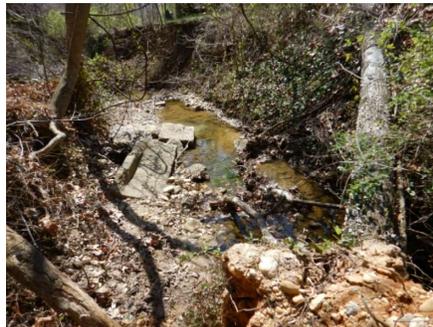
Image 5

Channel obstructions (downed tree & concrete) in the lower project reach.

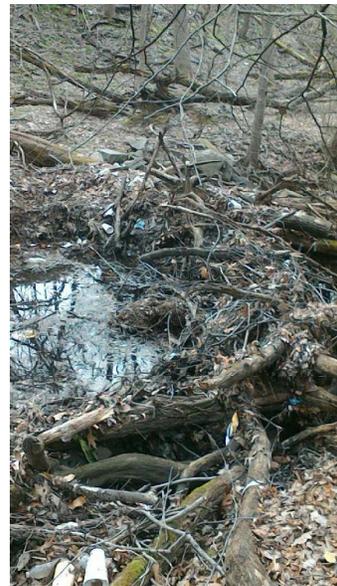
Image 6 Debris blockage

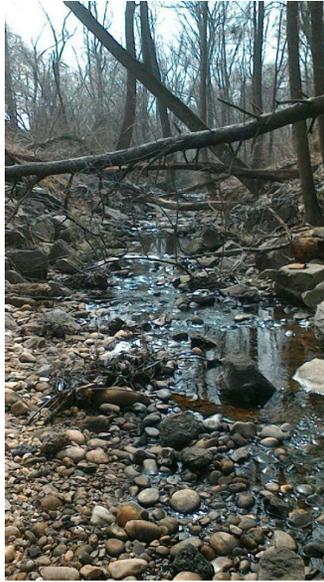
Image 7 Fallen trees
