## APPENDIX D: **Case Study Area Summaries**

# CASE STUDY 1: I-395 / LANDMARK MALL

City of Alexandria

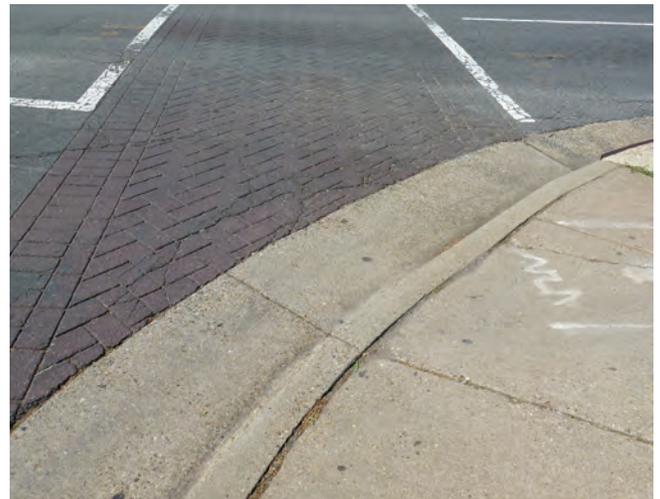
Non-compliant curb ramp in Alexandria

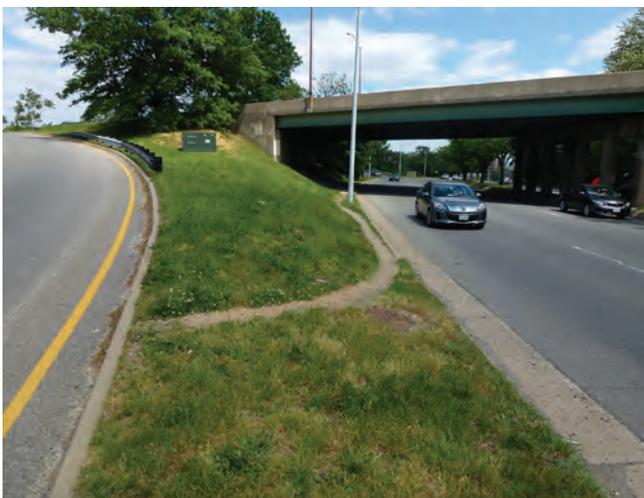
Goat path along Duke Street

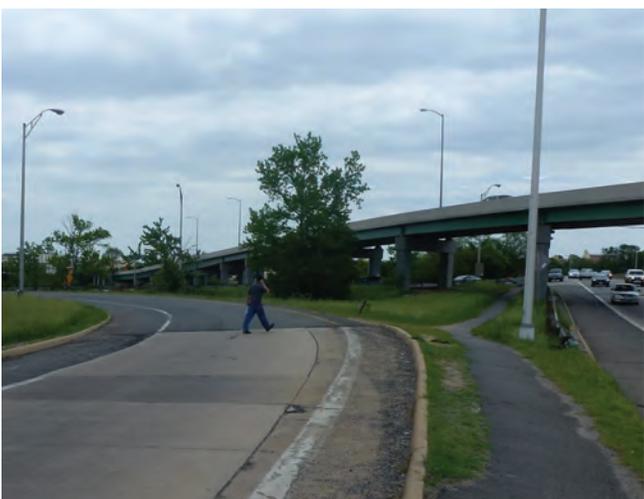
Pedestrian crossing the middle of the on-ramp

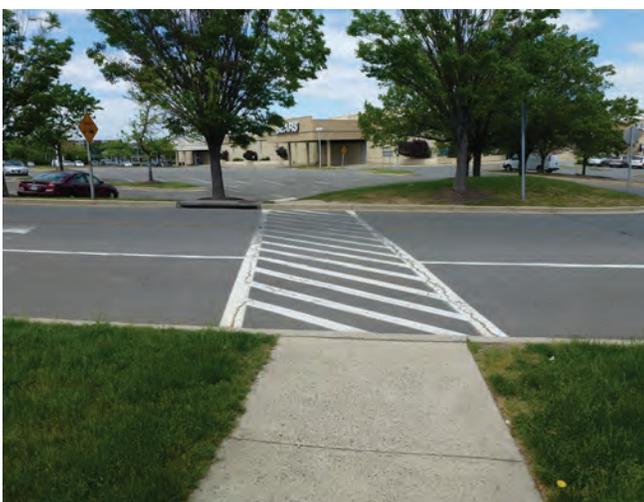
Crosswalk lacking ADA ramps

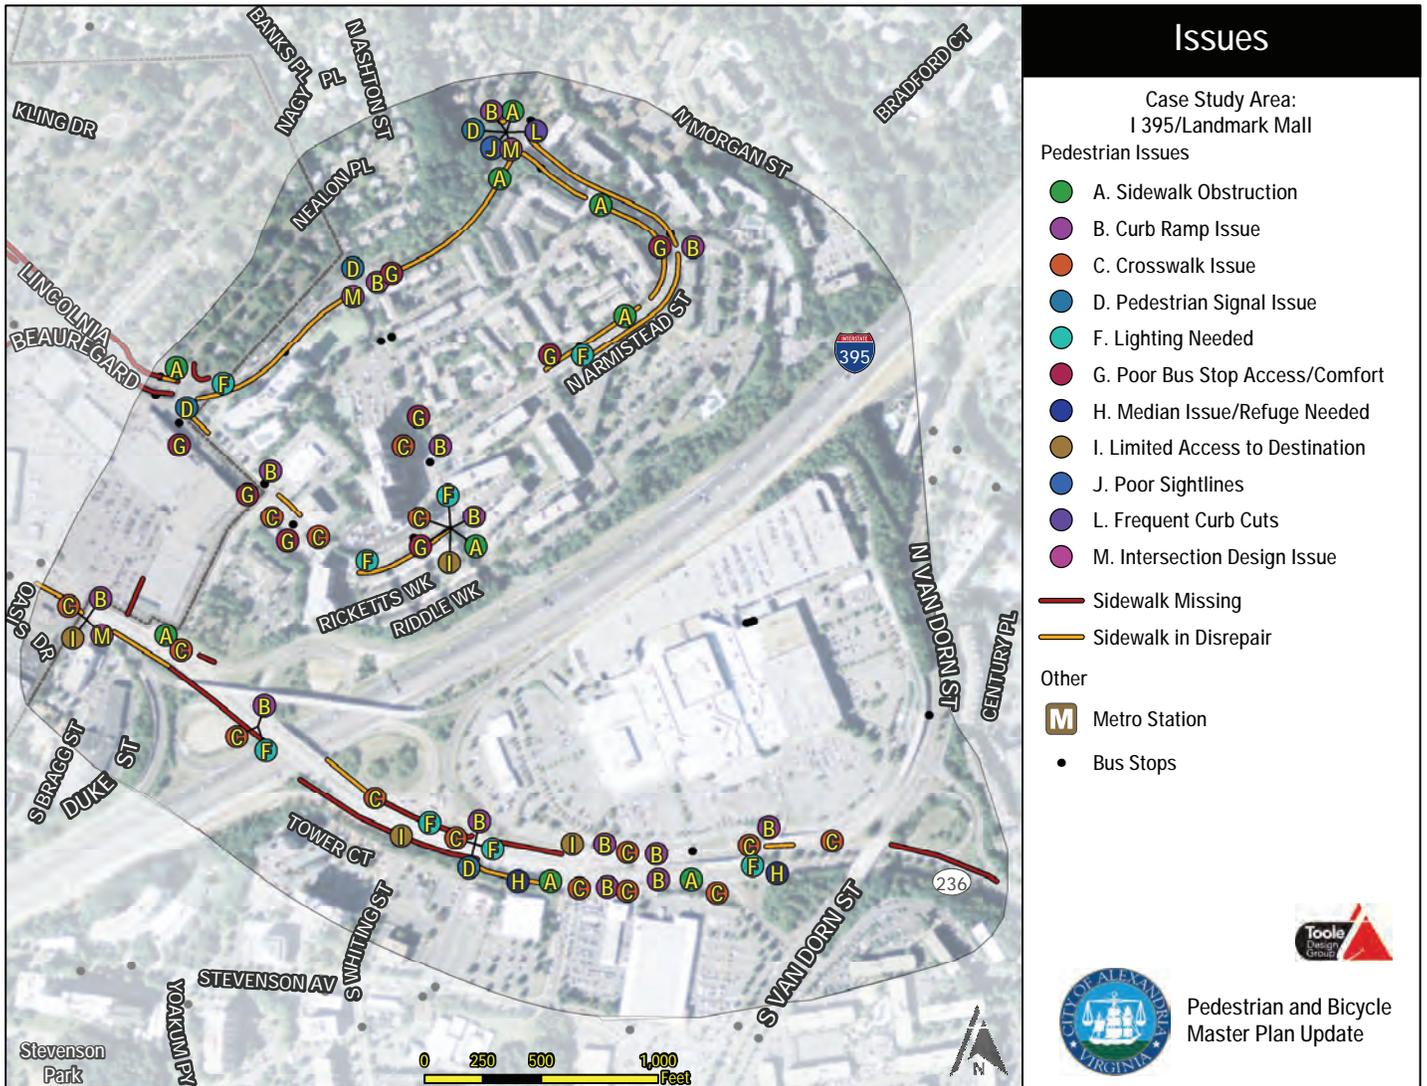
Figure 1: Map of Issues Identified

Table 2 shows the types and frequency of issues observed during the field work in the I-395/Landmark Mall Case Study Area. As in all the Case Study Areas, sidewalk obstructions and disrepair, crosswalks, and curb ramps are the most prevalent pedestrian infrastructure issues. Sidewalks exist along most, though not all, streets and are typically five feet wide. Similarly, most --but not all-- of the sidewalks have buffers. Other notable issues in this corridor include poor lighting and poor bus stop access, as shown in Figure 1.

Within the Case Study Area, the most challenging corridor for pedestrians is along Duke Street between Beauregard Street and South Van Dorn Street. Sidewalks are missing in many locations, and where sidewalks do exist they are in disrepair or are too narrow to create a comfortable walking environment, given the surrounding context and vehicle speeds. Many pedestrians were observed along Duke Street despite the uncomfortable conditions. Worn paths in the dirt/grass were observed in most locations where the sidewalk is discontinuous, demonstrating a need for more permanent infrastructure. The City is currently completing a sidewalk project along Duke Street from Oasis Drive to Walker Lane, which is a step toward addressing the connectivity issues in this area.

Another important issue in this Case Study Area is the limited pedestrian access to the Landmark Plaza shopping center as well as the Landmark Mall. Although there is a recently restriped crosswalk on Duke Street at South Walker Street, the connecting sidewalks are narrow or in disrepair and there is not an ADA accessible route to the Mall from the nearest bus stop on Duke Street.

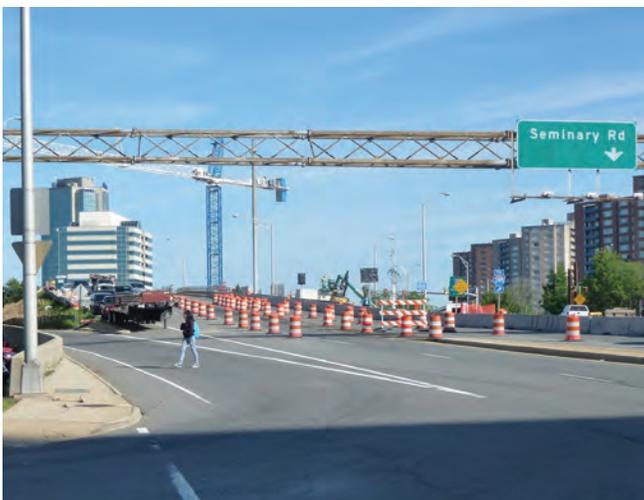
Student crossing mid-block on Seminary Road at Kenmore Avenue near I-395 entrance

Within the Case Study Area, one of the most challenging locations for pedestrians is the Seminary Road crossing at Kenmore Avenue. During the project field work, numerous pedestrians were observed crossing mid-block on Seminary Road to access the bus stop and shopping centers on Kenmore Avenue and Library Lane. This condition likely results from the concentration of higher density housing to the south of Seminary Road, the commercial development and bus stops to the north, and the long distances between marked crossings in this area.

To help with the issue of people crossing mid-block on Seminary Road at Kenmore Avenue, a near-term recommendation is to consider relocating the bus stop on the north side of the street closer to the signalized intersection of Seminary and Library Lane. Longer term, the City could evaluate the potential for a new traffic signal or pedestrian activated signal at Seminary and Howard; however, the close proximity to the adjacent signal at Library Lane may make this infeasible.

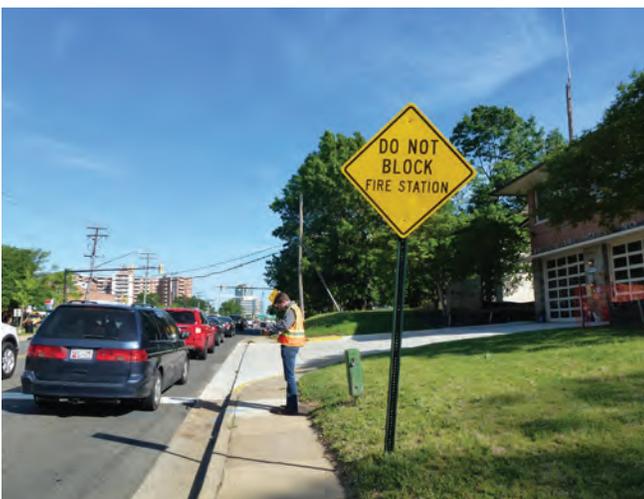
Traffic outside Hammond Middle School blocking the fire station

To improve pedestrian access and safety near Hammond Middle School, additional highly-visible school zone signage is recommended. School officials should also increase enforcement of school drop off/pick up zones to minimize backups on Seminary Road.

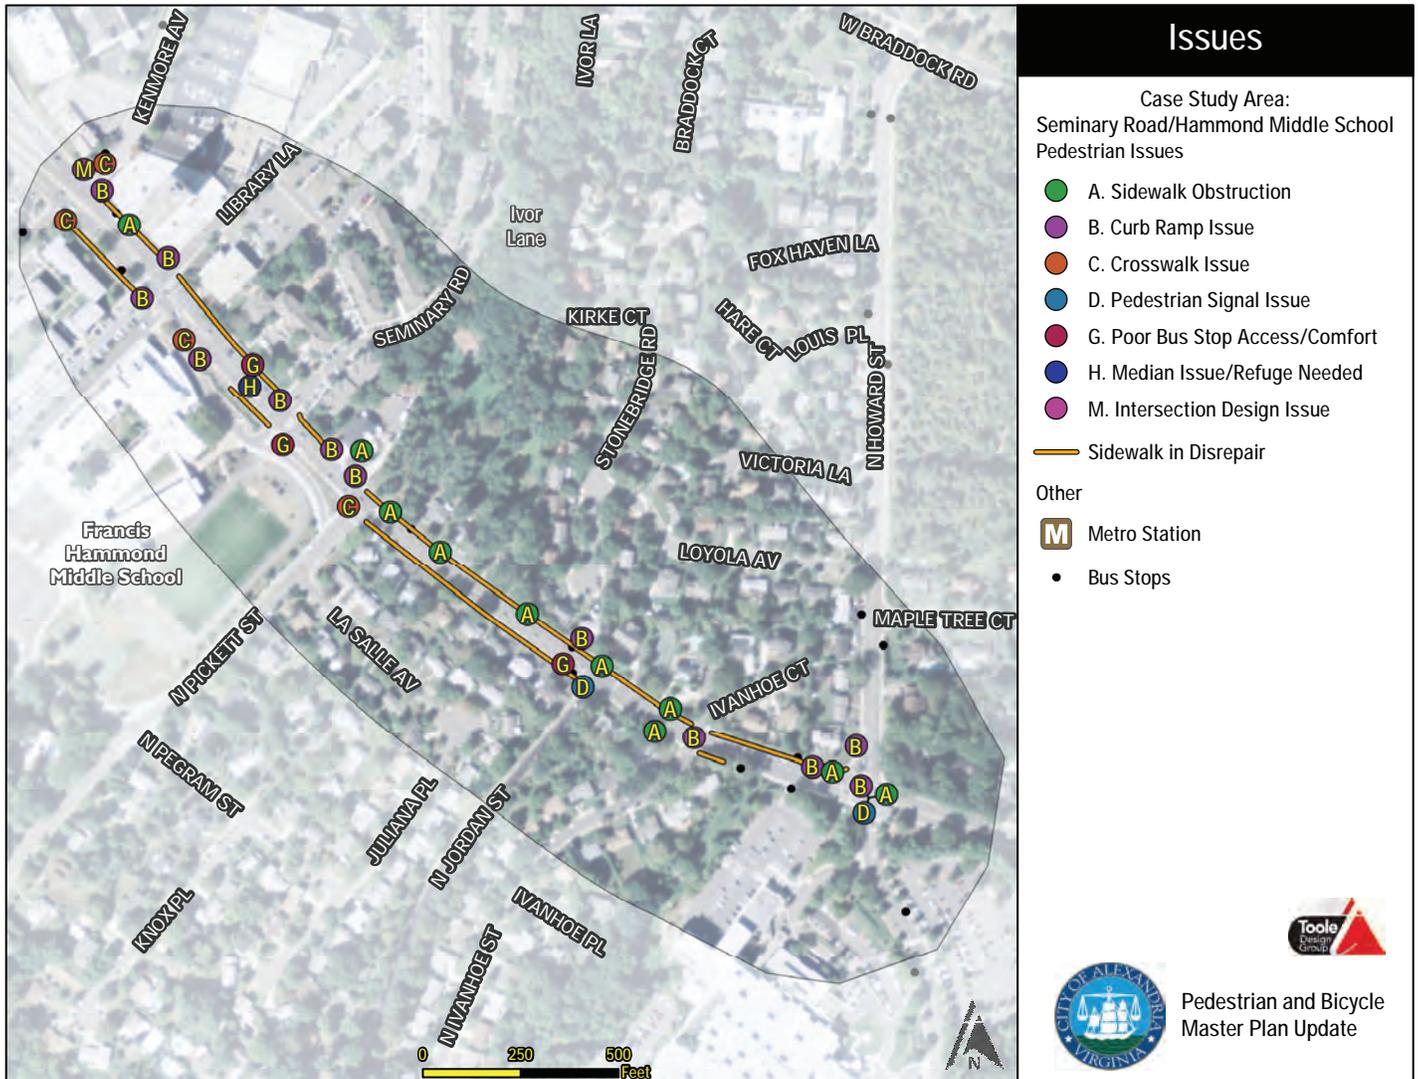
Figure 3: Map of Issues Identified

As in all the Case Study Areas, curb ramps, sidewalk obstruction/disrepair, missing or narrow sidewalks, and crosswalks are key issues in the Seminary Road/Hammond Middle School area. Sidewalks exist on both sides of the streets and vary in width from four and six feet. Sidewalk buffers of between four and six feet exist on some segments of Seminary Road and nearby local streets, but in some instances buffers are narrow given the speed and volume of traffic. Additionally, many sidewalks and curb ramps are not ADA compliant, and several intersections lack marked crosswalks. Other issues in this corridor include poor bus stop access and inaccessible or broken pedestrian signals, as shown in Table 4 and Figure 3.

Walkability and pedestrian safety in this Case Study Area is particularly important due to the presence of Hammond Middle School. Alexandria has an active Safe Routes to School program that aims to support increased walking and bicycling to school. Several curb ramps and crosswalks in front of the school need improvement, and the field work team noted a lack of visible signage alerting parents to the school zone, especially at the west end of the school zone. Another challenge in this area is that vehicles back up on Seminary Road in front of Hammond Middle School as parents wait to drop off/pick up their children. This situation blocks the sidewalks and creates the potential for conflicts between the queuing vehicles and other traffic.

Finally, bicycle infrastructure is very limited in this area. Bicyclists were observed riding on both the sidewalks and on Seminary Road, though the traffic volumes are too high for most people to be comfortable riding on the street. Also, the edge of the street creates challenges for bicyclists given the prevalence of storm drain grates and unmaintained gutter seams.

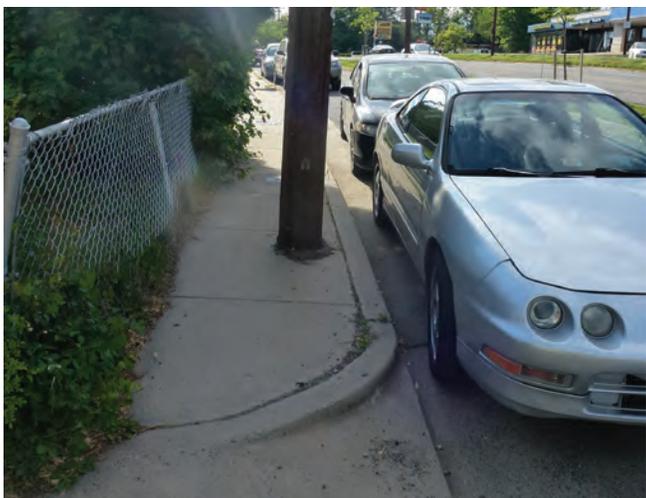
Sidewalk obstruction and curb ramp issue

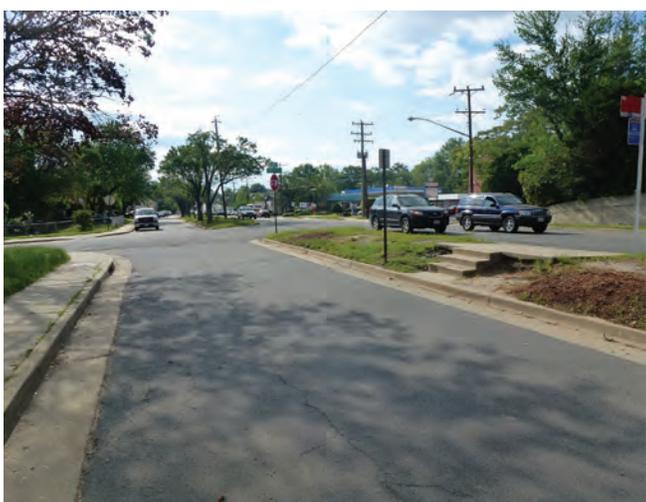
Non-ADA compliant bus stop

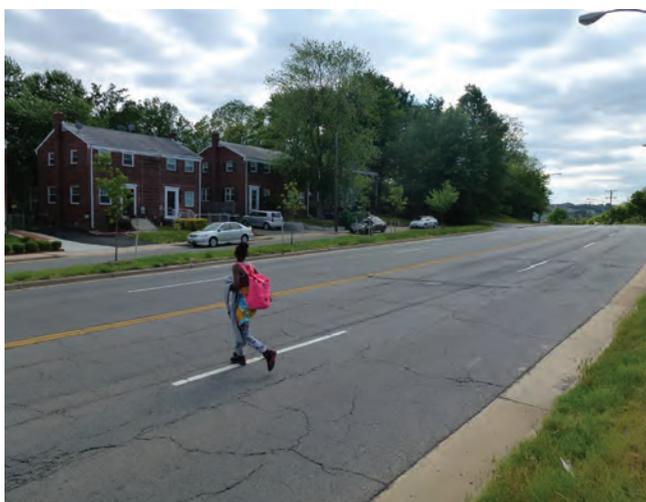
Student crossing mid-block across Duke Street to local access road

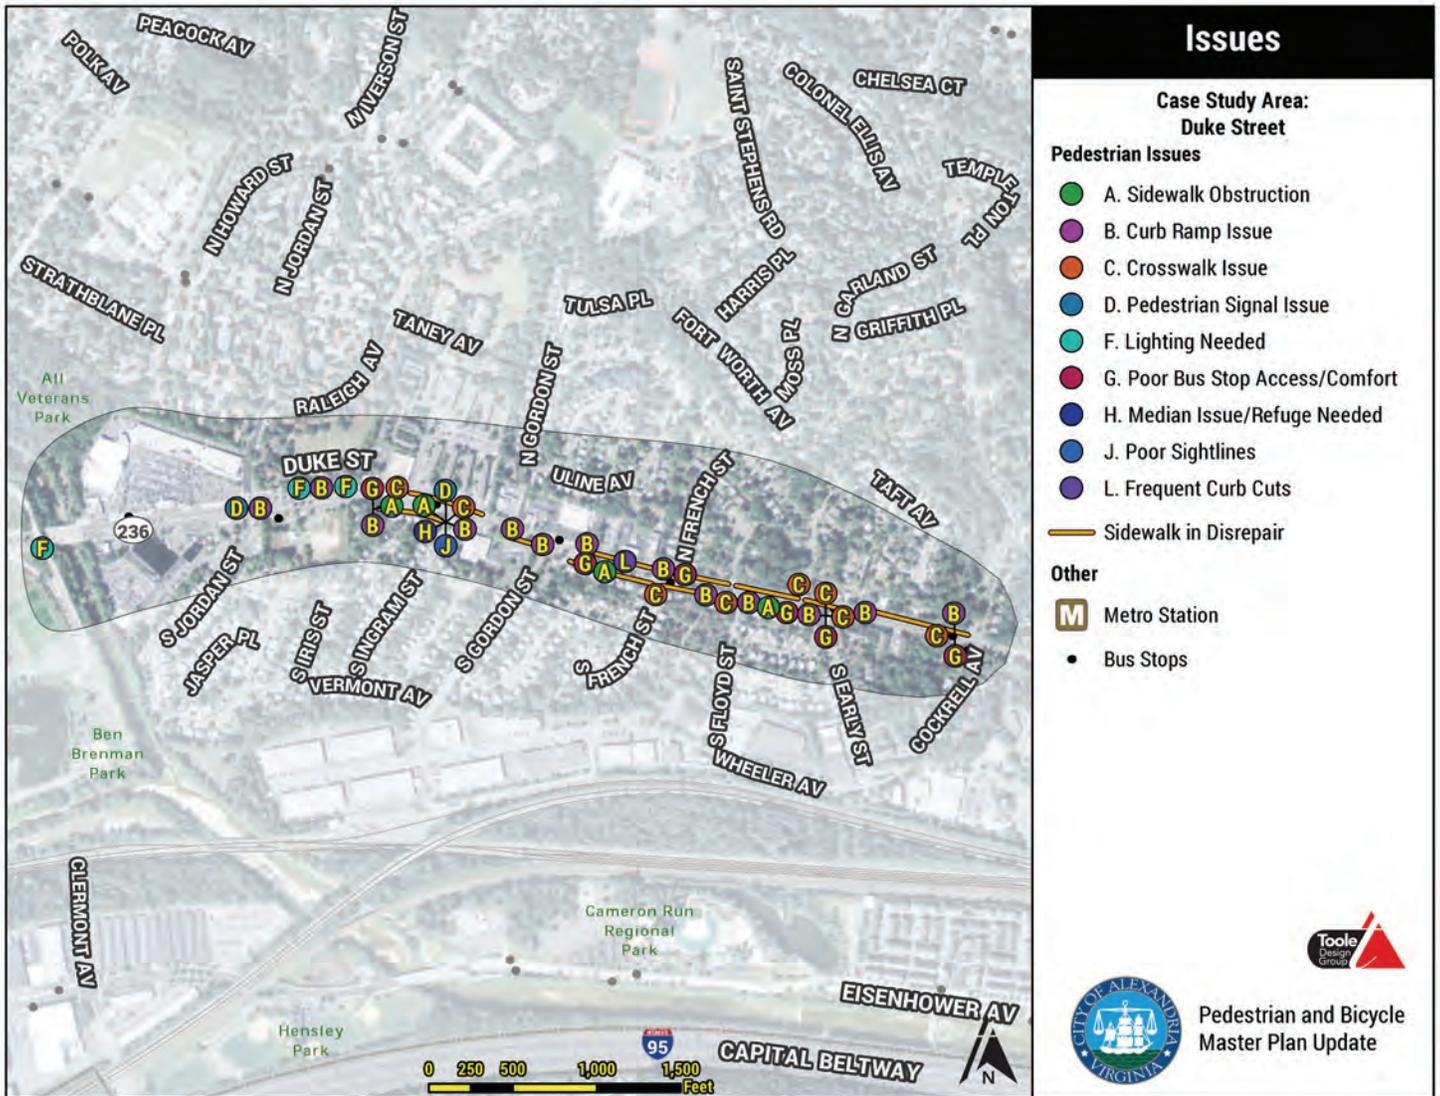
Figure 5: Map of Issues Identified

As shown in Table 6 and similar to other Case Study Area, curb ramps, crosswalks, sidewalk obstruction/disrepair, and missing or narrow sidewalks are key issues in the Duke Street Corridor. Other issues in this corridor include poor bus stop access/comfort and poor lighting, as shown in Figure 5. Sidewalks exist on both sides of the street in some, but not all locations and vary in width between five and six feet. However, the sidewalks are not buffered from traffic in many locations, and multiple driveways and access roads create conflict points for pedestrians. Additionally, many sidewalks and curb ramps are not ADA compliant. Several bus stops lack shelter, seating, and curb ramp access from the adjacent side sidewalk.

The most problematic segment of the Case Study Area is Duke Street between Ingle Place and Gordon Street. This segment has a two-way access road on the north side of Duke Street, and the vehicle lane configuration leads to numerous potential conflict points with other vehicles, pedestrians, and bicyclists. Another issue with this segment is that there is no pedestrian accommodation at the intersection of Duke Street at Ingram Place. The nearest signal with crosswalks, pedestrian signal heads, and curb ramps is 400 feet away, making it difficult for pedestrians to safely cross in this portion of the corridor. Additionally, there is poor access to the existing bus stops in this segment due to narrow sidewalks on the south side of Duke Street.

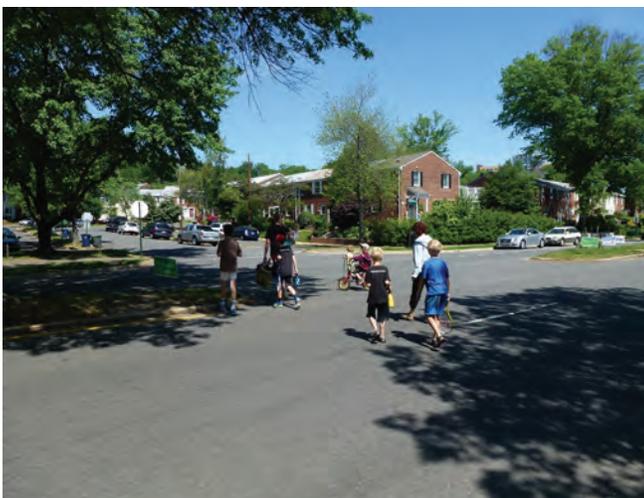
Group of kids crossing mid-block across Commonwealth Avenue to Ansell Street

There are a few intersections in the Case Study Area that present particular challenges for pedestrians crossing the street. There is currently no crosswalk on Kennedy Street at Ansell Street, despite the fact that many families in this area frequently visit the Goat Hill Park playground on the north side of Kennedy Street, and Colasanto Park at the end of Ansell Street on Commonwealth Avenue. The Neighborhood Parks Improvement Plan included a recommended crosswalk to improve access to Goal Hill Park. Additionally, there is no crosswalk on Commonwealth Avenue at Ansell Street leading to Colesanto Park.

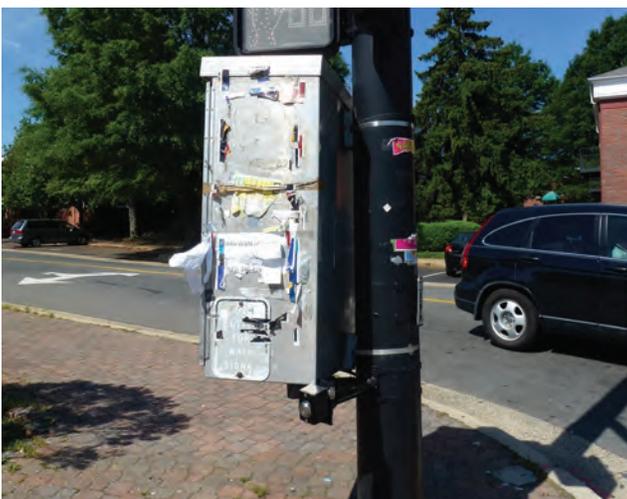
Obstructed pedestrian crossing signal button and signage on Mt. Vernon Avenue

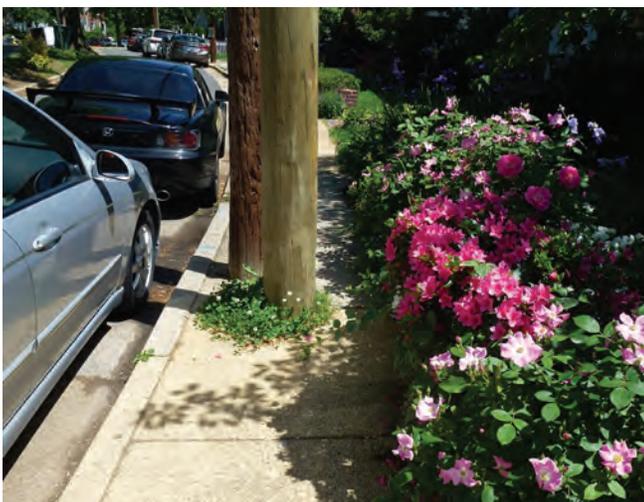
Sidewalk obstruction on a local street near the Mt. Vernon Commercial District

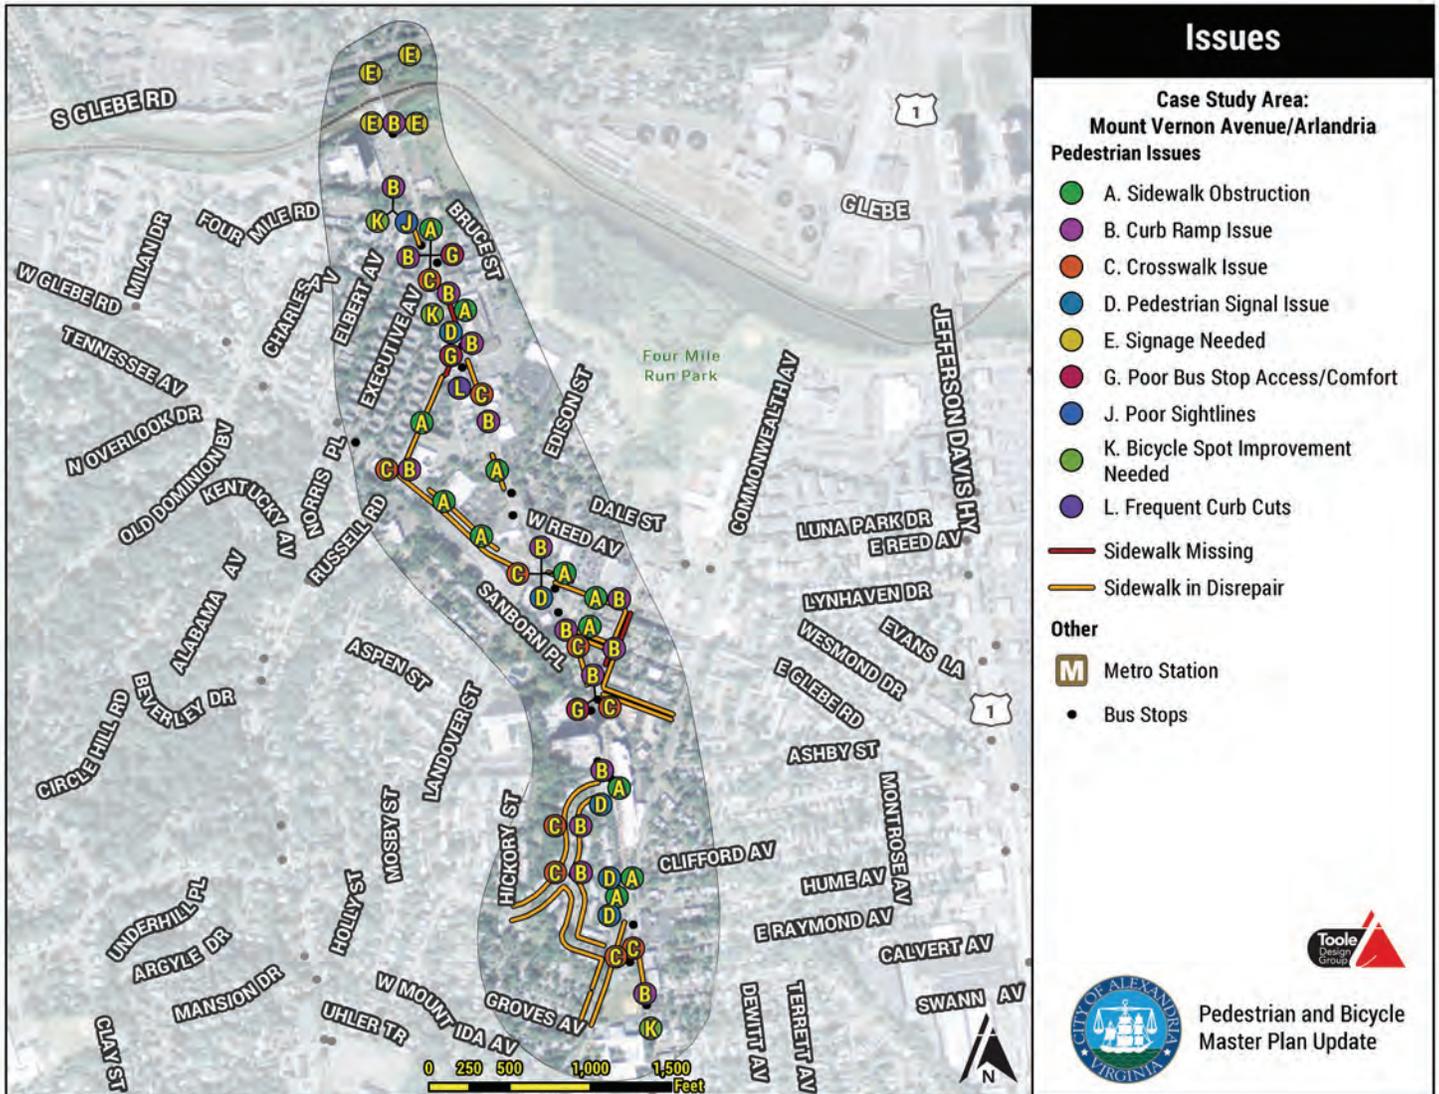
Figure 7: Map of Issues Identified

While the Mount Vernon Avenue/Four Mile Run corridor is relatively pedestrian-friendly overall, there are some issues that were identified by the study team. As in all the Case Study Areas, curb ramps, sidewalk obstruction/disrepair, missing or narrow sidewalks, and crosswalks are the main issues throughout the area (see Table 8). Sidewalks exist on both sides of the street in most areas, though they are missing and/or narrow in several locations. Sidewalk widths range from five to six feet, and many segments also have a sidewalk buffer. However, many sidewalks and curb ramps are not ADA compliant. Other leading issues include inaccessible or broken pedestrian signals and lack of signage, as shown in Figure 7.

Mount Vernon Avenue at West Glebe Road is a wide intersection with long crossing distances, which is uncomfortable for pedestrians and bicyclists. Mount Vernon Avenue at Russell Road is less problematic, but there is a long right-turn only lane adjacent to the sidewalk, which encourages fast vehicle turning movements that can make it difficult for pedestrians to cross.

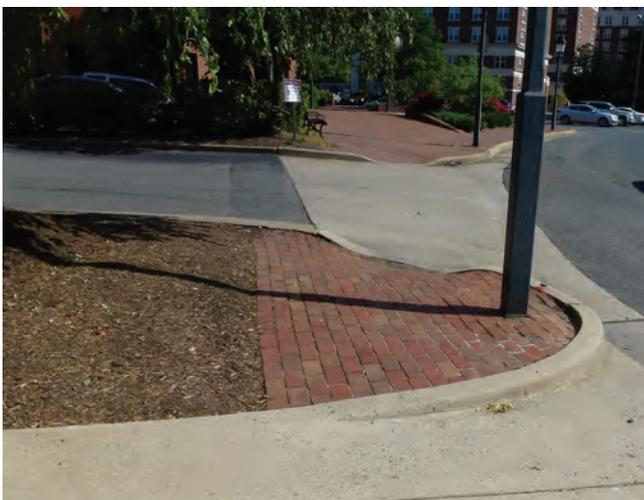
Missing and non-ADA compliant curb ramps

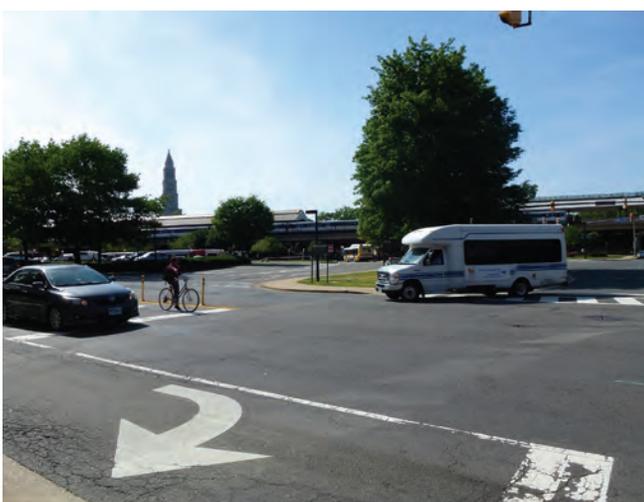
Challenging intersection near King Street Metro

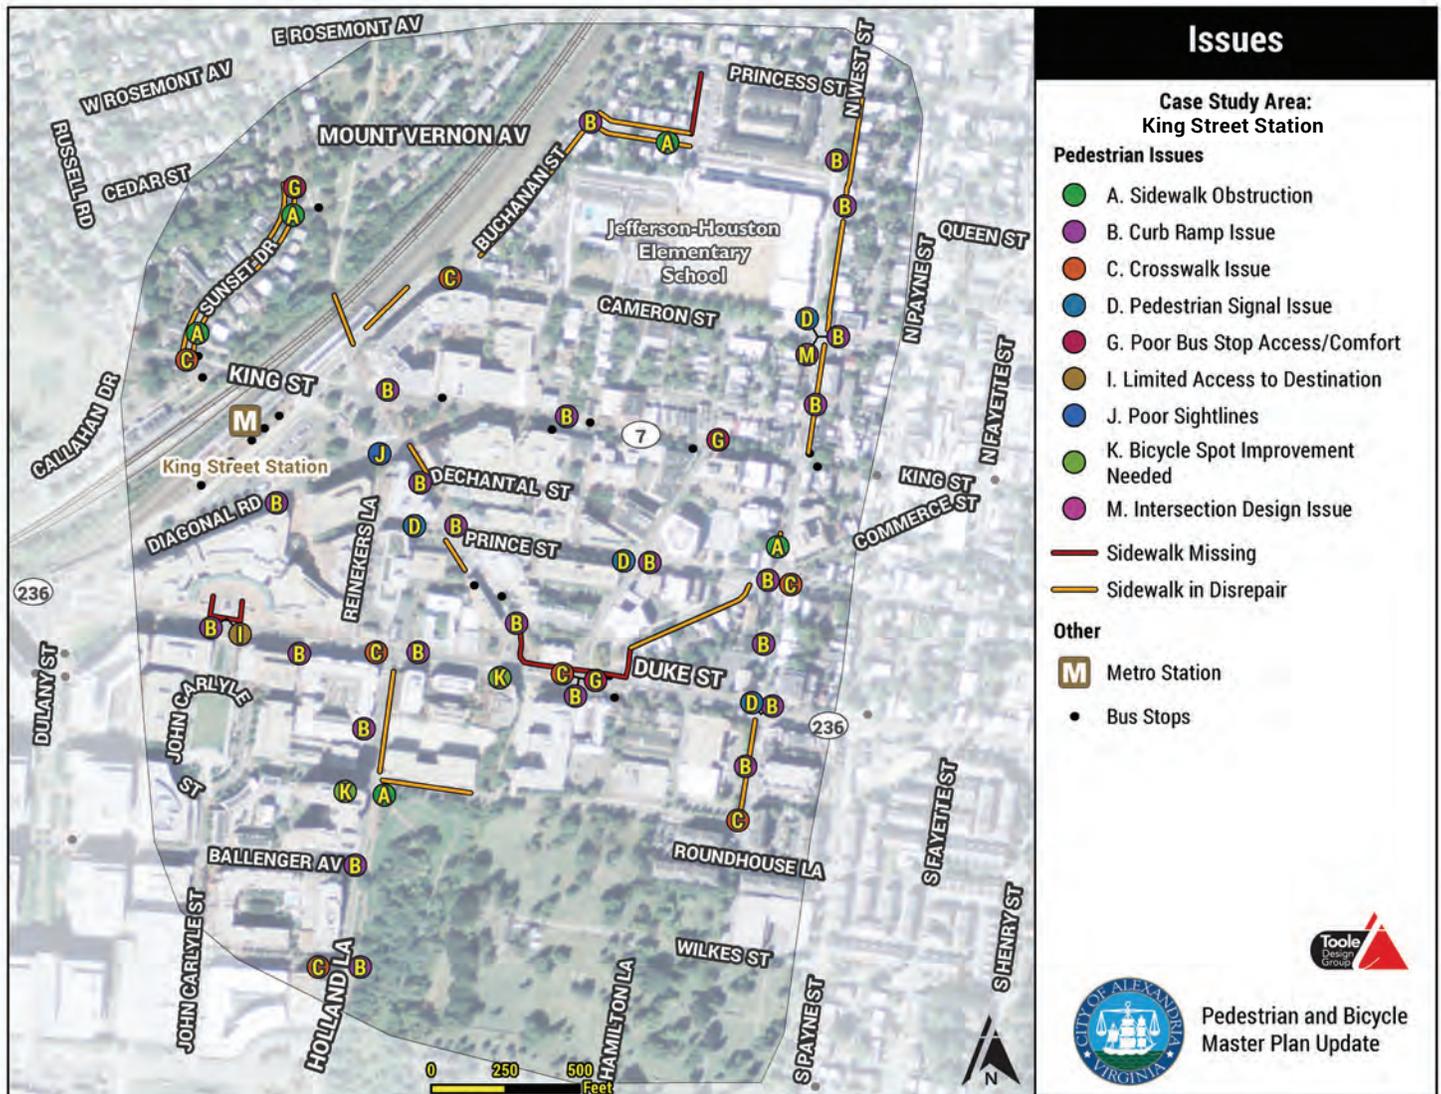
Figure 9: Map of Issues Identified

While the neighborhood surrounding King Street Station is relatively walkable, there are still opportunities to improve the pedestrian environment. As shown in Table 10, curb ramps are a particular issue in this area. Curb ramp designs in Old Town vary greatly, and many of the existing curb ramps are not compliant with national accessibility standards. While sidewalks exist on both sides of the street in most areas, there are a few gaps and/or narrow conditions, as well as many instances of obstacles or maintenance issues on existing sidewalks (see Figure 9).

Smaller, spot issues exist throughout the Case Study Area, especially regarding the frequency and quality of crossings. Crosswalks are missing in a few key locations, such as King Street at Sunset Drive, where there is a playground, and Cameron Street near Buchanan Street, where there is an entry point to a walking path. Similarly, corridors like King Street lack pedestrian signals except for at major signalized intersections like Henry Street, Patrick Street, and near the King Street Metro Station.

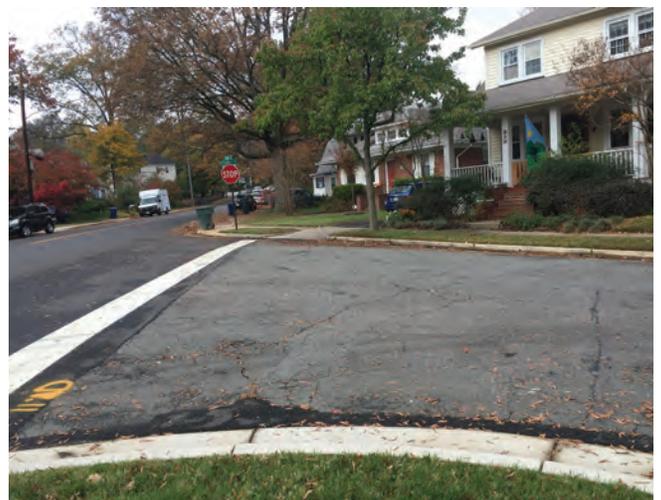
Missing crosswalks and curb ramps on residential areas

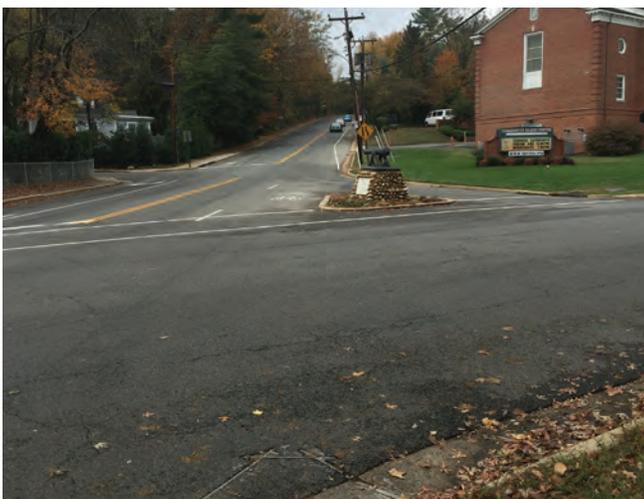
Missing crosswalk at intersection of Russell Road and Braddock Road

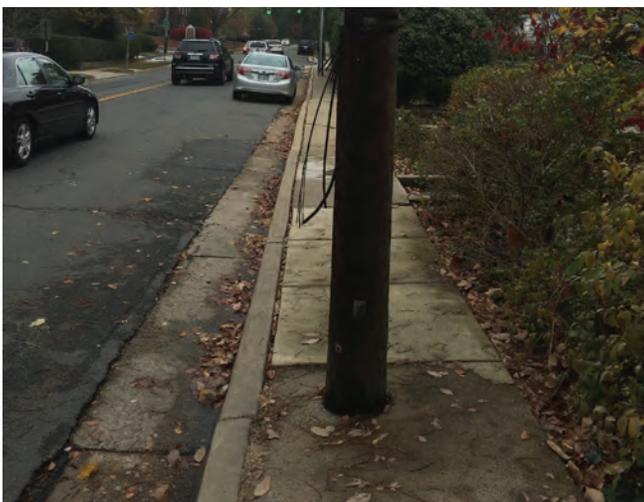
Utility post obstructing existing sidewalk

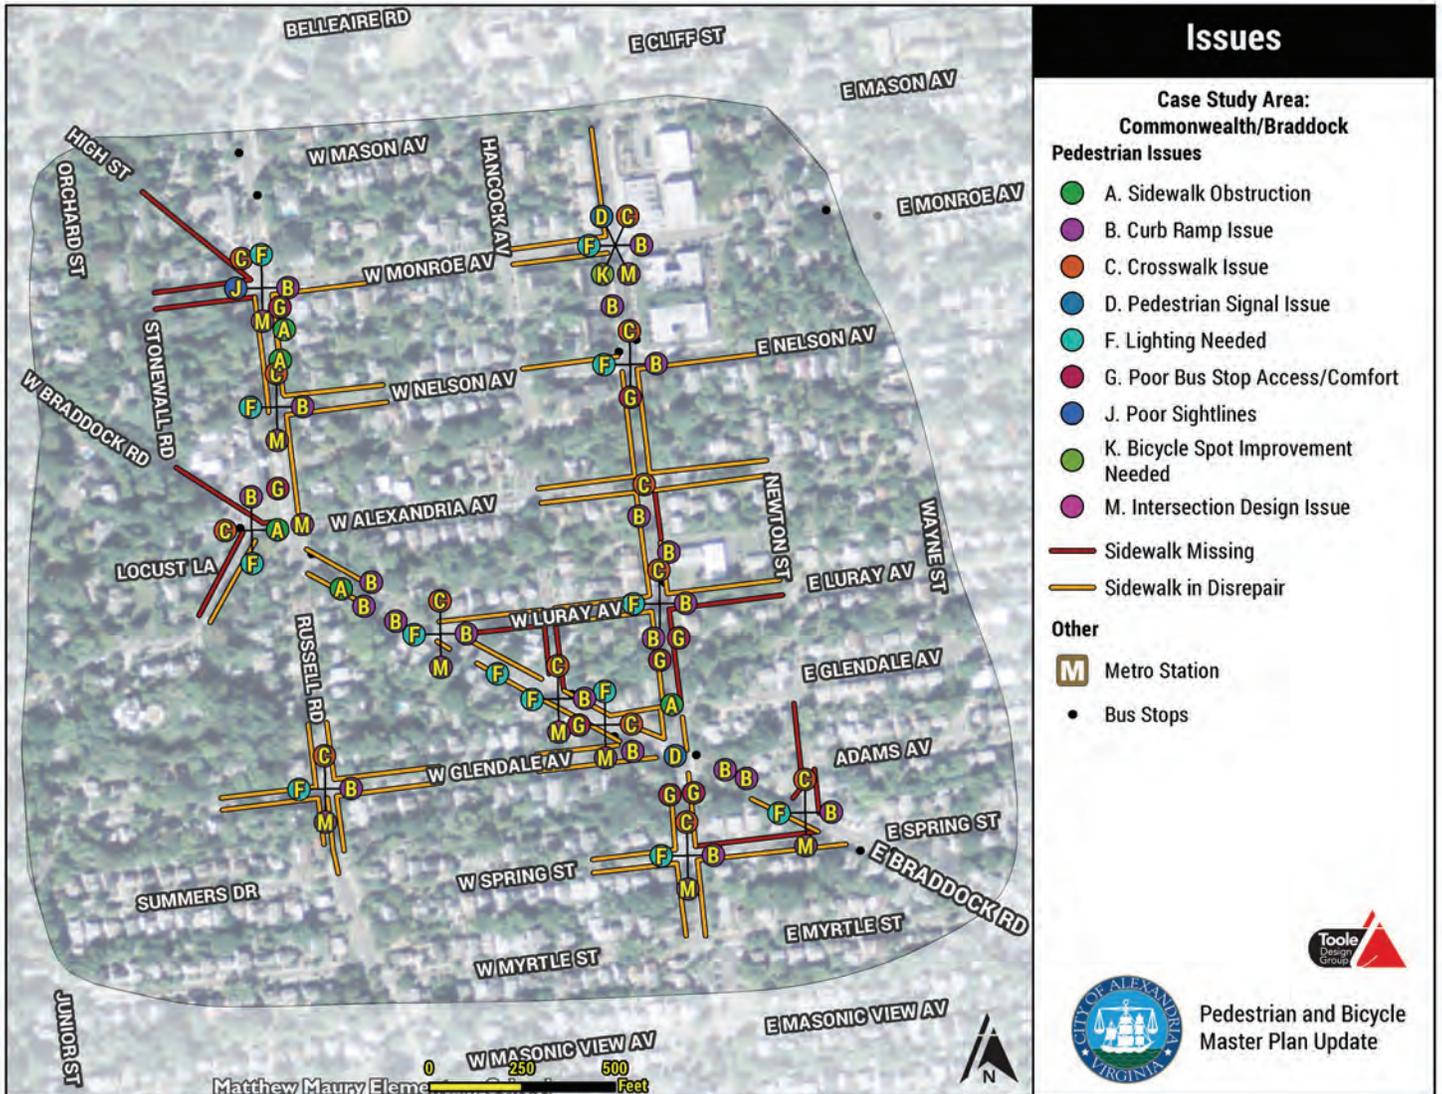
Figure 11: Map of Issues Identified

Following a pedestrian fatality at this intersection in 2015, the City made a number of changes that aim to improve safety in the area. The City installed “No Turn on Red” signs and a leading pedestrian interval at the signal, which will allow pedestrians to start crossing before vehicles enter the intersection.

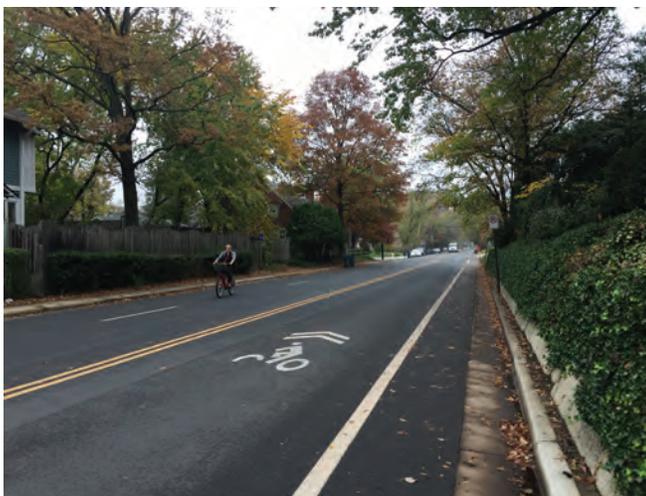
Missing sidewalk near Commonwealth Avenue and Glendale Avenue
