Strawberry Run Forensic Investigation

Prepared for:
Stormwater Management Division Transportation and
Environmental Services

City of Alexandria

June 2022

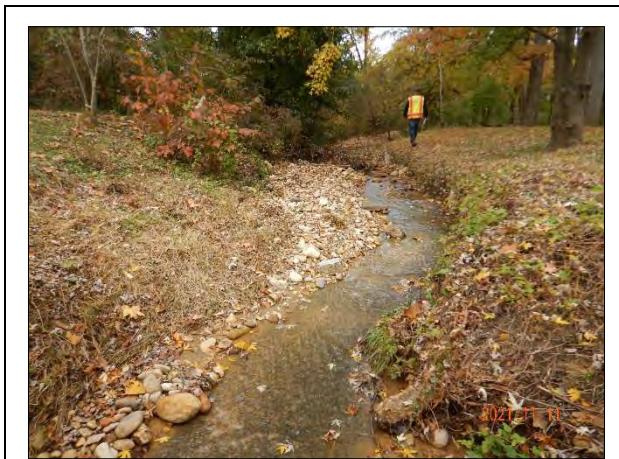
Figure 19. Stream Reach #1 – Looking Upstream (Station 0+10)

- Channel appears more stable towards culvert
- More floodplain access compared to other stream reaches
- Low bank heights, approximately 2 – 2.5 feet
- Concrete debris observed in channel
- Stream meanders with signs of deposition – cobble
- Likely a backwater area from downstream culvert control

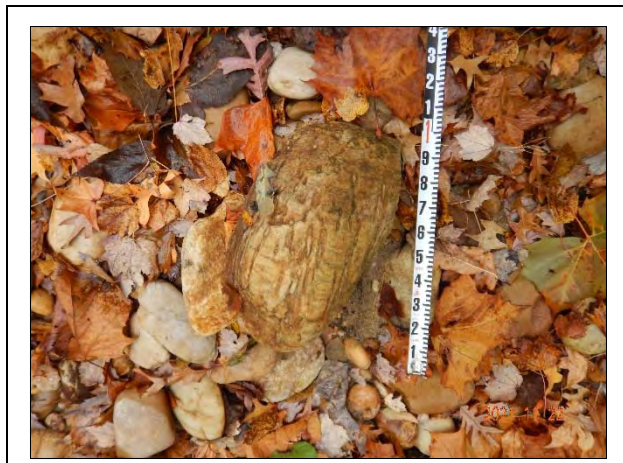
Figure 41. Typical Largest Particle (305 mm) Observed Along the Streambed

Analysis of the stream substrate was performed to characterize the sediment material comprising the channel and moving through the system. A reach-wide composite pebble count was undertaken to classify the dominant bed material along the previously restored reach. Pebble counts were taken along each of five representative sections with 20 particles (stones) collected along each transect (Figure 38). The calculated D_{50} (median particle size; 50% of streambed substrate is smaller, and 50% of streambed substrate is larger) for the representative sections was 64 mm and the D_{95} (95% of streambed substrate is finer) was determined to be 130 mm. The restored reach is comprised of equal parts cobbles and gravels. Results of the pebble count are summarized in Figure 39. The largest natural particles observed during the investigation were approximately 305 mm (Figure 41).

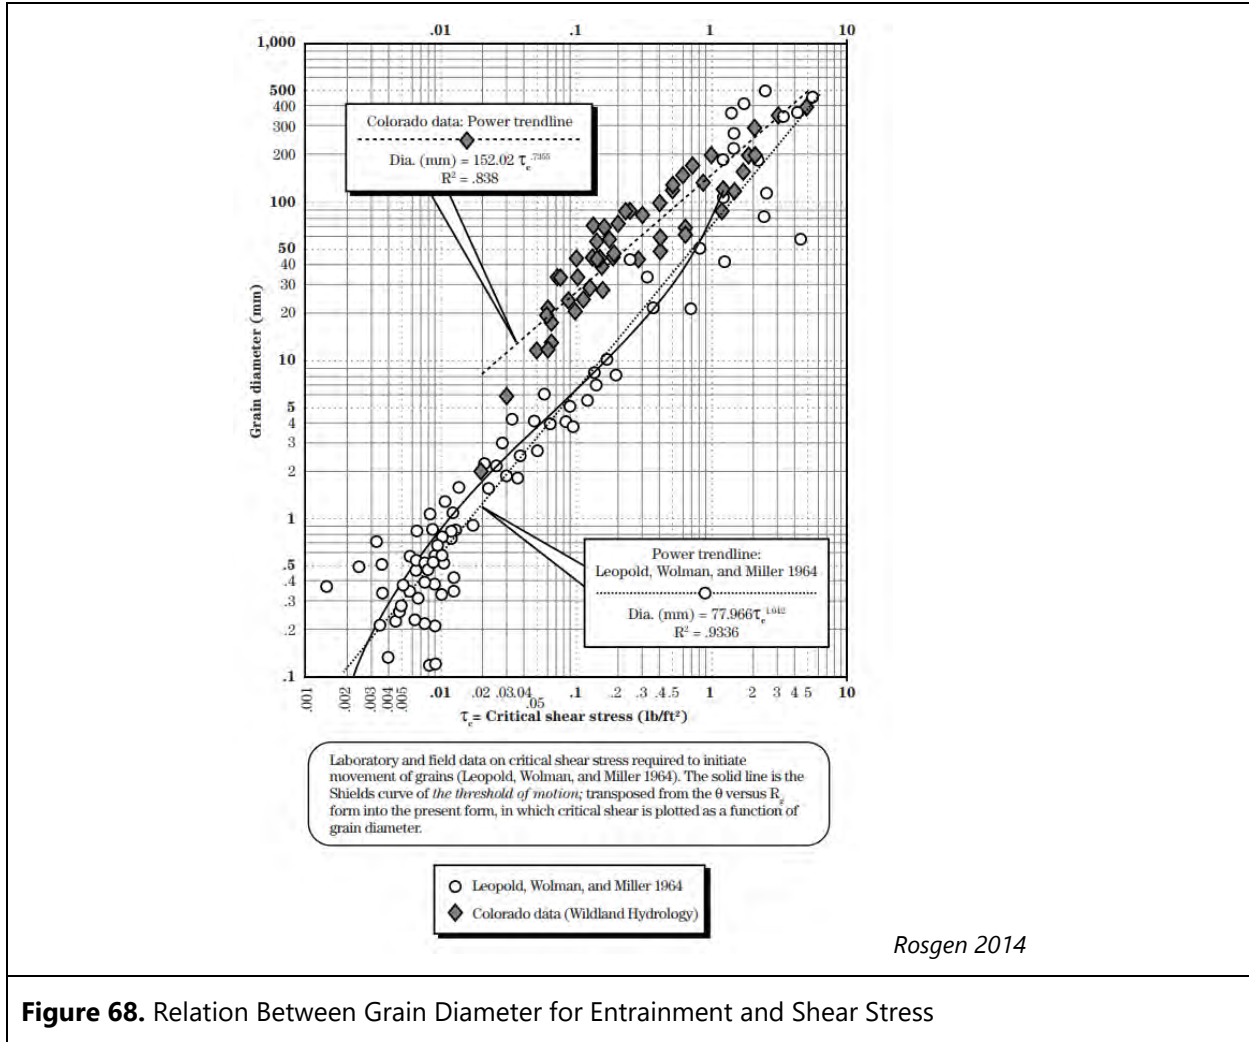
Figure 68. Relation Between Grain Diameter for Entrainment and Shear Stress

The first hydraulic analysis performed was to determine what depth of water in each of the sections is required to mobilize, or entrain, the D_{95} of the bed. The D_{95} of the bed is 130 mm; meaning that 95% of the bed is finer (smaller) than 130 mm.

The required shear stress to mobilize the D_{95} (130 mm particle) is 0.81 lb/ft². For the four cross sections the depth required to entrain the D_{95} ranged from approximately 1.0 to 1.4 feet and the corresponding discharges ranged from 25 to 46 ft³/sec. Just over one foot of water in the stream channel has the potential to mobilize 95% of the bed material.

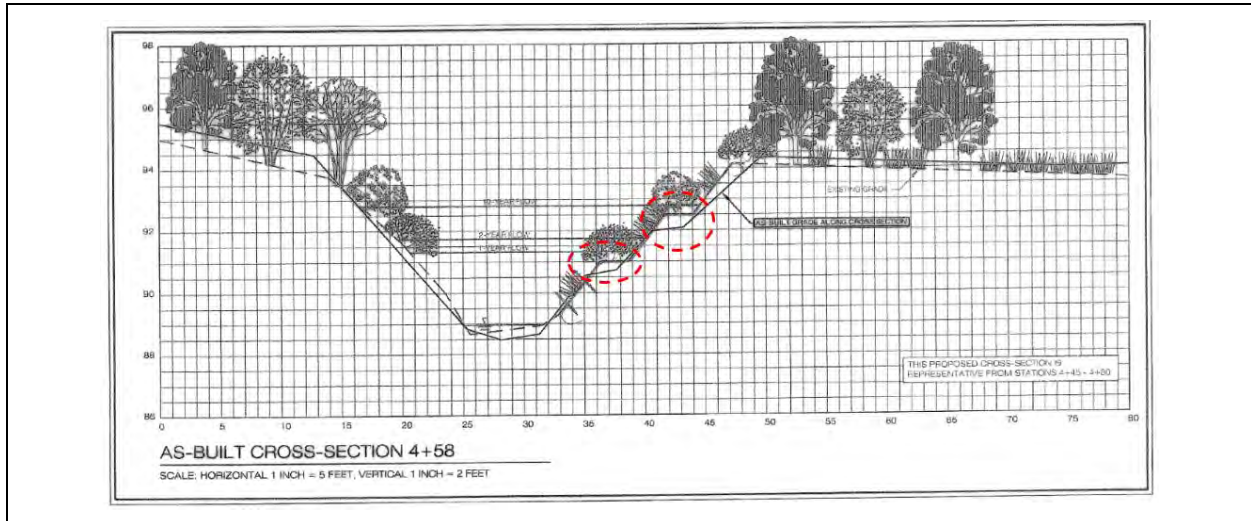
Figure 72. As-Built Cross-Section 4+58

* Red circles indicate areas where bankfull benches were constructed at an incorrect elevation.

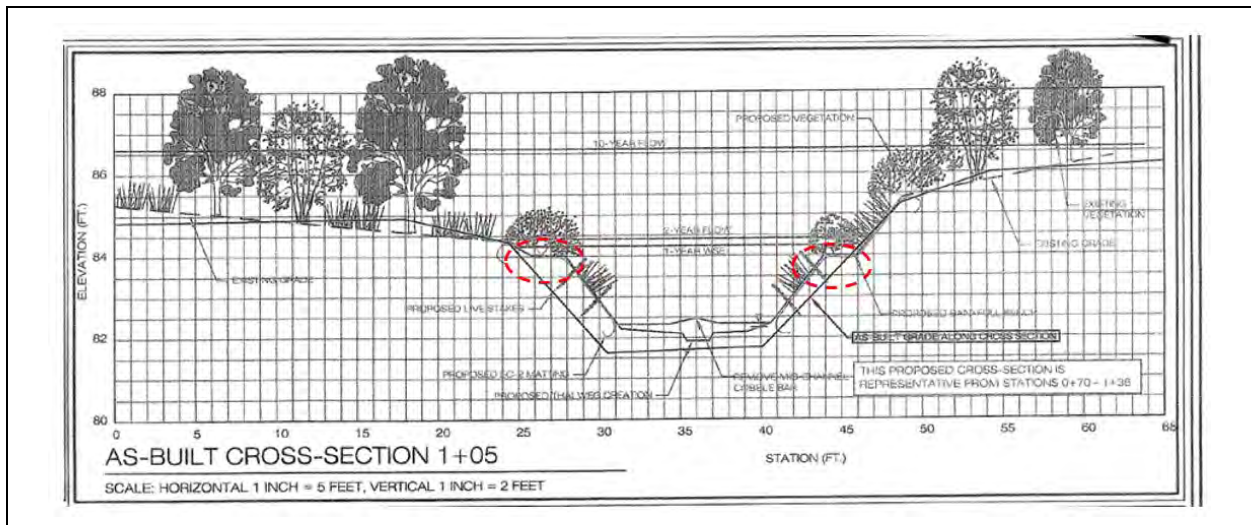
Figure 73. As-Built Cross-Section 1+05

* Red circles indicate absence of areas where bankfull benches were to be constructed.

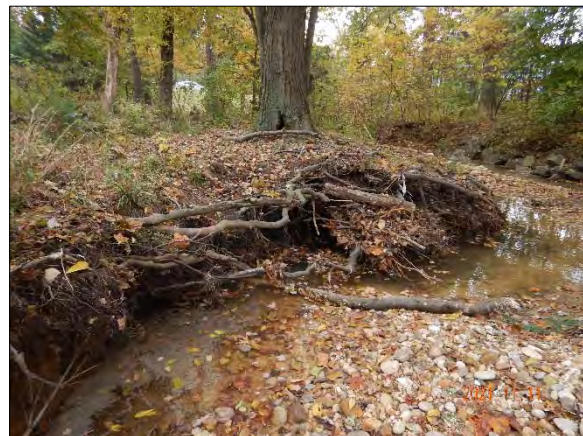
Figure 79. Same Location: Tree Washed Away (November 2021, Station 2+20)

3. Downed trees/channel blockages (Figures 76 and 78). Like excess sediment, channel blockages and debris have the potential to cause local flow accelerations and flow diversions leading to bank erosion and widening. While logs can be useful as bank protection measures, structures need to be securely anchored and placed to prevent washout (Figures 77 and 79).
