Safe Routes to School Assessment

Francis Hammond Middle School

Final

National Capital Region
Transportation Planning Board

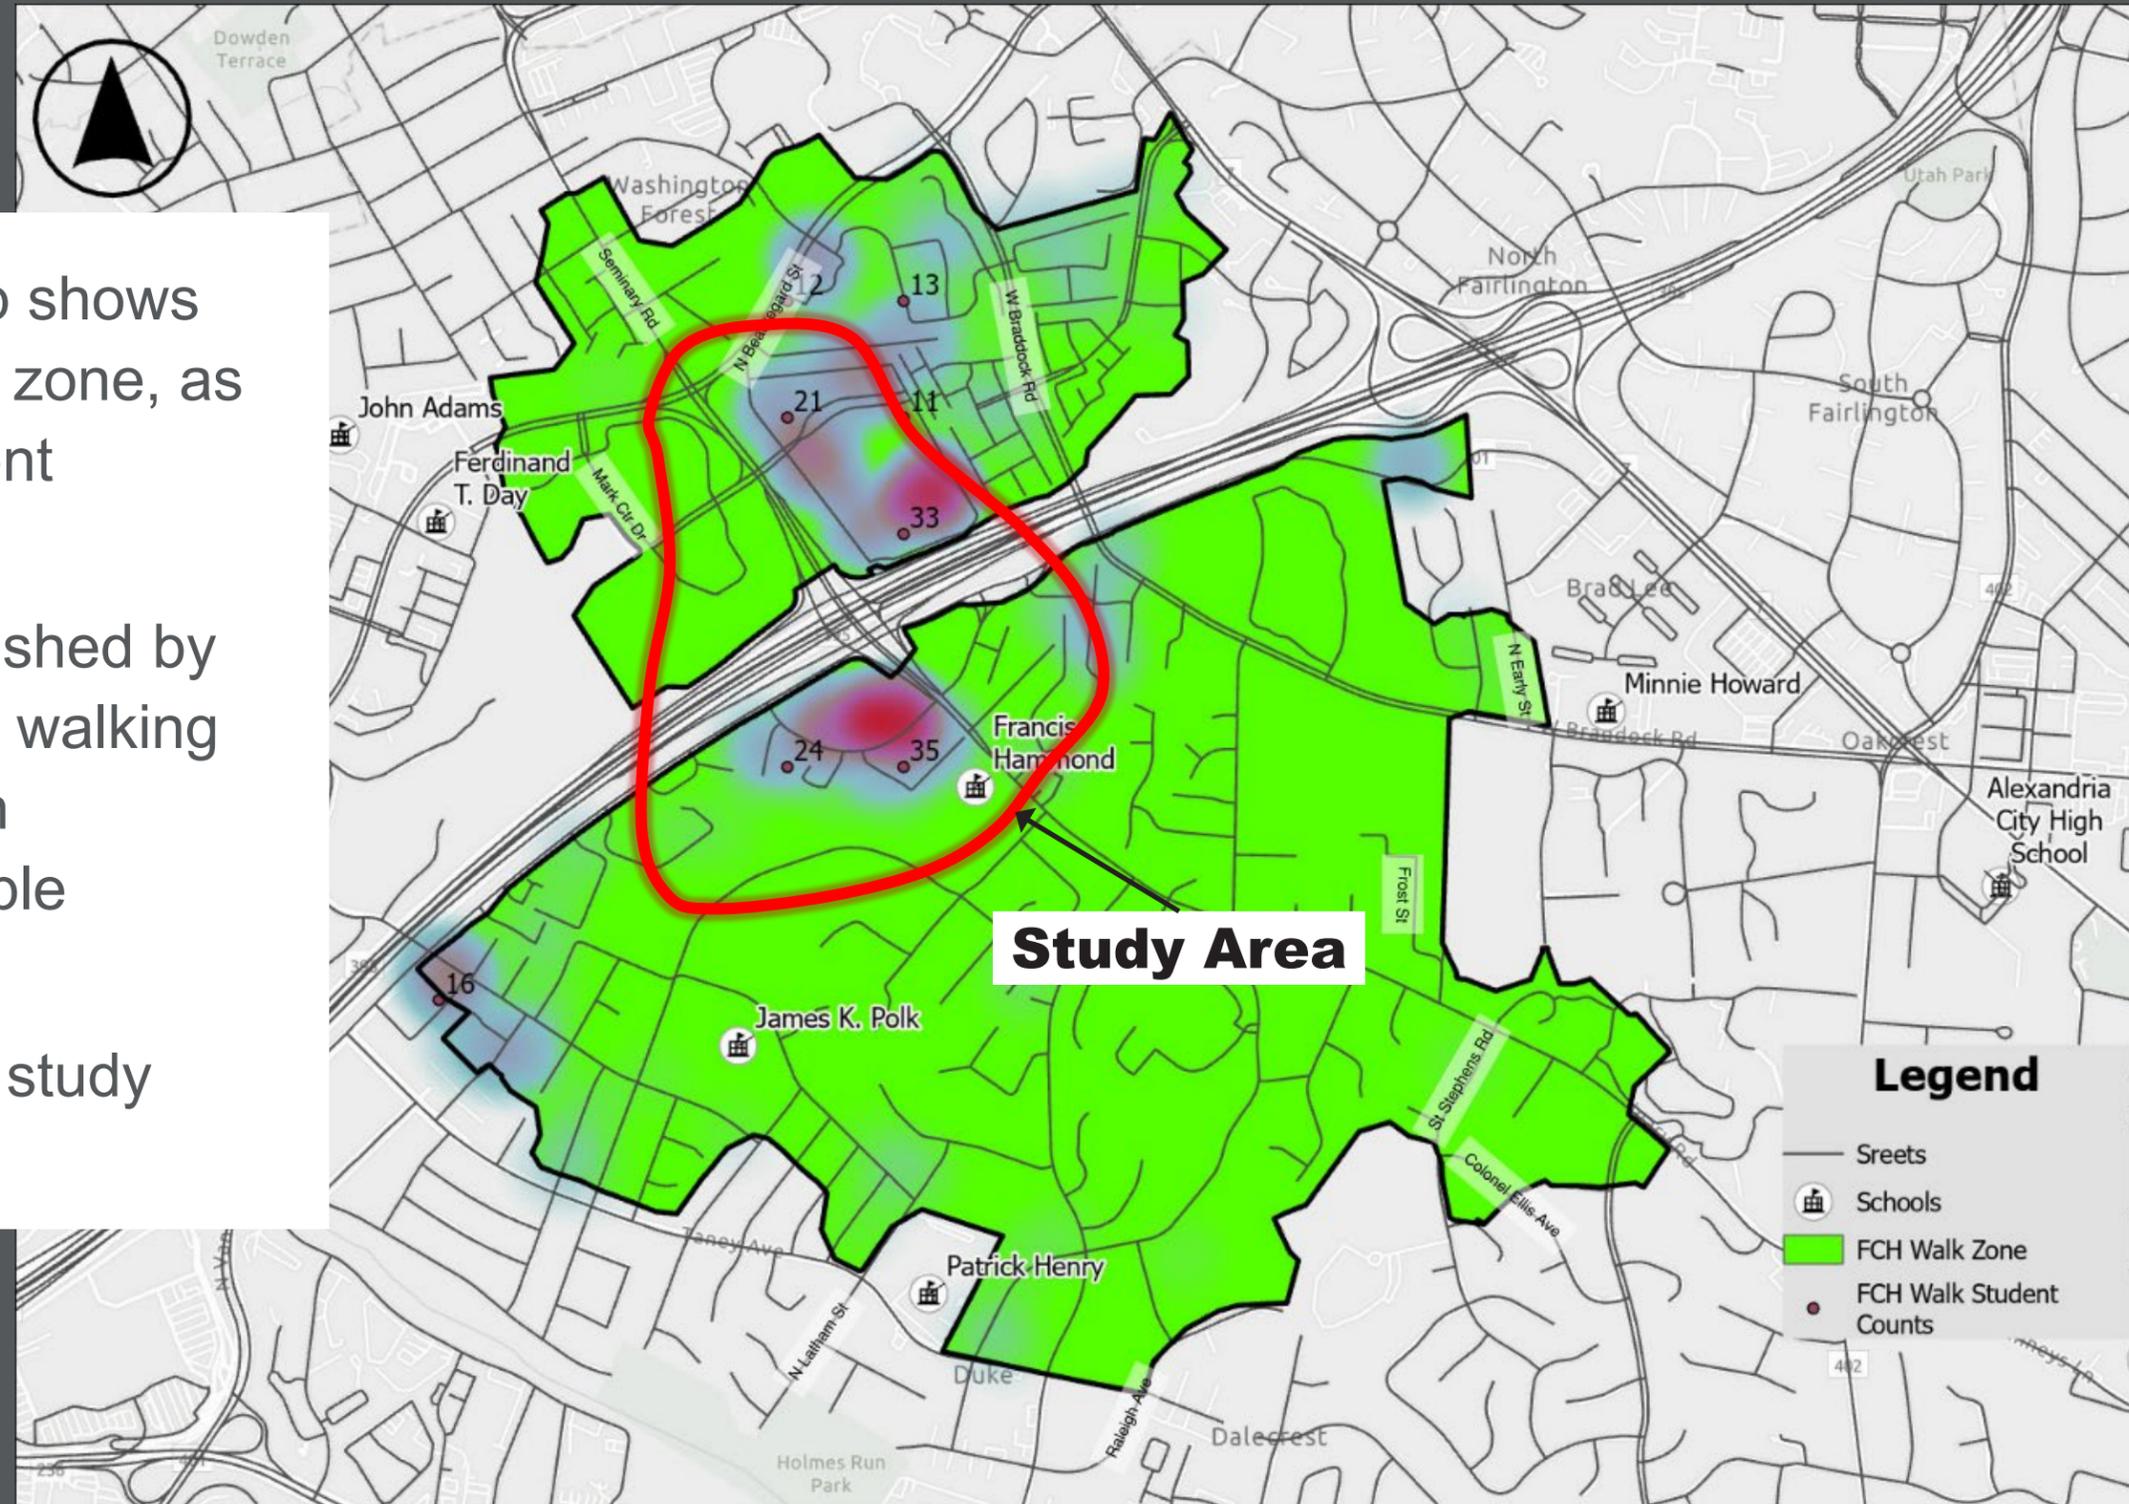
Francis Hammond MS Walker Clusters

- The Walker Cluster map shows the existing school walk zone, as well as clusters of student addresses.
- The walk zone is established by ACPS by evaluating the walking distance to the school in combination with available infrastructure.
- Red line shows approx. study area.

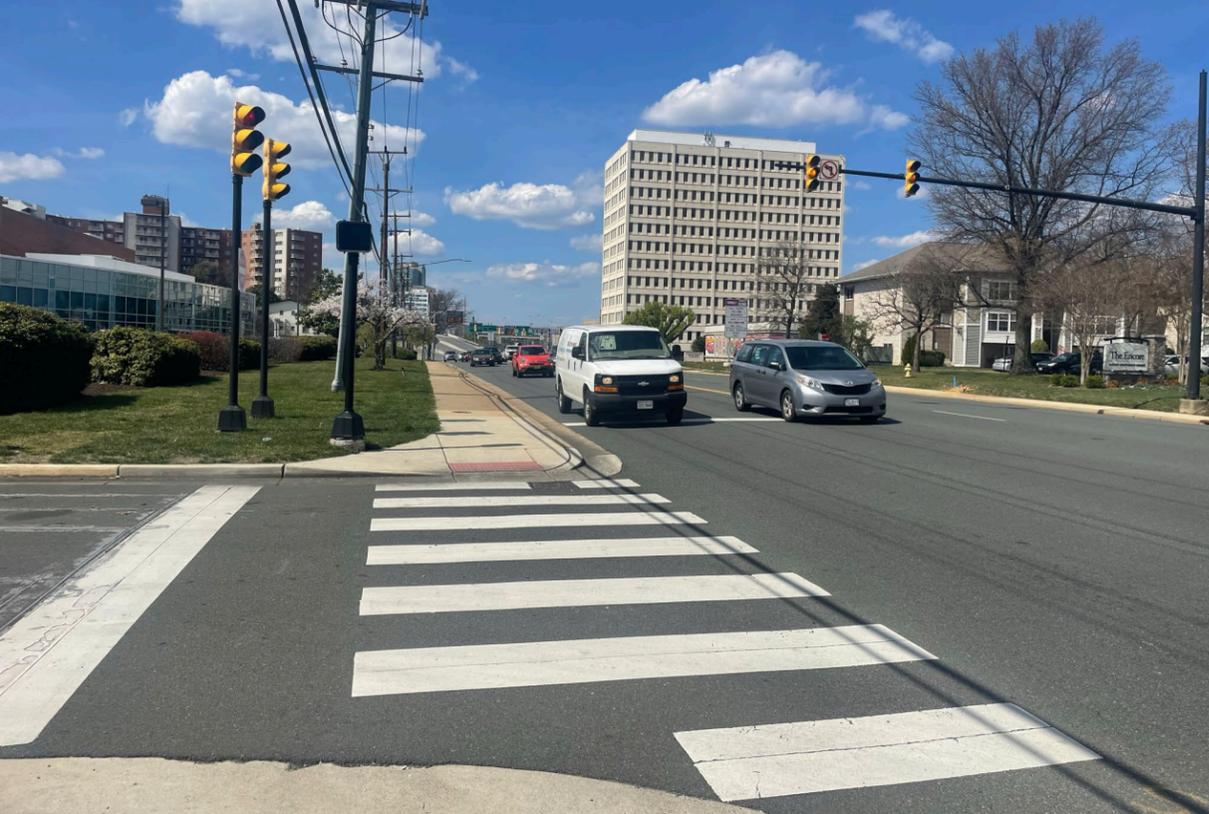
Front driveway exit at Seminary Road

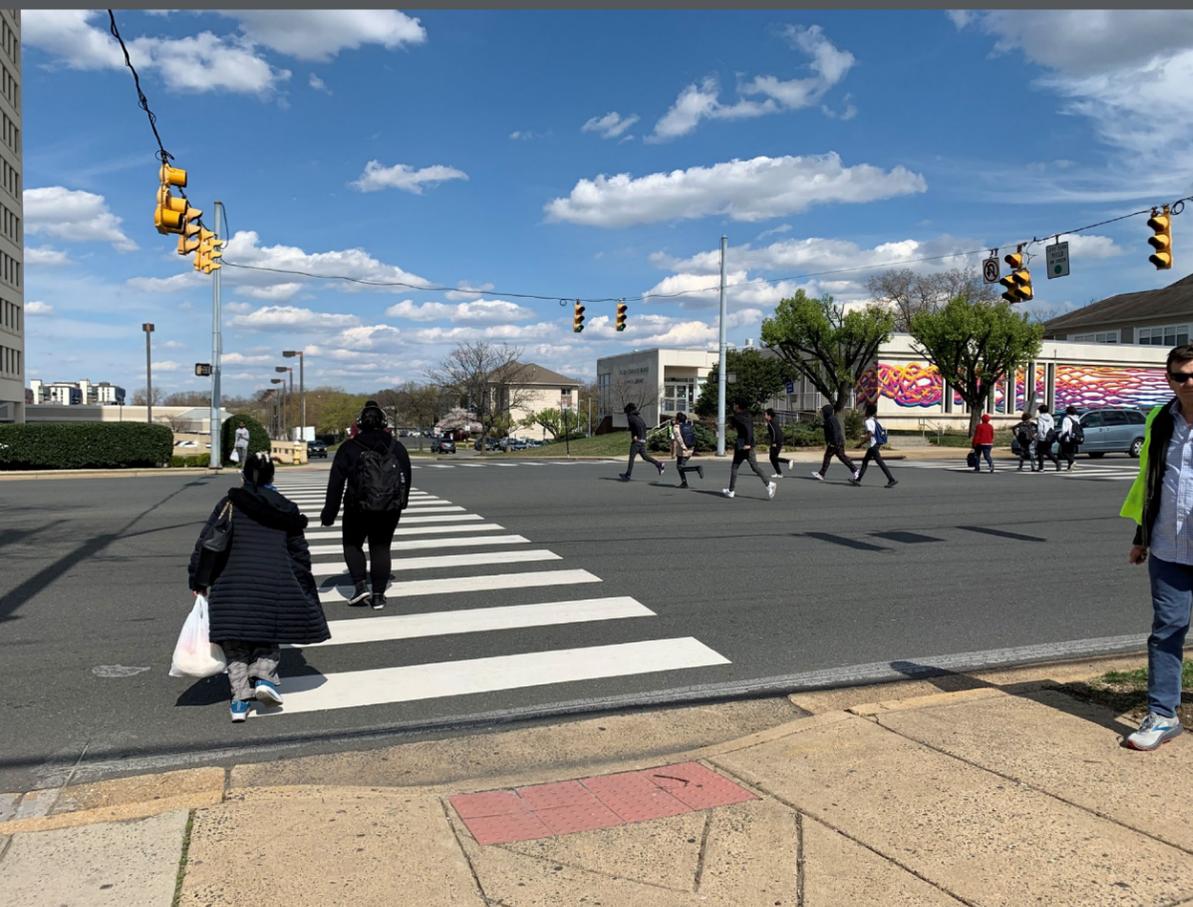
Students crossing diagonally at N. Seminary Road and Library Ln.

4c	Francis C Hammond MS	Seminary Rd & Library Ln, Intersection or Crossing	Students cross diagonally on the exclusive pedestrian phase. Students don't have enough time to cross and often begin their crossing with little time left. Exclusive pedestrian phase requires pedestrians to press a push button.	Explore formalizing a diagonal crossing and extend crossing time; put pedestrian signal on auto recall during school hours.	■ ■ ■ □ □	City

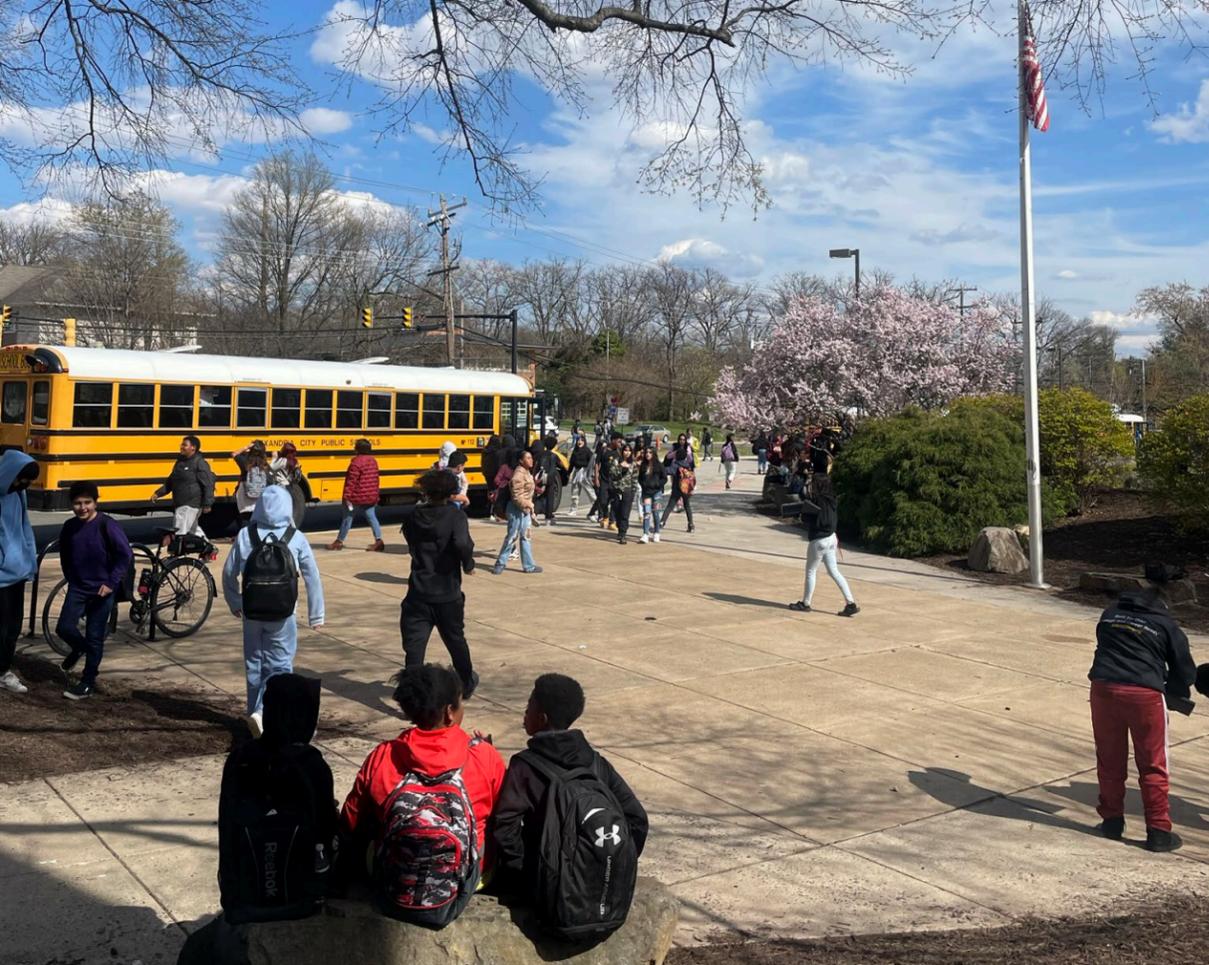
Students at front entrance during dismissal

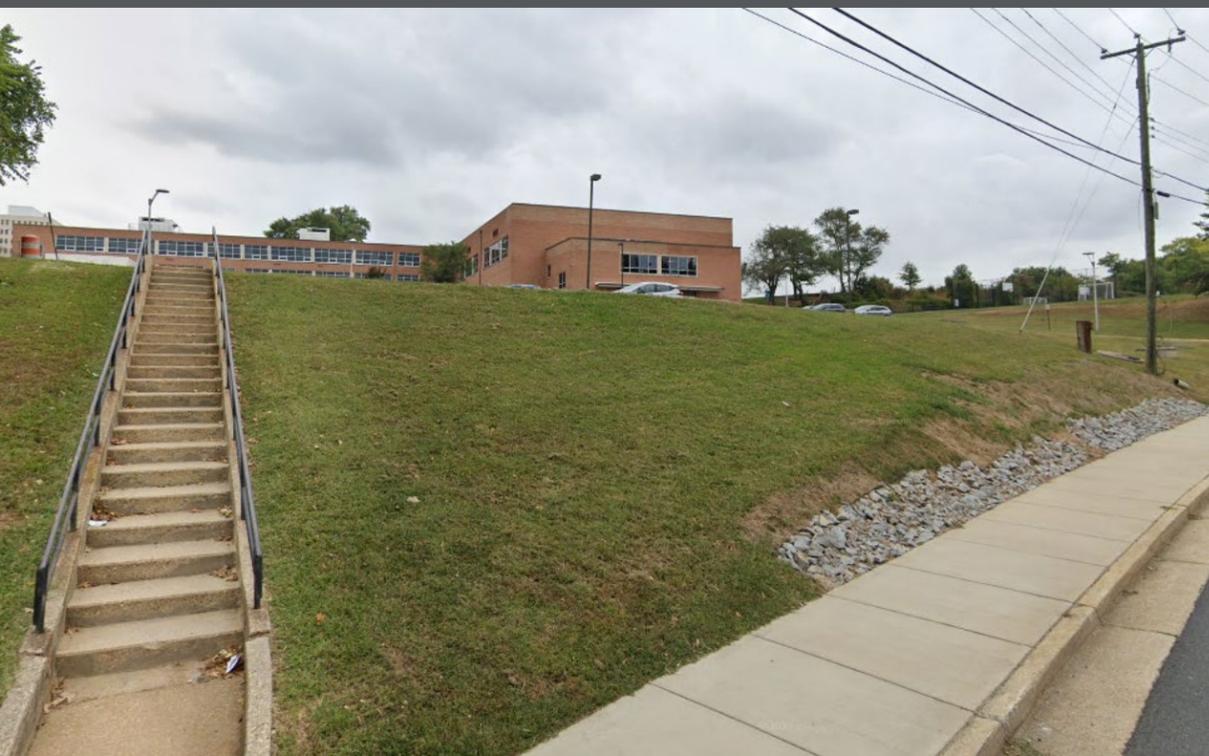
Rear exit stairs at N Pegram Street

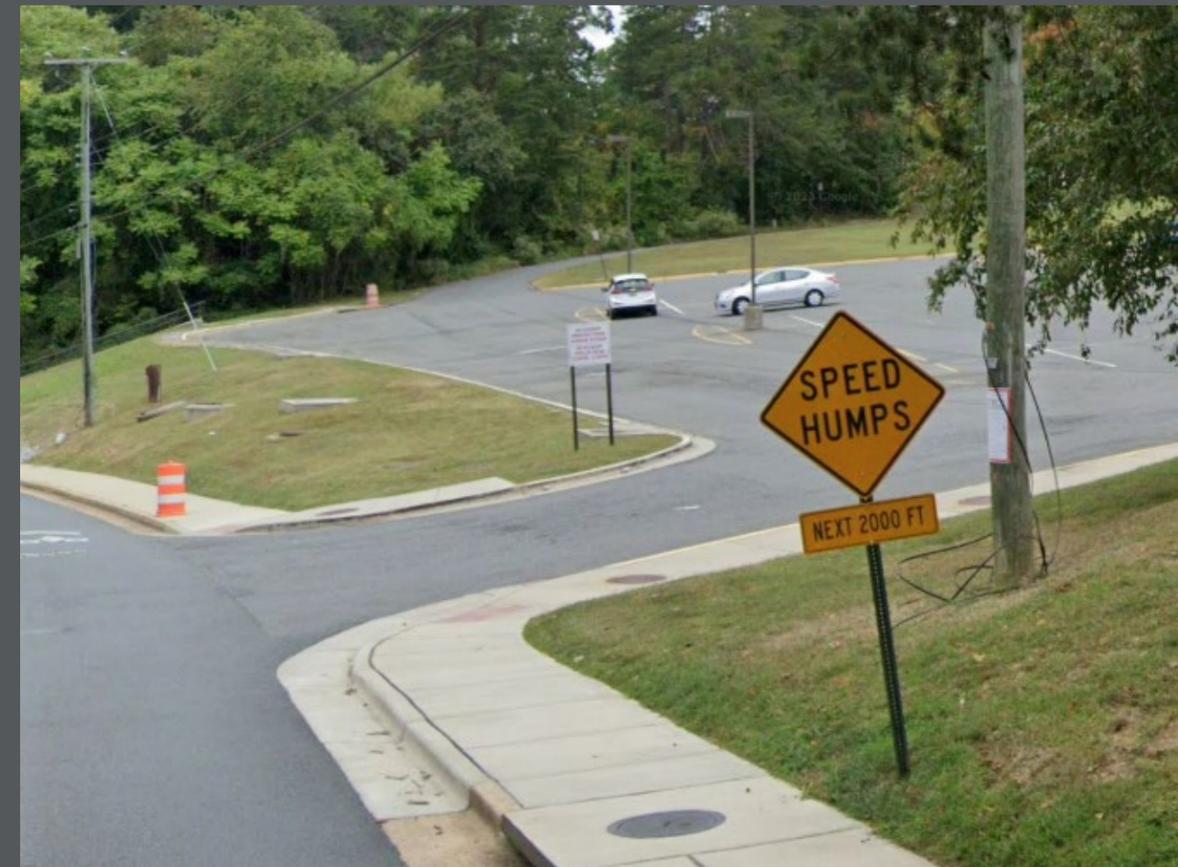
Rear driveway exit

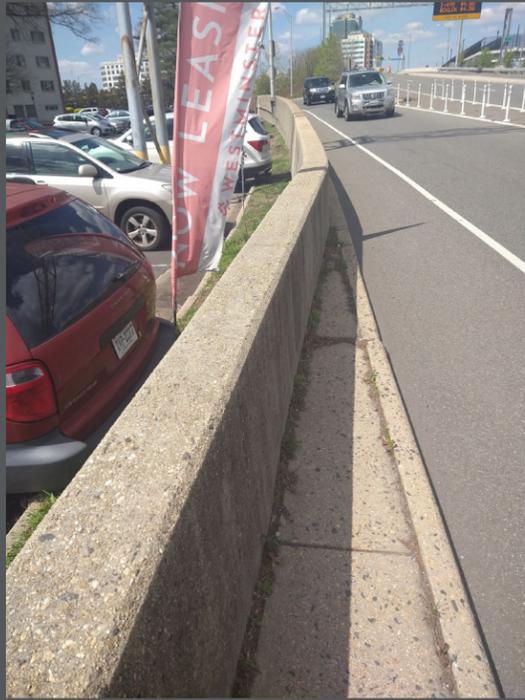
North of Kenmore Avenue, the sidewalk along the south side of Seminary Road dwindles to nothing as the road splits into multiple exit and entry ramps and bridges across I-395.

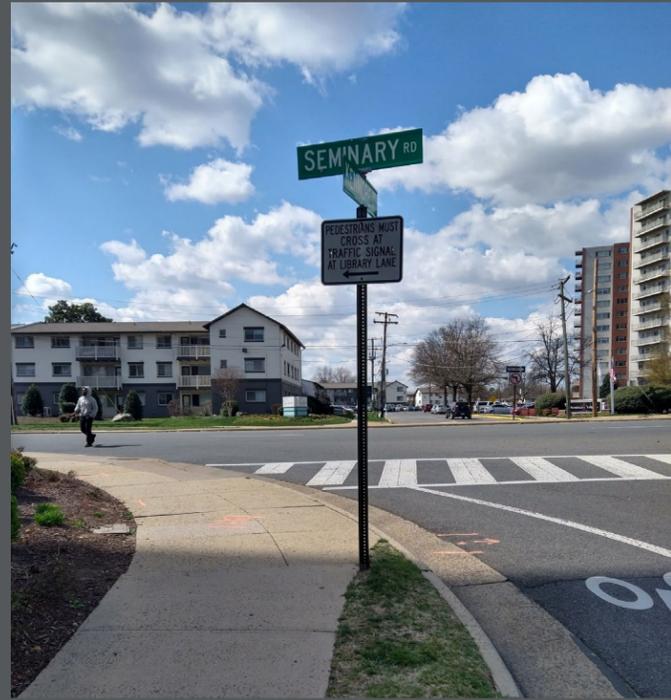
Rather than return to the nearest crosswalk, several hundred feet southeast, some people, including parents with small children, cross Seminary Road at or northwest of Kenmore Avenue.

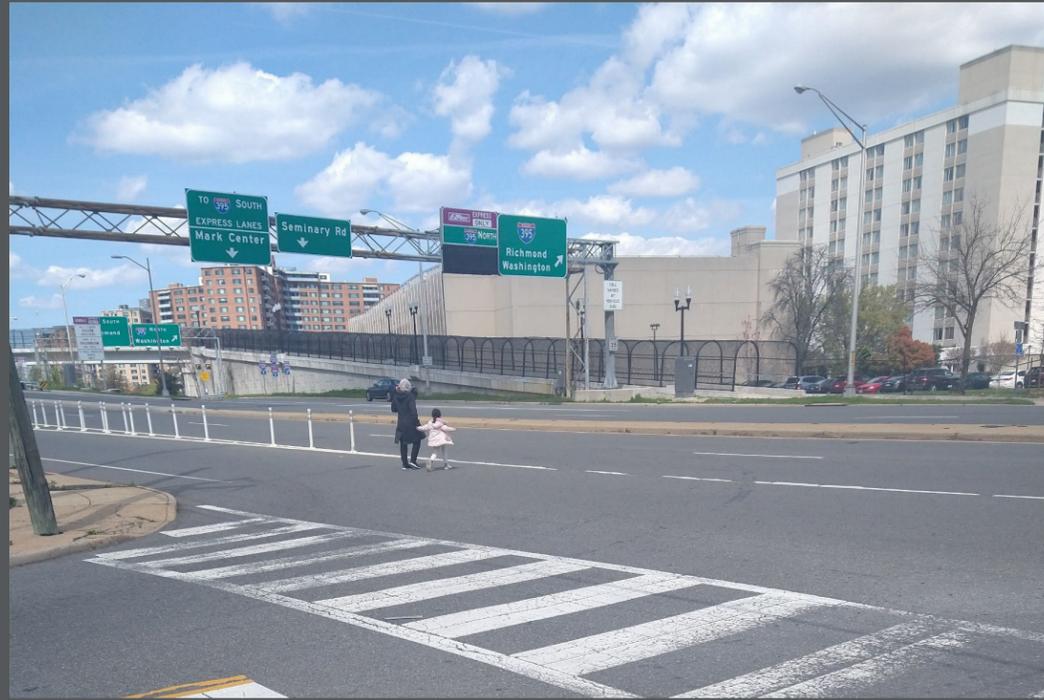
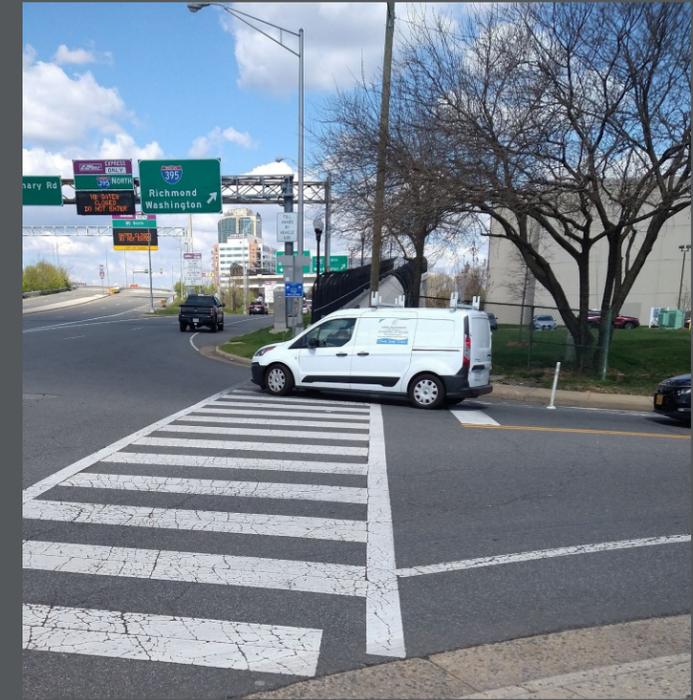
Traffic waiting to turn right from Kenmore Avenue onto westbound Seminary Road often stop in the crosswalk. Multiple drivers were observed looking only for other vehicles from their left, not pedestrians or bicyclists from the sidewalk or bridge over I-395 to their right.

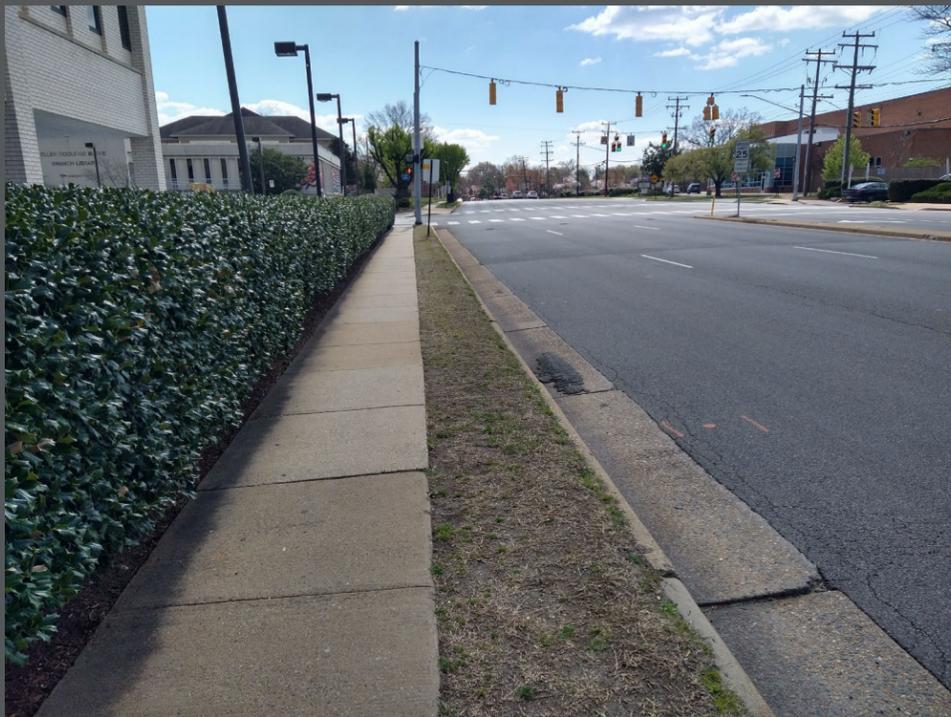
Much of the sidewalk along Seminary Road between the I-395 overpass and the school (in upper right of image) not only has very little buffer from speeding traffic but is also lined with a tall hedge that obstructs 1/8 to 1/4 of its width.

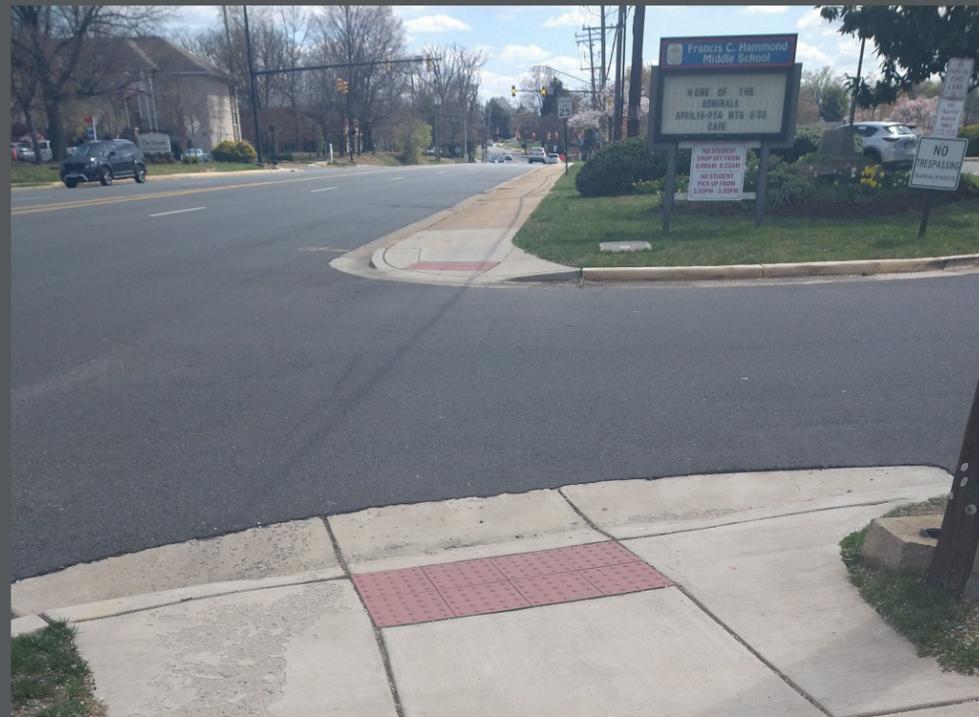
Many of the school's entranceways have detectable warning surfaces, but no crosswalk markings. Some have neither.

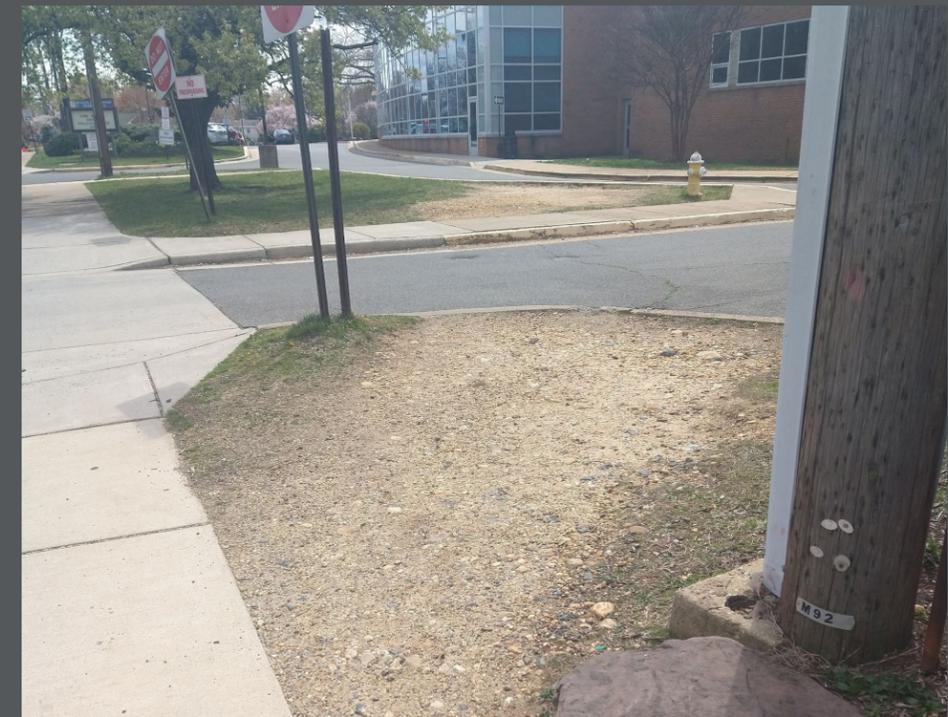
The straight-line path between the Seminary Road sidewalk at the corner of the school property and the front door of the school building—even across the driveway—has been worn to gravel.

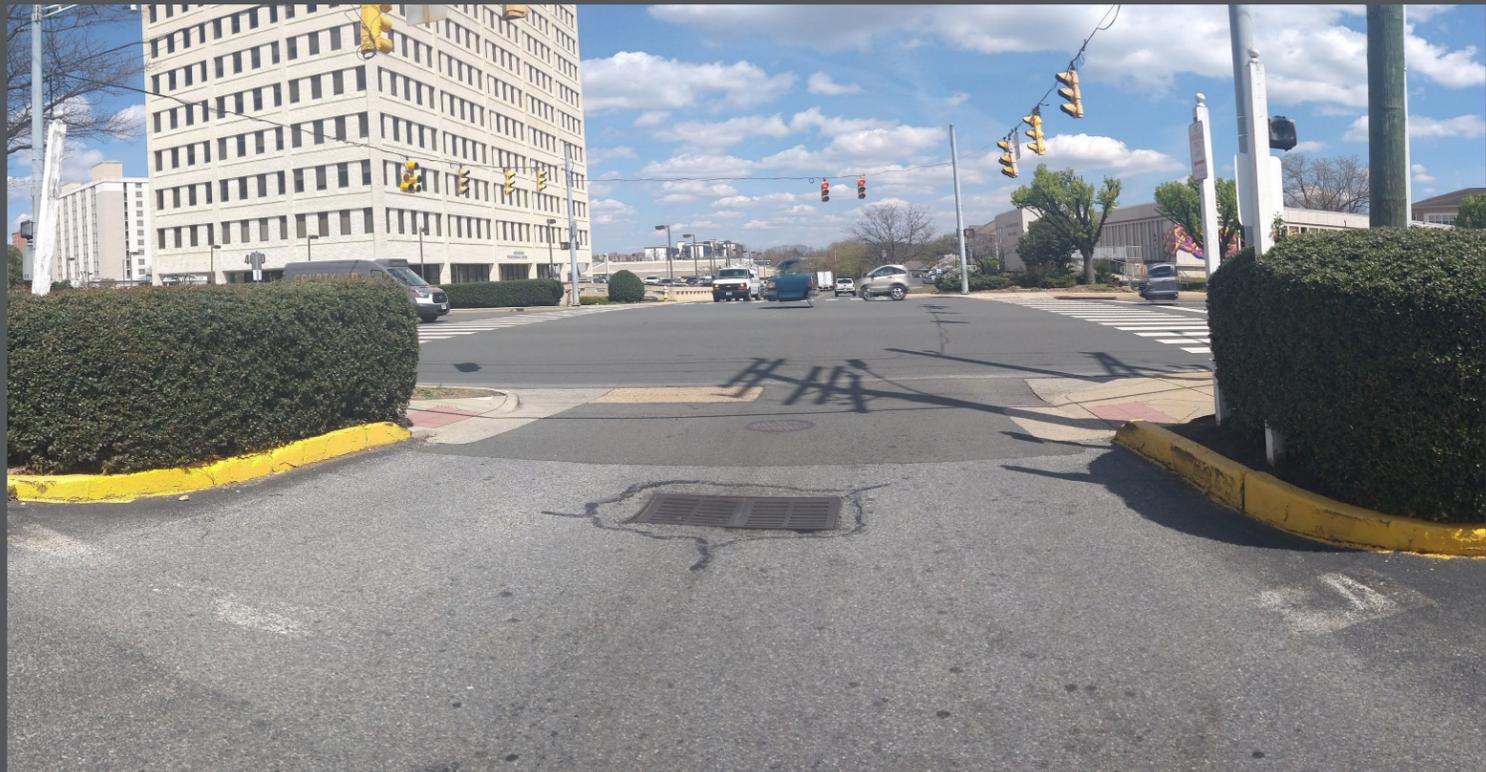
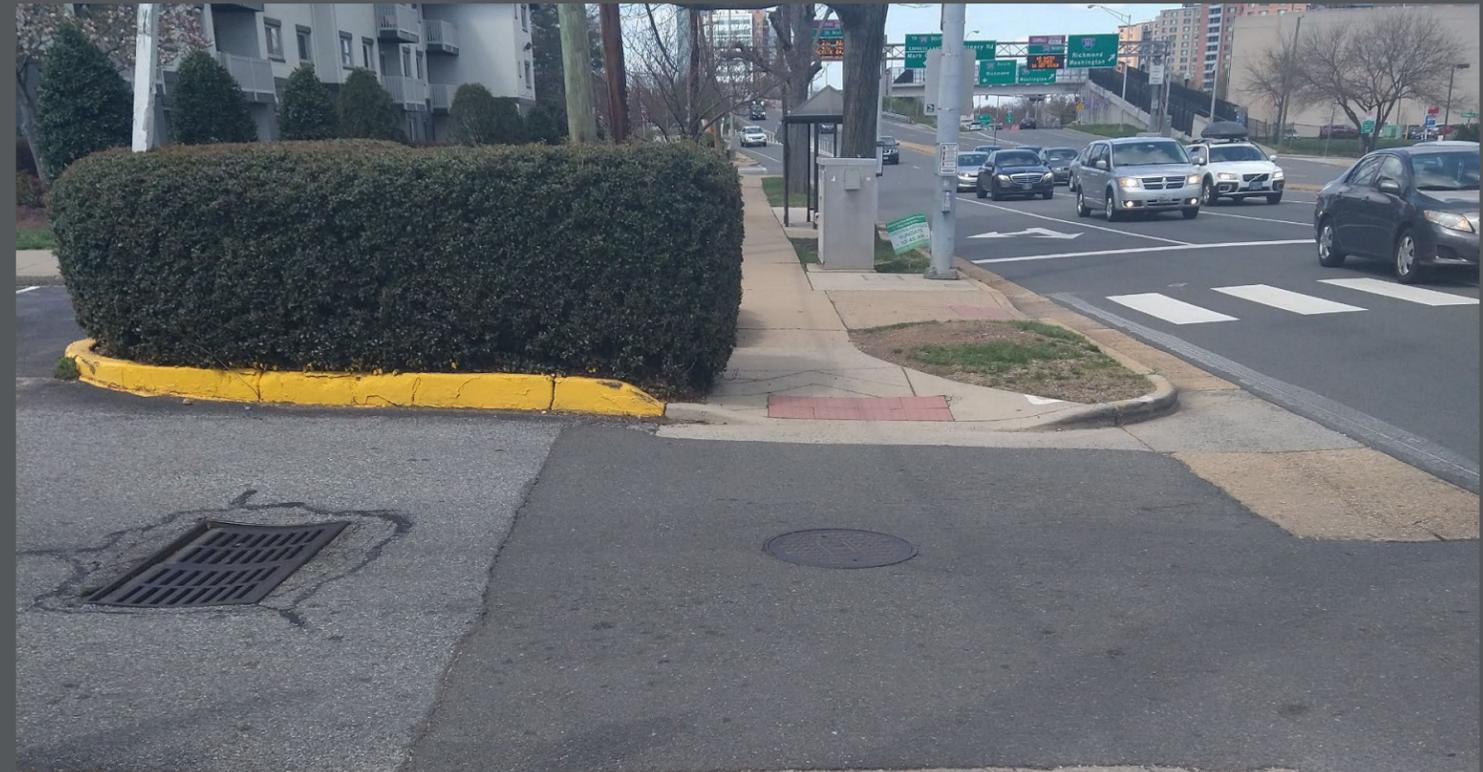
Visibility is extremely limited for drivers exiting the apartment complex immediately west of the school, opposite Library Lane. The same hedges that restrict drivers' ability to see students and others walking past their driveway also block part of the sidewalk itself, and the shy distance of a hedge taller than a student's head cuts the sidewalk's usable width in half.

6	Francis C Hammond MS	Seminary Rd (Pickett St to Kenmore Ave), Speed Management, School Zone Signs and Pavement Markings	Speeding on Seminary Road was a concern from parents and school.	Conduct speed study and perform speed mitigation measures.	■ ■ ■ ■ □	City
7a	Francis C Hammond MS	Seminary Rd & The Encore Apt Drwy, Intersection or Crossing	Northern crossing of The Encore Apt Driveway is missing crosswalk markings and has no stop bar.	Install high-visibility crosswalk marking and stop bar.	■ □ □ □ □	City

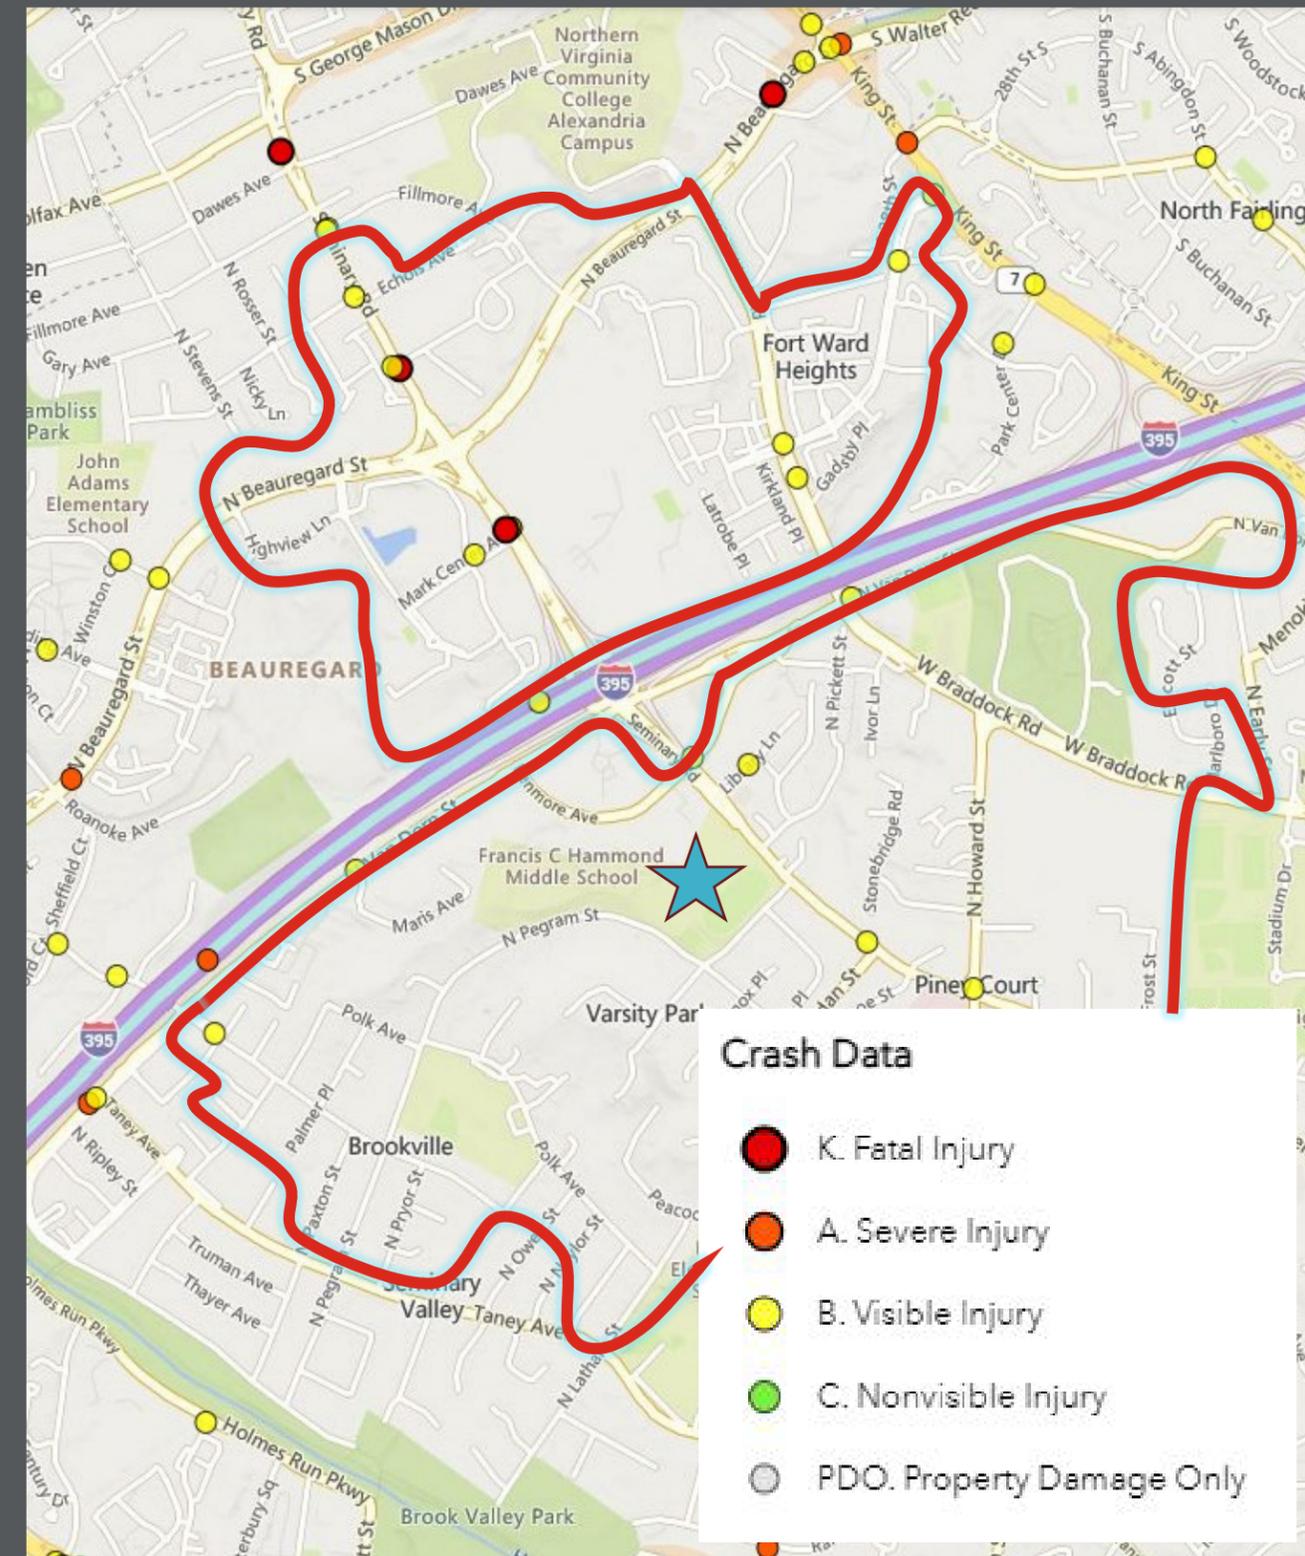
- Crash Data was gathered for the school walk area for the years 2018-2022.
- Within the walk zone, there were 457 crashes. Of these crashes, 17 involved a pedestrian, 6 involved a bicyclists. There were 2 pedestrian fatalities.
- Crash reports for multiple pedestrian injury crashes list driver speeding as improper action.

*Pedestrian-Involved Crashes 2018-2022
Source: VDOT
Red line shows approx. walk zone.*

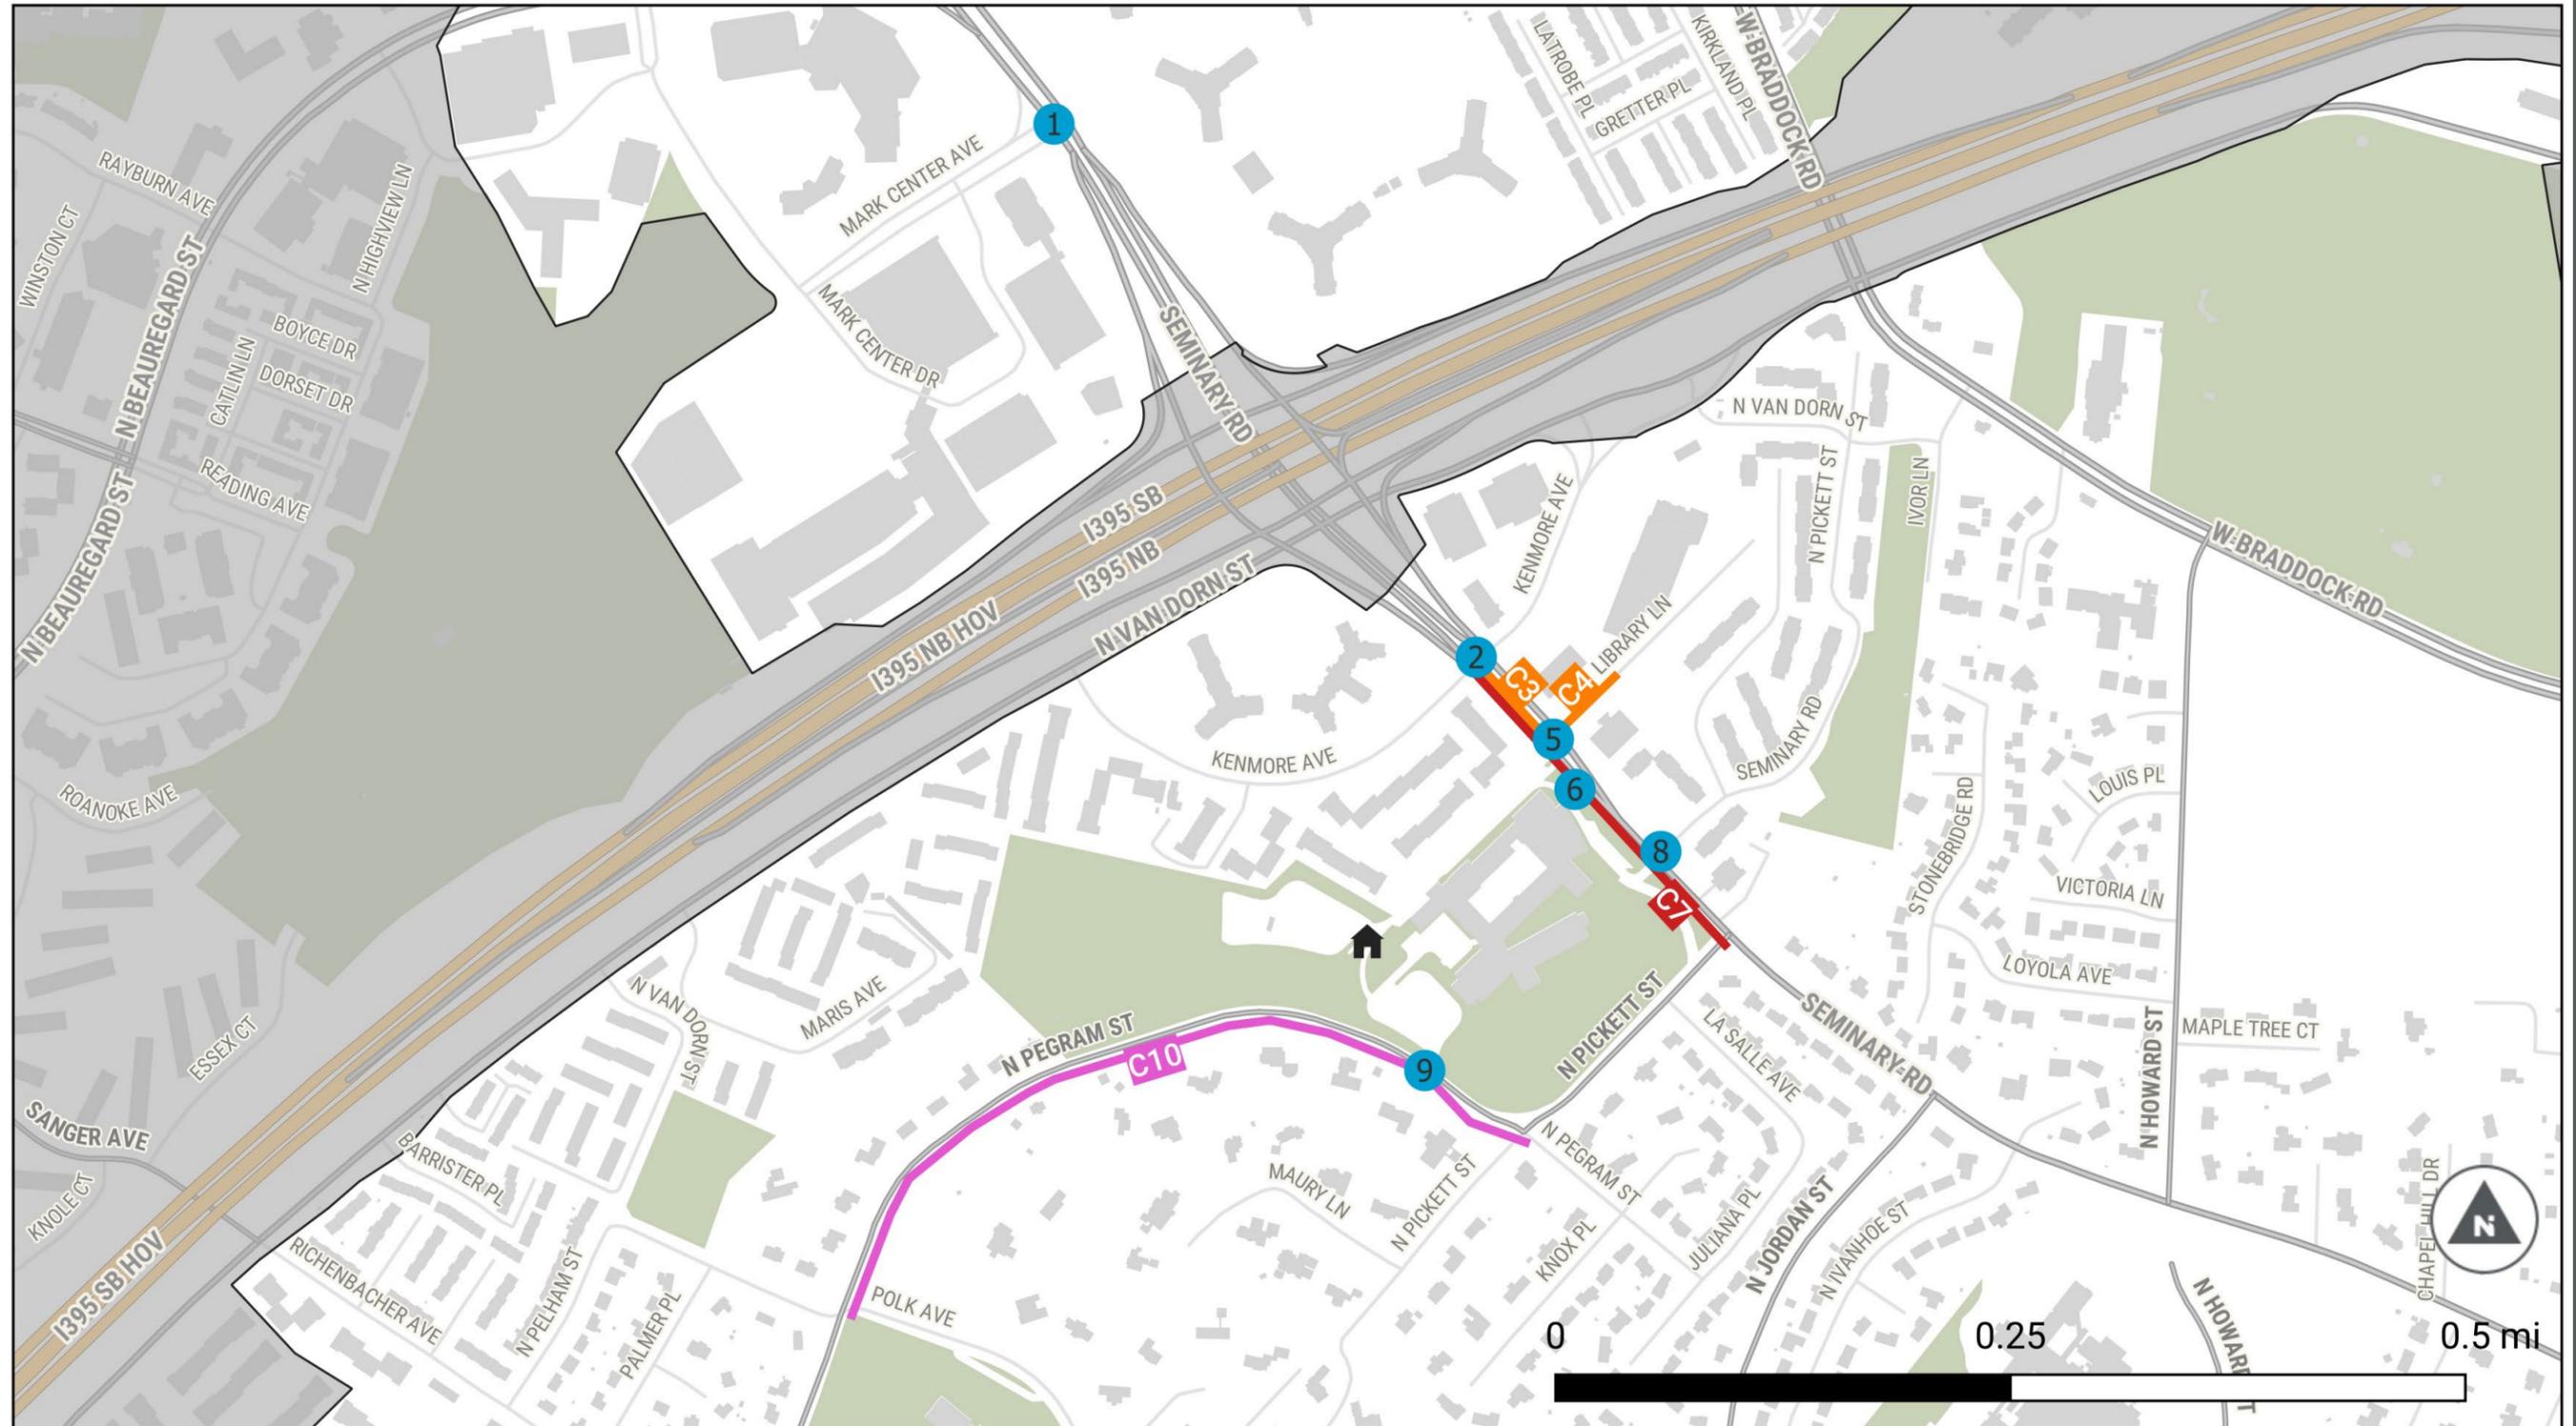
Francis C Hammond MS - Recommendations

The following map and tables summarize infrastructure recommendations within and outside of the current school walk zone as relevant. Key student walking or bicycling routes were identified based on information received from school administration, parent surveys, and school observations.
