Safe Routes to School Assessment

George Washington Middle School

National Capital Region
Transportation Planning Board

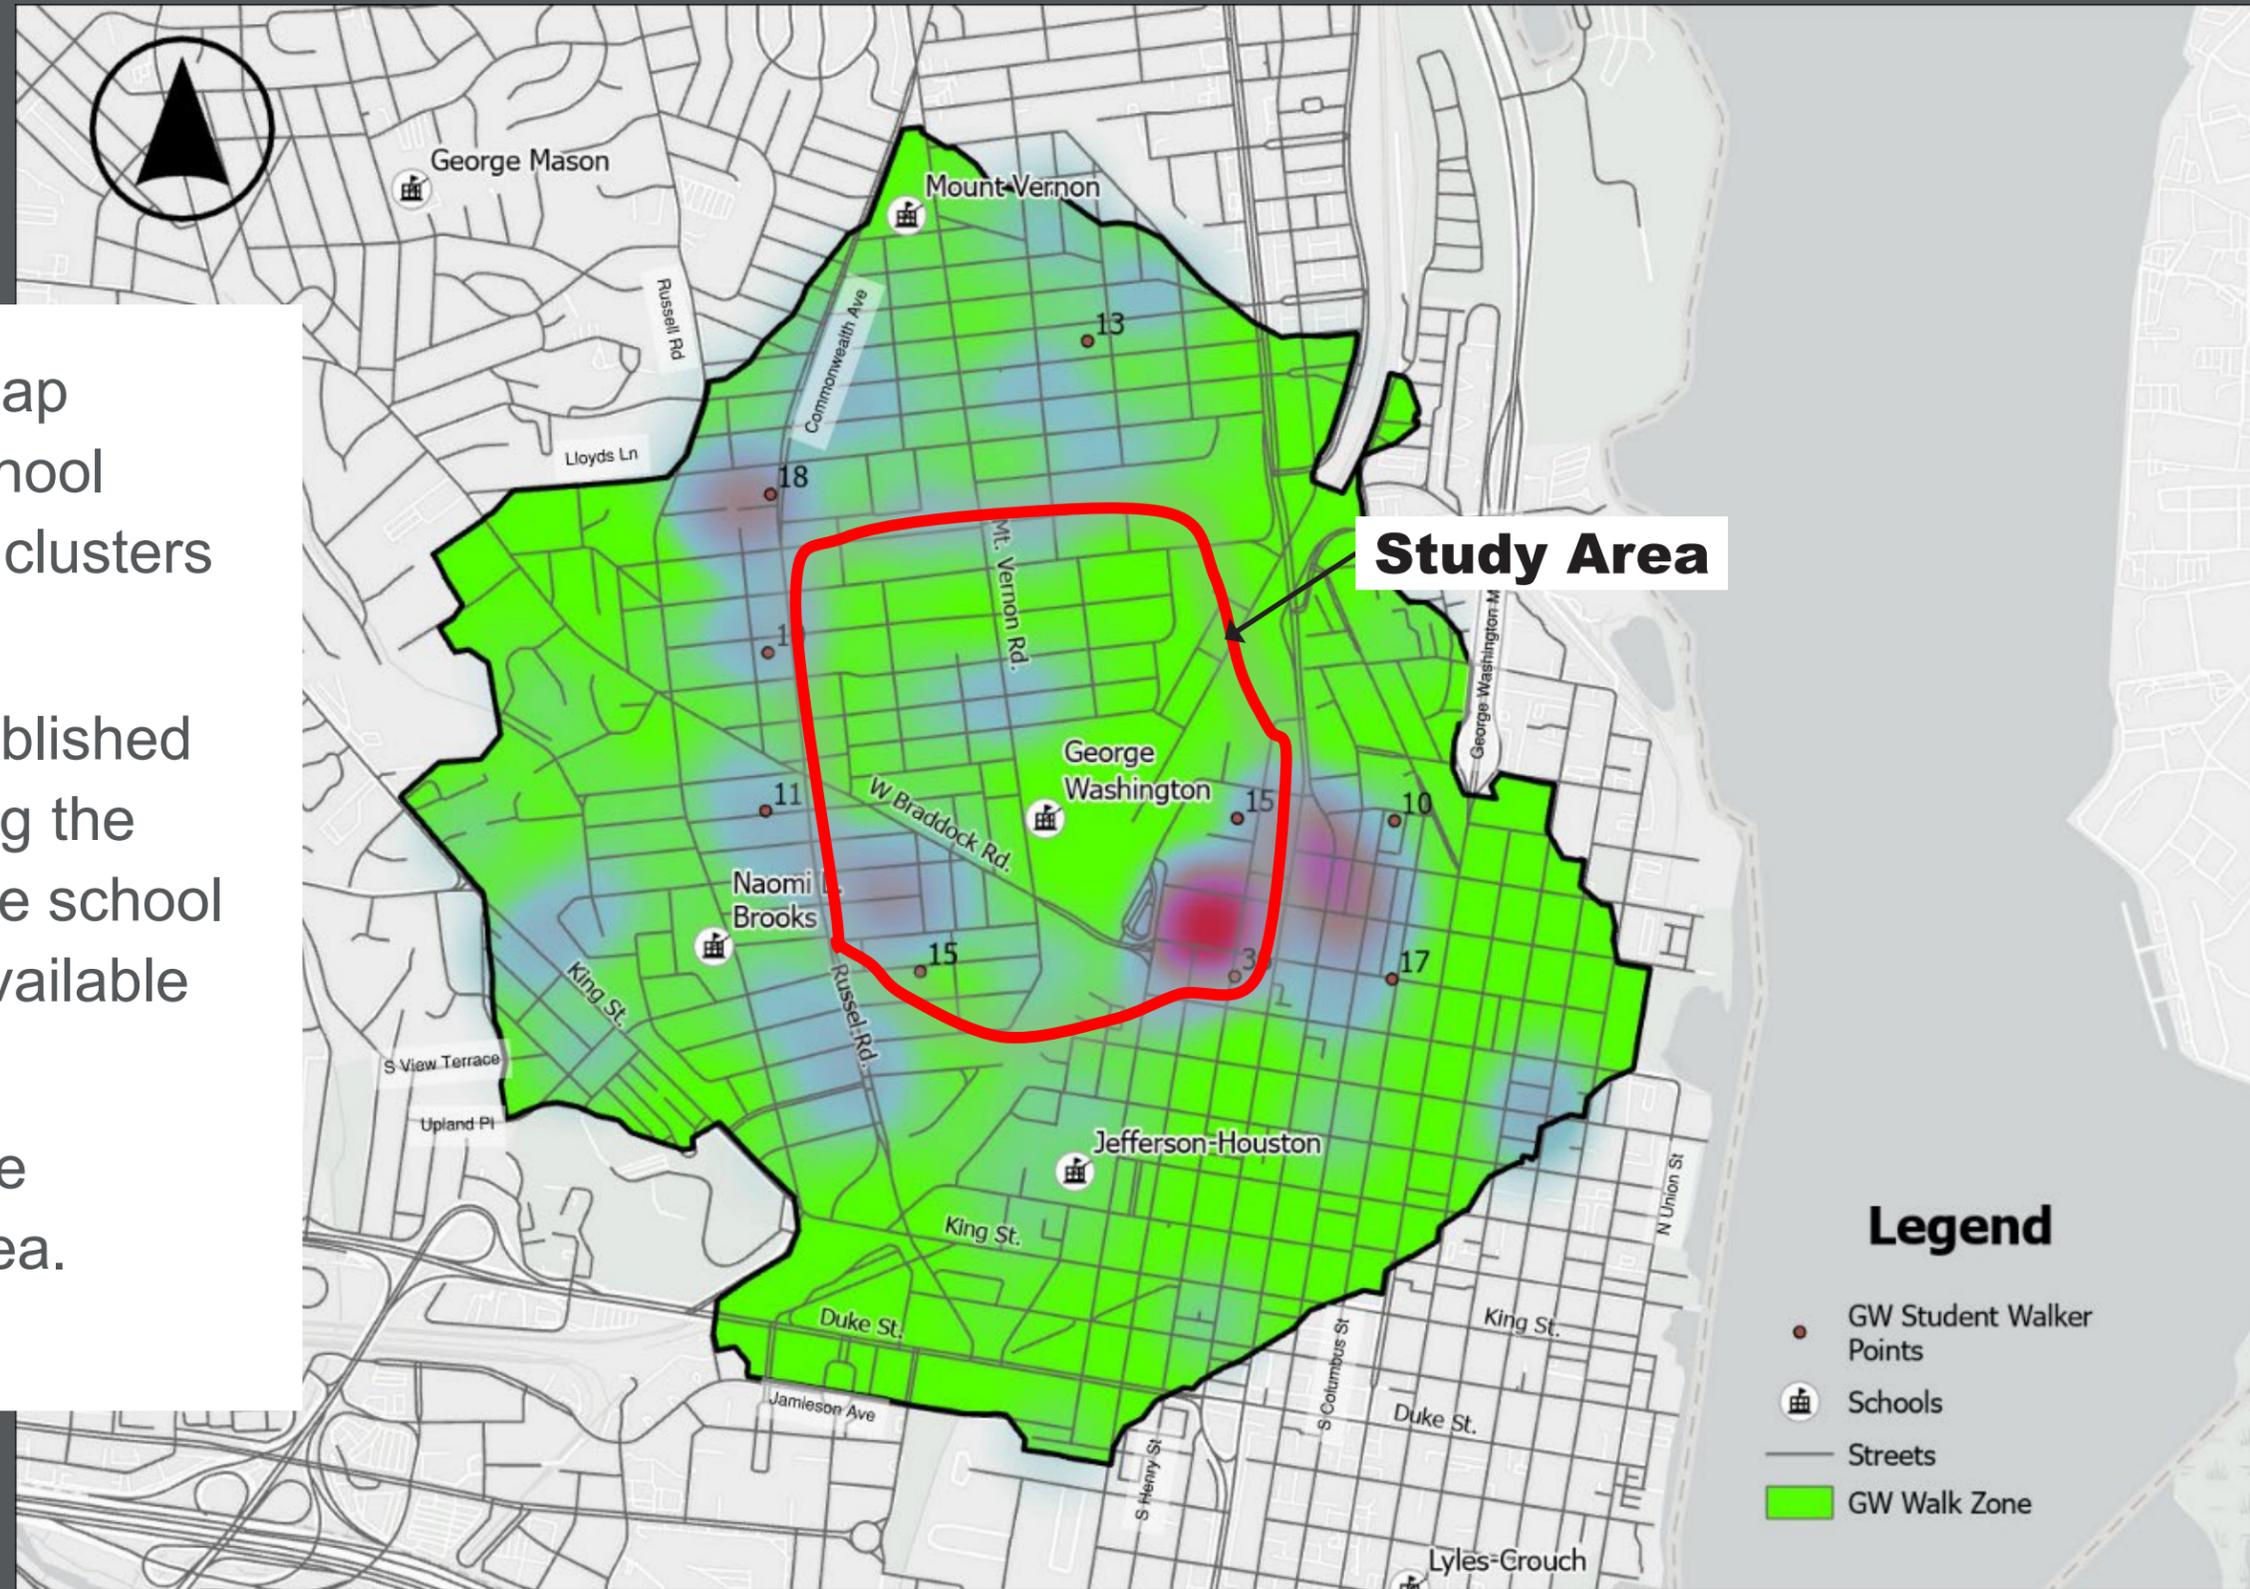
George Washington MS Walker Clusters

- The Walker Cluster map shows the existing school walk zone, as well as clusters of student addresses.
- The walk zone is established by ACPS by evaluating the walking distance to the school in combination with available infrastructure.
- The red line shows the approximate study area.

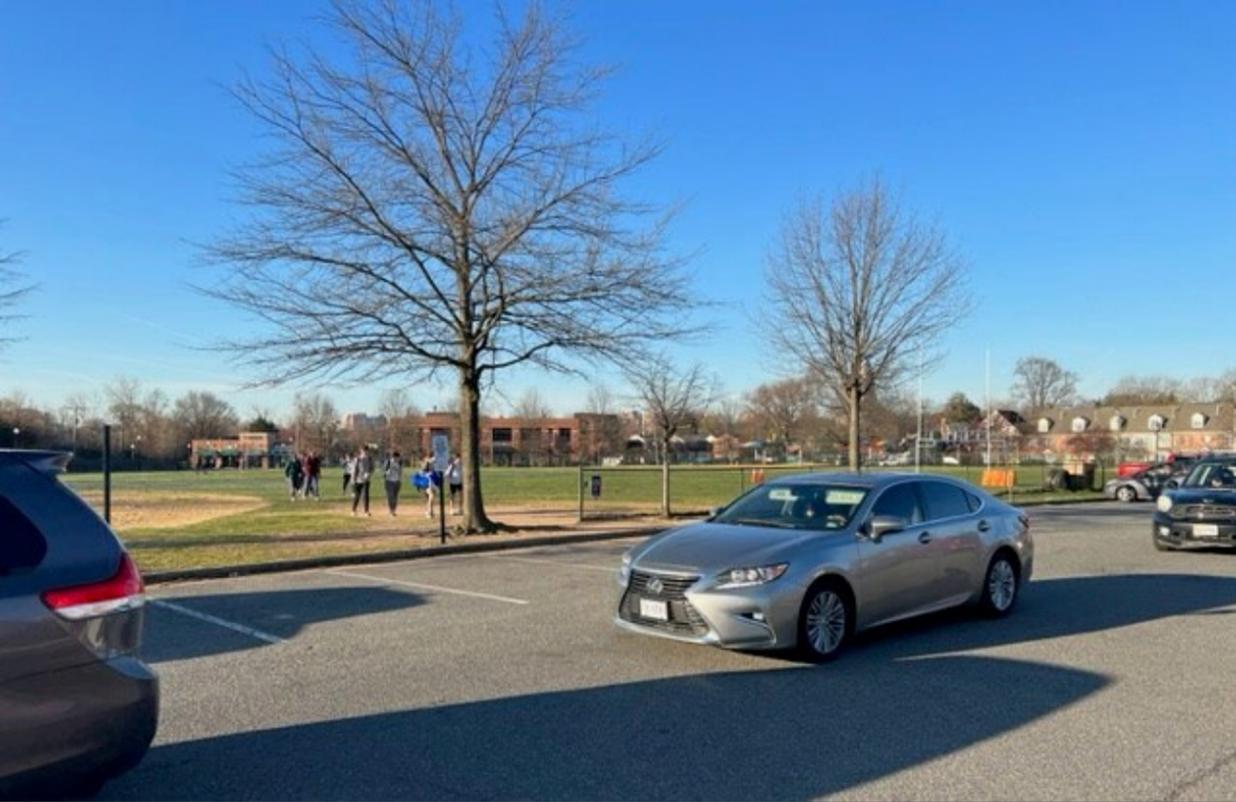
Students walking across the field to get to school

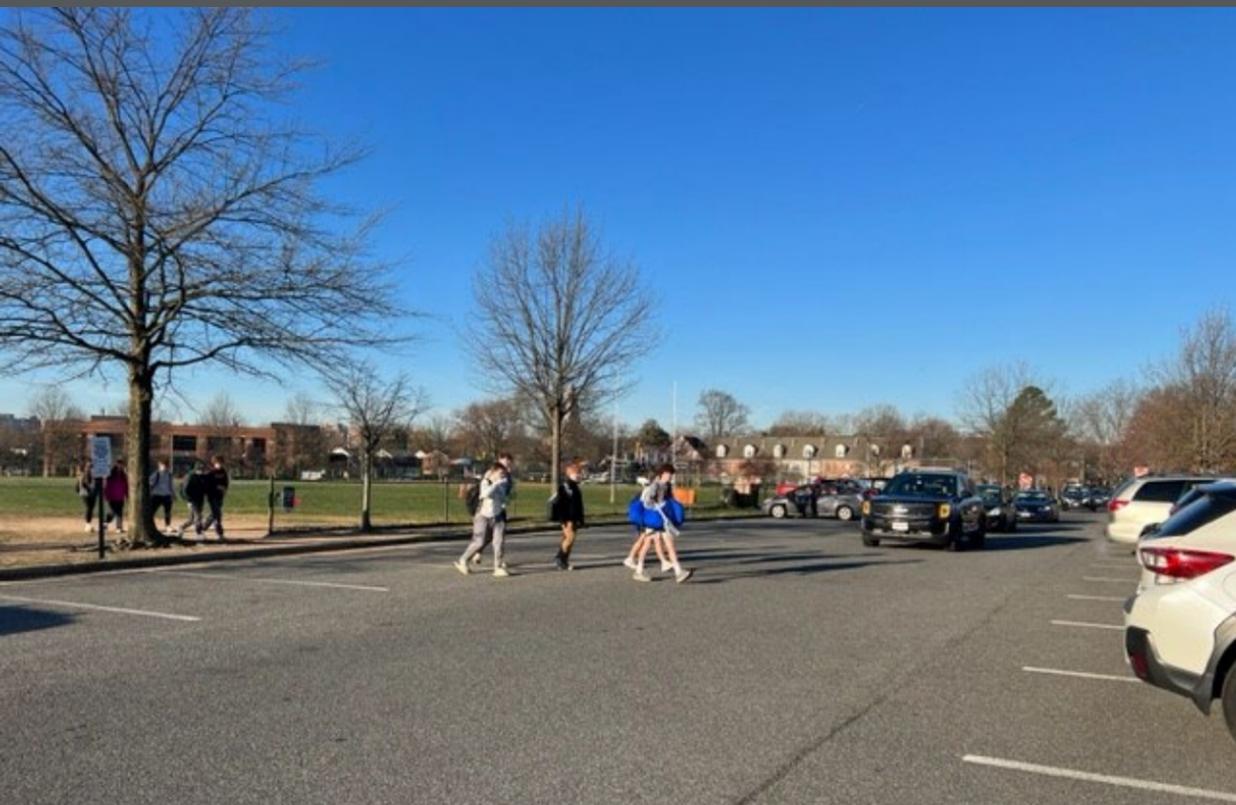
Students crossing the drop-off line

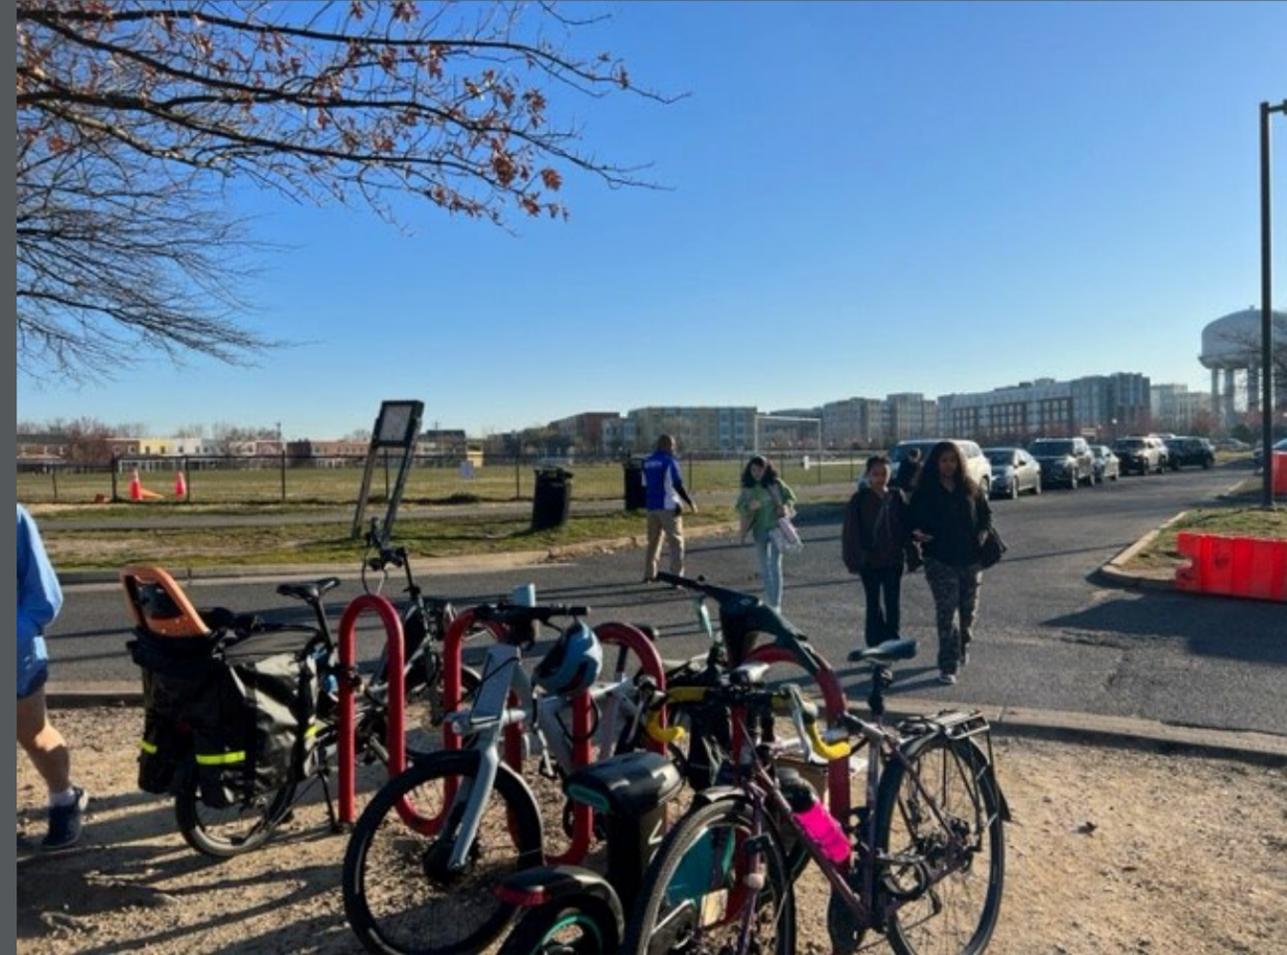
Students crossing drop-off line

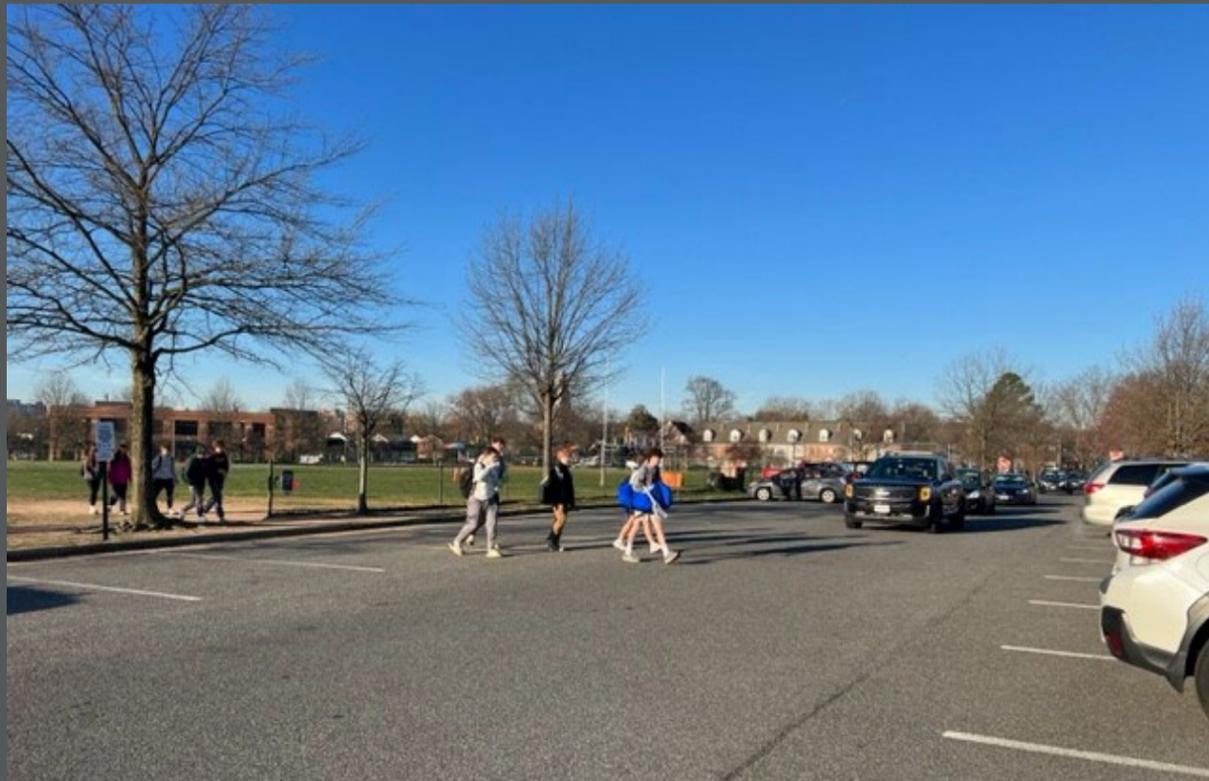
- There is no marked crossing connecting students from where parents drop them off and the school door.
- Students leave the drop-off line and cross the bus drop-off aisle at several locations near the existing crosswalk.
- Parents reported that when buses are stopped in the bus drop-off area, the crosswalk is obscured by oncoming buses.
- ADA ramp faces parking lot at a skewed angle and has no detectable warning surface.
- Bike parking is uncovered. There is no ramp to access the bike racks. At least one student was observed parking their bicycle somewhere other than the bike racks.

Parking lot and field intersect at a point where it dumps students into the drop-off line, with no marked crossing.

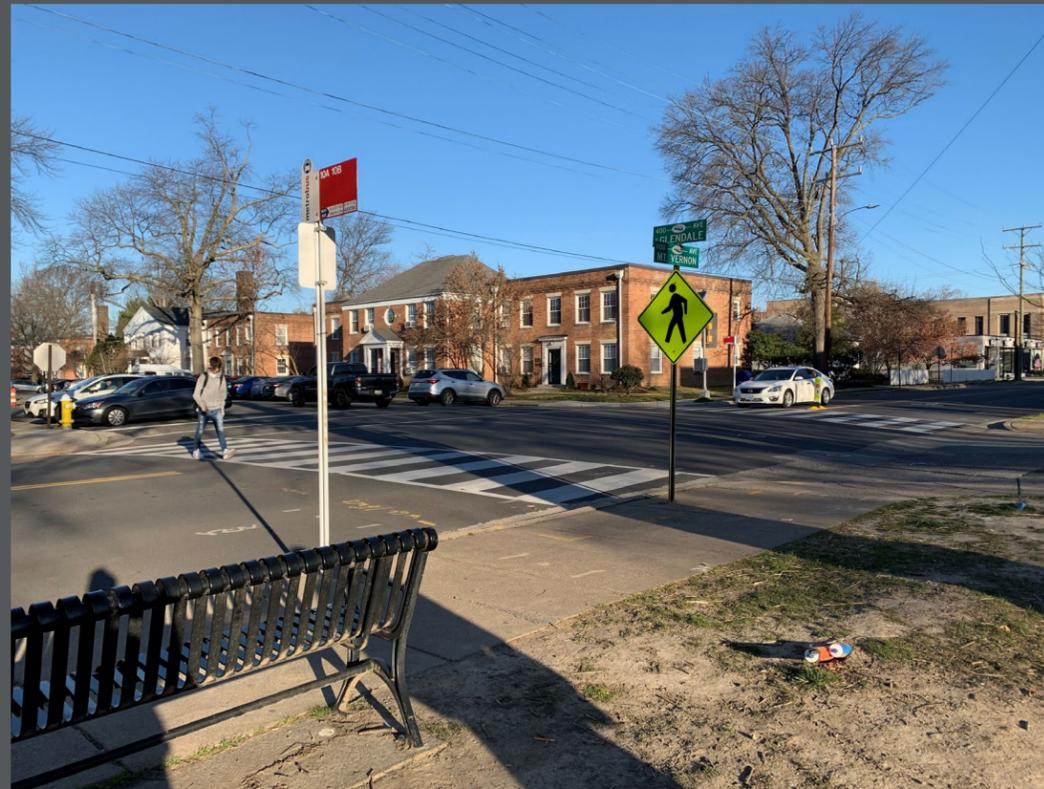
Intersection of Mt. Vernon Avenue and E Glendale Avenue, where many students cross to access the school campus.

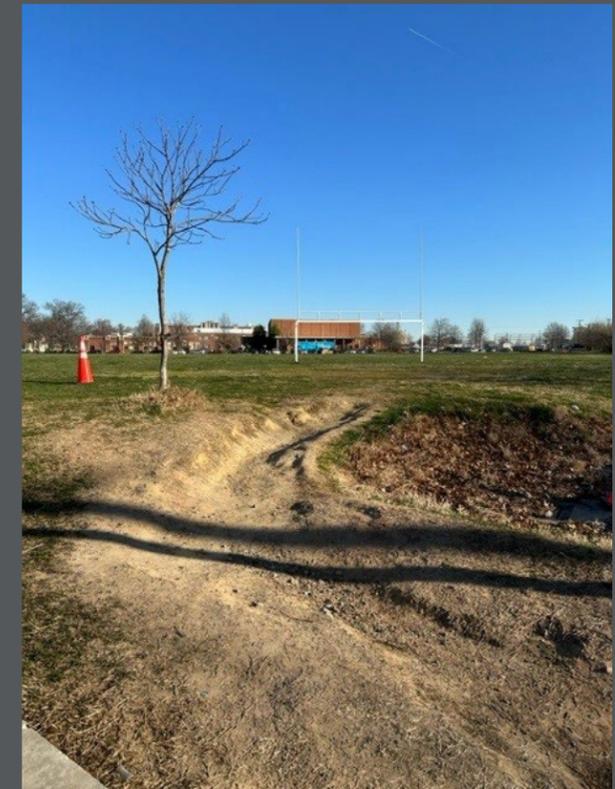
There is a desire line from E Braddock Road that leads students across the athletic fields, which gives them direct access to the school.

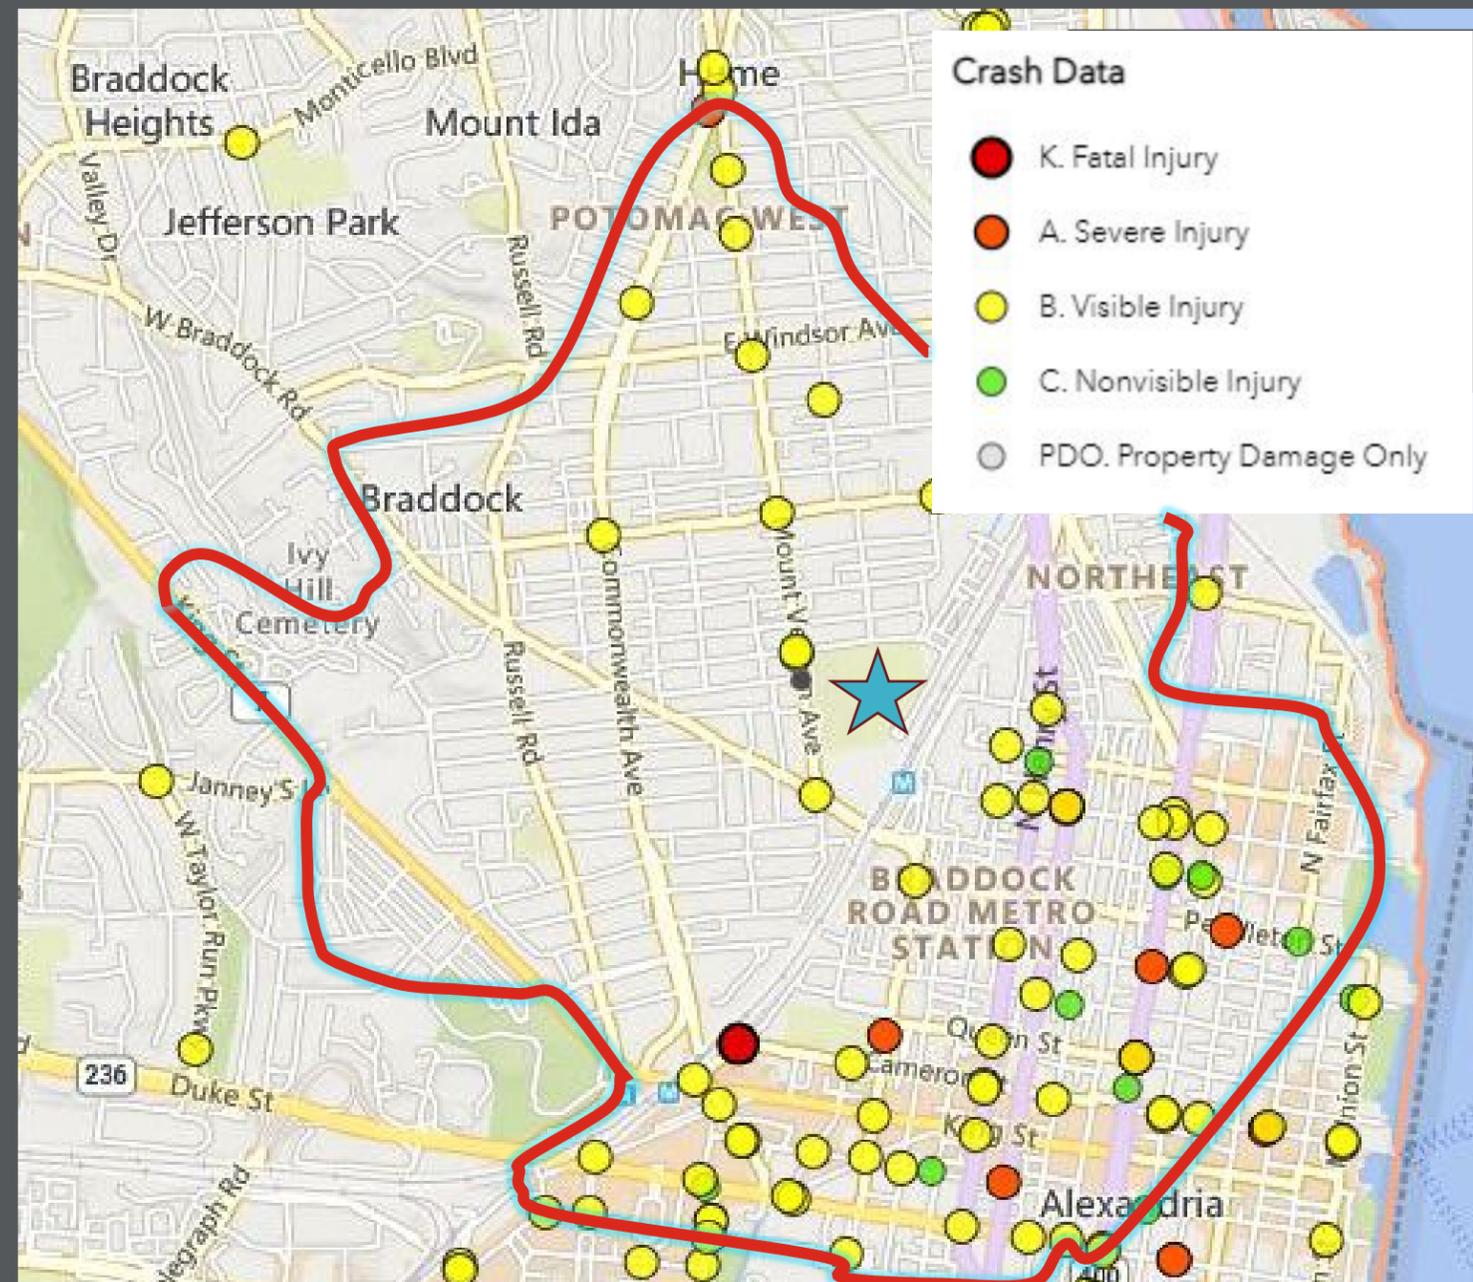
- Crash Data was gathered for the school walk area for the years 2018-2022.
- Within the walk zone, there were 831 crashes. Of these crashes, 58 involved a pedestrian, 13 involved a bicyclist. There was 1 pedestrian fatality.
- There was a pedestrian crash at the intersection of E Braddock Road and Mt. Vernon Avenue involving a 14 year old at 3:23pm, aligning with dismissal time. Pedestrian had a visible injury.

Crashes for all modes 2018-2022
 Source: VDOT
 Red line shows approx. walk zone.

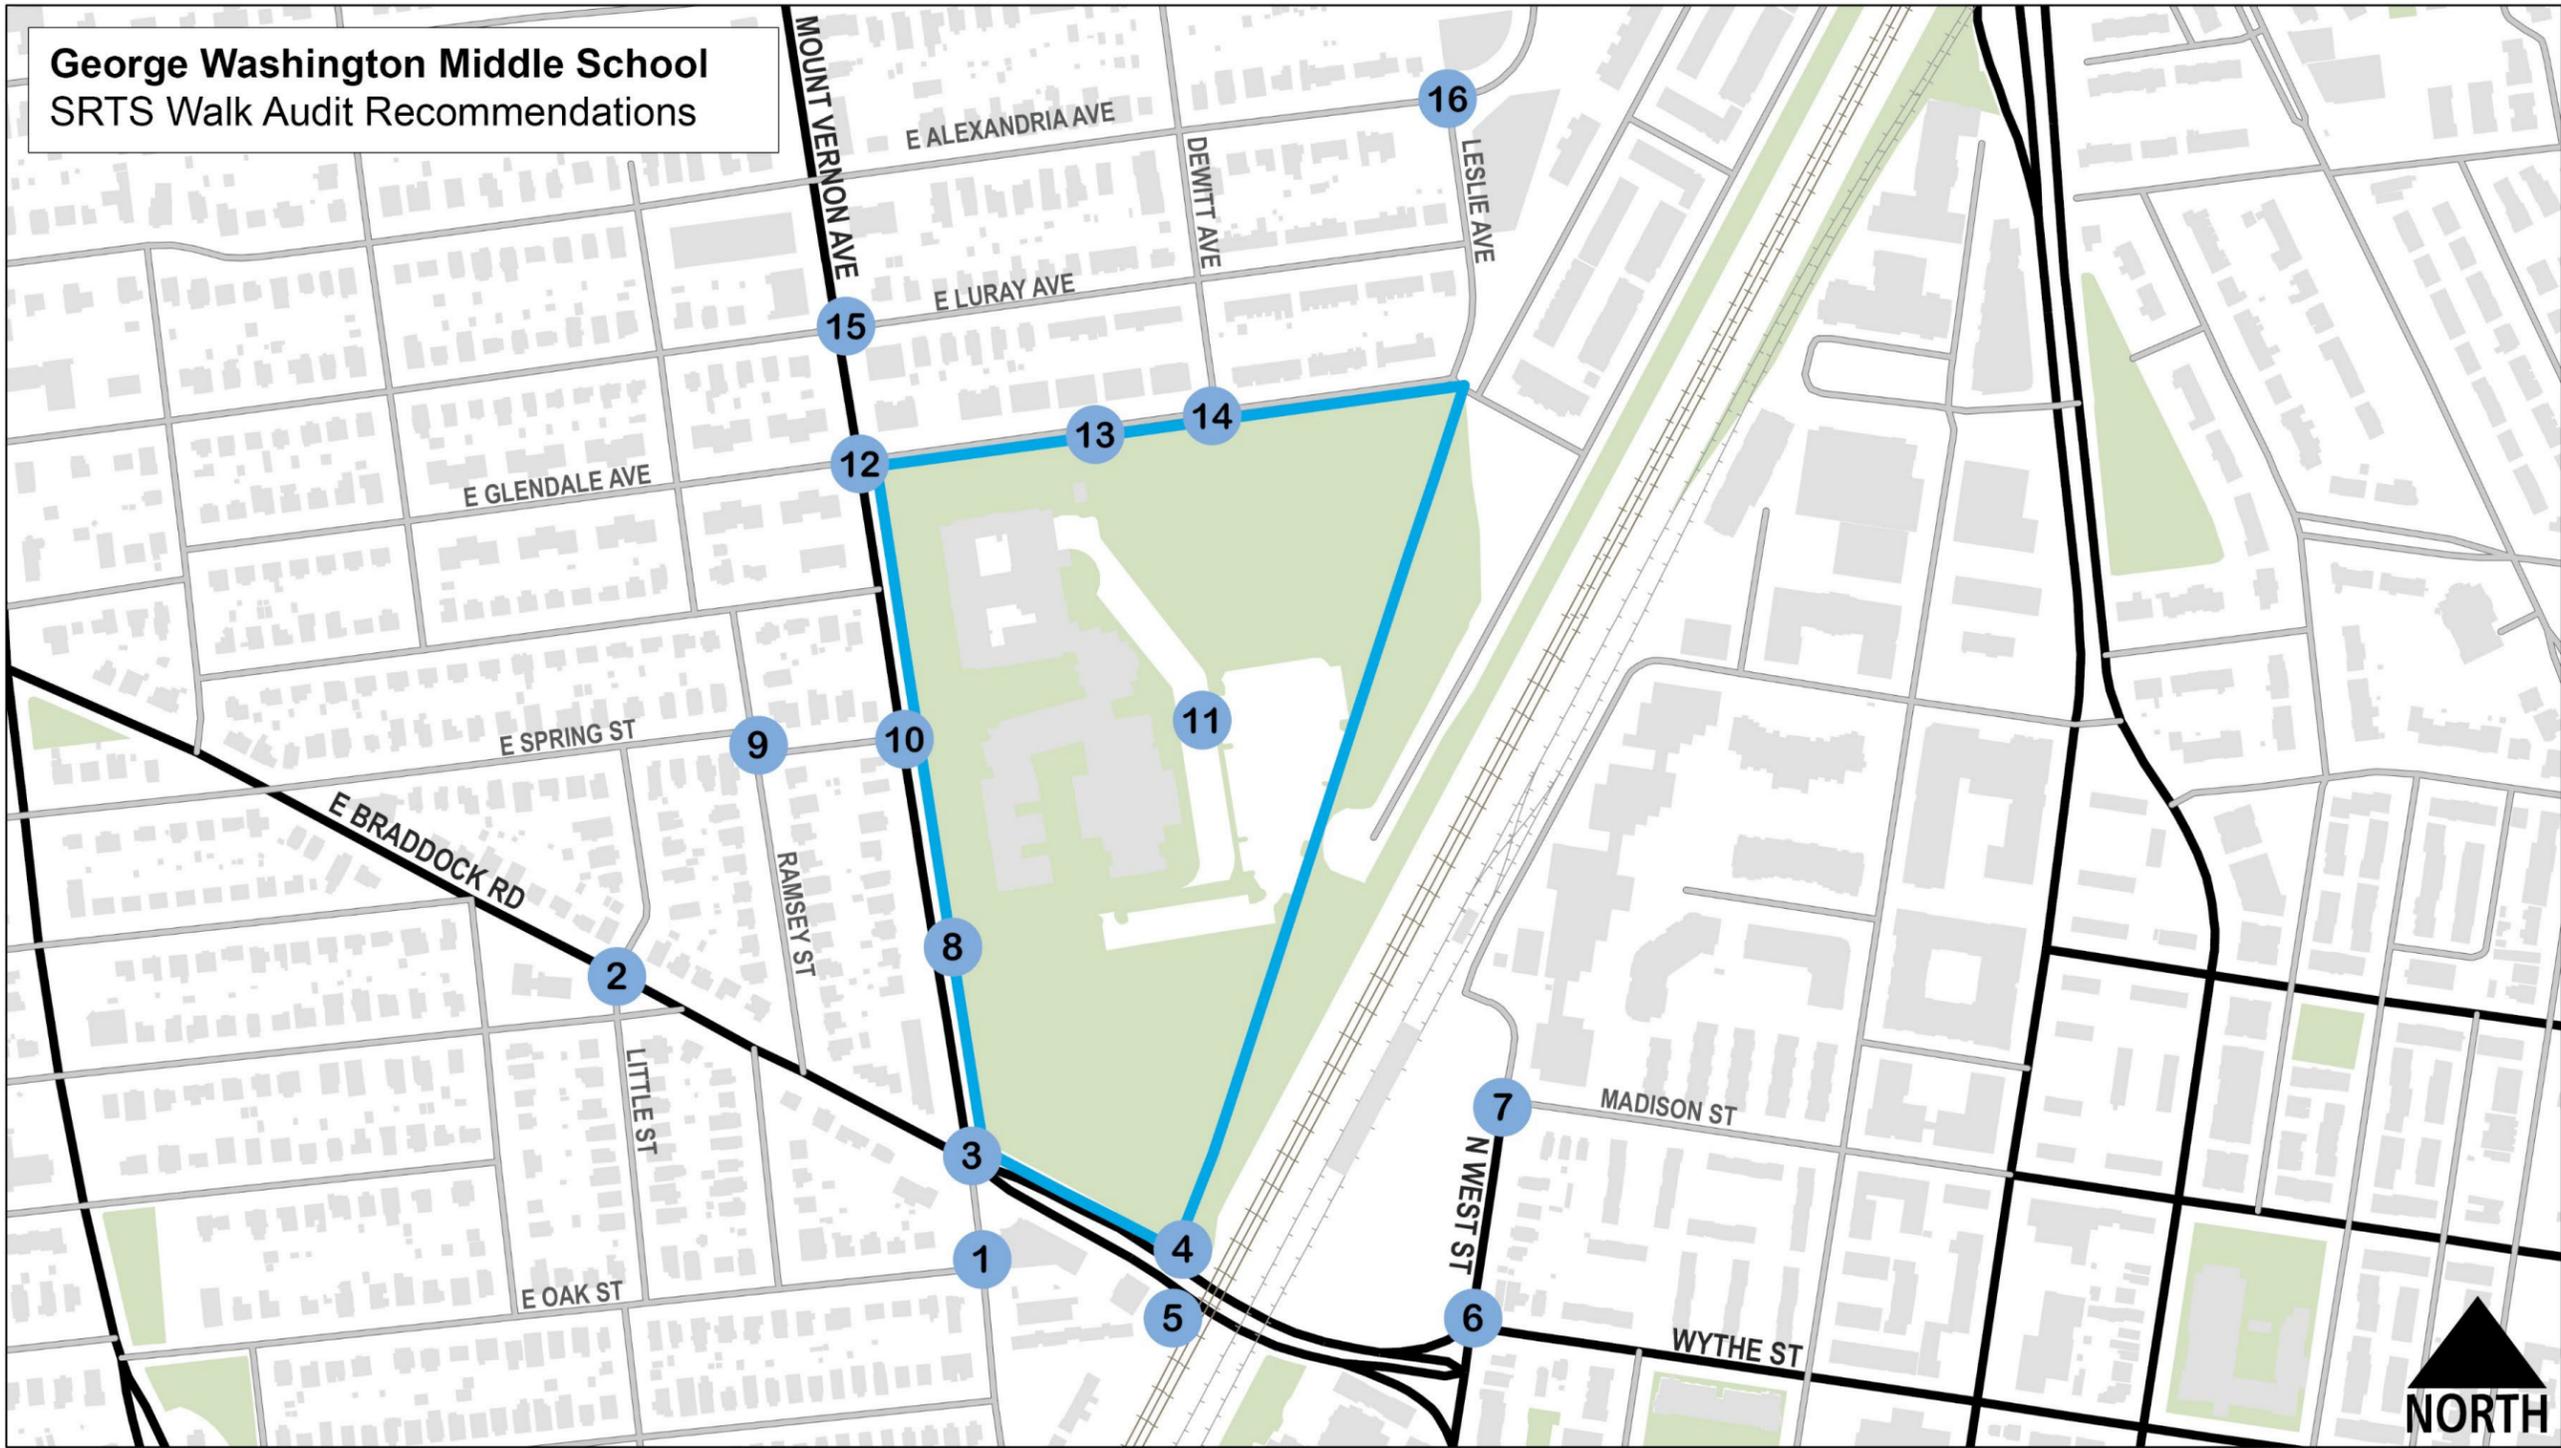
George Washington Middle School
SRTS Walk Audit Recommendations

The following map and tables summarize infrastructure recommendations within and outside of the current school walk zone as relevant. Key student walking or bicycling routes were identified based on information received from school administration, parent surveys, and school observations.

Map ID	Location School	Location, Recommendation Type	Issue	Recommendation	Complexity	Responsibility
1	George Washington MS	Mt Vernon Ave & E Oak St, Intersection or Crossing	Eastern crossing of Oak St is missing crosswalk markings and both ramps (northwest and southwest corners) have insufficient level landing and lack detectable warning surfaces.	Install new standard (transverse) crosswalk and reconstruct curb ramps.	■ ■ □ □ □	City
2	George Washington MS	Little St & E Braddock Rd, Intersection or Crossing	Western crossing is not marked and no curb ramps exist. Crossing at this location support both the school and the bus stop on the south side. Northern crossing has no stop bar.	Install high-visibility crosswalk markings and install new curb ramps. Install new stop bar at northern crossing. Exploring installing crosswalk at Ramsey Street for westbound bus stop.	■ ■ □ □ □	City
3	George Washington MS	E Braddock Rd & Mt Vernon Ave, Intersection or Crossing	Crossings are relatively long, and motorists were observed taking turns quickly; not all crossings are high visibility; not all curb ramps are present (northwest and southwest corners) or ADA compliant; no auto-recall for pedestrians crossing Braddock Rd.	Explore modifying intersection design to provide safer crossings and better pedestrian access, including geometric improvements and/or signal timing changes.	■ ■ ■ ■ □	City

Map ID	Location School	Location, Recommendation Type	Issue	Recommendation	Complexity	Responsibility
4	George Washington MS	Potomac Yard Trail & E Braddock Rd, Intersection or Crossing	There are concerns about motorist speed and not yielding as well as a multiple threat condition on the northern portion of the crosswalk.	Study crossing to determine changes to improve safety at the crossing; possible recommendations include: install RRFB, install school crossing signs, reduce speed limit to 15 MPH during school hours, reduce to one lane in each direction through crossing.	■ ■ ■ ■ □	City
5a	George Washington MS	Metro Trail & E Braddock Rd, Intersection or Crossing	Ramps lack detectable warning surfaces and level landing.	Reconstruct ramps.	■ ■ □ □ □	City
5b	George Washington MS	Metro Trail & E Braddock Rd, Intersection or Crossing	Western crossing is missing high-visibility crosswalk marking.	Install high-visibility crosswalk marking (when street is repaved).	■ □ □ □ □	City

Map ID	Location School	Location, Recommendation Type	Issue	Recommendation	Complexity	Responsibility
6	George Washington MS	E Braddock Rd & N West St & Wythe St, Intersection or Crossing	Intersection has many challenges for pedestrians. The slip lane on the northwest corner introduces conflicts, especially when southbound and westbound motorists have the green indication but also have to yield to pedestrians in the crosswalk. There is one missing curb ramp (northwest corner of E Braddock Rd and N West St), many lack detectable warning surfaces, and some may have insufficient level landings.	Study options to improve intersection design and operations. Improvements may be contingent on redevelopment.	■ ■ ■ ■ ■	City
7	George Washington MS	Madison St & N West St, Intersection or Crossing	Northern crosswalk markings faded and no pedestrian crossing signs present.	Update high-visibility crosswalk and install pedestrian crossing signs	■ □ □ □ □	City

8a	George Washington MS	Mt Vernon Ave at south driveway, Intersection or Crossing	Sidewalk on the east side is too narrow, kids walking from the south of the school end up having to walk through the grass if anyone is walking from the opposite direction.	Widen sidewalk.	■ ■ ■ ■ □	City

Map ID	Location School	Location, Recommendation Type	Issue	Recommendation	Complexity	Responsibility
8b	George Washington MS	Mt Vernon Ave at south driveway, Intersection or Crossing	Eastern crossing does not have stop bar.	Install new stop bar.	■ □ □ □ □	ACPS
8c	George Washington MS	Mt Vernon Ave at south driveway, Intersection or Crossing	Northern crossing of Mt Vernon Ave is missing high-visibility crosswalk marking. Ramps are missing at this crossing.	Install high-visibility crosswalk markings and install new curb ramps.	■ ■ □ □ □	City
9	George Washington MS	Ramsey St & E Spring St, Intersection or Crossing	Crossing of Ramsey St has no marked crossing or ramps. Eastern crossing of Spring St is missing crosswalk marking and neither ramp has a level landing or detectable warning surface.	Install transverse crosswalk markings and install new curb ramps.	■ ■ □ □ □	City
10	George Washington MS	Mt Vernon Ave & E Spring St, Intersection or Crossing	Northern and southern crossings of Mt Vernon Ave lack pedestrian crossing signs and are a relatively long crossing. Concerns about motorists speeds and yielding.	Install curb extension; restrict parking in advance of the crosswalk; install school crossing signs with downward pointing arrows.	■ ■ □ □ □	City

Map ID	Location School	Location, Recommendation Type	Issue	Recommendation	Complexity	Responsibility
11	George Washington MS	Bus Drop Off Loop and Parent Drop Off Loop, Intersection or Crossing	Ramp lacks detectable warning surface.	Reconstruct or repair existing ramp.	■ ■ □ □ □	City
12a	George Washington MS	Mt Vernon Ave & E Glendale Ave, Intersection or Crossing	Western crossing of Glendale Ave is missing crosswalk markings and relatively wide due to perpendicular parking on Glendale Ave.	Short-term recommendation: install in-street crossing sign on southern crossing to match northern crossing. Install curb extensions, high-visibility crosswalks, and pedestrian crossing signs on each leg of the intersection. Explore benefit of RRFB.	■ ■ ■ □ □	City
12b	George Washington MS	Mt Vernon Ave & E Glendale Ave, Intersection or Crossing	Students were observed taking the inbound/southbound 10A/B bus and getting off at E Glendale Ave. It is likely that they take the outbound/northbound bus. There is no shelter for the outbound/northbound bus.	Add a shelter to the northbound bus stop.	■ ■ ■ ■ □	City

13	George Washington MS	E Glendale Ave & School Drwy, Intersection or Crossing	Southern crossing of school driveway is missing crosswalk markings and a stop bar.	Install new stop bar and crosswalk.	■ □ □ □ □	City

Map ID	Location School	Location, Recommendation Type	Issue	Recommendation	Complexity	Responsibility
14	George Washington MS	E Glendale Ave & Dewitt Ave, Intersection or Crossing	Eastern crossing is not marked and no curb ramps exist.	Install new ramps; install crosswalk markings; install school crossing signs with downward pointing arrows.	■ ■ □ □ □	City
15	George Washington MS	Mt Vernon Ave & Luray Ave	Northern and southern crossings of Mt Vernon Ave lack pedestrian crossing signs and have relatively long crossing distances.	Install pedestrian warning signs and consider parking restrictions or curb extensions to improve visibility.	■ ■ ■ □ □	City
16	George Washington MS	Leslie Ave & E Alexandria Ave, Intersection or Crossing	Eastern crossing of Leslie Ave is along a horizontal curve and lacks appropriate crossing signage.	Install pedestrian crossing signs with downward pointing arrows; evaluate sight distance and consider a curb extension on the northside to improve visibility.	■ ■ ■ □ □	City
