SIDING + TRIM

Steps for Siding Analysis

OLD AND HISTORIC DISTRICT CITY OF ALEXANDRIA

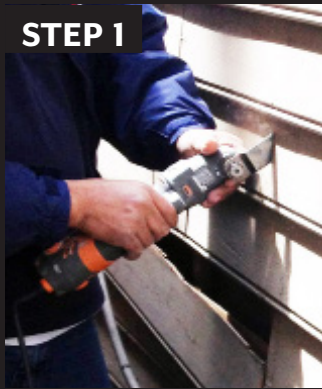
STEP 1

Carefully remove a 2 foot by 2 foot portion of the surface siding.

Intact historic siding may be hidden beneath layers of siding, such as aluminum, vinyl, artificial brick, or stone. To determine if multiple layers of siding exist, remove at least one portion a minimum of 2 feet by 2 feet to reveal the first layer of siding. Staff will inspect the mock-up in the field prior to any approval. The graphic on the following page gives an overview of this process.

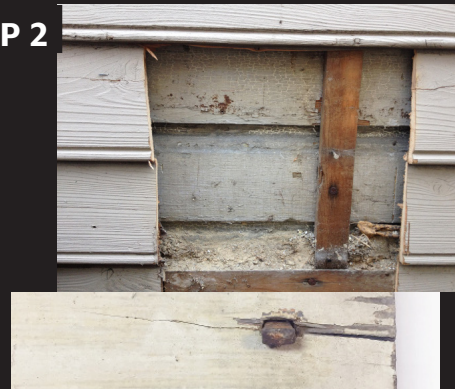
STEP 2

Using clues such as the siding profile and the type of nails used, Staff makes a determination on the age of the siding.

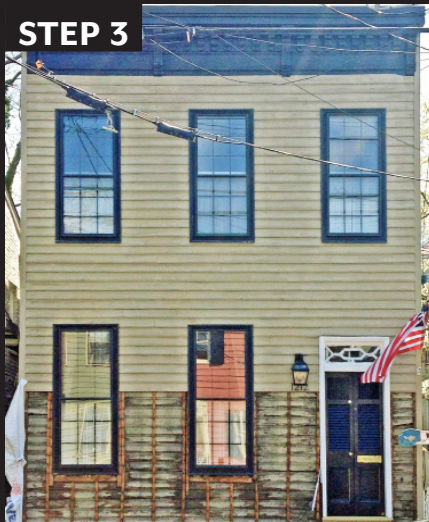
STEP 3

^ BEFORE

More of the historic siding is exposed for Staff to assess its condition. In this case, the historic siding is in very good condition and will be stripped and painted for reuse on this building.
