Steps for Siding Analysis

SIDING + TRIM

OLD AND HISTORIC DISTRICT

CITY OF ALEXANDRIA

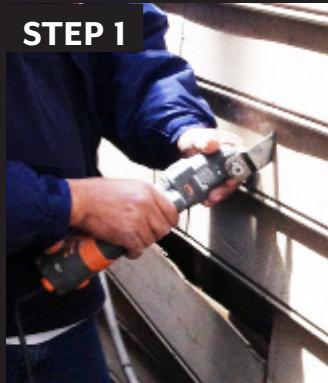
STEP 1

Carefully remove a 2 foot by 2 foot portion of the surface siding.

Intact historic siding may be hidden beneath layers of siding, such as aluminum, vinyl, artificial brick, or stone. To determine if multiple layers of siding exist, remove at least one portion a minimum of 2 feet by 2 feet to reveal the first layer of siding. Staff will inspect the mock-up in the field prior to any approval. The graphic on the following page gives an overview of this process.

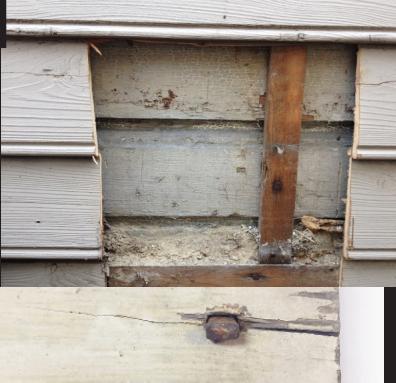
STEP 2

Using clues such as the siding profile and the type of nails used, Staff makes a determination on the age of the siding.

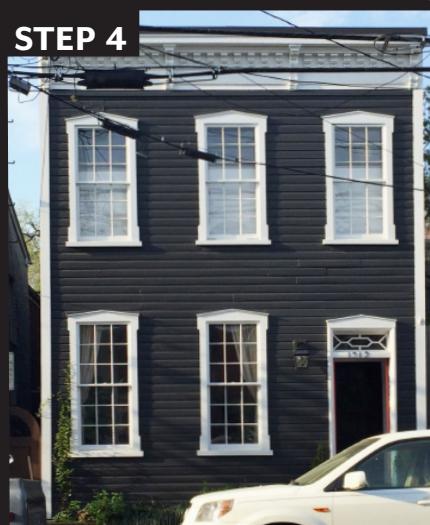
STEP 4

^ AFTER

In this case, removal of the contemporary siding also revealed ghost marks in the old paint from which the original window and door trim was able to be recreated.
