City of Alexandria's Semi-Annual Report
ATG-Oronoco Site Summary
July 1, 2025 to December 31, 2025

This Semi-Annual Report summarizes site remedial activities for the former Alexandria Town Gas – Oronoco manufactured gas plant site (ATG-Oronoco) as described in Appendices A, B, and C of the Consent Decree between Potomac Riverkeeper Network and the City of Alexandria, Virginia, as filed January 9, 2024 in the U.S. District Court for the Eastern District of Virginia (Case No. 1:22-cv-00506-CMH-WEF).

March 1, 2026

ATG-Oronoco Site Summary July 1, 2025 to December 31, 2025

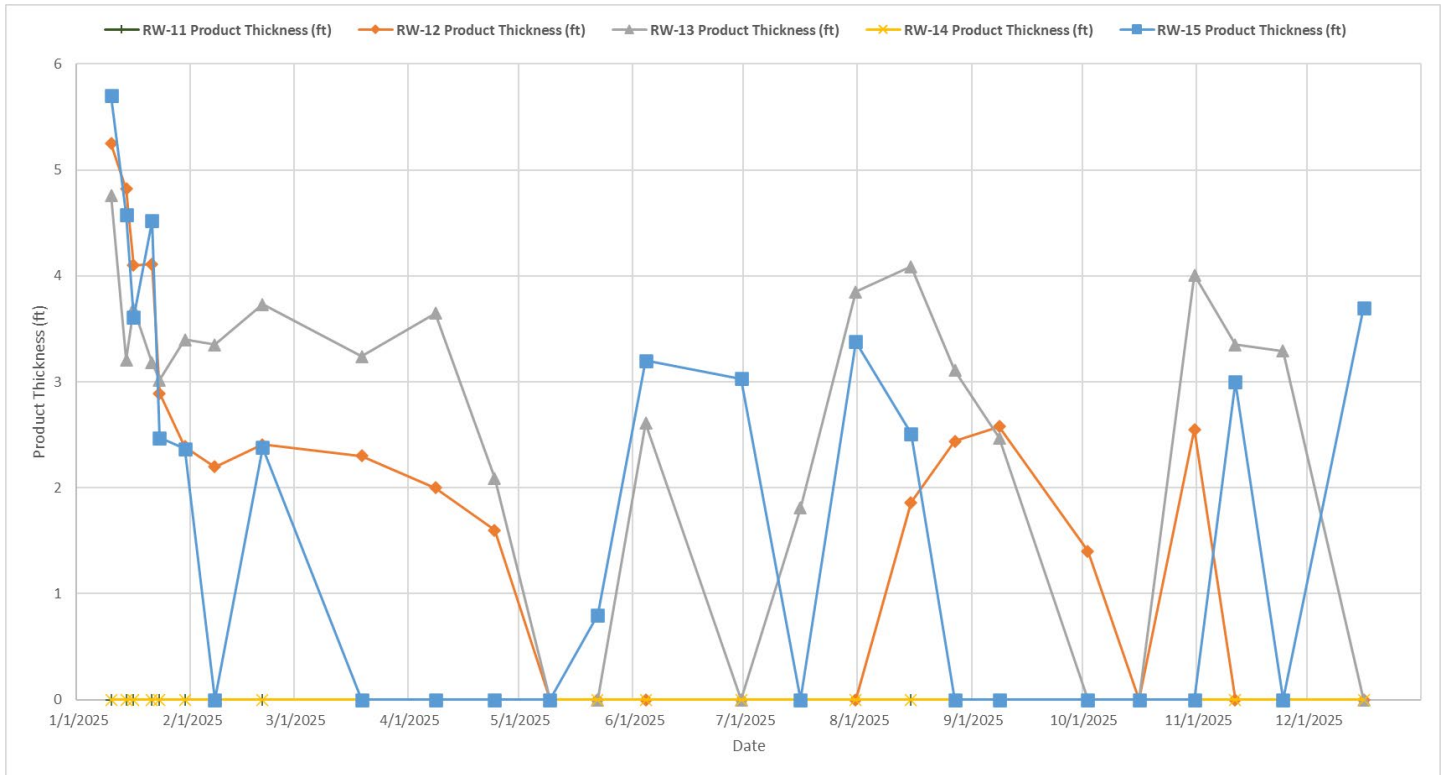
Figure 4 - DNAPL Thickness Over Time in 2025

The following **Figure 4** shows the measured thickness of DNAPL in the recovery wells RW-11 through RW-15 during 2025. The graph shows a marked decline in DNAPL thickness during January 2025 (frequent DNAPL recovery was completed during the prior month in December 2024) in wells RW-12, RW-13, and RW-15. The presence and thickness of DNAPL then cycles throughout the remainder of the year from non-detection to three feet thick or more (returning to non-detection after recovery efforts). This suggests that recharge rates are variable and potentially influenced by seasonal fluctuations in groundwater levels or other factors.

The study concluded that recharge rates to wells RW-12, RW-13, and RW-15 exhibited a significant decline during late January 2025 (between days 52 and 59 of the data collection period). After this period, the average number of days to fully recharge a well so that the collection sump became full (maximum well storage) was calculated as 30 days.

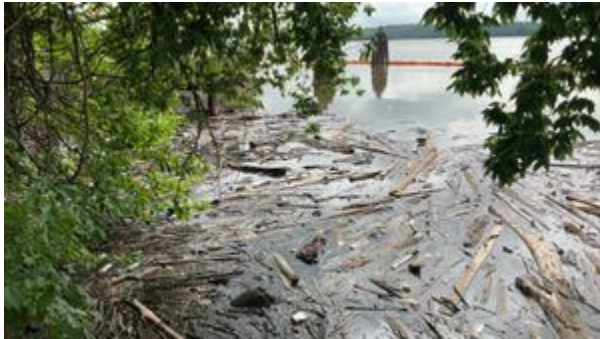
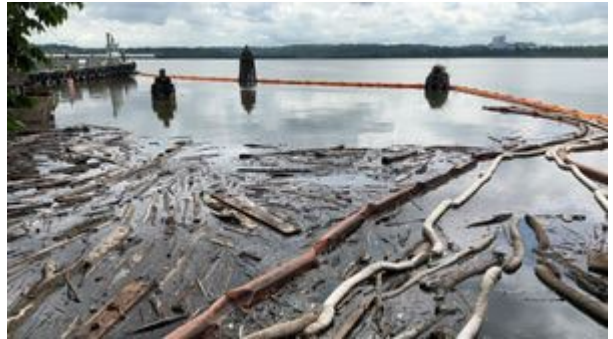
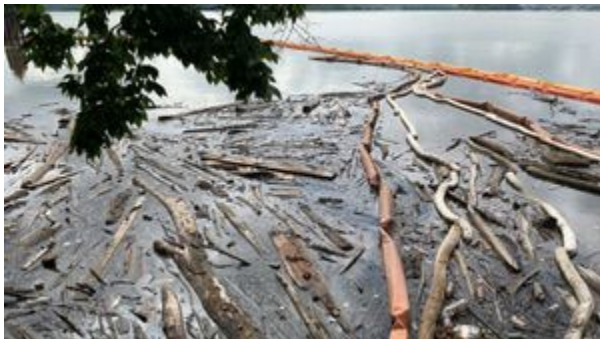
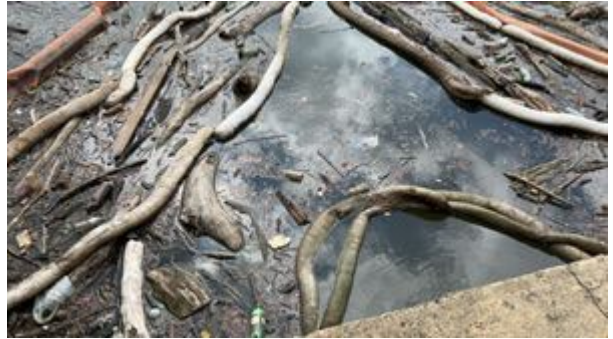
Replacement needed

SPOTTY sheen

Inner boom is fully saturated/discolored

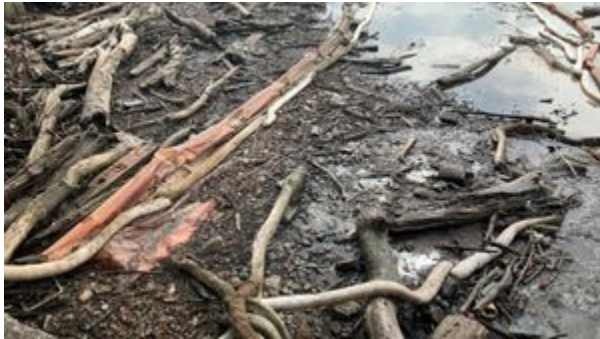
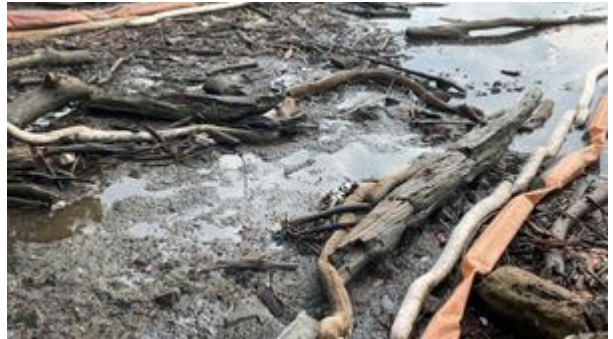
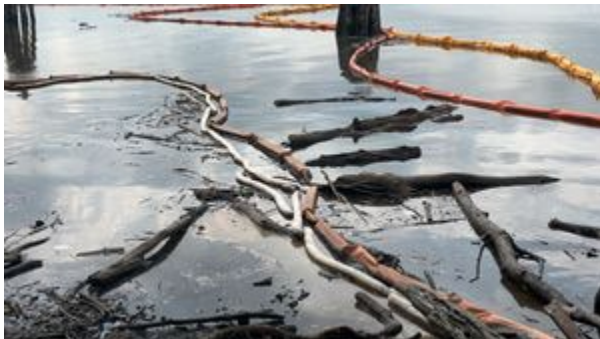
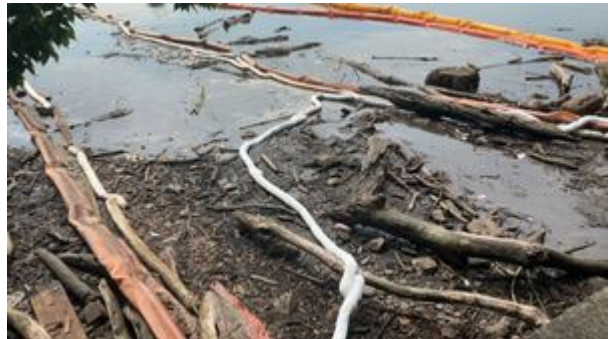
Replacement needed

MODERATE sheen

SLIGHT odor

Crew on site to clean out manway to put in camera in. Stantec personnel will be switching out inner soft boom only.

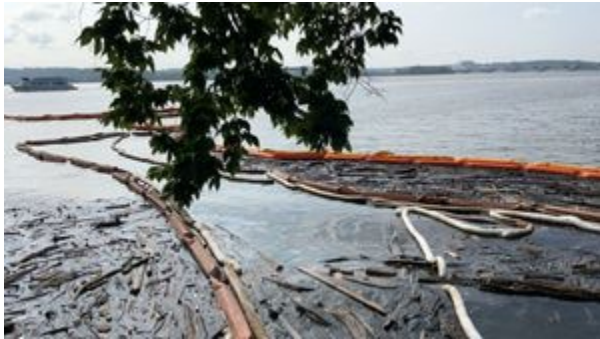
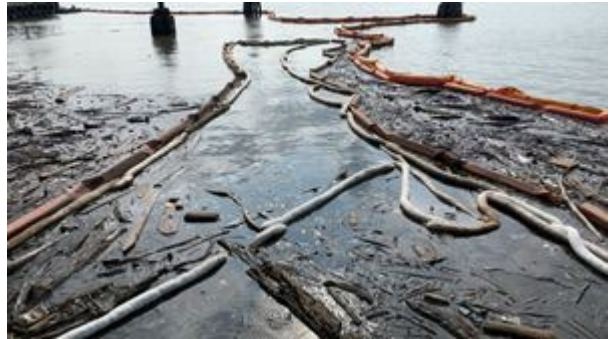
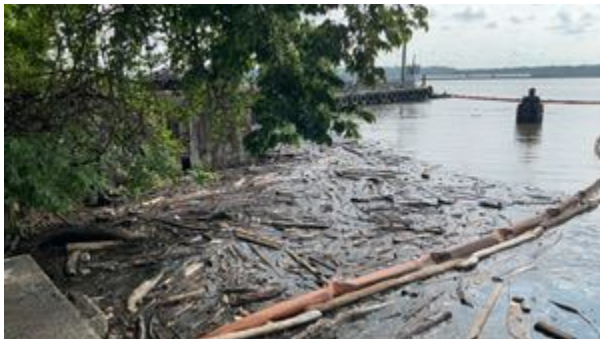
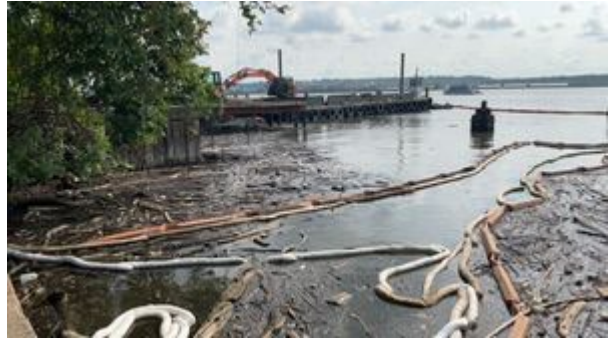
MODERATE sheen

Will need to replaced outer soft boom soon.

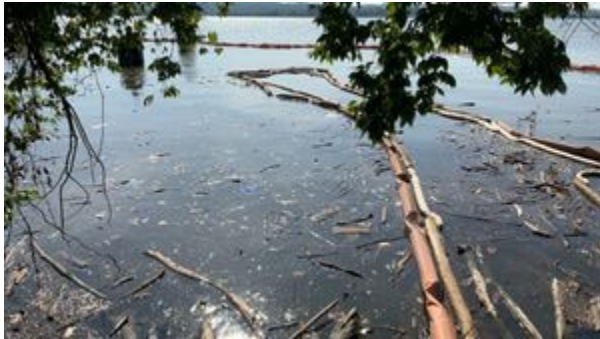
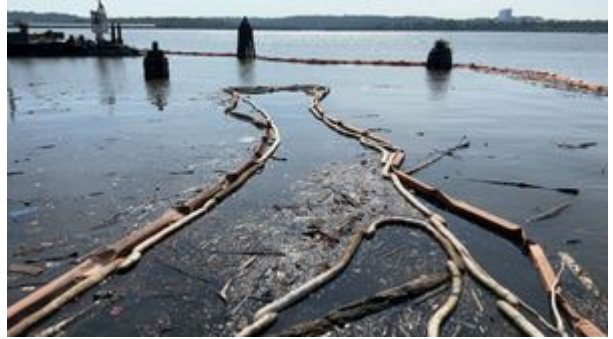
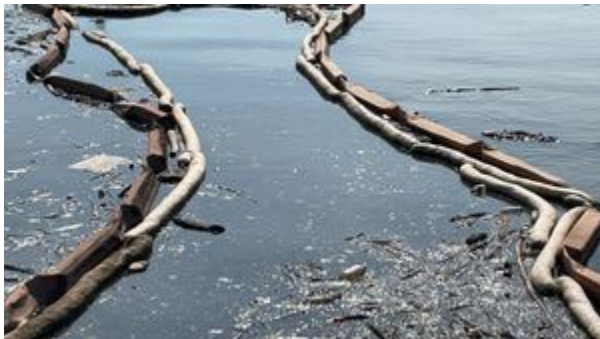
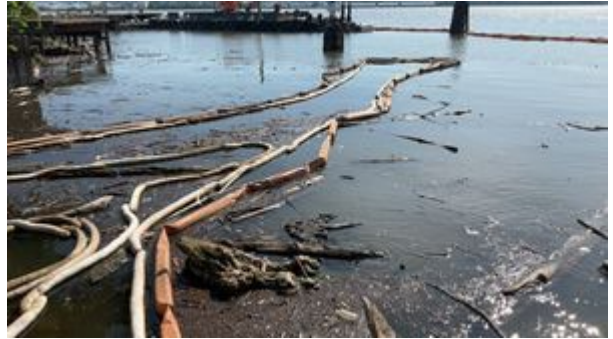
Replacement needed

SLIGHT sheen

Majority of Sheen is mostly located between inner and outer soft boom. Will be replacing outer soft boom today.

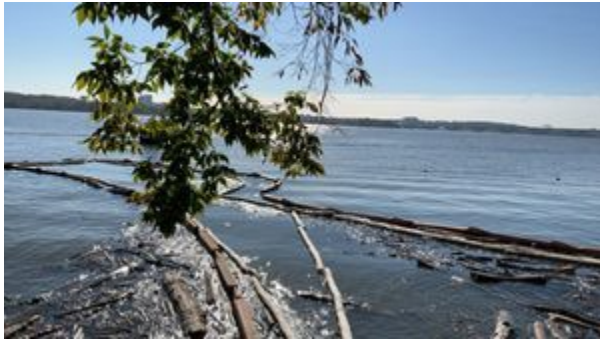
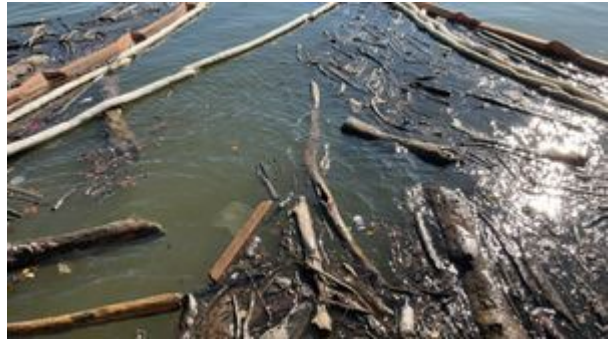
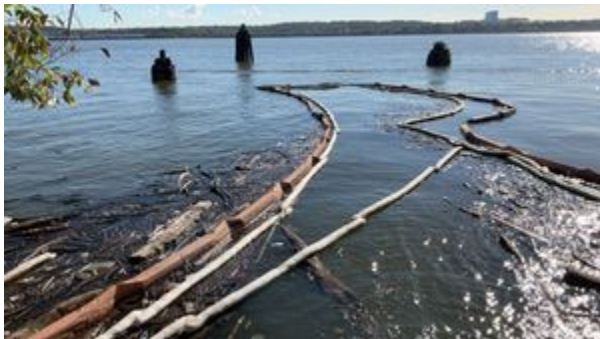
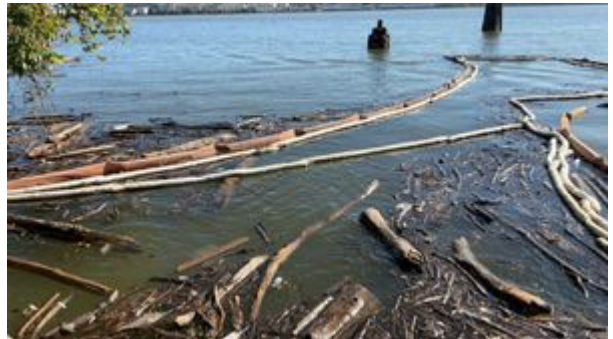
Will need to do debris clean up at outfall soon and straighten out turbidity curtain also. Also saw sheen at MH-93 but did not smell any odor on used sweep. When ahead and replace sweep at MH-93.
