ARCHEOLOGICAL MONITORING OF A WALL REPLACEMENT ALONG NORTH COLUMBUS STREET, CHRIST CHURCH, ALEXANDRIA, VIRGINIA

By Michael Clem

March 2002

Prepared By:
Thunderbird Archeological Associates, Inc.
126 East High Street
Woodstock, Virginia 22664

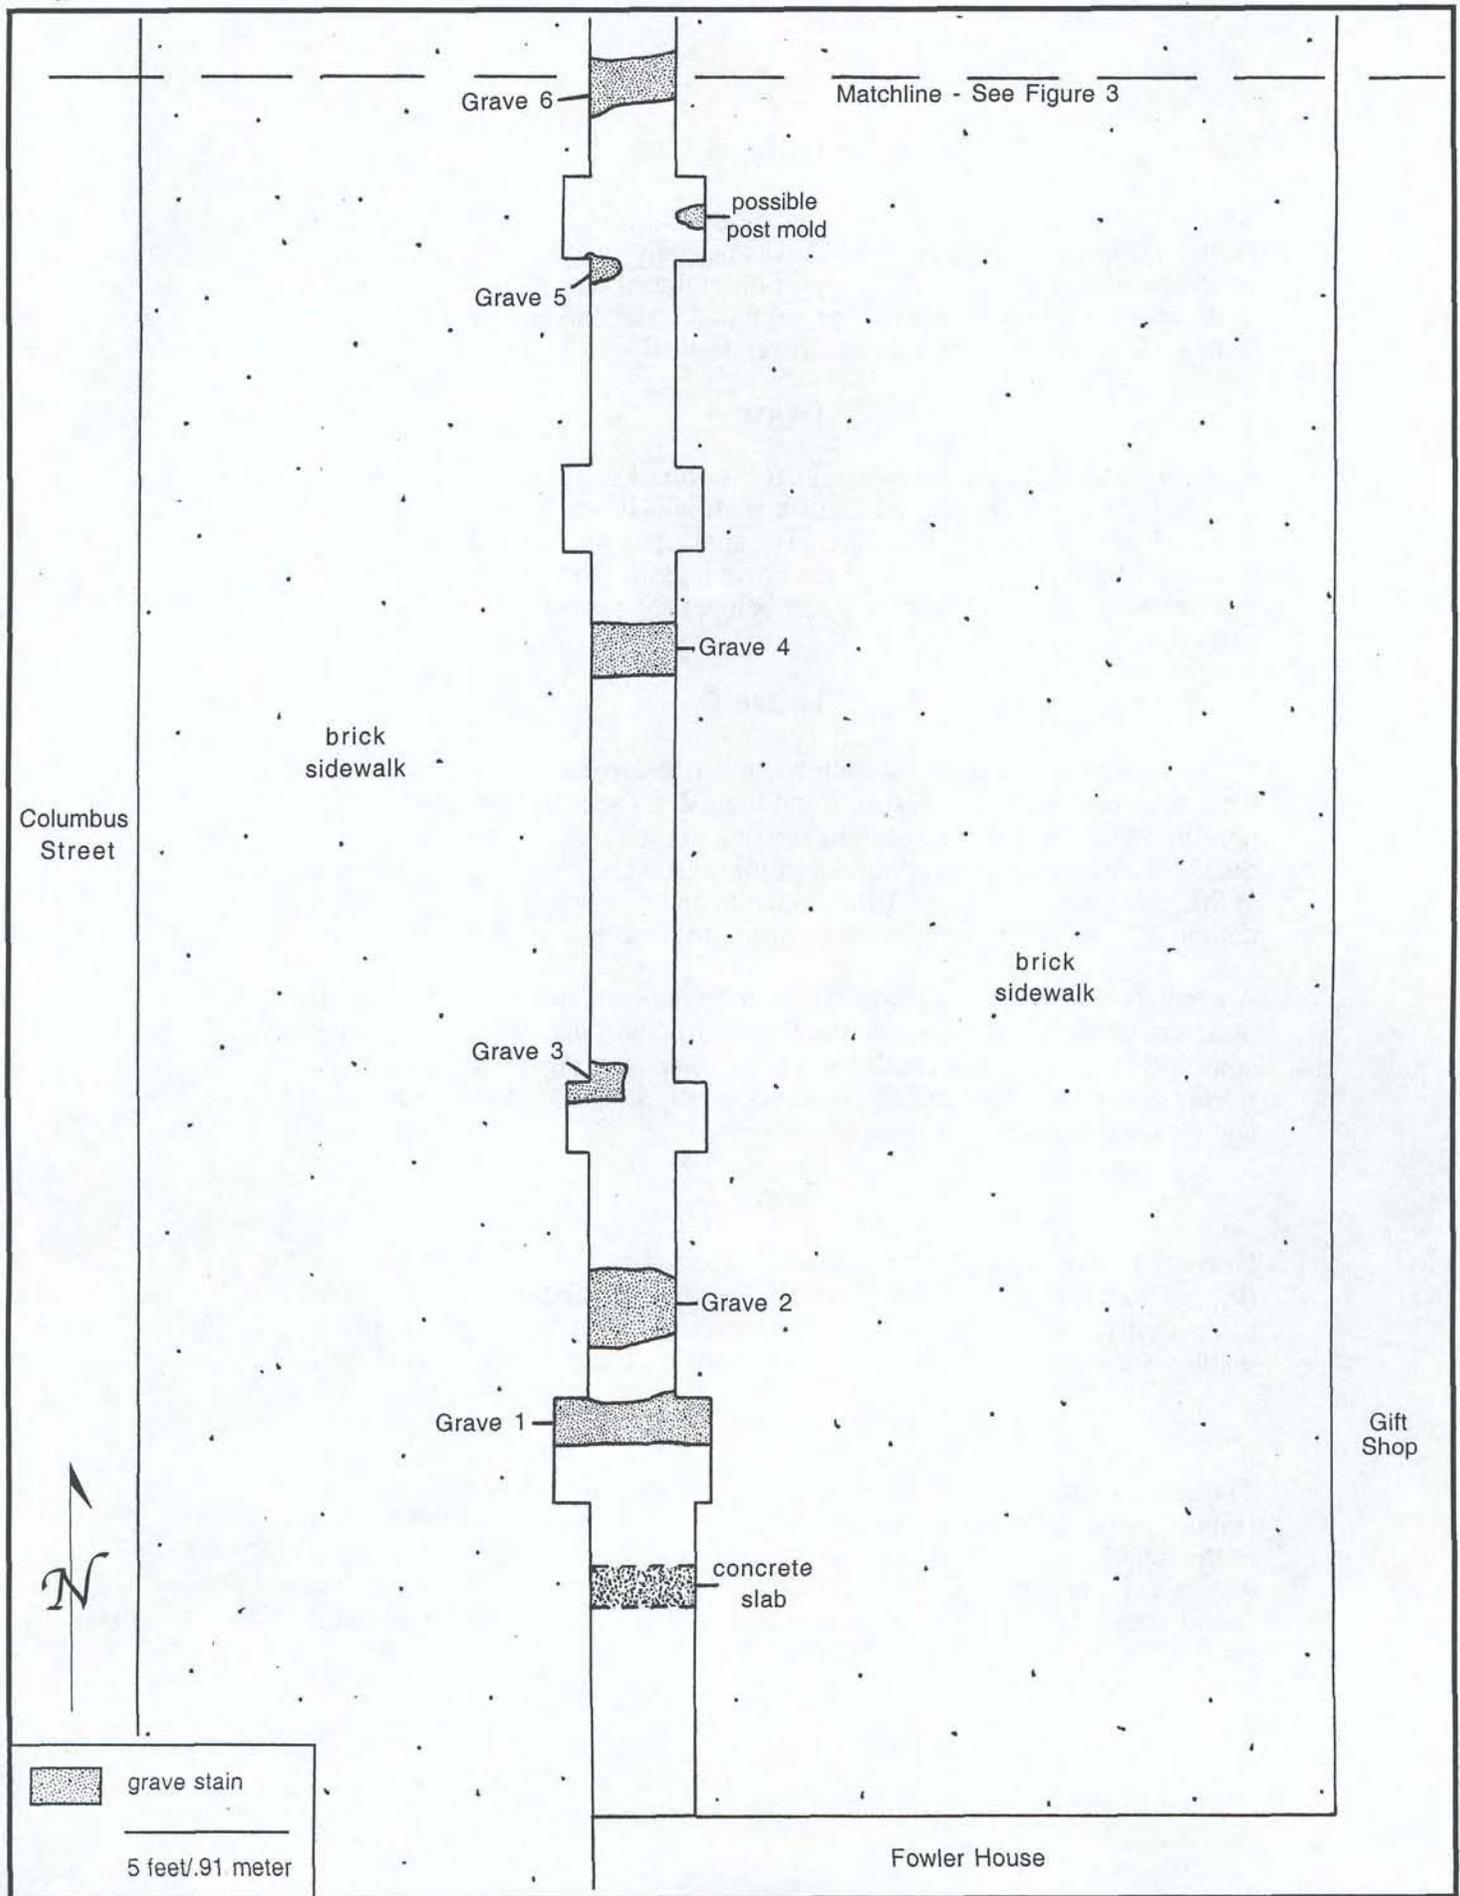
FIGURE 2
Portion of Plan Map Showing Graves 1 - 6

Grave 1 was represented by a grave shaft that appeared at the base of post-interment organic and gravel fill at the first structural pier (Figure 2). It was visible at just under two feet below the present Columbus Street sidewalk or at .65 feet below datum. Only 4.5 feet of the shaft was exposed; this spanned the width of the wall trench. The visible shaft was narrow, measuring about 1.5 to 2 feet in width. The soils within the shaft were similar in color to the adjacent undisturbed soil, but were slightly darker, much less compact and lacked the structure of the sterile soil. The location of the grave shaft on the walls of the trench was marked by gray streaks in the wall profile. The streaks appear to have resulted from water percolating along the grave shaft.

Grave 2, represented by a very faint grave shaft, lay approximately 1.5 feet north of Grave 1 (Figure 2). The shaft was defined at .45 feet below datum and circa 2 feet below the level of the current sidewalk. The shaft was 2.5 feet long, spanning the width of the trench, and 2.0 feet wide. The sides converged slightly towards the east wall. Soils were similar to those seen in Grave 1.

A grave shaft, first discerned at .6 feet below datum, marked the location of Grave 3 (Figure 2). The grave shaft was partially situated within the second structural pier of the wall. Only a portion of the eastern end of the grave shaft, approximately 1.5 feet of the "foot end", extended into the construction trench. The soils were similar to Graves 1 and 2.

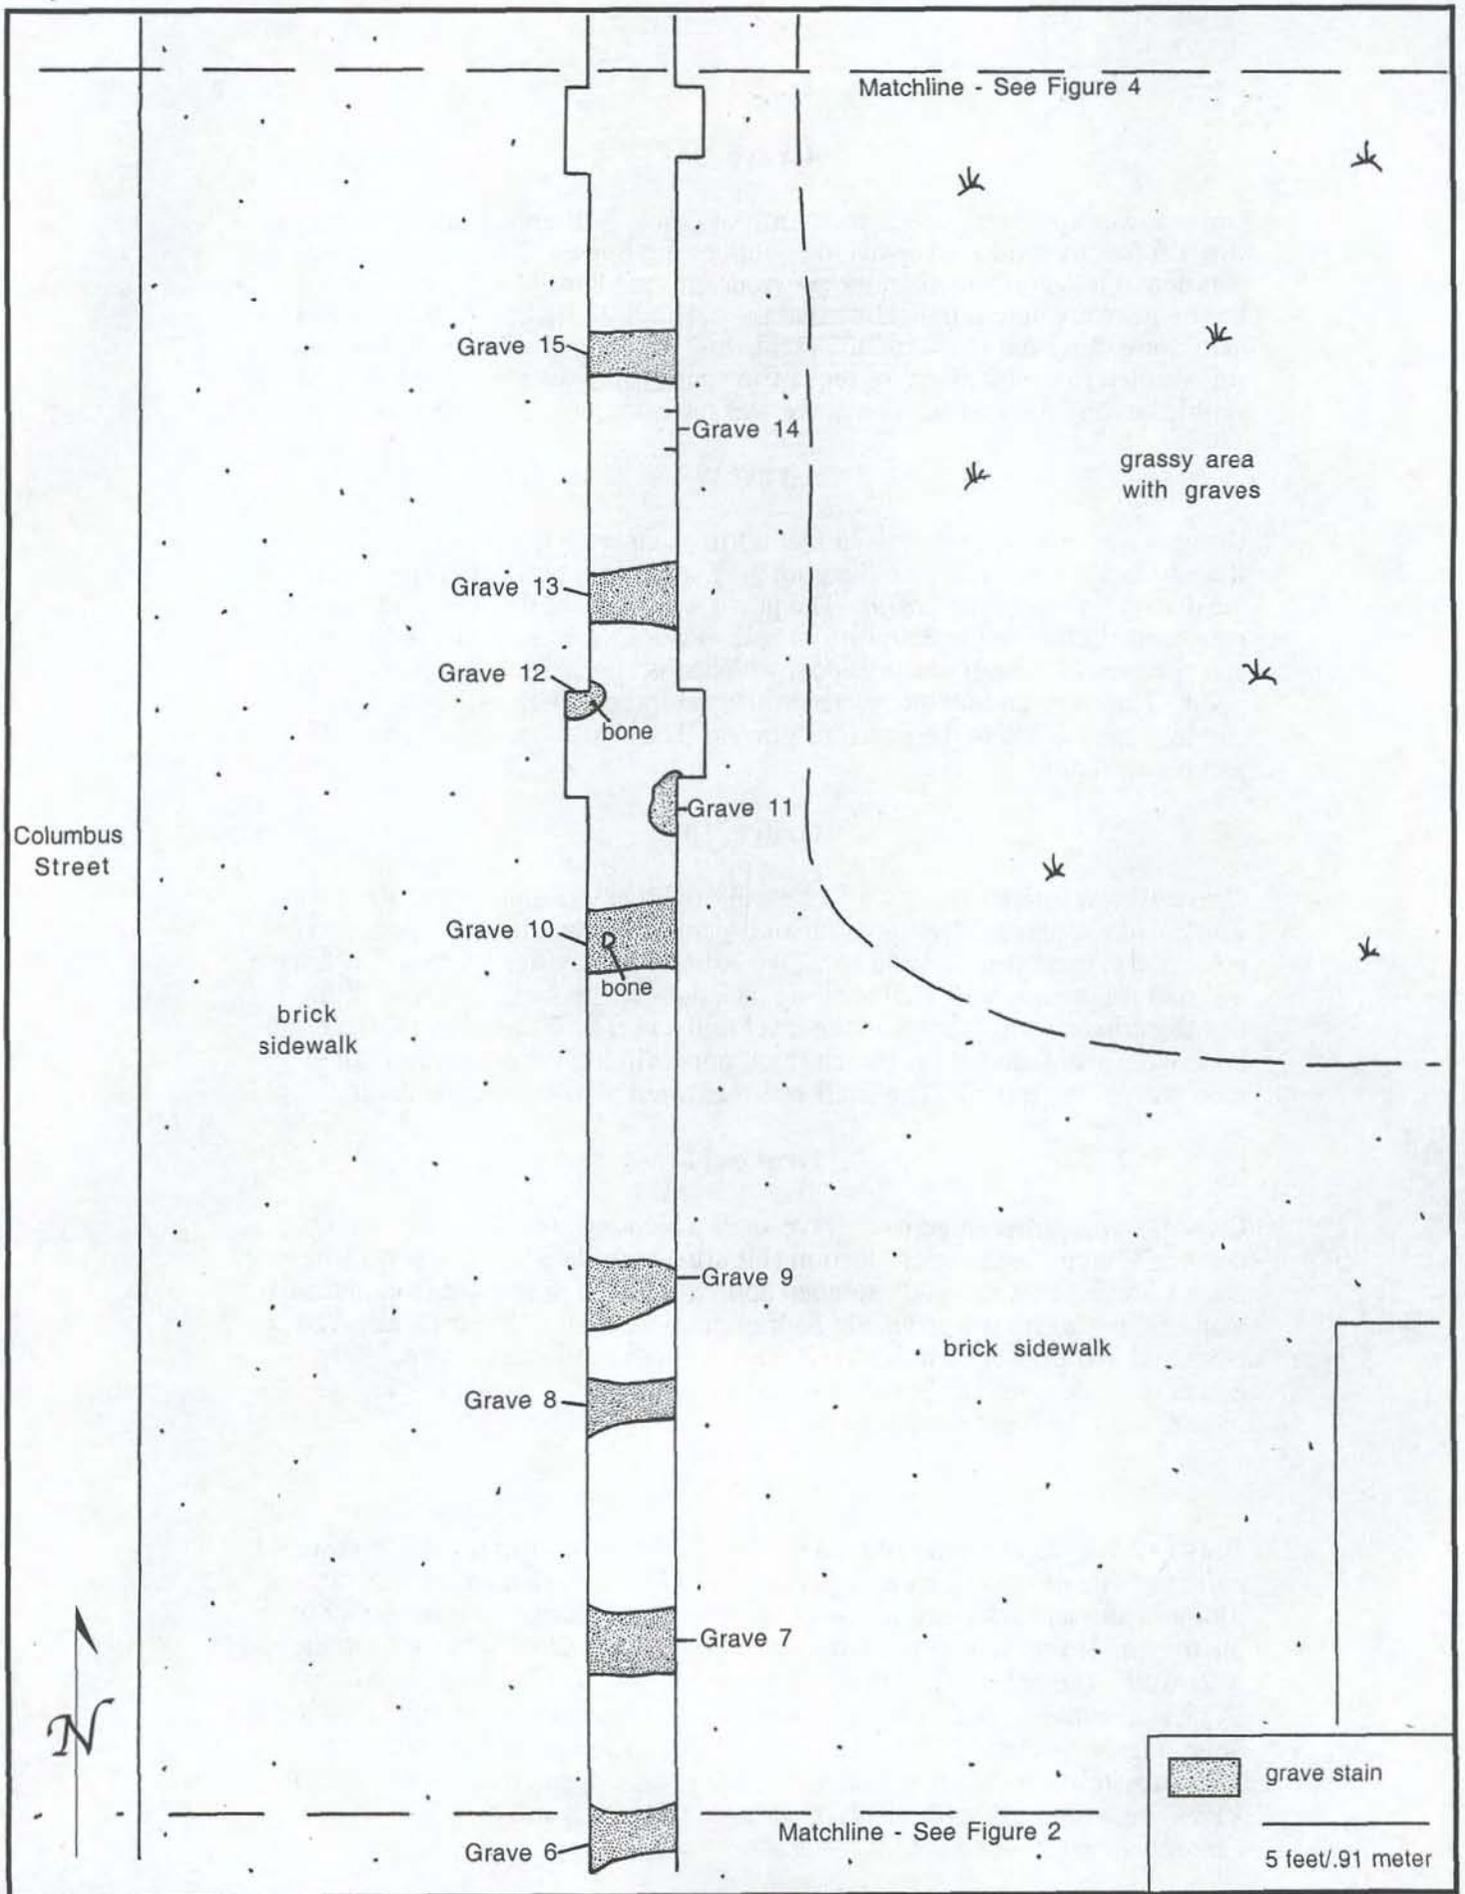
FIGURE 3
Portion of Plan Map Showing Graves 6 - 15

The grave shaft marking Grave 7 was approximately 3.5 feet north of Grave 6 (Figure 3 and Plate 4). It was circa 1.75 feet in width and spanned the width of the trench. The color and texture were similar to Grave 6, being slightly darker and less compact than the previous graves. The shaft was measured at .1 feet above datum. A rectangular stain was noted at the eastern end of the shaft. The cause or origin of the stain is not known.

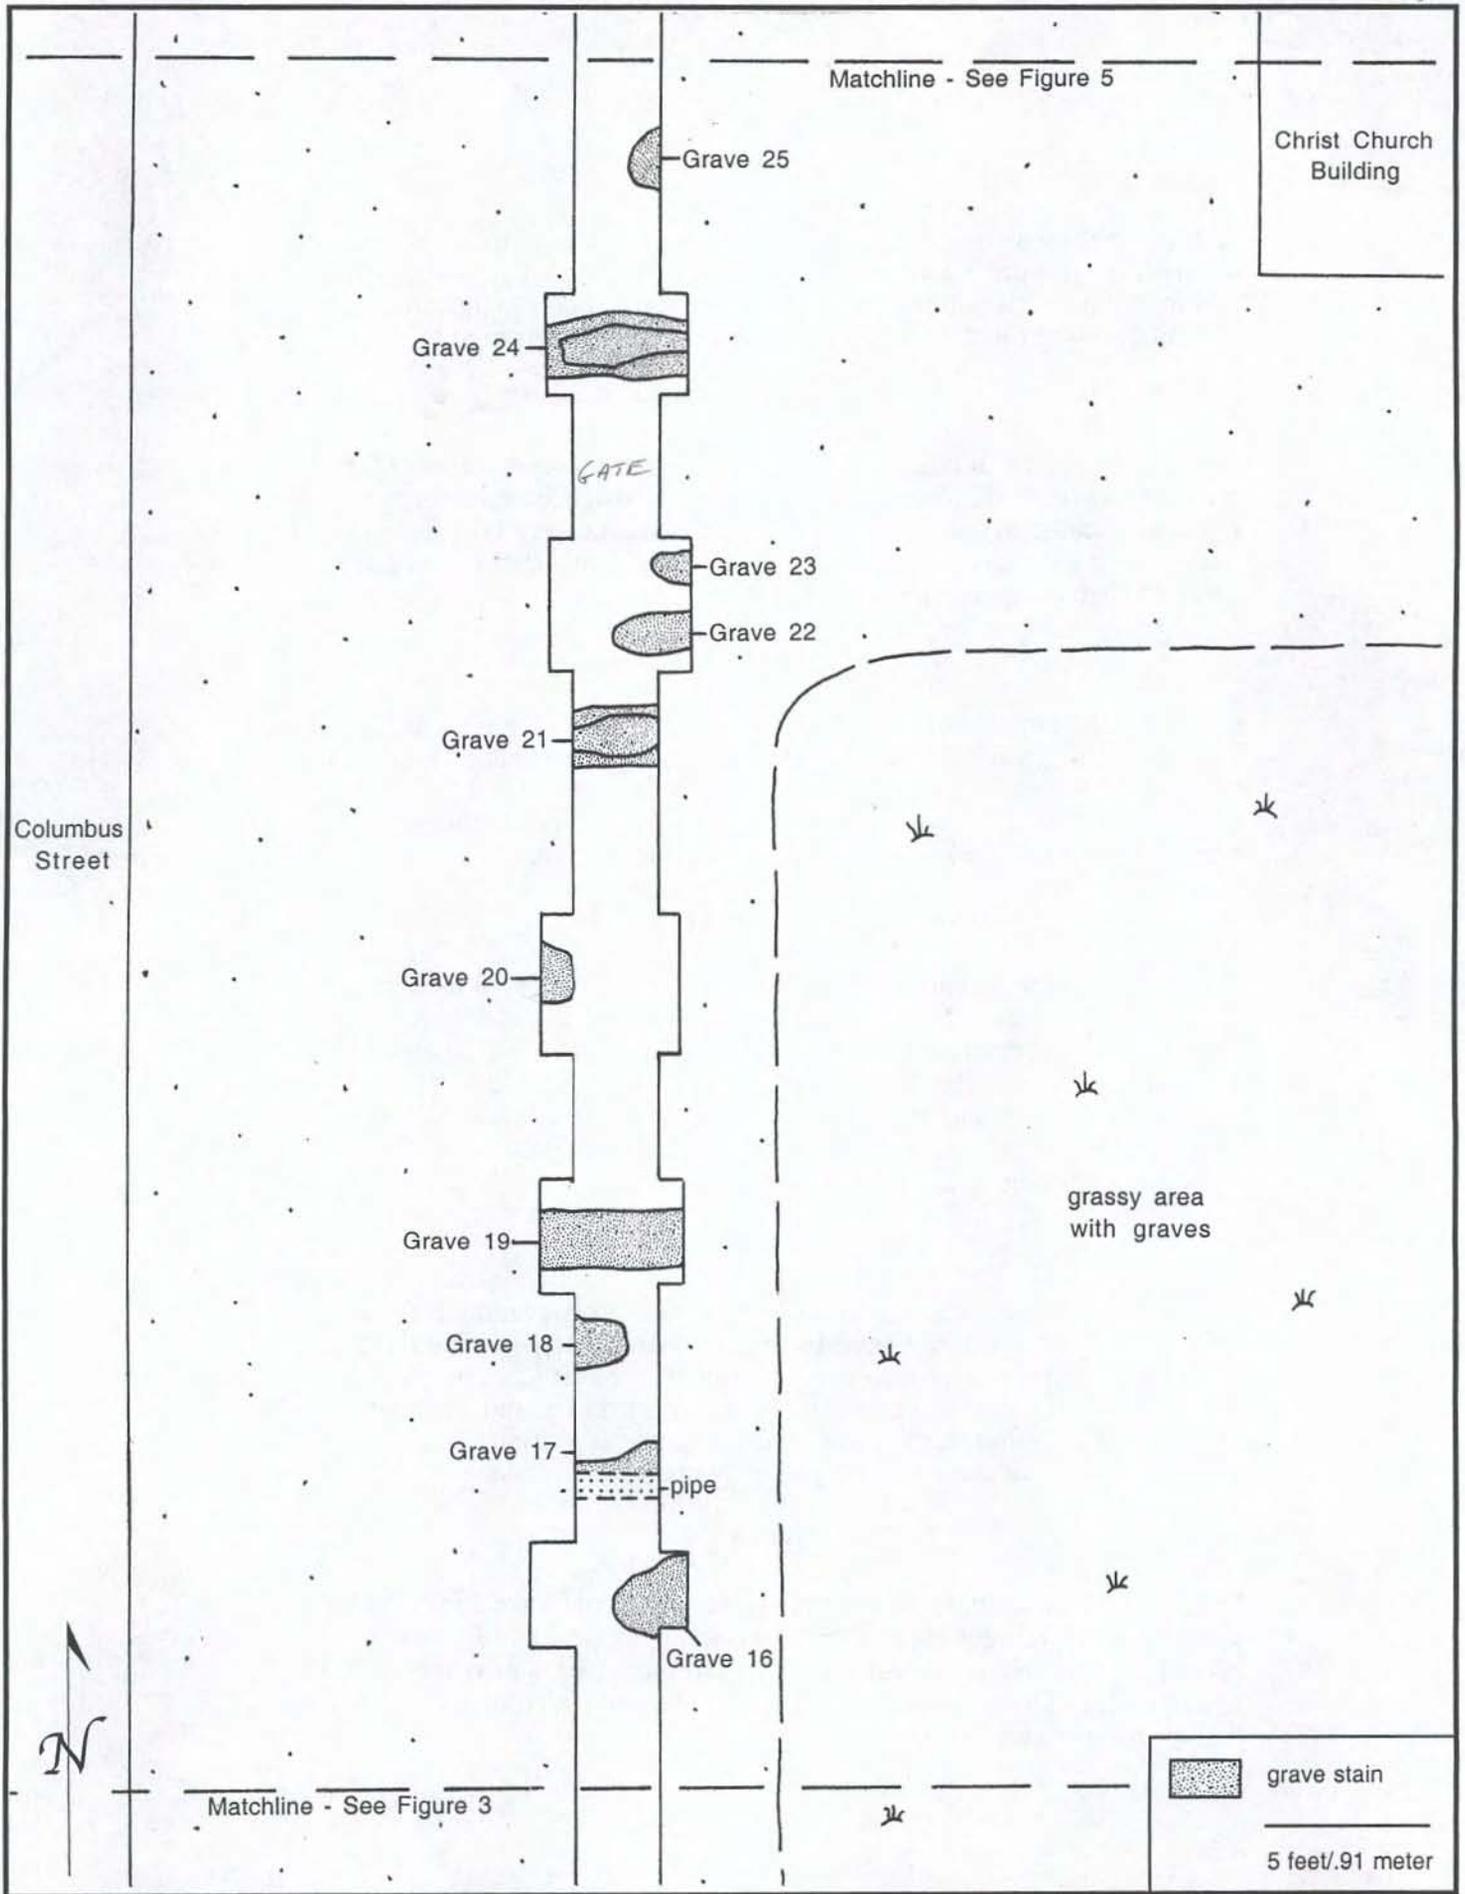
FIGURE 4
 Portion of Plan Map Showing Graves 16 - 25

Grave 19 was marked by a grave shaft which lay in the location of a former structural pier, approximately 1.5 feet north of Grave 18 (Figure 4). The shaft was 2.5 feet long, spanning the width of the trench, and 1.5 feet wide. The shaft was defined at .5 feet above the USGS datum and circa 2.5 feet below the level of the current sidewalk. The soils were like that of the surrounding subsoil in color, with the softer texture being the discerning characteristic.

This grave shaft was approximately 6 feet north of Grave 19 (Figure 4). Grave 20 was circa 1.75 feet in width and extended approximately 1 foot out from the west wall of the trench and under a former structural pier. It was visible both in the floor and in the west wall. The color and texture were darker and softer than the surrounding sterile subsoil and were delineated by grayish water leached soils indicating the grave shaft limits. The shaft was identified at .15 feet above datum

Only a portion of Grave 25 was noted, extending out from the eastern wall of the trench approximately 3.5 feet north of Grave 24 (Figure 4). This grave shaft was 1 foot long and 1.5 to 2 feet wide and the shaft was primarily visible in the floor of the trench. The shaft was defined at .15 feet below the USGS datum and circa 2 feet below the level of the current sidewalk. The soil here was much like that of the surrounding subsoil in color with the softer texture and water leached shaft edges being the discerning characteristics.

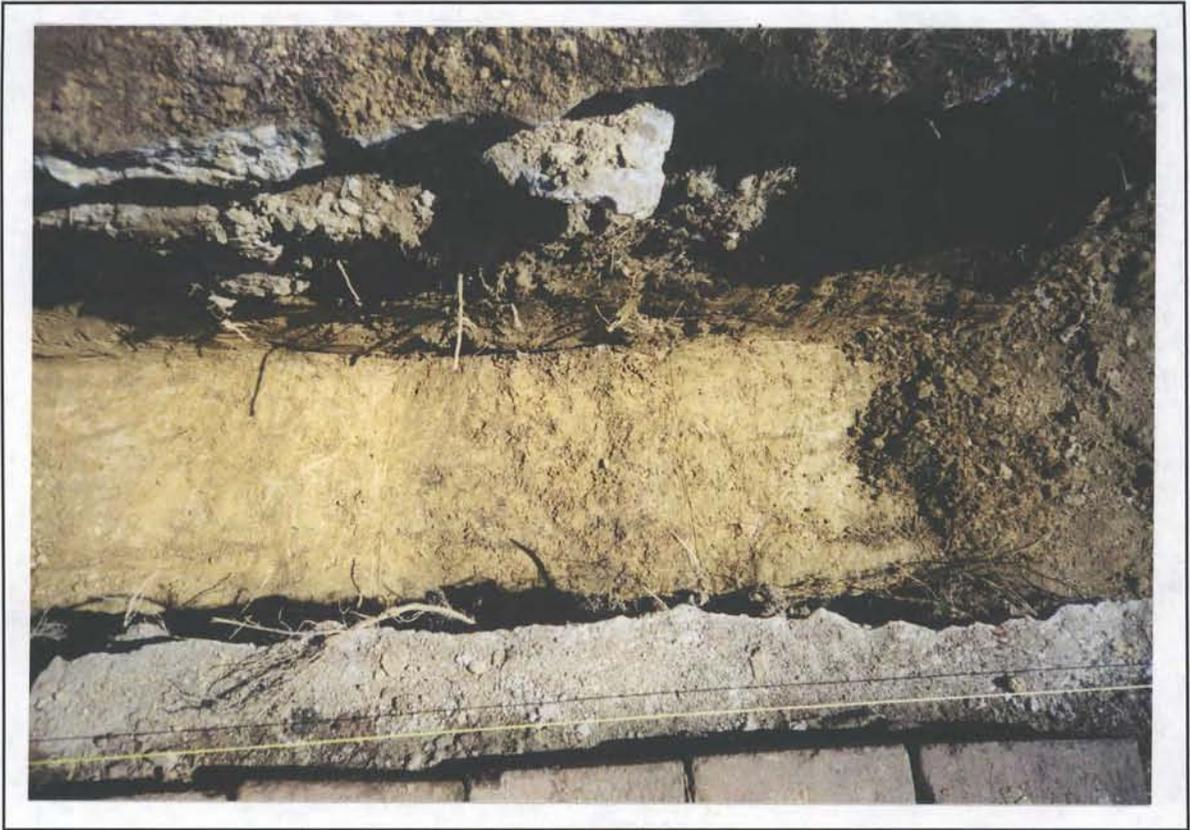
PLATE 1
View of Grave 4

Grave 4 was noted approximately 11 feet north of Grave 3 (Figure 2 and Plate 1). This grave was marked by a grave shaft which was similar to the previous three in color and texture. The shaft spanned the width of the trench, exposing circa 2.5 feet of the grave length. The shaft lay at a depth of .15 feet below datum and about 2 feet below the Cameron Street sidewalk surface.

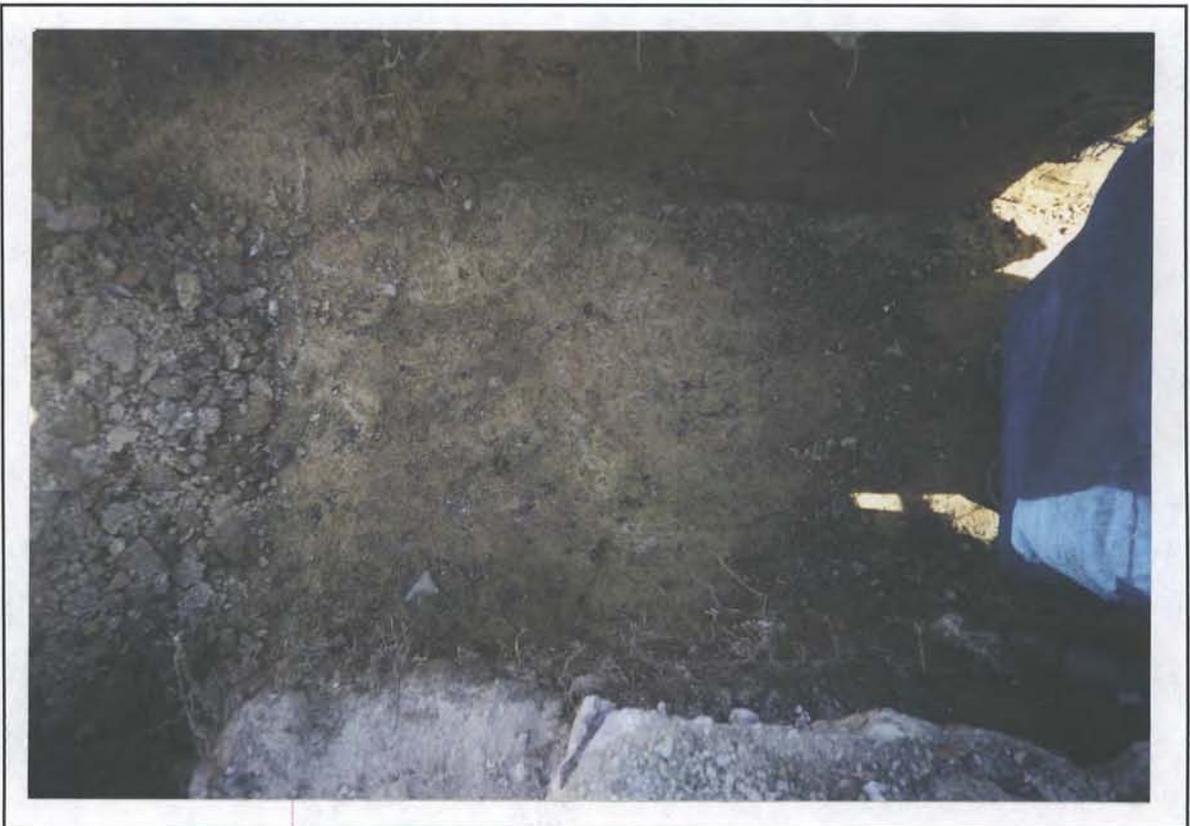
PLATE 2
View of Grave 5

Grave 5 was represented by a stain when was present at the southern edge of the fourth structural pier (Figure 2 and Plate 2). The stain marking Grave 5 appeared to be the extreme eastern end of a grave shaft. Only about 1 foot of the shaft was visible, extending out of the west wall of the trench. The shaft at this point was only about 1 foot in width and was noted at .15 feet below datum. The color and texture were similar to the previous graves.

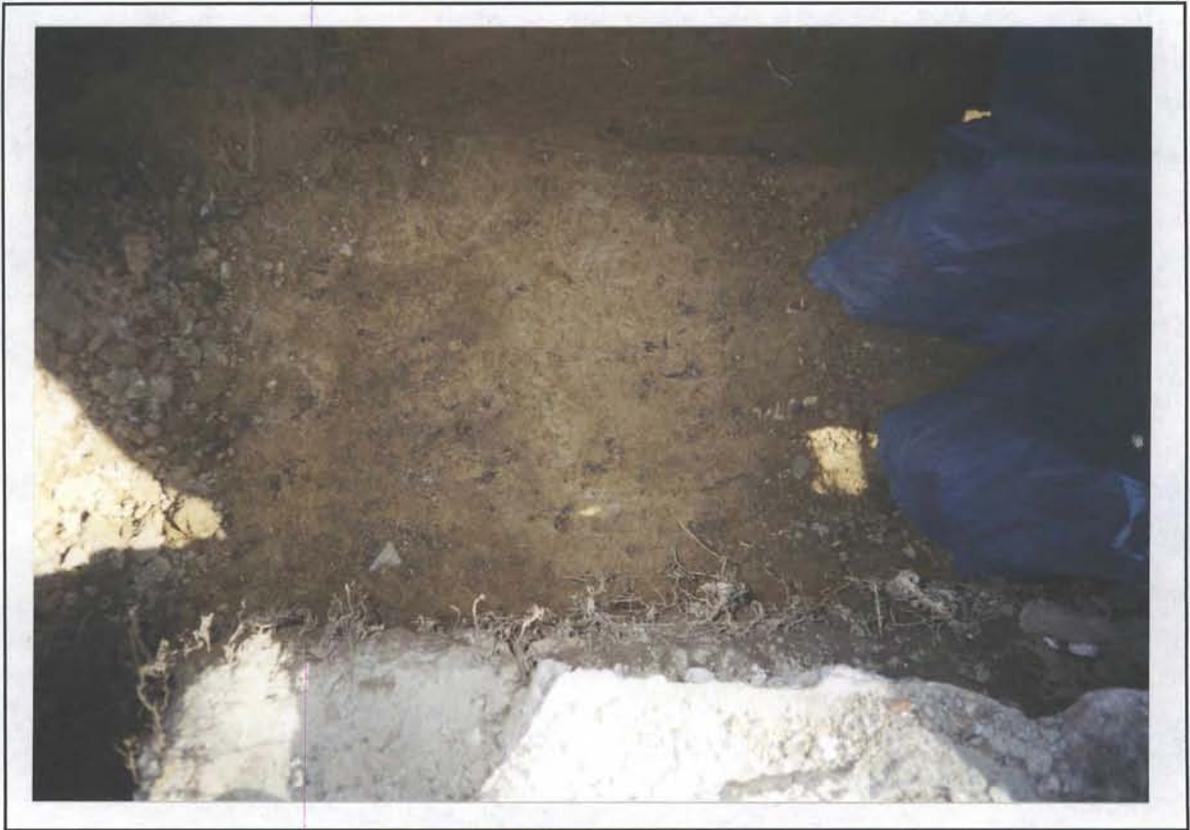
PLATE 3
View of Grave 6

Grave 6, represented by a shaft, was approximately 4.5 feet north of Grave 5 (Figure 2 and Plate 3). It was circa 1.5 feet in width and spanned the width of the trench. The color was slightly darker than the previous graves and texture was softer and less compact. The shaft lay at .65 feet below datum.

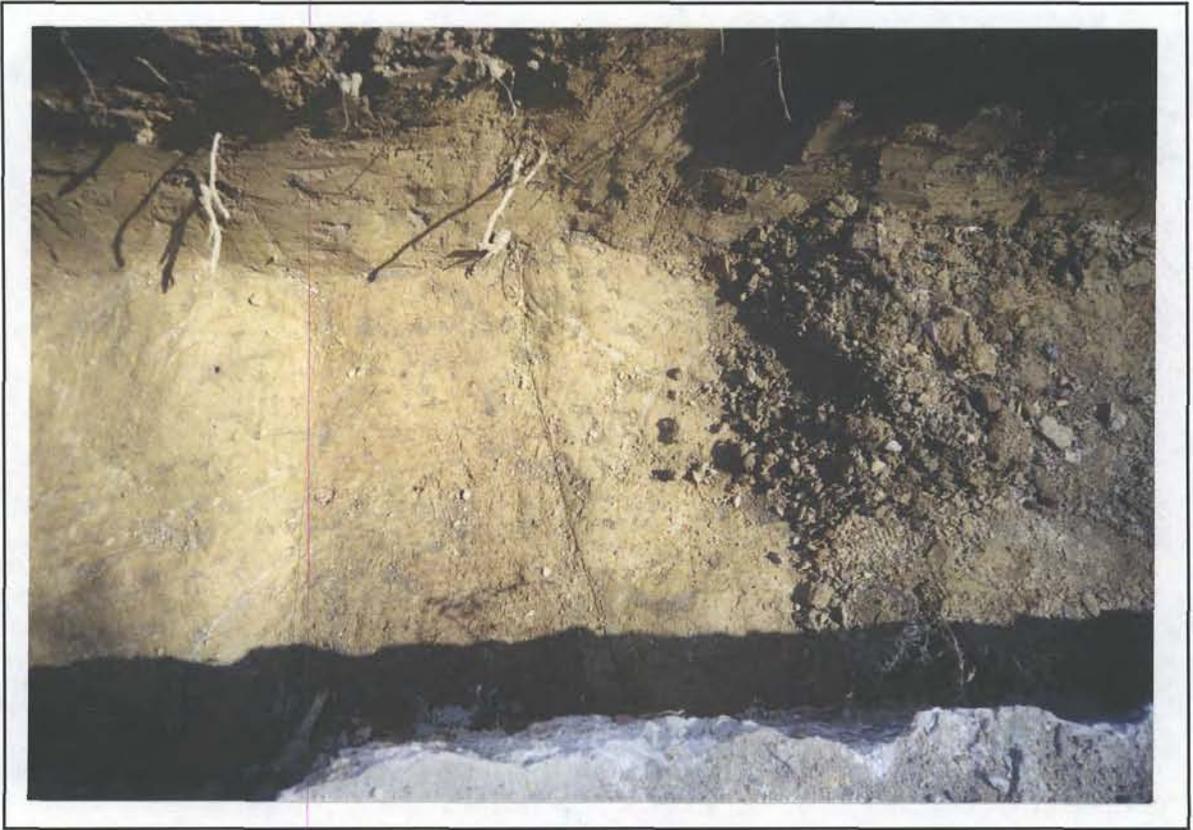
PLATE 5
View of Grave 8

Grave 8 was approximately 5 feet north of Grave 7 (Figure 3 and Plate 5). It was 1.5 feet in width and spans the width of the trench. The soil was much darker and less compact than the previous graves. Rusted nails and nail fragments were noted, indicating that the coffin itself had been disturbed. The nails were observed at less than 2 feet below the current sidewalk. The dark soil seemed to be the extent of the coffin stain, while the grave shaft was not visible beyond the coffin. The grave was measured at .15 feet below datum.

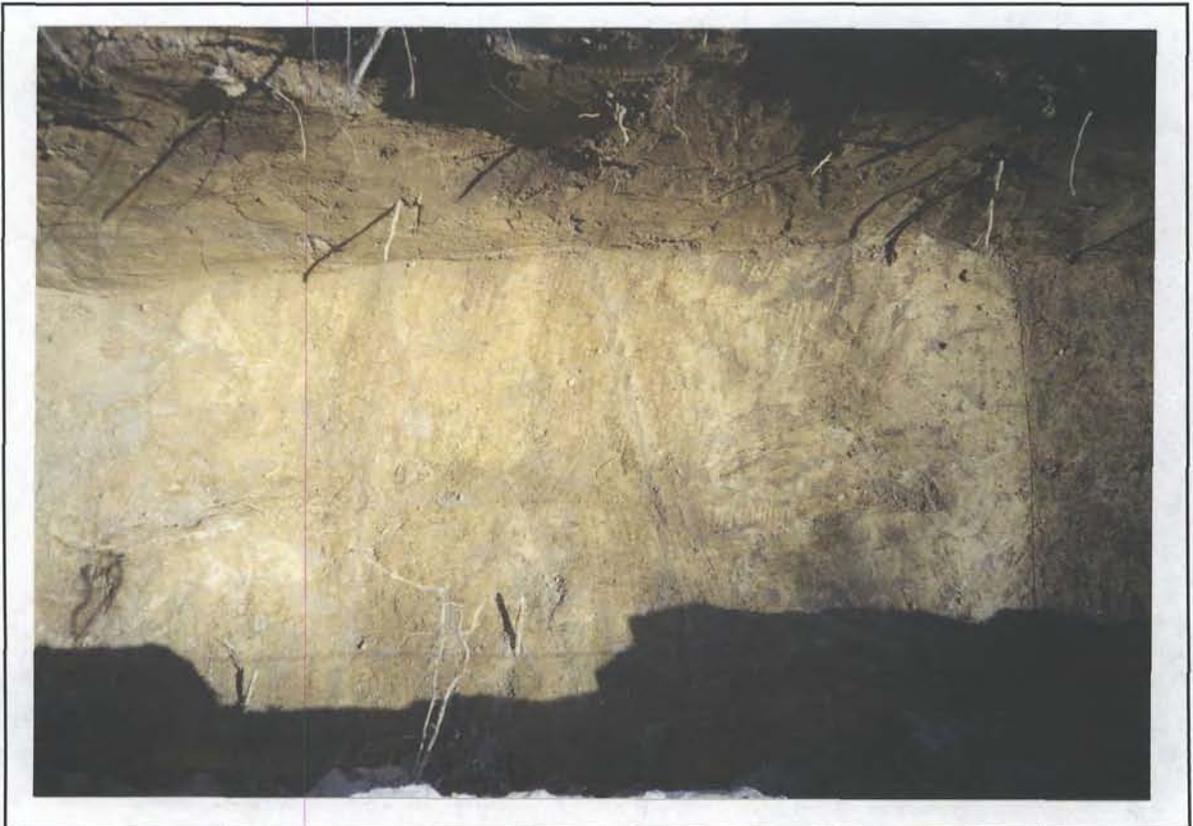
PLATE 6
View of Grave 9

Grave 9 was approximately 1.75 feet north of Grave 8 (Figure 3 and Plate 6). It was represented by two converging gray stains that probably represented the decayed sides of the coffin. The grave was wider at the west end and narrowed slightly to the east, or foot end. The grave was circa 2 feet in width and spanned the width of the trench, which was approximately 2.5 feet at this point. The color and texture were similar to Grave 6, being slightly darker and less compact than the previous graves. The shaft was measured at .35 feet below datum.

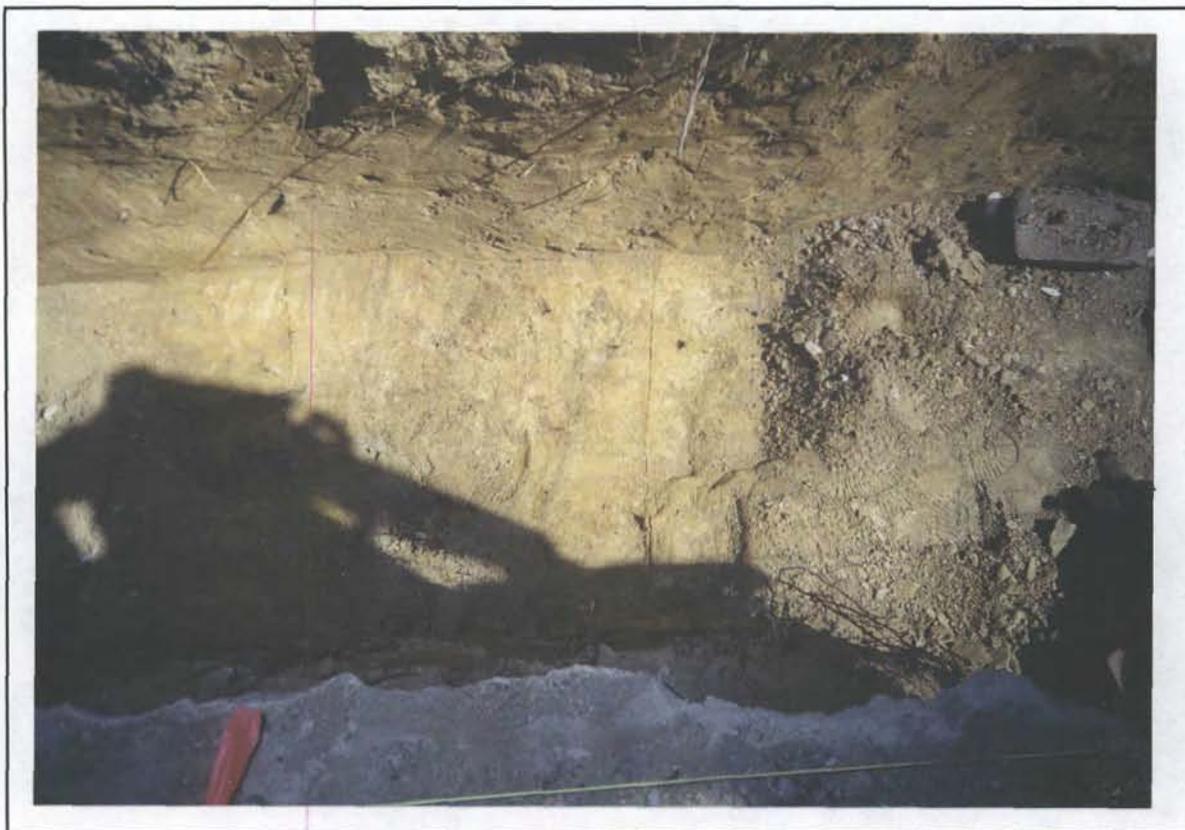
PLATE 7
View of Grave 10

Grave 10 was approximately 8 feet north of Grave 9 (Figure 3 and Plate 7). The grave was circa 2 feet in width and spanned the width of the trench. The color and texture were similar to Grave 8, being darker and quite soft. Nails and nail fragments were visible along the edges of the dark stain, indicating that disturbance was present to the level of the coffin. Several small flakes of bone were also noted in the trench floor, approximately 6 inches from the west wall of the trench. The shaft was measured at .6 feet below datum.

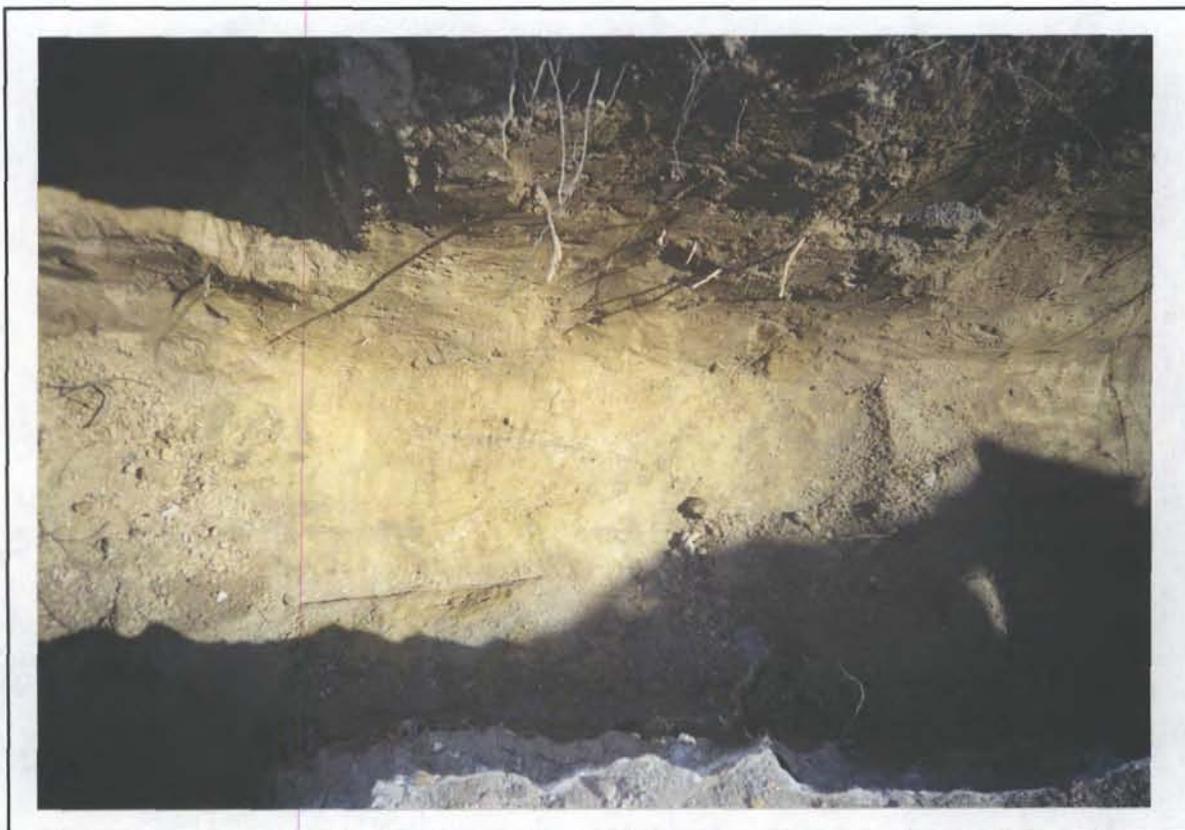
PLATE 8
View of Grave 11

Grave 11 was represented by a grave shaft which lay approximately 2 feet north of Grave 10, in a pier location (Figure 3 and Plate 8). The shaft was circa 1.75 feet in width and extended approximately .75 feet out from the east wall of the trench. It was visible both in the floor and in the east wall. The color and texture were similar to Grave 1, with the soils that were slightly darker and less compact than the surrounding subsoil. The shaft was measured at .55 feet below datum.

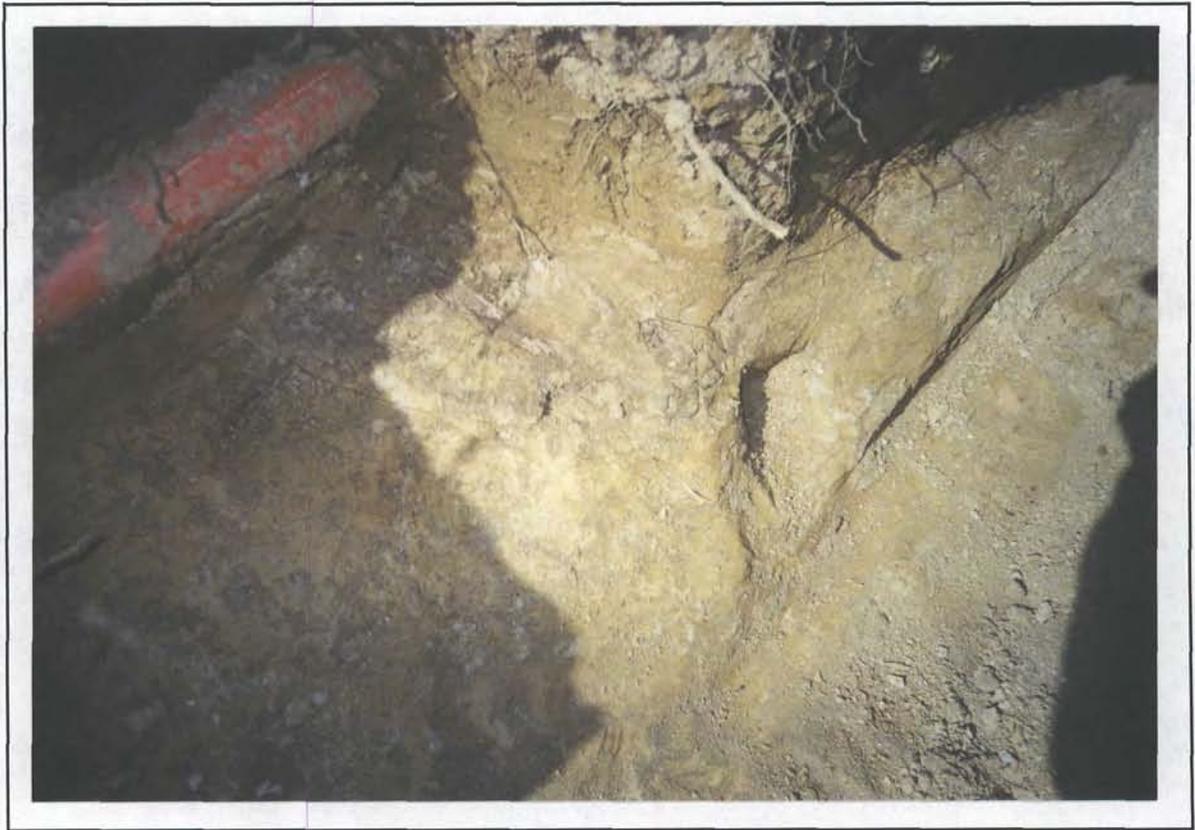
PLATE 9
View of Grave 12

Grave 12 was approximately 1.75 feet north of Grave 11 in the northwest corner of one of the brick piers (Figure 3 and Plate 9). The grave was circa 1 foot in width and extended approximately .75 feet out from the west wall of the trench. It was visible primarily in the floor but could also be seen in the west wall. The color and texture were similar to Grave 8, being dark brown and less compact. The shaft was measured at .5 feet below datum. Two long bone fragments were visible in the grave shaft. The bone fragments were approximately 3 to 5 inches in length. The grave appeared to be disturbed by a PVC pipe running north-south adjacent to the trench and below the North Columbus Street sidewalk.

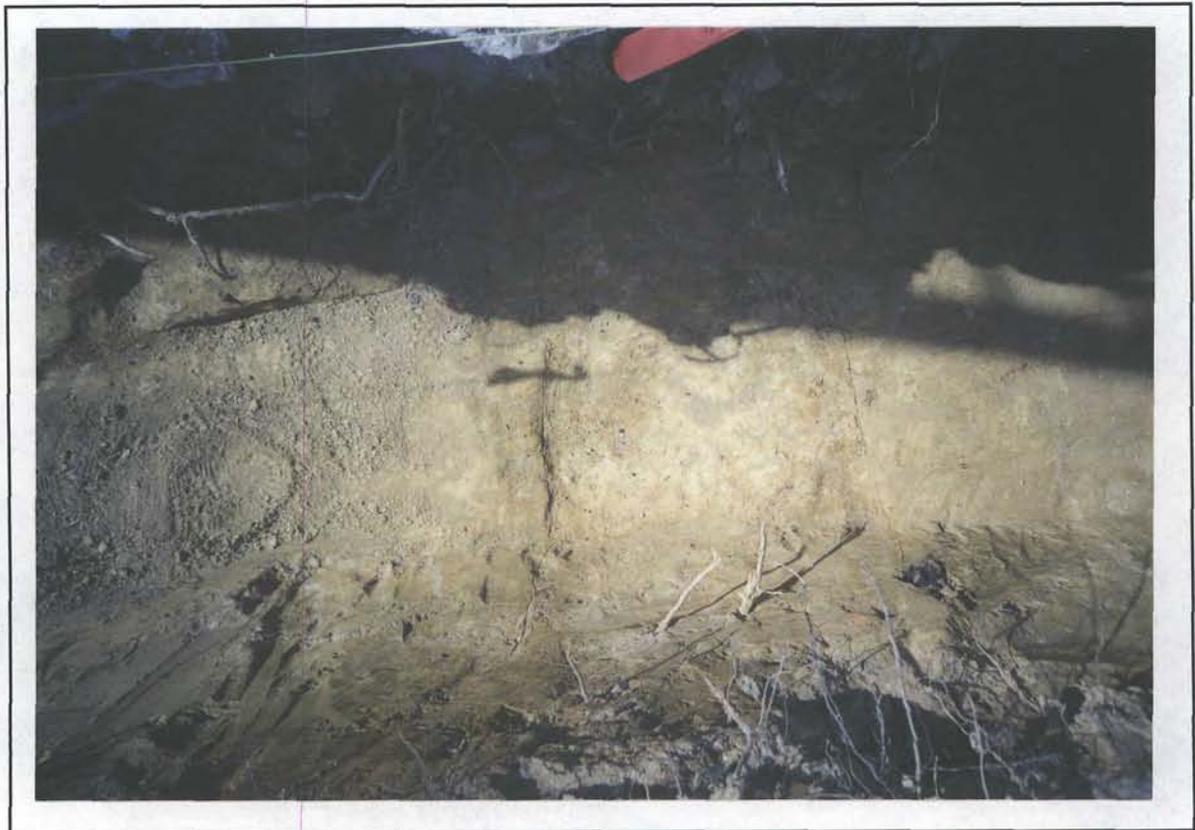
PLATE 10
View of Grave 13

A grave shaft, which appeared at .65 feet below datum, marked the location of Grave 13 (Figure 3 and Plate 10). The shaft measured approximately 1.5 feet in width. Soils within the shaft were similar in color to the adjacent subsoil but were much less compact and lacked the structure of the sterile soil.

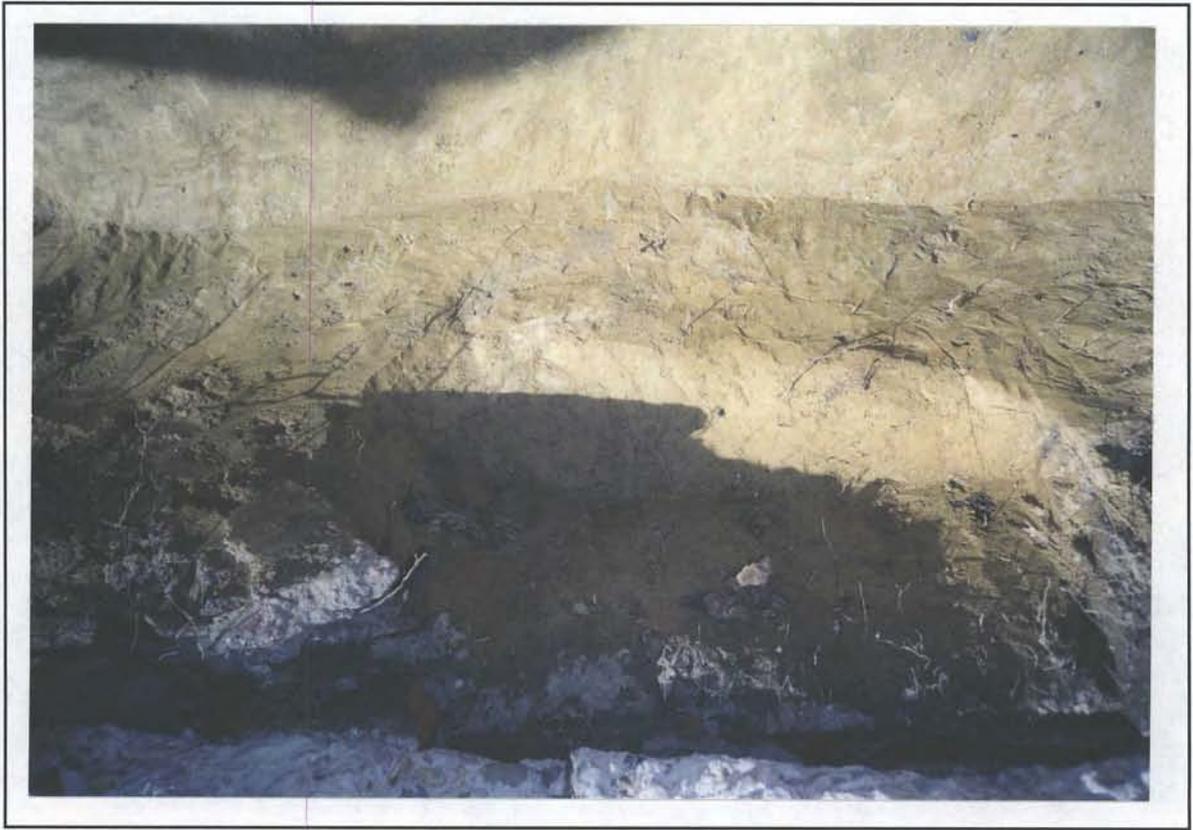
PLATE 11
View of Grave 14

Grave 14 appeared in the east trench wall at .55 feet above datum, 2.5 feet north of Grave 13 (Figure 3 and Plate 11). The shaft denoting this grave was not visible in the trench floor. It measured approximately 1.75 feet in width. Soils within the shaft were brown in color, and slightly darker and much less compact than the adjacent undisturbed soil.

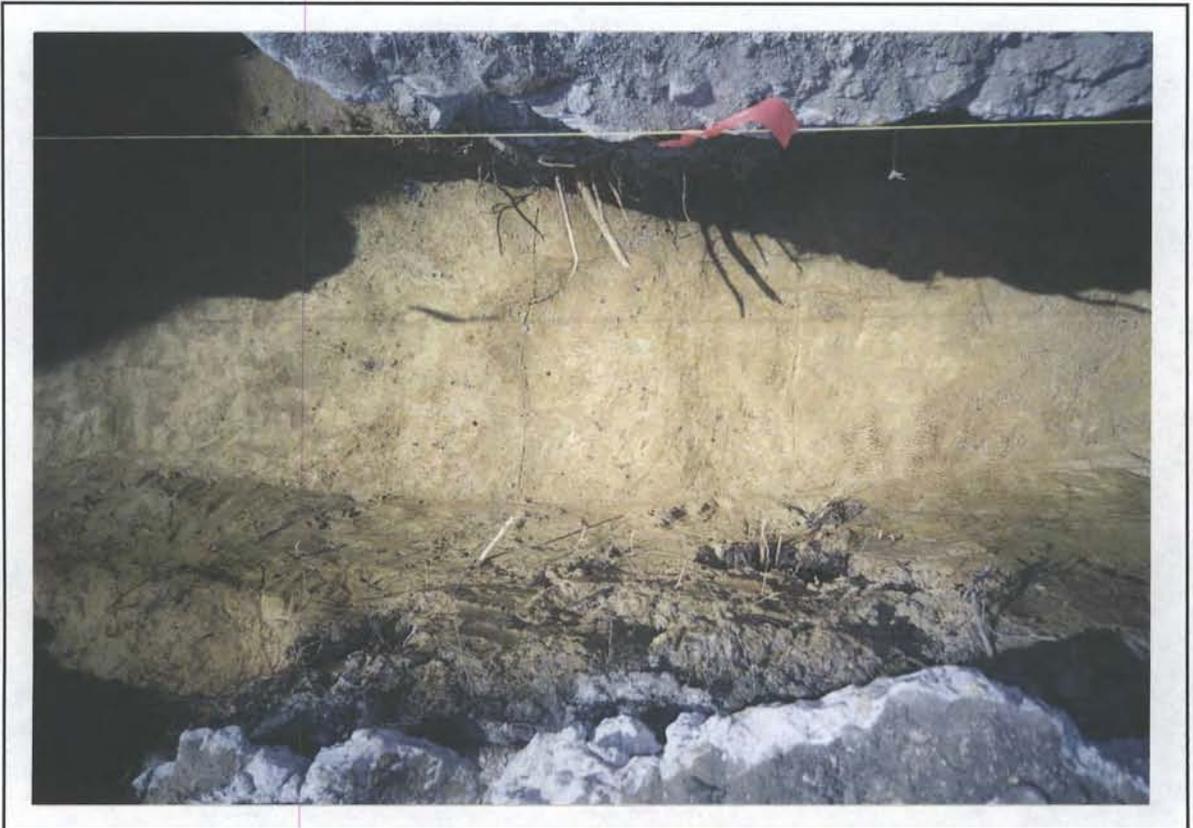
PLATE 12
View of Grave 15

Grave 15 was approximately 1 foot north of Grave 14 (Figure 3 and Plate 12). The grave shaft was 2.5 feet long and 1.5 feet wide and spanned the width of the trench. It was defined at .45 feet below datum and circa 2.5 feet below the level of the current sidewalk. The soils were similar to those in Grave 1, being only slightly darker than the subsoil around the shaft.

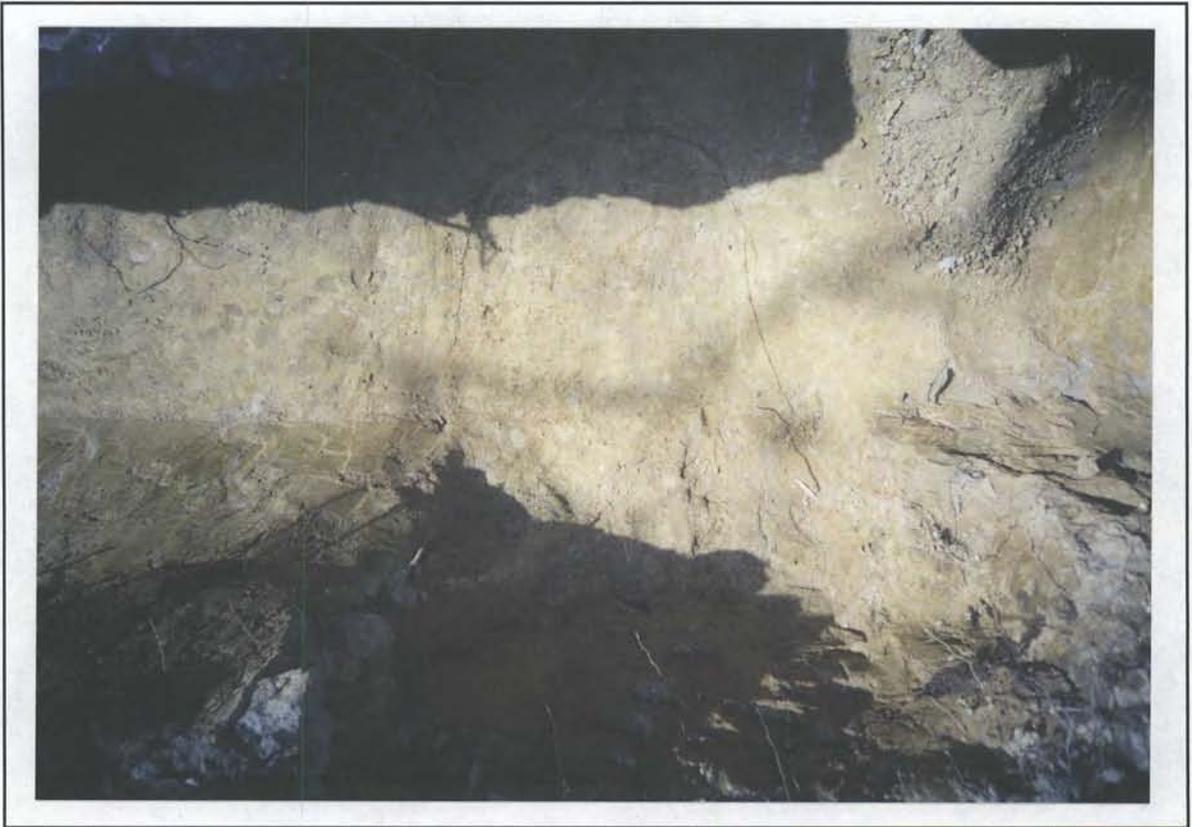
PLATE 13
View of Grave 16

This grave was approximately 11.5 feet north of Grave 15, in the location of a former structural pier (Figure 4 and Plate 13). The grave shaft was circa 2 feet in width and extended approximately 1.75 feet out from the east wall of the trench. It was visible both in the floor and in the east wall. The color and texture were darker and softer than the surrounding sterile subsoil and were delineated by grayish water leached soil indicating the grave shaft limits. The shaft was identified at 2.5 feet above datum.
