ARCHEOLOGICAL MONITORING OF A WALL REPLACEMENT ALONG NORTH COLUMBUS STREET, CHRIST CHURCH, ALEXANDRIA, VIRGINIA

By Michael Clem

March 2002

Prepared By:
Thunderbird Archeological Associates, Inc.
126 East High Street
Woodstock, Virginia 22664

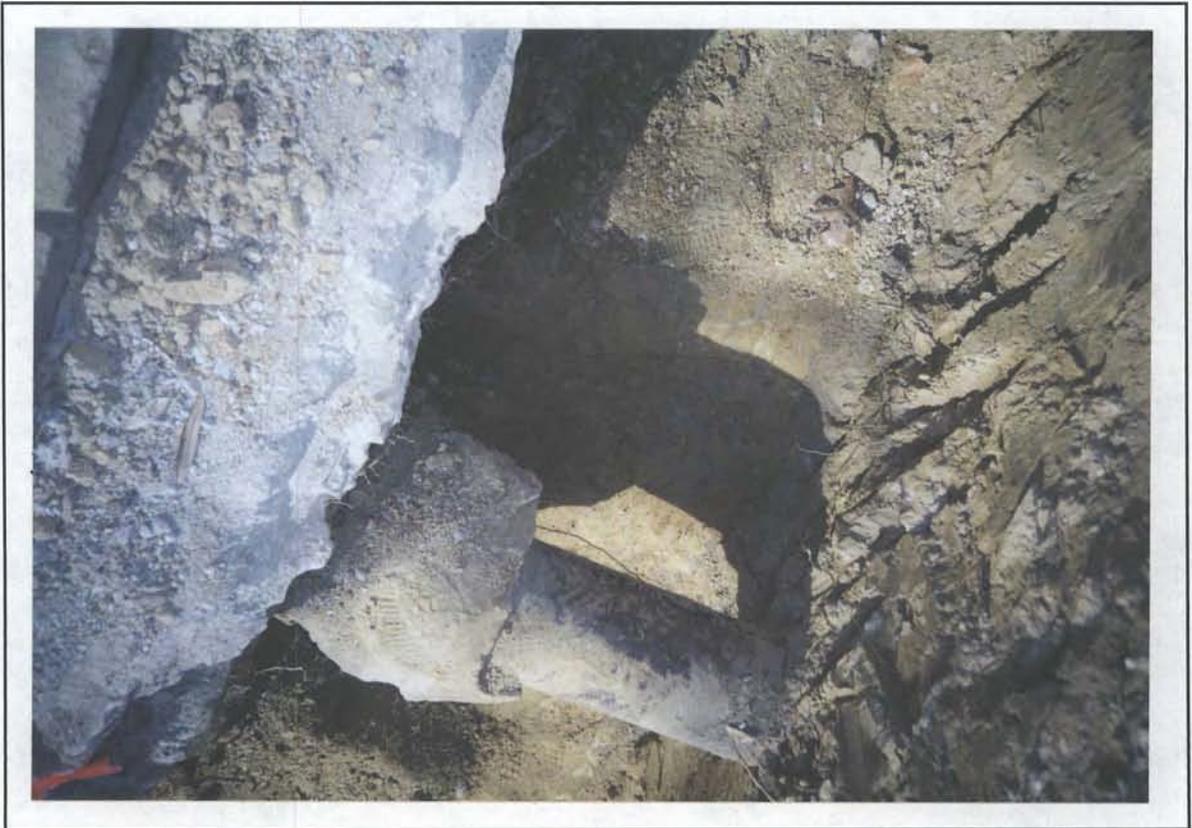
PLATE 14
View of Grave 17

Grave 17 appeared in the east trench wall at the same elevation as the site datum and 2 feet north of Grave 16 (Figure 4 and Plate 14). The shaft was irregular in shape and measured approximately 1.5 feet in width. The soils within the shaft were brown in color, and slightly darker and less compact than the adjacent undisturbed soil. The grave was identified slightly to the north of a pipe that ran east-west perpendicular to the trench.

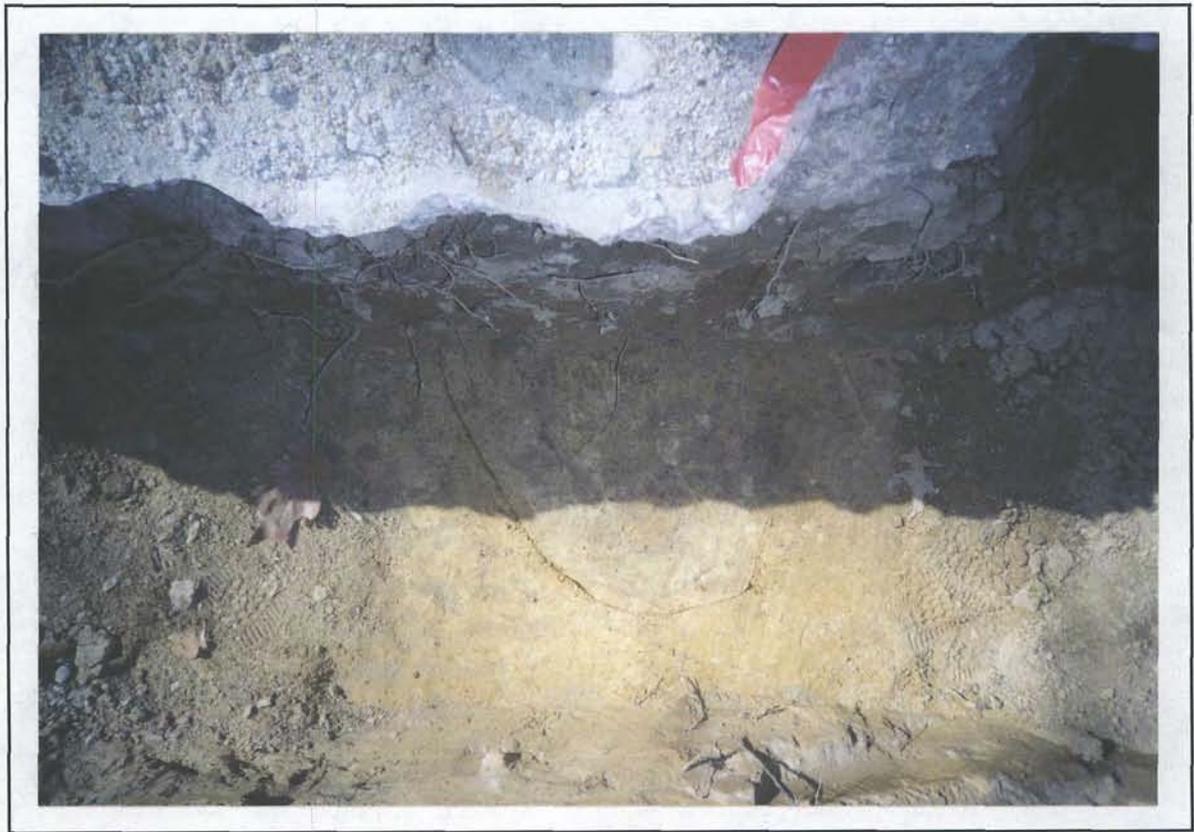
PLATE 15
View of Grave 18

Grave 18 appeared in the trench floor, 2 feet north of Grave 17, extending approximately 1.5 feet out from the west wall (Figure 4 and Plate 15). The grave lay at .15 feet above datum. The shaft measured approximately 1.75 feet in width. The soils within the shaft were brown in color and slightly darker than the surrounding subsoil.

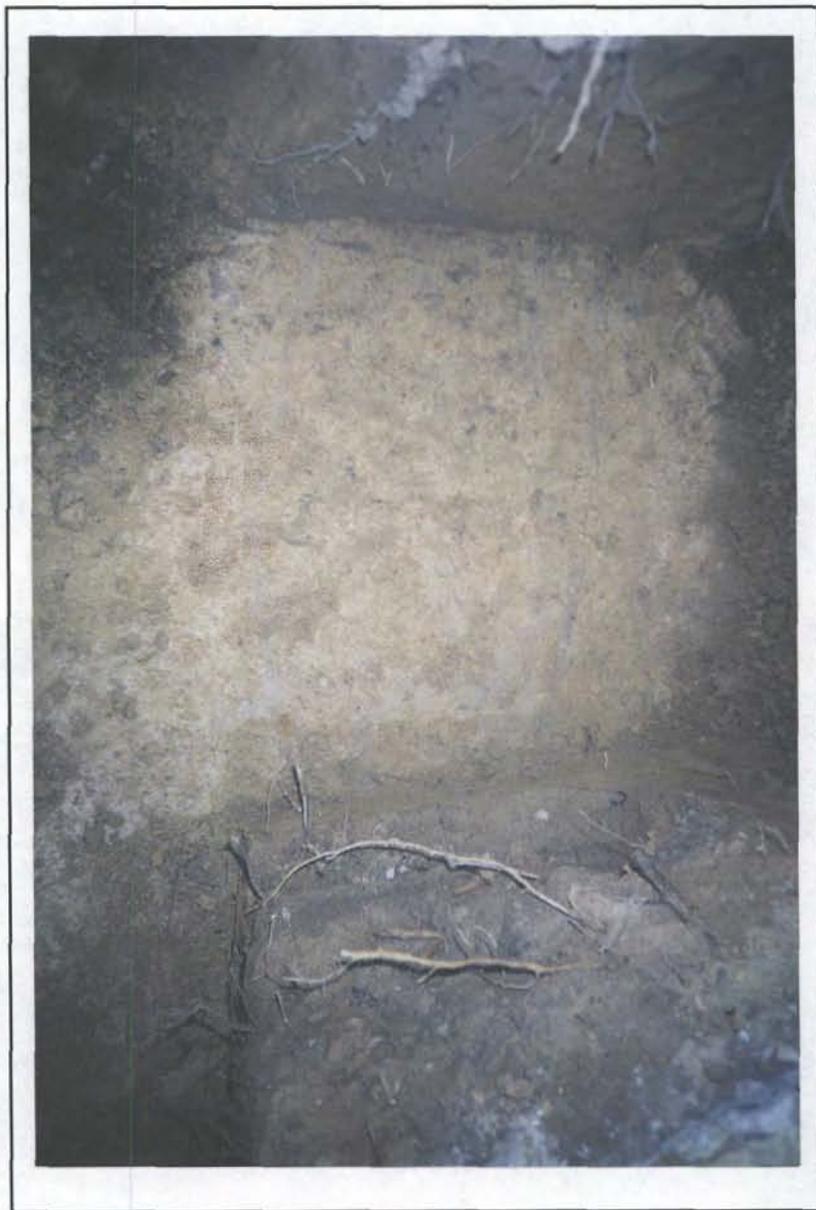
PLATE 16
View of Grave 21

Grave 21 spanned the length of the trench floor, 6 feet north of Grave 20 (Figure 4 and Plate 16). The grave was identified at .25 feet below datum. The edges of an hexagonal coffin were easily discernable as grayish stains that converged at the east and west ends. The coffin stain measured approximately 1.5 feet in width. Nails were present along the coffin edges and within the grave matrix. The grave shaft was brown in color and softer in texture than the subsoil.

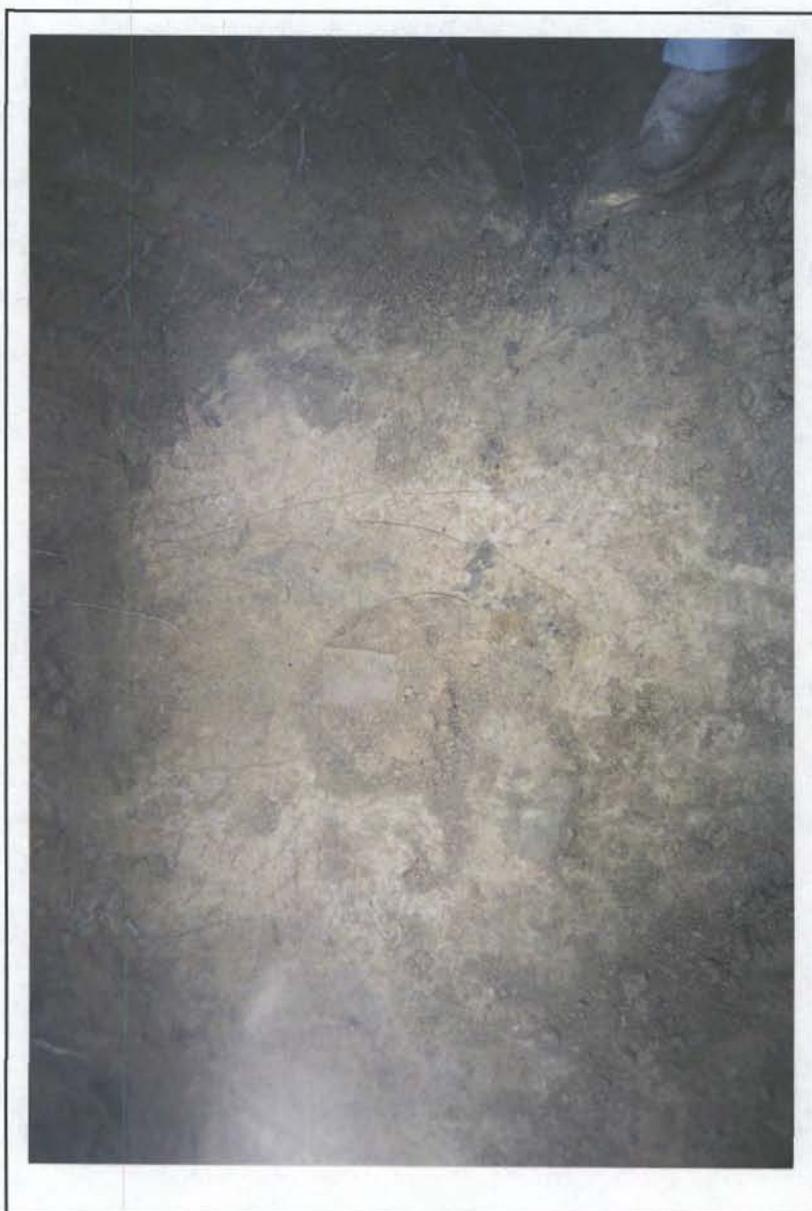
PLATE 17
View of Grave 22

Grave 22 extended approximately 2 feet in the trench floor from the east wall (Figure 4 and Plate 17). It was 1.5 feet north of Grave 21, in the area of the new gate placement. There was considerable disturbance here from construction of the previous gate. Soils were quite wet and contained a large amount of brick and mortar rubble. Once the disturbed soil was removed, the dark brown stain that defined the coffin was visible as were rusted iron fragments. The coffin was approximately 1.5 feet in width. The coffin was at .25 feet below datum and less than 3 feet below the current church yard surface.

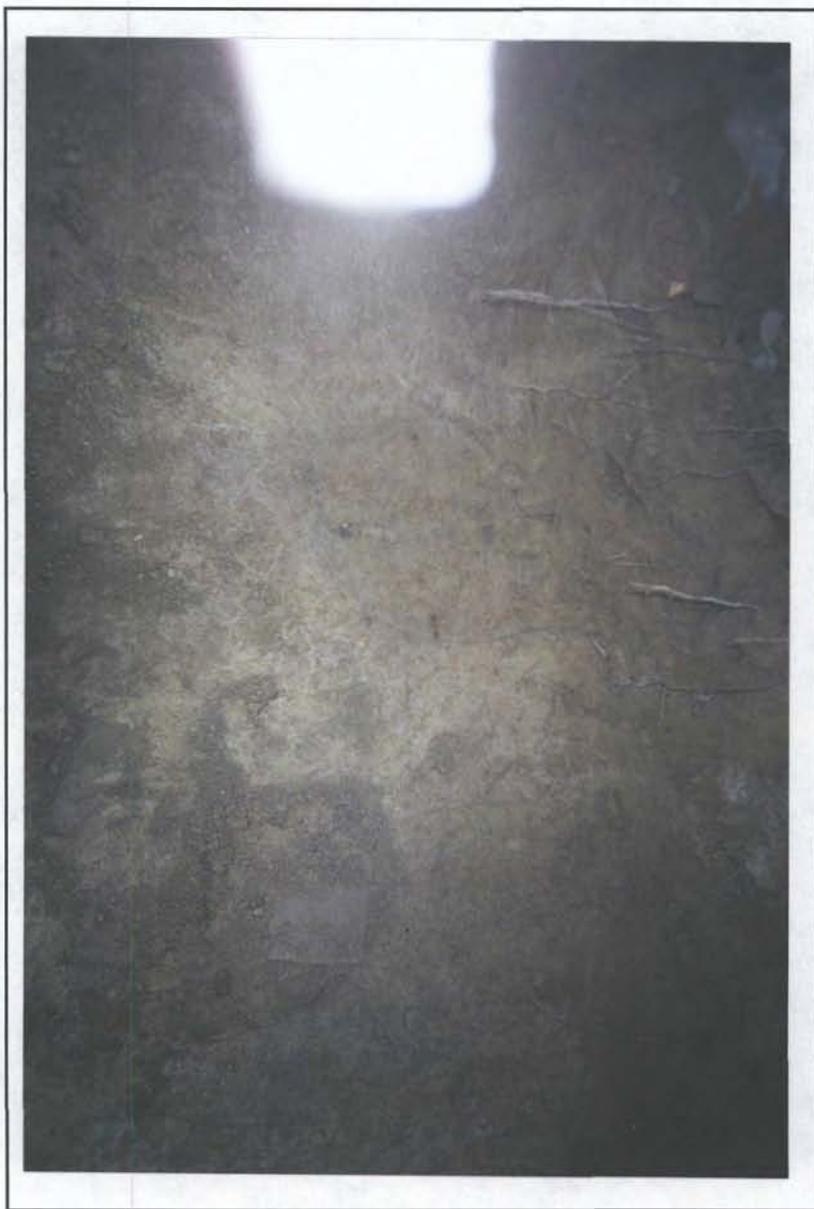
PLATE 18
View of Grave 23

Both a coffin stain and a grave shaft identified Grave 23, which was 1 foot north of Grave 22 and was also in the location of the new gate (Figure 4 and Plate 18). This grave extended slightly more than 1 foot into the trench floor from the east wall. Soils were similar to those at Grave 22 and there was considerable disturbance here as well. Again, the dark brown stain that defined the coffin was visible along with several rusted nail fragments. The portion of the coffin that was exposed was approximately 1 foot in width. Like Grave 22, the coffin was at .25 feet below datum and less than 3 feet below the current church yard surface. A single small human tooth fragment was observed in the western edge of the coffin stain.

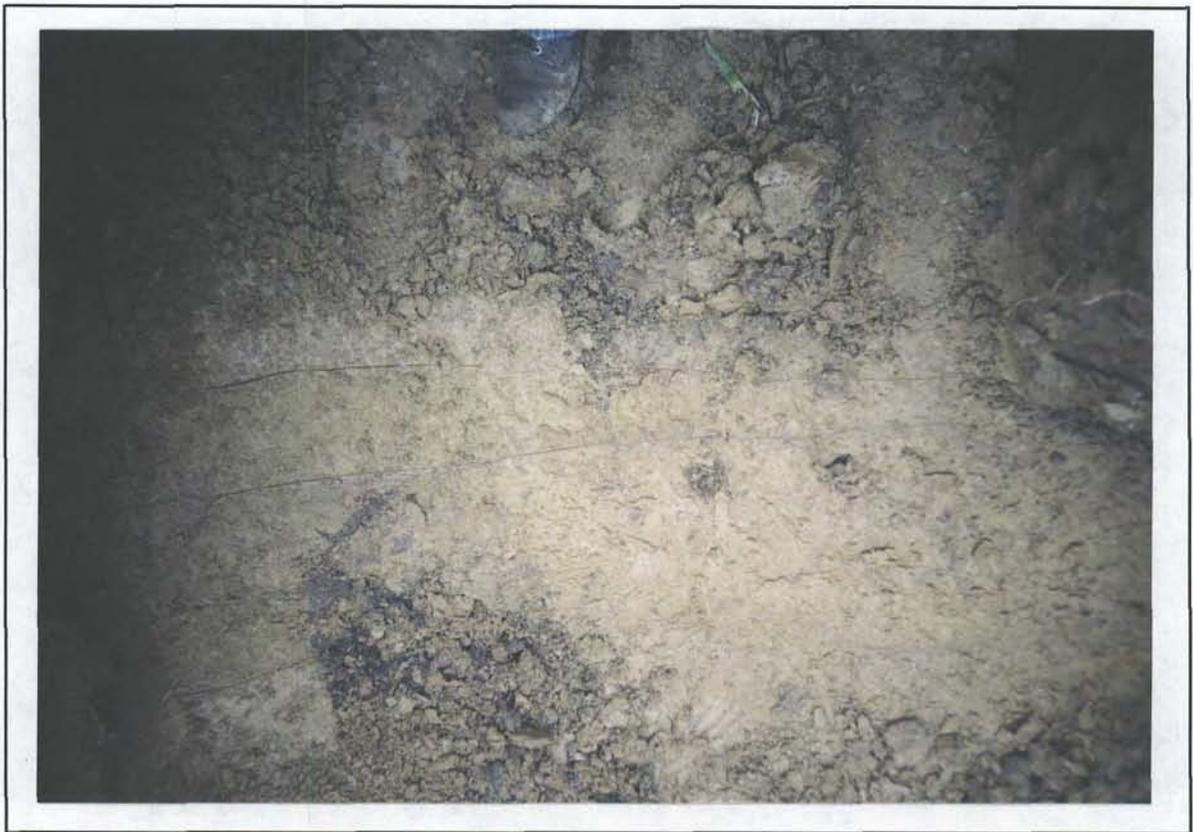
PLATE 19
View of Grave 24

Grave 24 spanned the width of the trench floor (Figure 4 and Plate 19). It lay 5 feet north of Grave 23 and stains from the grave shaft as well as the coffin were identified. The grave was noted at .05 feet above datum. A dark gray brown stain marked the coffin edges, which converged at the east and west ends, outlining an hexagonal coffin. The coffin stain measured approximately 1.5 feet in width, while the grave shaft was circa 2 feet wide. The grave was located at a structural pier and consequently the trench was wider at this point. The coffin appeared to measure about 4 feet in length. Nails were present along the coffin edges and within the central portion of the grave. The grave shaft was brown in color and softer in texture than the surrounding subsoil.

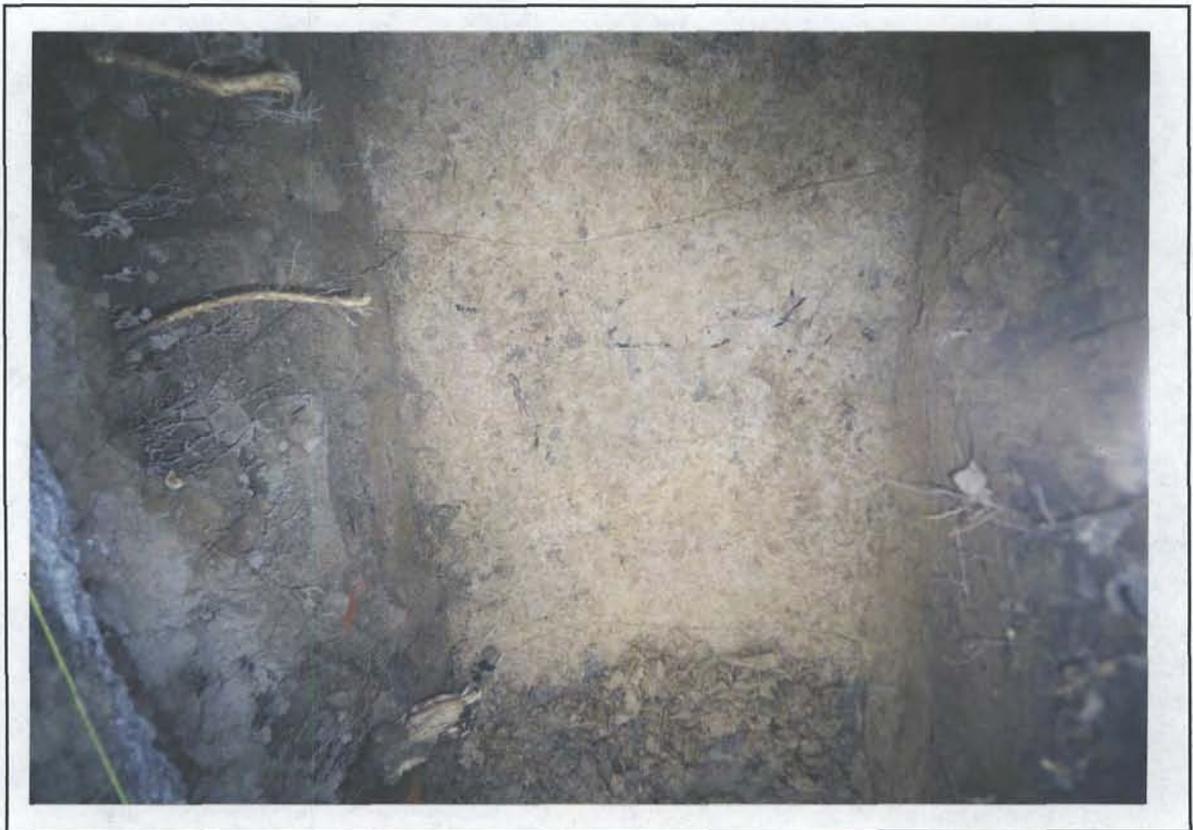
PLATE 20
View of Grave 26

Grave 26 was 3 feet long and 1.5 feet wide, spanning the width of the trench (Figure 5 and Plate 20). The grave was approximately 9 feet north of Grave 25. The grave shaft was defined at .15 feet above the USGS datum and about 2 feet below the current sidewalk. The soils within the shaft were similar to those of the surrounding subsoil in color, with the slightly less compact texture and gray water leached marks defining the shaft edges.

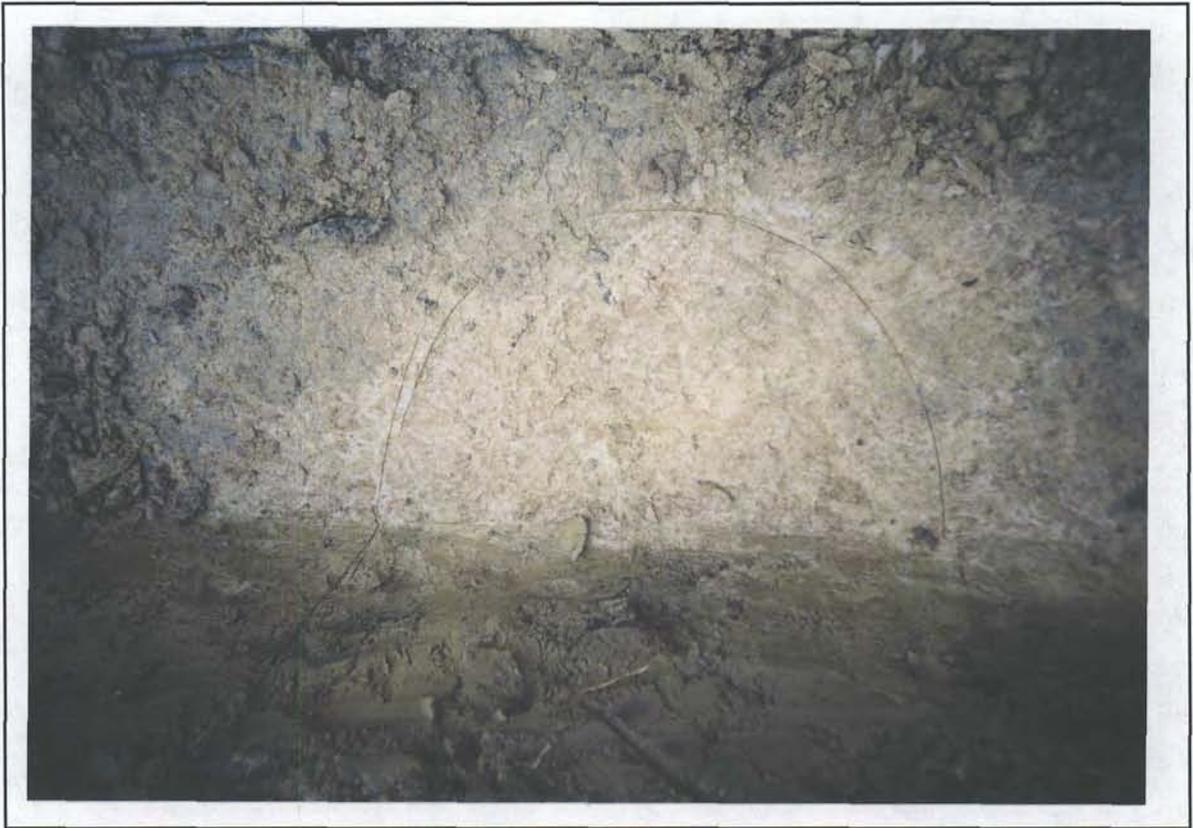
PLATE 21
View of Graves 27 and 28

Grave 27 extended into the trench approximately .5 feet from the east wall and 7.5 feet north of Grave 26 (Figure 5 and Plate 21). It was primarily visible in the floor of the trench, with two small water leached stains marking the shaft edges visible in the wall. The shaft was defined at .35 feet above the USGS datum and less than 2 feet below the current sidewalk. The soils were similar in color to that of the surrounding subsoil with a slightly softer texture.

The feature, delineated Grave 28, spanned the width of the trench, approximately 11 feet north of Grave 27 (Figure 5 and Plate 21). It was visible only in the floor of the trench and was quite narrow. It is possible that it is related to some other type of disturbance, such as a drain or water pipe, however the soil characteristics and orientation were similar to many of the other graves. The shaft was measured at .15 feet above the USGS datum. The soils were again similar in color to that of the surrounding subsoil with a slightly softer texture.

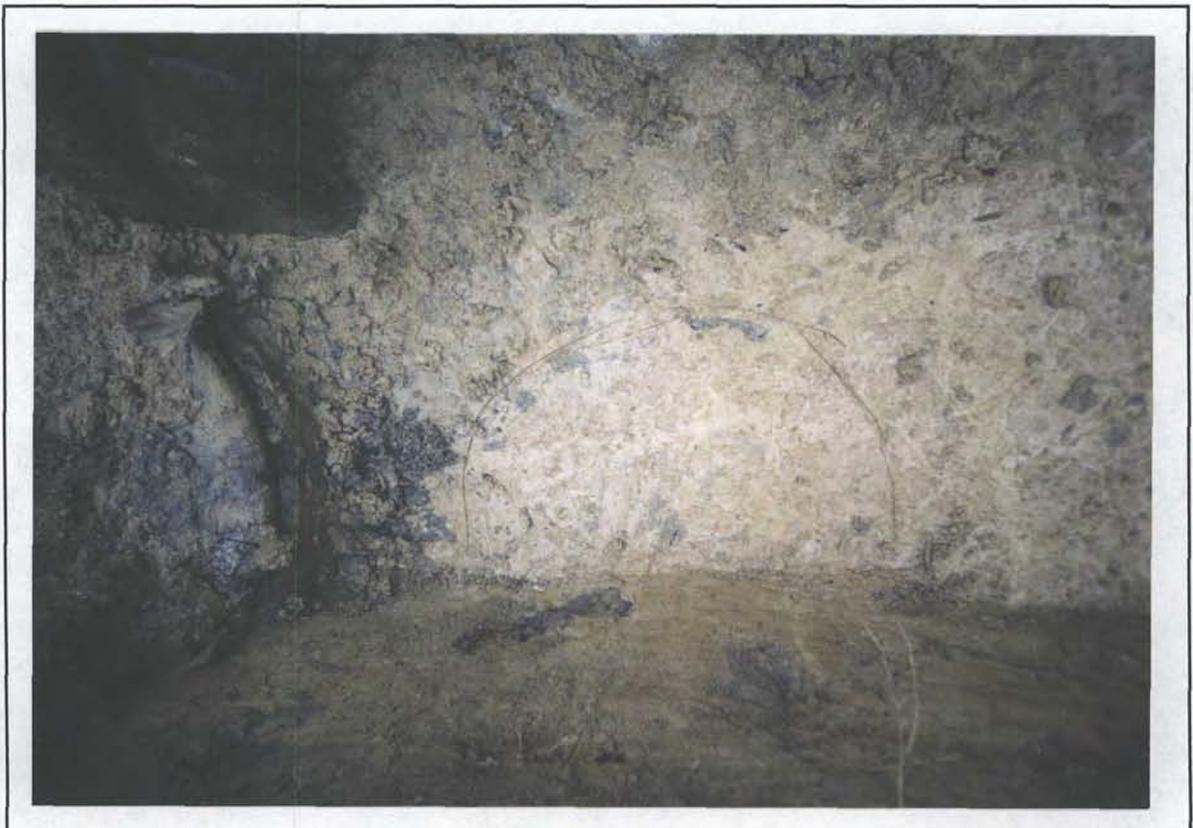
PLATE 22
View of Grave 29

This grave, represented by a shaft, was approximately 3 feet north of Grave 28 (Figure 5 and Plate 22). Grave 29 was circa 1.5 feet in width and extended about .75 feet from the east wall of the trench. It was visible both in the floor and in the east wall. The color and texture were similar to the surrounding sterile subsoil but were delineated by gray water leached soils. The shaft was measured at .15 feet above datum.

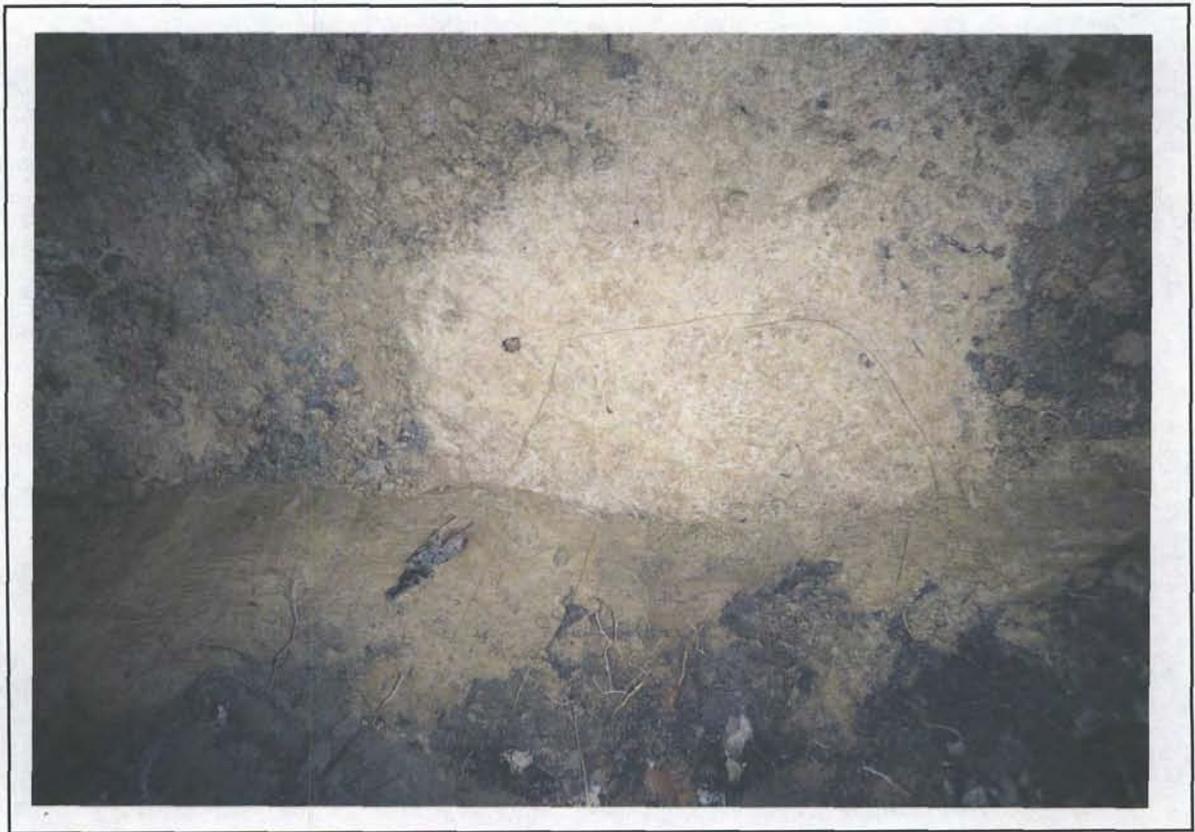
PLATE 23
View of Grave 30

Grave 30 was 6 feet north of Grave 29 (Figure 5 and Plate 23). It was marked by a grave shaft which was approximately 2 feet in width and extended 1 foot out from the east wall of a pier location within the trench. The grave was visible in the floor of the trench with some evidence of darker soil in the wall above. The color was a slightly darker brown than the surrounding sterile subsoil and was delineated by grayish water leached soil. The shaft was noted at .1 feet below datum.

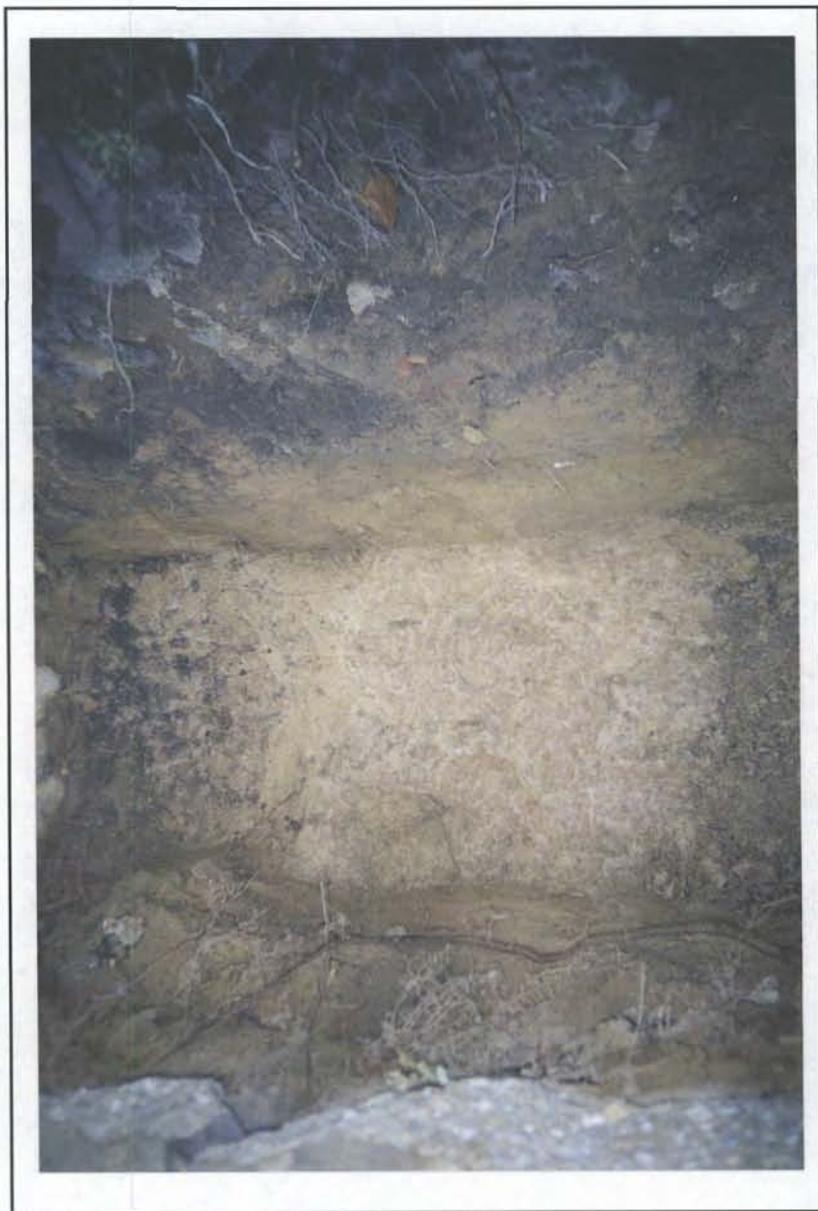
PLATE 24
View of Graves 31 and 32

The shaft of Grave 31 was circa 4 feet north of Grave 30 (Figure 5 and Plate 24). Grave 31 extended about .5 feet out from the west wall of the trench and was circa 1.5 feet in width. The color was similar to the surrounding sterile subsoil but was marked by gray water leached soils and a slightly less compact texture. The shaft was measured at the same level as the datum.

Grave 32, also marked by a grave shaft, is similar to Grave 31 (Figure 5 and Plate 24). It was nearly east of Grave 31 on the opposite wall and floor of the trench. The grave extended about .75 feet out from the east wall of the trench and was circa 1. feet in width. The color was similar to the surrounding sterile subsoil but was defined by the gray water leached soils and a less compact texture. The shaft was measured at .15 feet above datum.

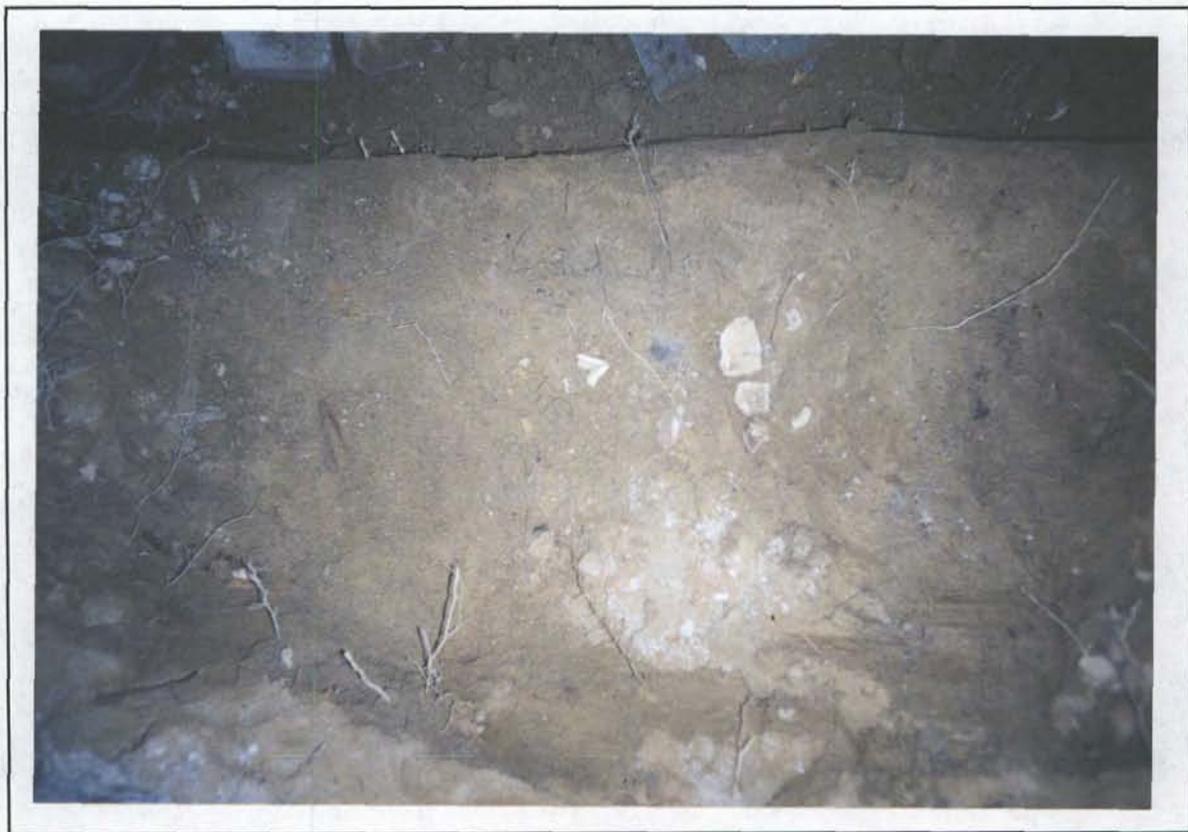
PLATE 25
View of Grave 33

Grave 33 was located approximately 3 feet north of Grave 26 and 3.5 feet south of Grave 27 and was identified as an existing pier was being removed from the trench (Figure 5 and Plate 25). At approximately 1.15 feet above datum, several bone fragments were observed in a concentration of soft dark brown soil. The bone had been broken prior to the current demolition as no fresh breaks were observed. The fragments appeared to be a portion of a pelvis, while two small fragments of long bone were observed circa 10 inches to the south within the pier area. Several rusted nail fragments were also observed in the vicinity. The soil here contained brick and mortar fragments along with sand and gravel. A utility pipe was observed under the Columbus Street sidewalk at less than 1 foot from the bone fragments and the bones lay

less than 1 foot below the current sidewalk level. The location and condition of the bones along with the soil composition, including brick and mortar, seemed to indicate some prior disturbance to this grave. Possibly the installation of utilities below the sidewalk or the sidewalk construction itself contributed to the disturbed condition of the grave.
