**ARCHEOLOGICAL MONITERING OF WALL
CONSTRUCTION AT CHRIST CHURCH, ALEXANDRIA,
VIRGINIA**

William M. Gardner and Michael Clem

March, 2000

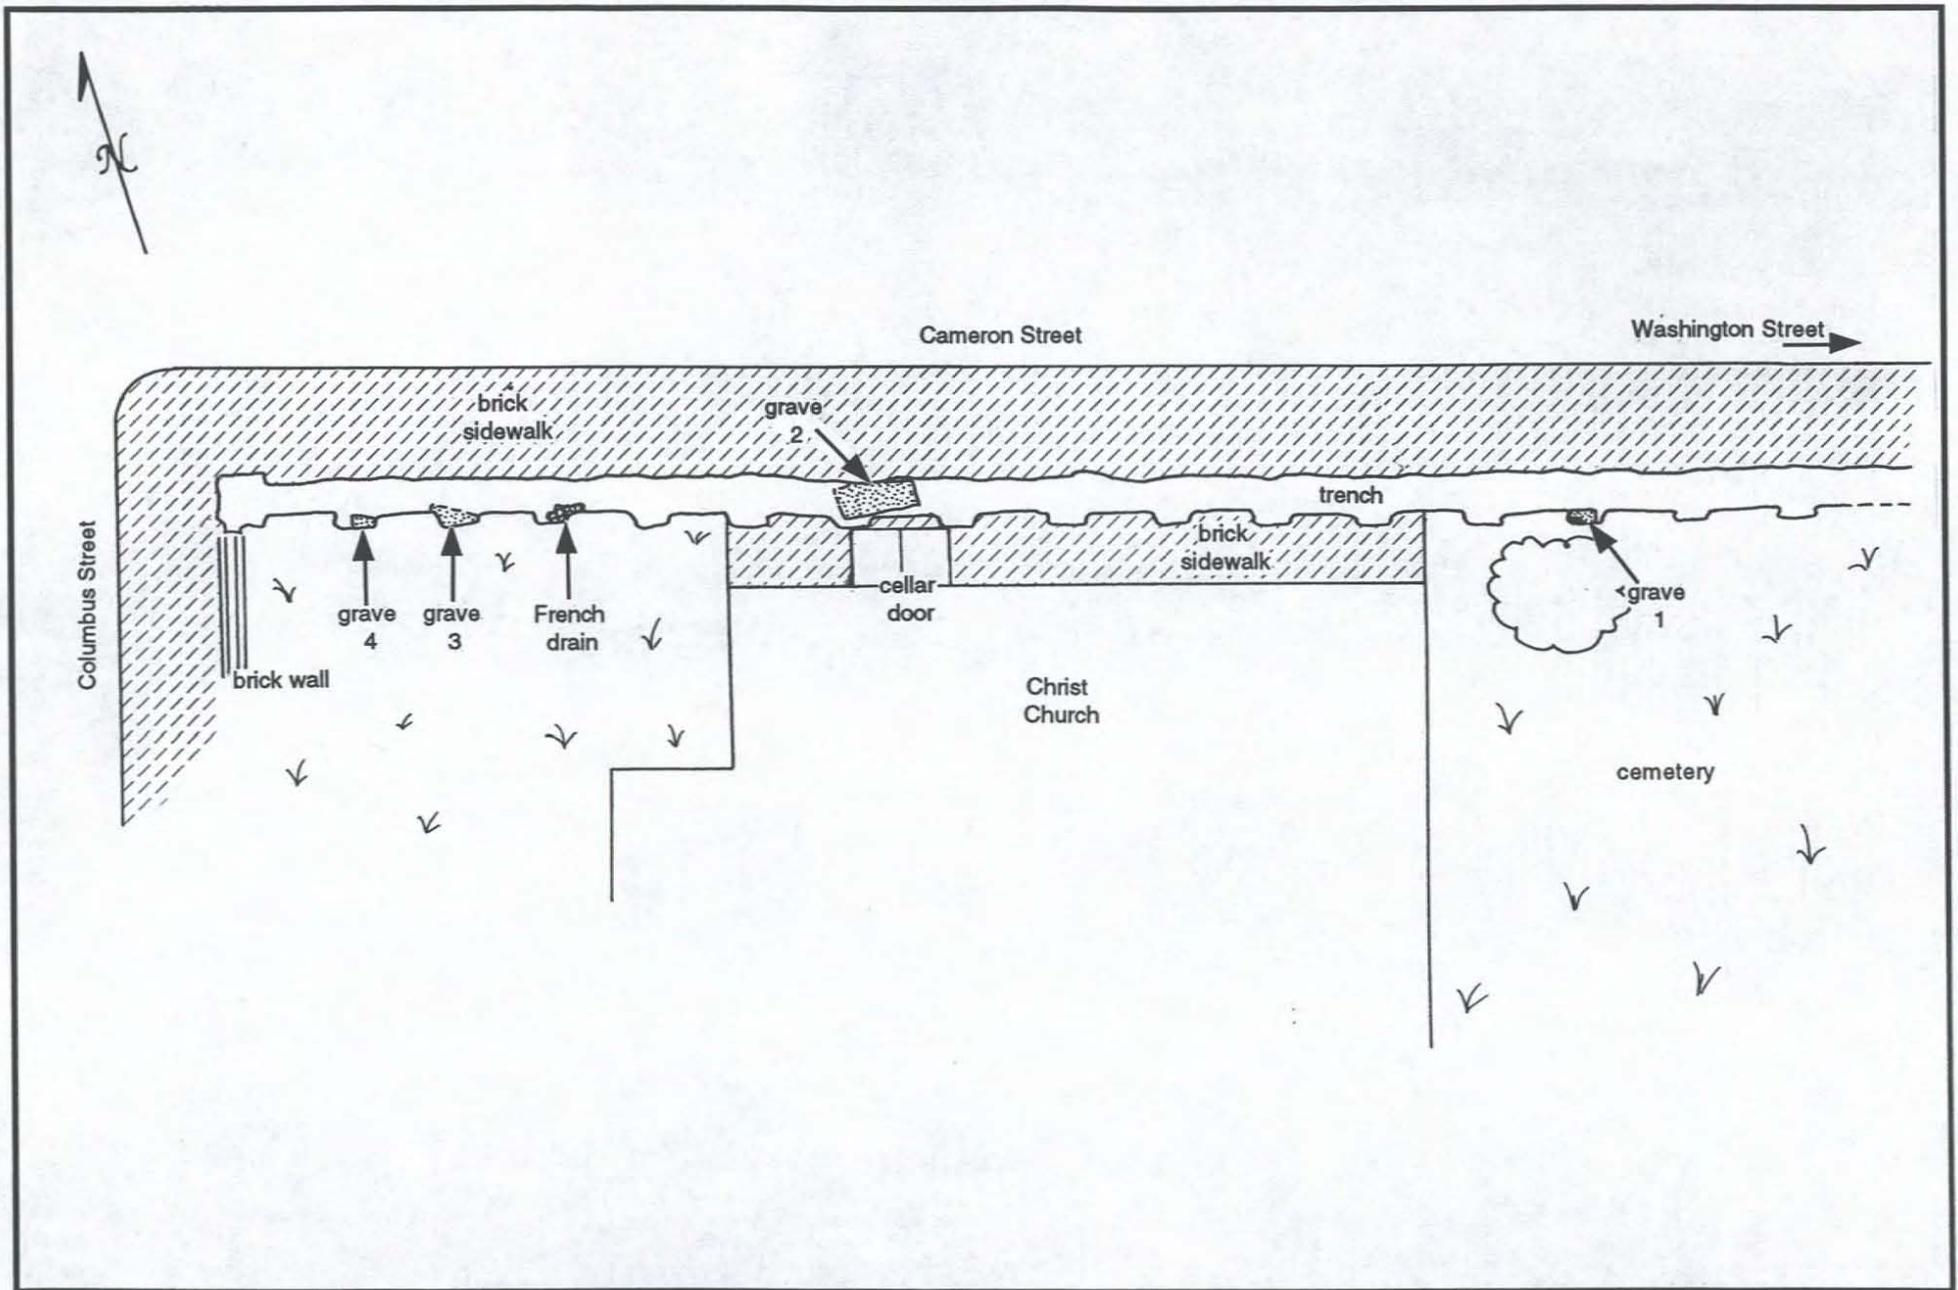
FIGURE 3
Plan Map of Project Area Showing Location of Graves 1, 2, 3 and 4 and a French Drain within the Trench Excavation

Four graves were uncovered by the excavations associated with the replacement of the wall (Figure 3 and Plates 1-4)). The grave shaft and wooden planking observed in one grave (Grave 1) had been exposed, indeed partially removed, when the earlier wall which the current work replaces was built. The northeastern portion of Grave 1 was exposed in both profile and plan, directly behind where one of the earlier wall pillars had rested in an indentation. The grave was defined by the presence of wooden planks and by the vertical profile of the shaft. The wooden planks were not part of the coffin but wood which was placed on top of the coffin prior to backfilling (Creveling 1987: 35). This is interpreted as a method preventing coffin collapse from the weight of the backfill (ibid.). This practice has been observed in connection with earlier archeological work done on other parts of the wall as well as in other locations. Again, as this was not to be disturbed, no further work was done.

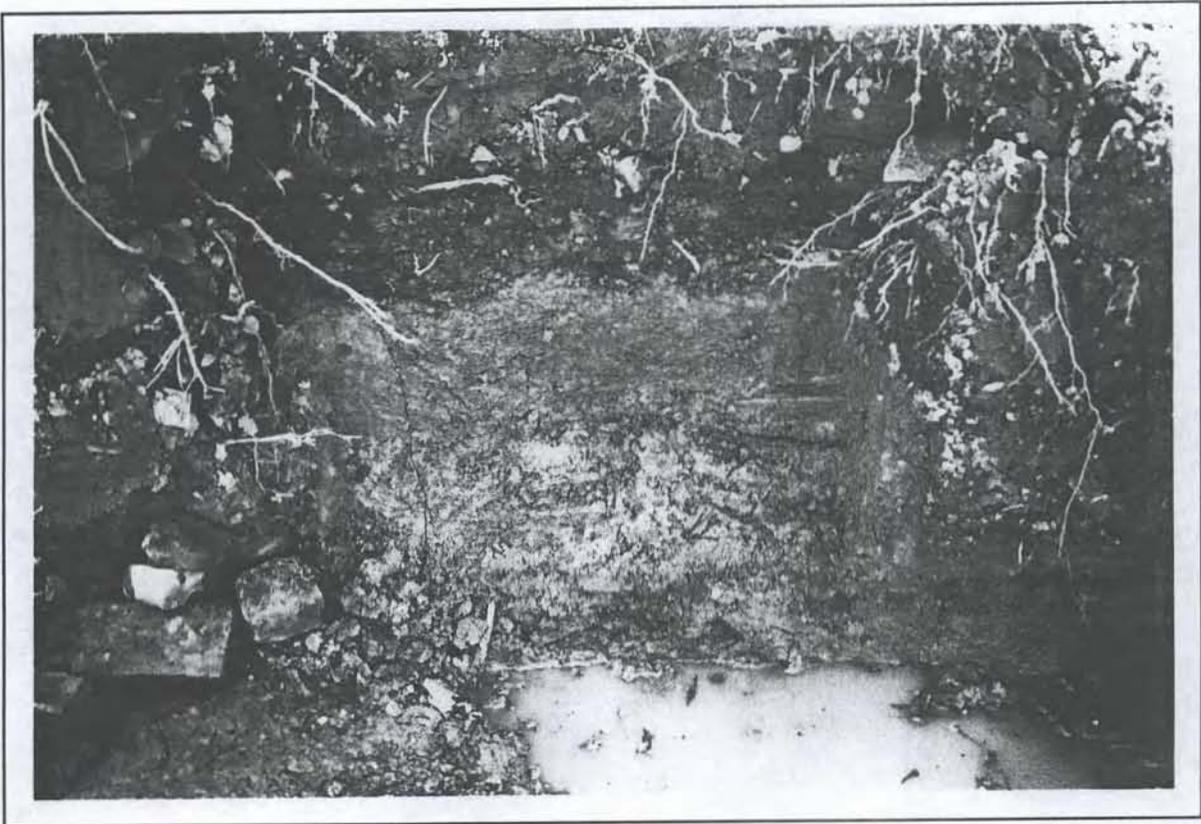
PLATE 1
Plan View of Grave 1

Grave 1

The planking appeared at 3.08 feet above datum and 11 inches below the sidewalk level. The shaft, which appeared at the base of post-interment organic fill, continued down another 1.25 feet to the base of previous and current excavations. Assuming an east-west orientation, only 2.5 feet of the northeast corner of the shaft and the plank covering was exposed.

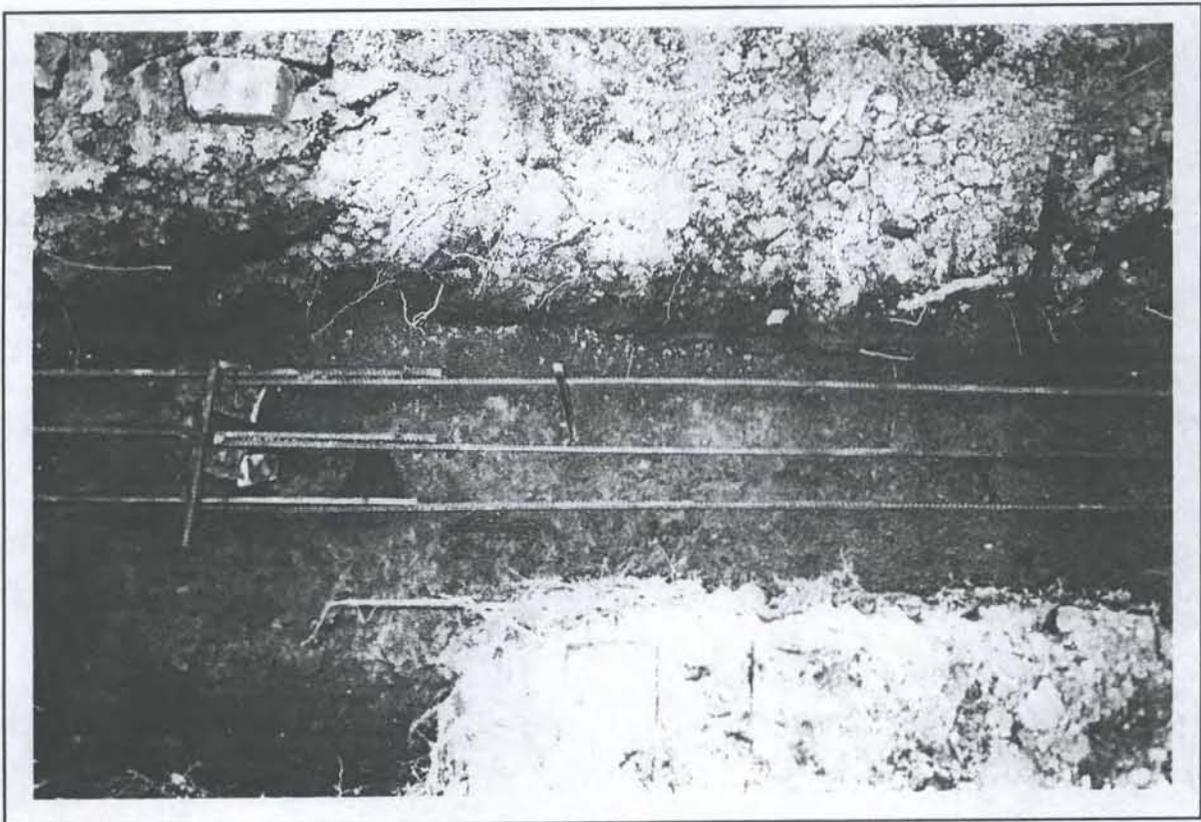
PLATE 2
Plan View of Grave 2

Grave 2

This was the most fully exposed grave shaft. The shaft was 6.0 feet long and 3.0 feet wide. Orientation was roughly east-west. The grave lay just outside the brick wall of a cellar/coal chute entrance into the church. The shaft was defined at 3.5 feet above the U.S.G.S. datum and 2.2 feet below the level of the current sidewalk.

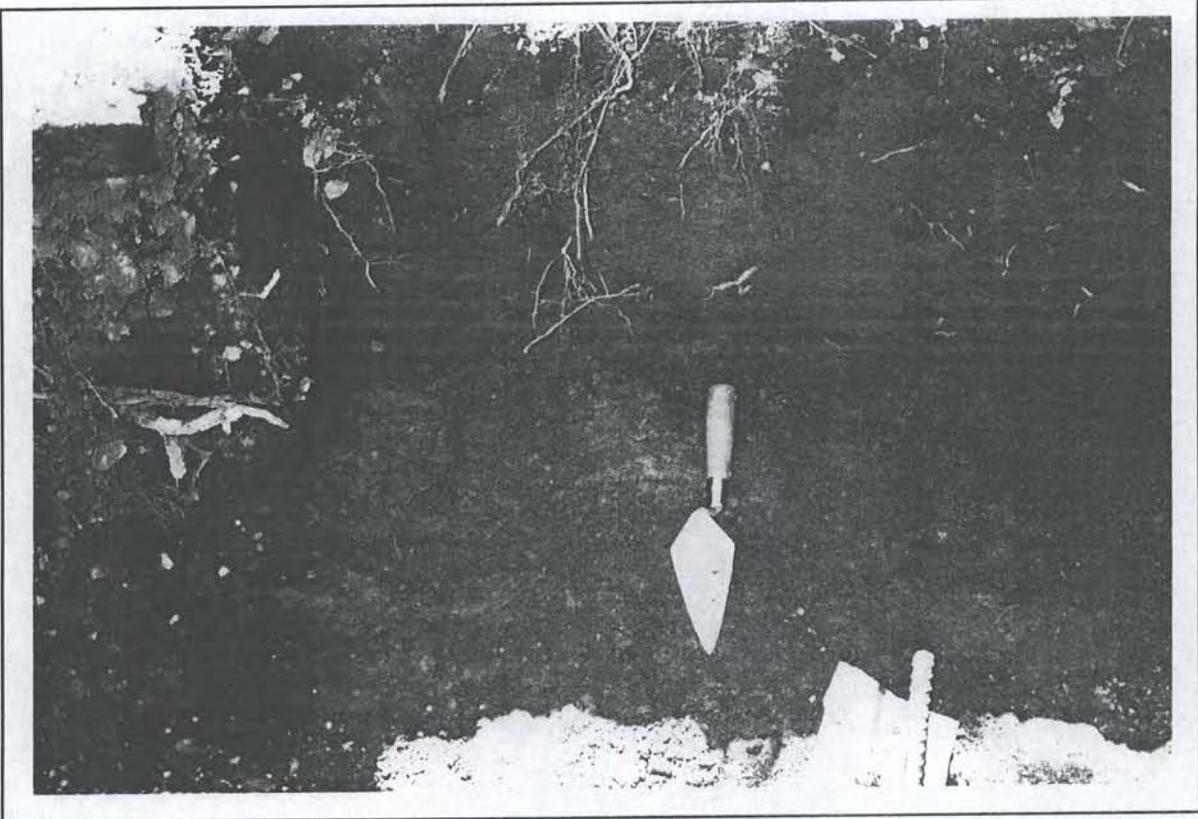
PLATE 3
Plan View of Grave 3

Grave 3

Part of the northern and northwestern edges of this grave were exposed after shovel scraping and troweling in the construction trench floor. Approximately 3.5 feet of the northern edge of the grave shaft was uncovered. Orientation was circa 25° north of east-west. The shaft was first discerned at 2.1 feet below the current Cameron Street sidewalk surface (3.4 feet above datum).

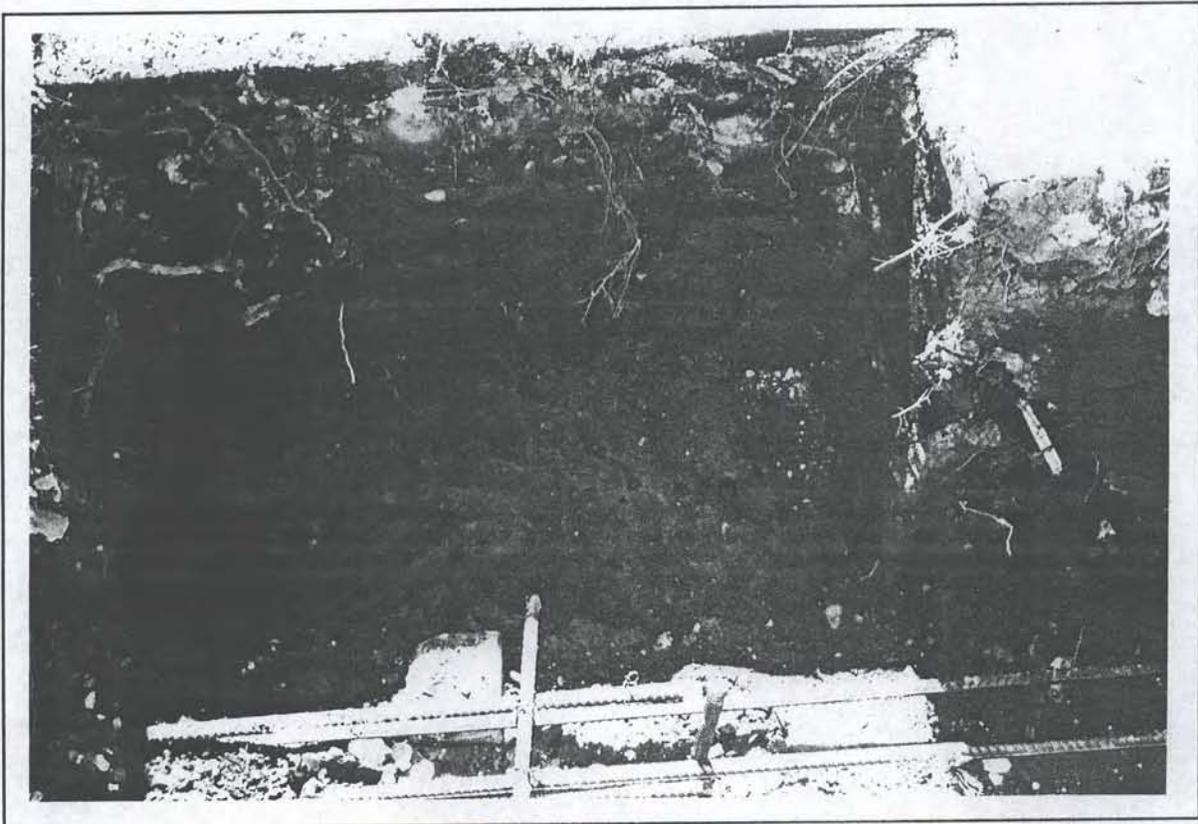
PLATE 4
Plan View of Grave 4

Grave 4

This grave shaft was also approximately 25° north of east-west. Only the northwest corner of the shaft was visible. The grave shaft was again at a depth of 2.1 feet below the Cameron Street sidewalk surface (3.4 above datum).

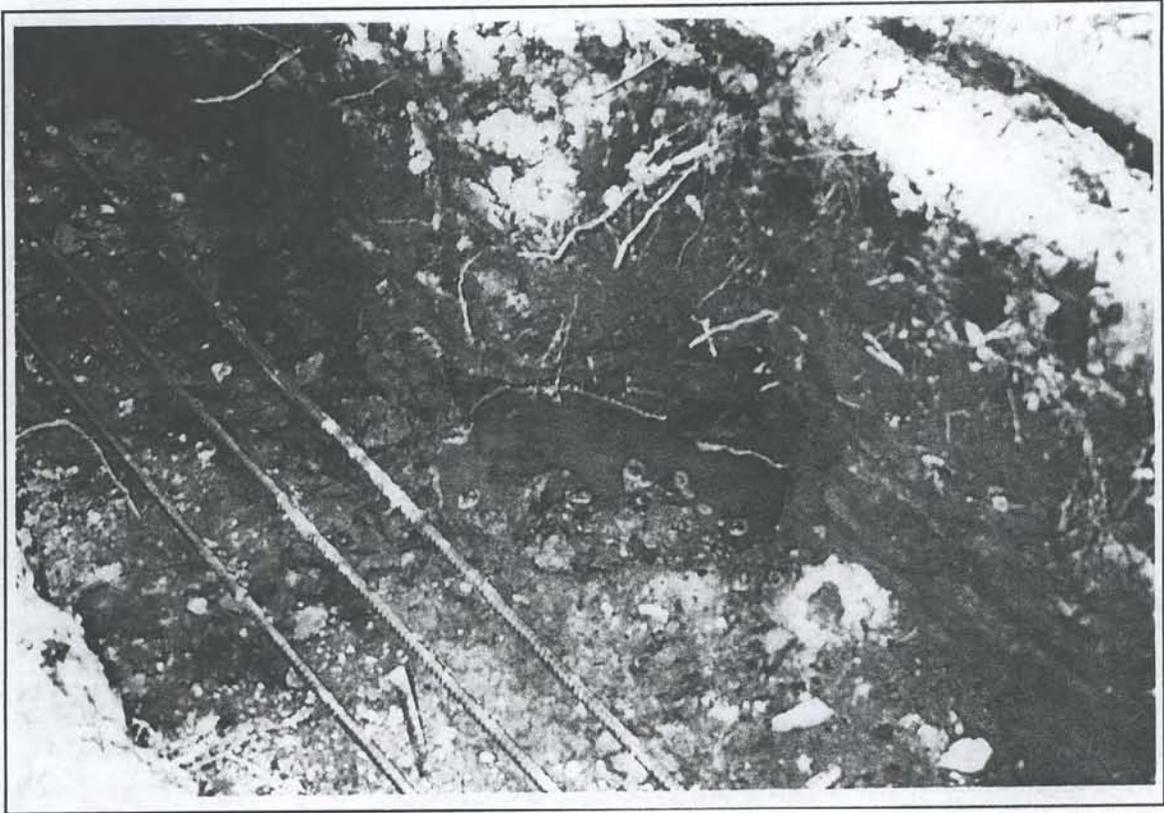
PLATE 5
View of French Drain

Two other features were noted. One was a French drain which occurred at circa 2.3 feet below current surface (Plate 5). This was approximately 6.0 feet east of Grave 3. The second feature was the cellar wall mentioned previously that was associated with the coal chute-basement entrance into the church.
