Reference: Archaeological Monitoring of Handicap Ramp Installation
Historic Christ Church, Alexandria, Virginia

New Wheelchair Ramp for Historic Christ Church Exposes Grave Shafts March, 2008 The Louis Berger Group, Inc. and Alexandria Archaeology

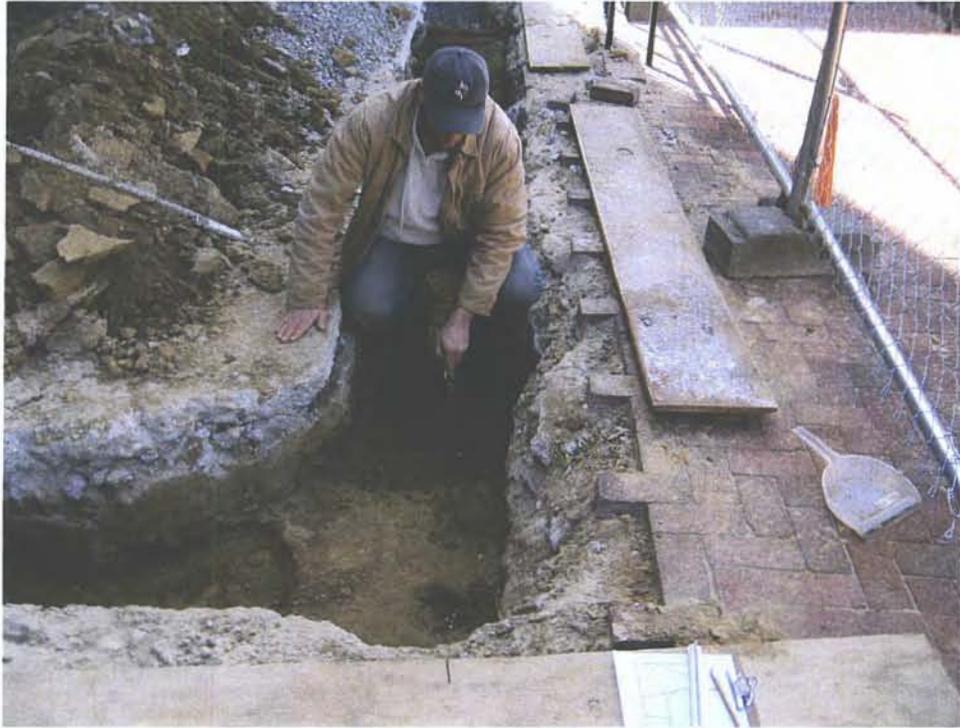
Feature 2 is a 2.0-foot wide stain running east-west across the trench. It appears to be a grave shaft. The soil is dark brown loam; this appears to be topsoil that slumped into the top of the grave shaft.

PLATE 1. ARCHAEOLOGIST JASON SHELLNHAMER EXPOSING FEATURE 2

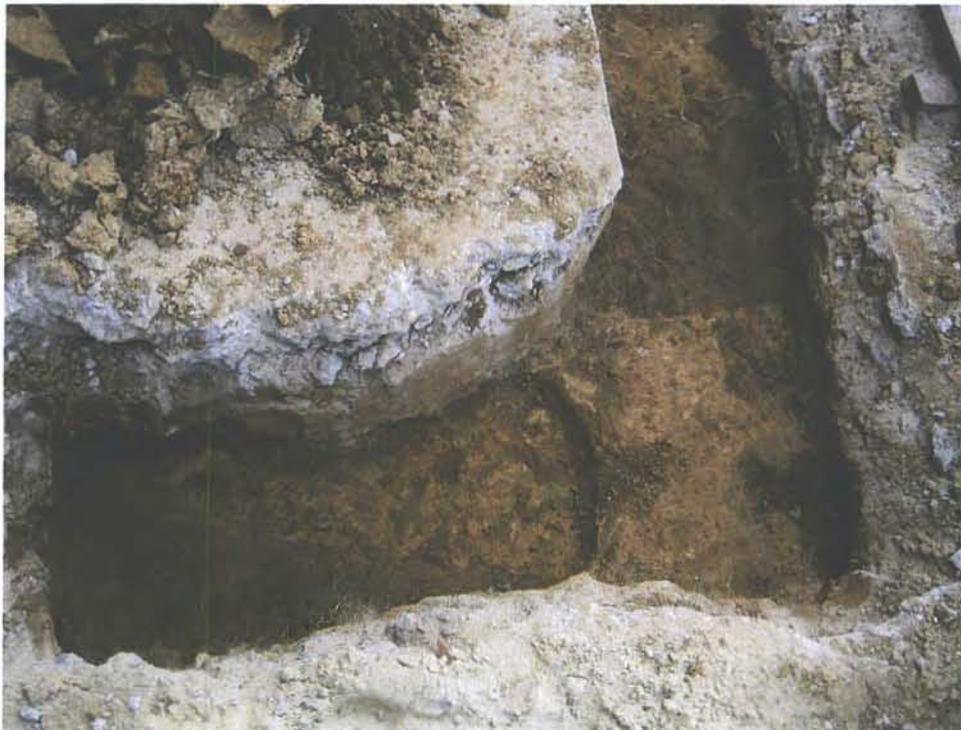
Feature 1 is partially visible along the north side of the east-west section of the trench (Plate 2). It consists of dark yellowish brown silt loam, with some admixture of darker and lighter soils. It is at least 4.3-foot long, and the visible edge runs 25 degrees off the east-west line. Feature 1 appears to be a grave shaft.

PLATE 2. FEATURES 1 (LOWER LEFT) AND 2 (UPPER RIGHT) WITHIN THE TRENCH.

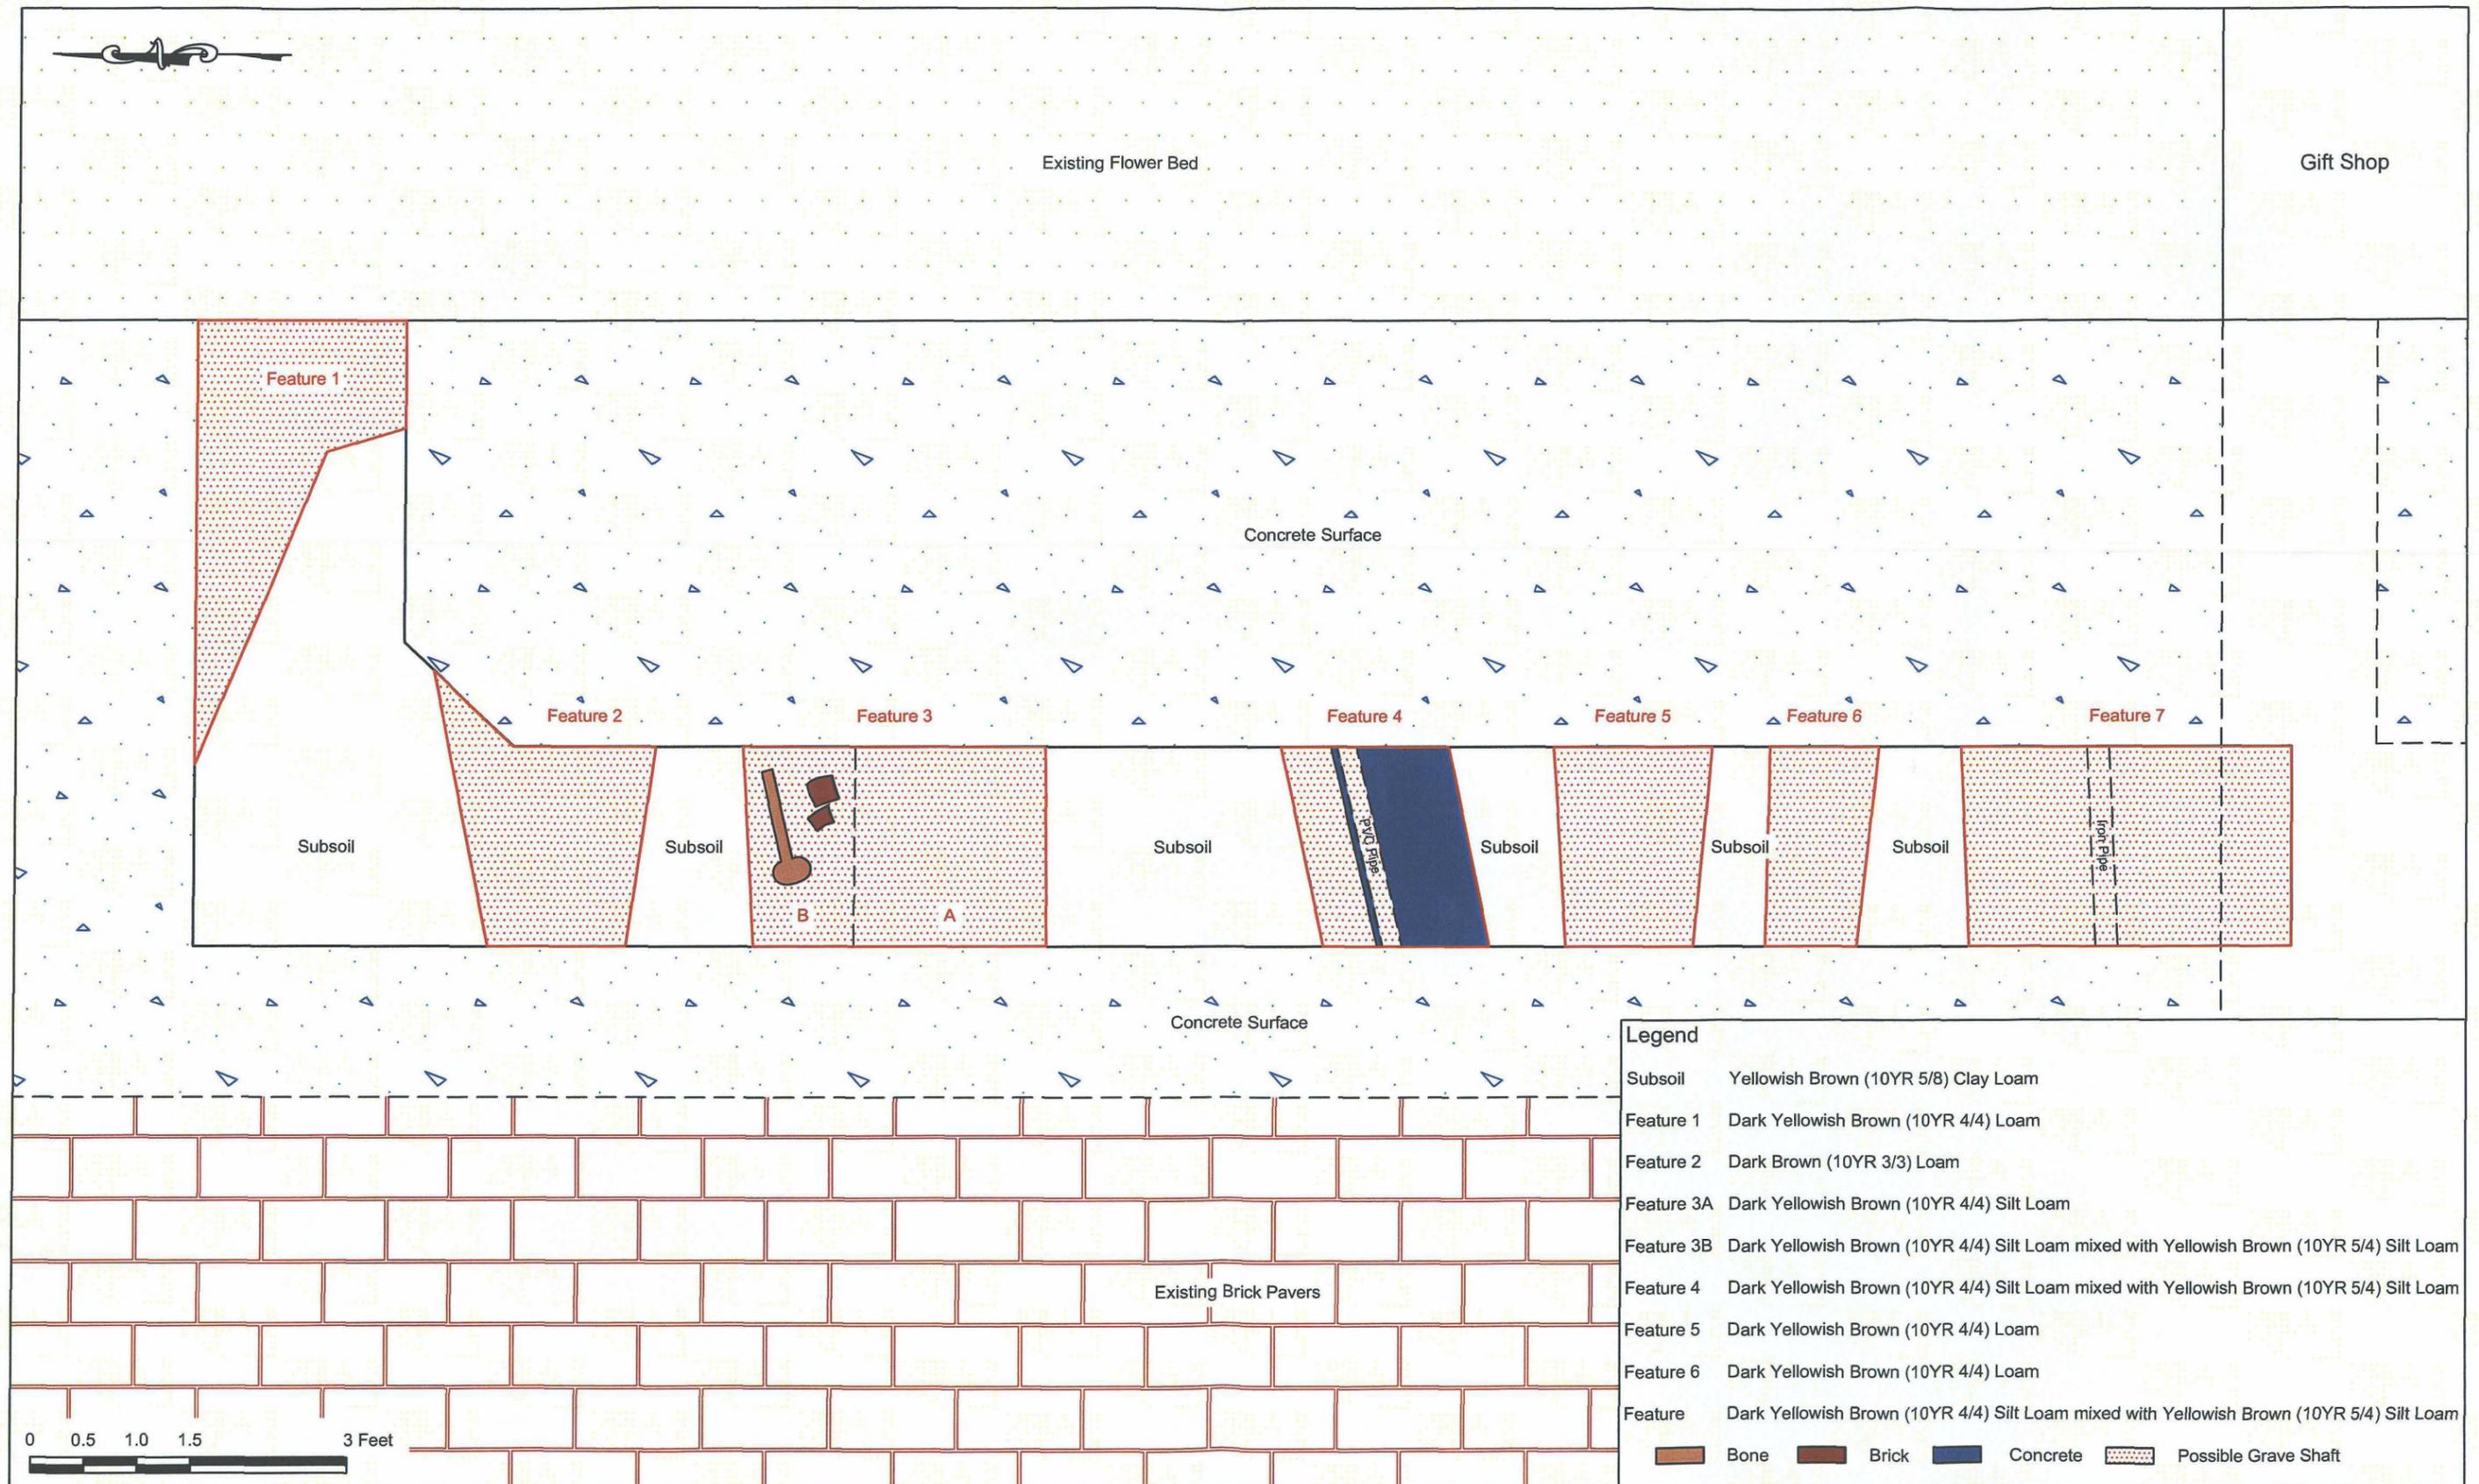
FIGURE 2: Plan of Excavation Trench

The archaeologically important part of the project was the L-shaped trench cut through the concrete slab north of the entrance (Figure 2). South of the entrance, nothing was observed but disturbed soil, recent fill, and gravel.

The trench north of the entrance is 2 feet wide. It measures 19.9 feet north to south. At the north end the trench turns east, extending 5.5 feet to an existing retaining wall. The concrete was about 0.5 foot thick. Beneath the concrete was about 0.5 foot of mixed fill. When this fill had been removed, natural subsoil was exposed. This subsoil, a yellowish brown clay loam, is about 1.3 feet below the top of the brick pavement. The historic topsoil was removed from this location before the fill and concrete were put down. It is not known how much soil was removed before the fill was placed, so it is not known how far below the historic ground surface the subsoil in the bottom of the trench once was. Based on its appearance, we surmise that no more than one foot of historic soil has been removed, and possibly only a few inches.

Several archaeological features are visible cutting into the natural subsoil. For convenience these have been numbered from north to south within the trench. Many are probably graves.

Ideally, the grave shafts would be avoided by construction. But this would require a complete redesign of the ramp, so some excavation within the grave shafts may be necessary. It is not known how far below the exposed ground surface the tops of the coffins or any human remains might be. To place footers 30 inches below the ground surface, as required by the Building Code, would require digging about 1.2 feet deeper than the based of the present level of the trench.

Based on the February 21 on-site meeting with Alexandria Archaeology staff, any excavation within the grave shafts should be carried out by qualified archaeologists. As long as human remains or coffins are not encountered, digging could proceed without a state permit for moving human remains. However, if such remains were encountered, digging would have to stop. As per the current scope of work, any excavation between the grave shafts could be done by the contractor, but it would have to be monitored by a qualified archaeologist.

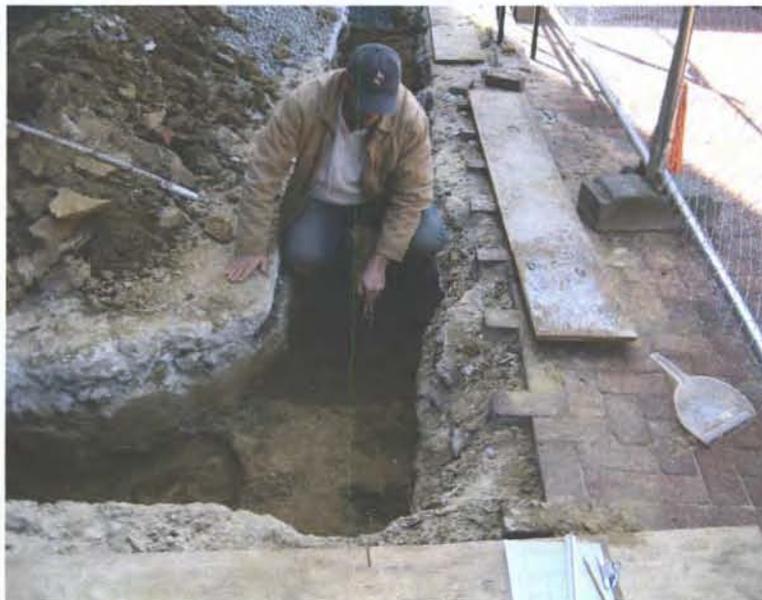
So when Christ Church decided to replace the steps on the west side of the Parish Hall with a wheelchair-accessible ramp, Alexandria Archaeology and Christ Church were concerned that graves might be disturbed. An archaeologist from The Louis Berger Group was on hand to watch the excavation for the ramp's foundation. The ground along that side of the Parish Hall was covered with a brick pavement, and beneath the brick was a concrete slab. A trench for the foundation was cut through that concrete, exposing the ground underneath. This trench was about two feet wide and twenty feet long. The archaeologist cleaned off the exposed ground by hand. This cleaning exposed a series of seven dark stains in the soil, all running east to west across the trench. Since the trench was only two feet wide, we could not be certain that they were old grave shafts, but in all probability they are graves.

Left: Archaeologist Jason Shellenhamer inspects one of the possible grave shafts.

In order to avoid disturbing these probable graves, excavation of the foundation trench was halted at that depth. The trench was then filled in with gravel and reinforced concrete, so it will serve as the foundation of the ramp. The Parish Hall will become more accessible to the whole church community, and the historic graves have been preserved intact.
