Final Report

Archeological Investigations
of the

COLROSS SITE
(44AX0197)

Alexandria, Virginia

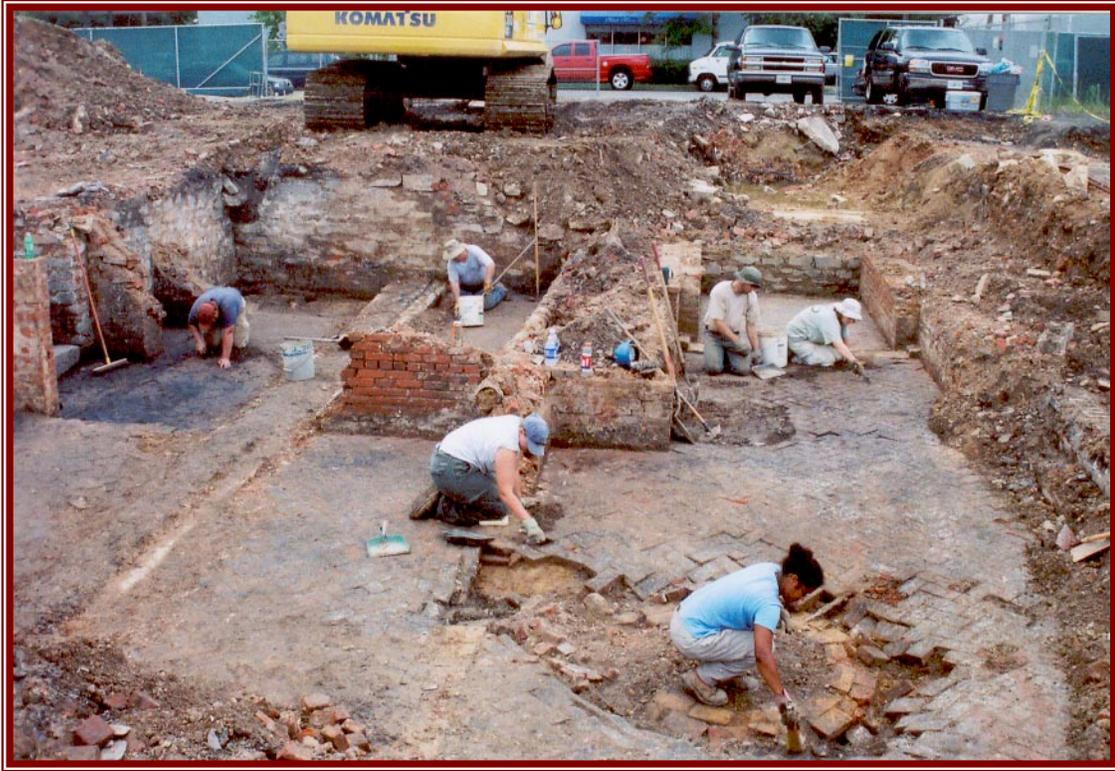
Archeologists from Goodwin & Associates, Inc. clean the elaborate herringbone pattern brick basement floor of Colross. Note the circular well in the lower right hand corner of the photograph.

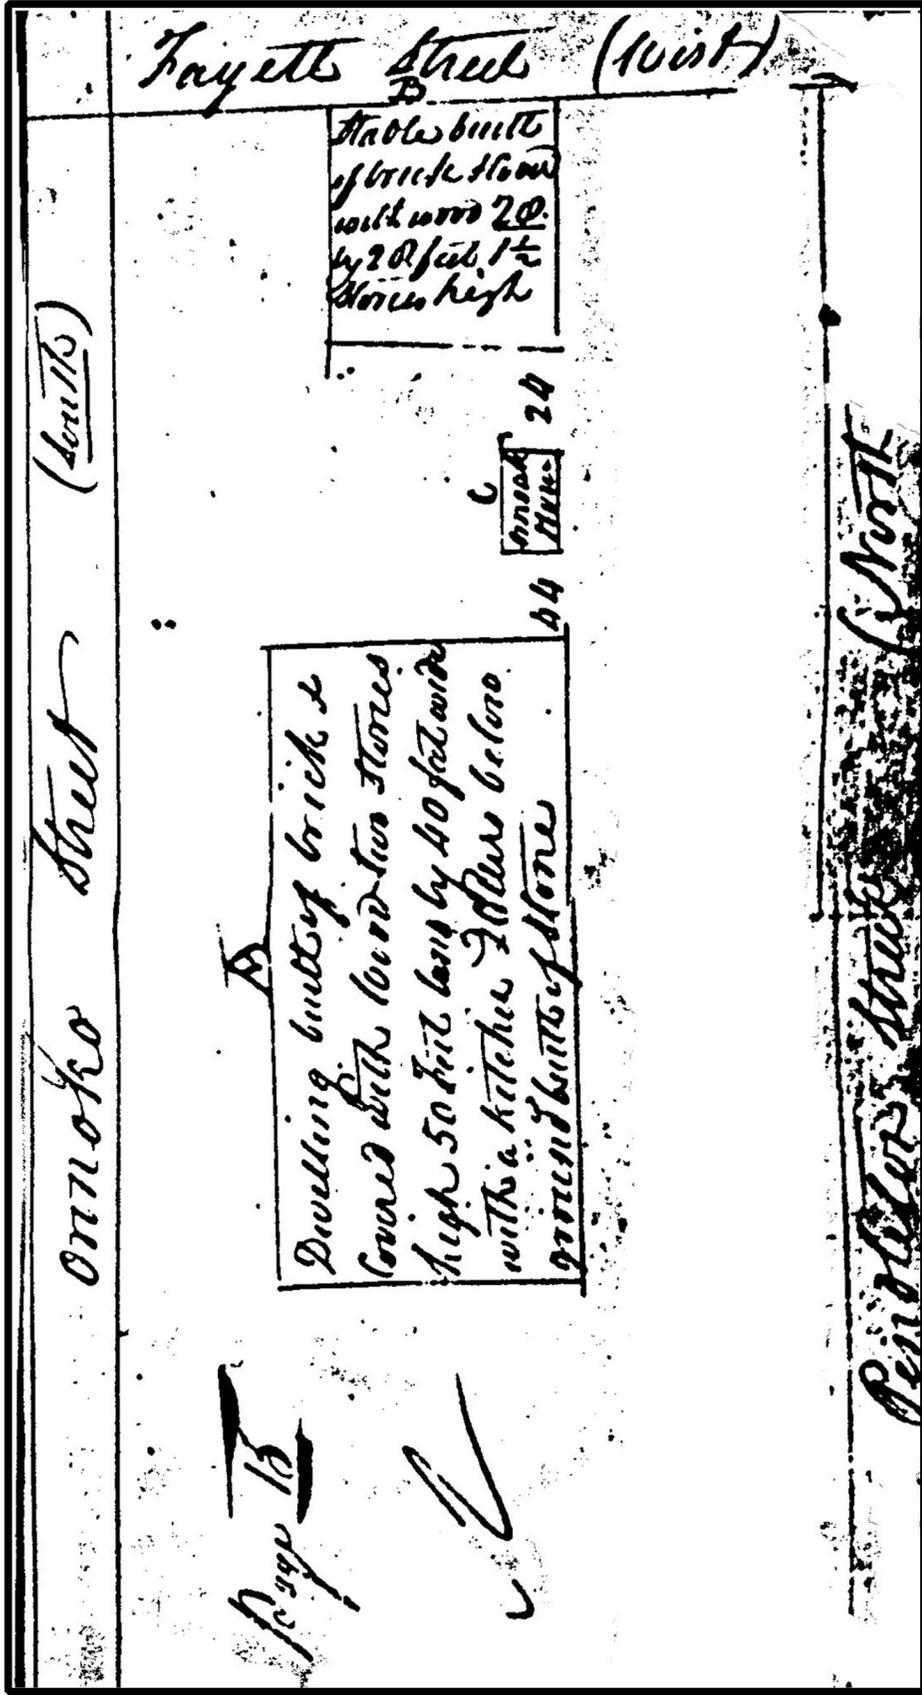
Figure 3. Virginia Mutual Assurance Society's records of Colross (1803)

Swift immediately moved to insure his new property, now valued at \$11,100, with the Virginia Mutual Assurance Society. The measured sketch that appeared on the original 1803 Declaration of Assurance (Figure 3) not only indicated that the complex contained all of the components advertised by Potts, but also provided more specific details. From this document, we learn that the kitchen of the two-story brick dwelling was located “below ground” inside the building’s stone basement foundation, and that the tiny “smoak” house was located 44 ft west of the main dwelling and 24 ft east of the 1½ story brick stable on Fayette Street (Mutual Assurance Society of Virginia 1803). Apparently, Swift modified parts of the

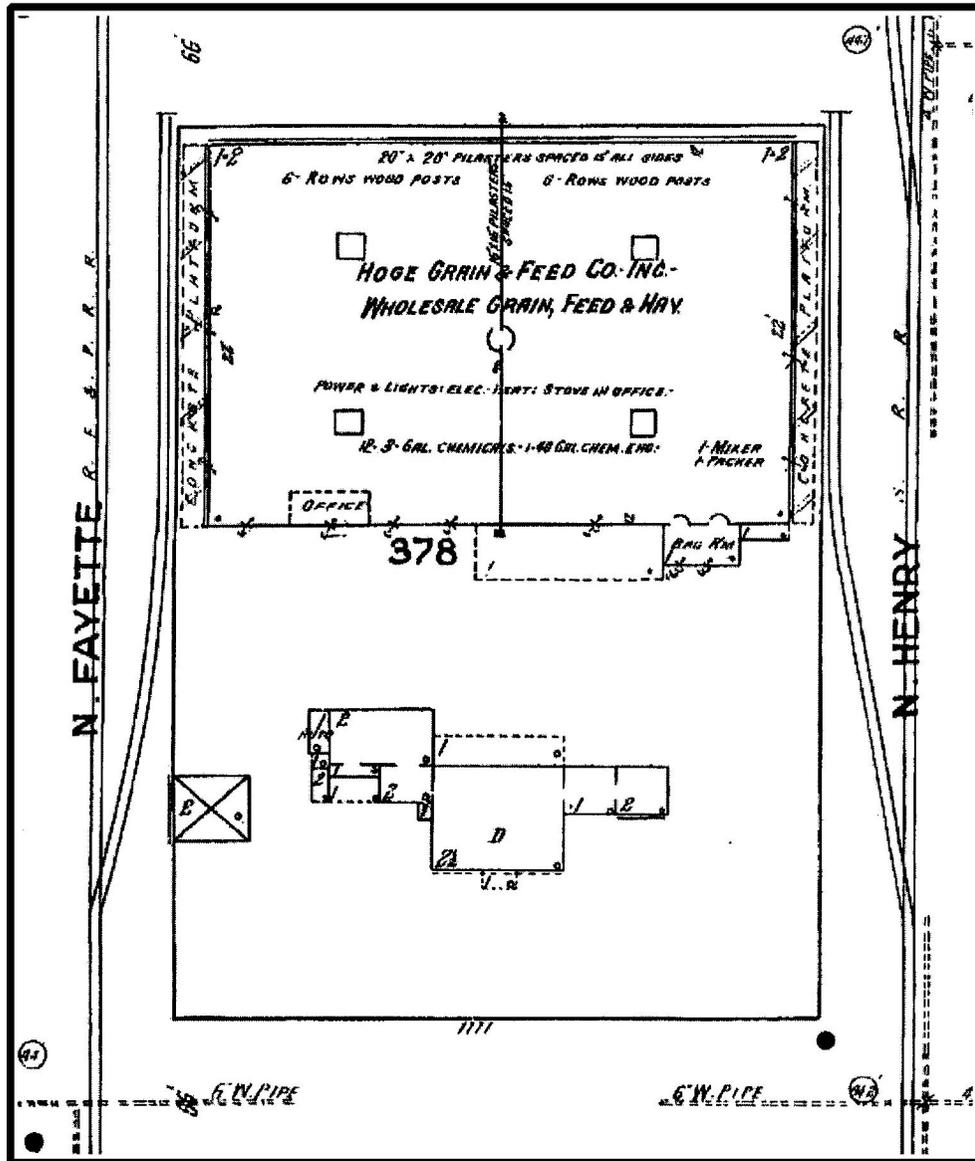
Figure 8. Sanborn's 1921 Fire Insurance Map of the Colross property, showing the Colross house and the east wing labeled as a "store"

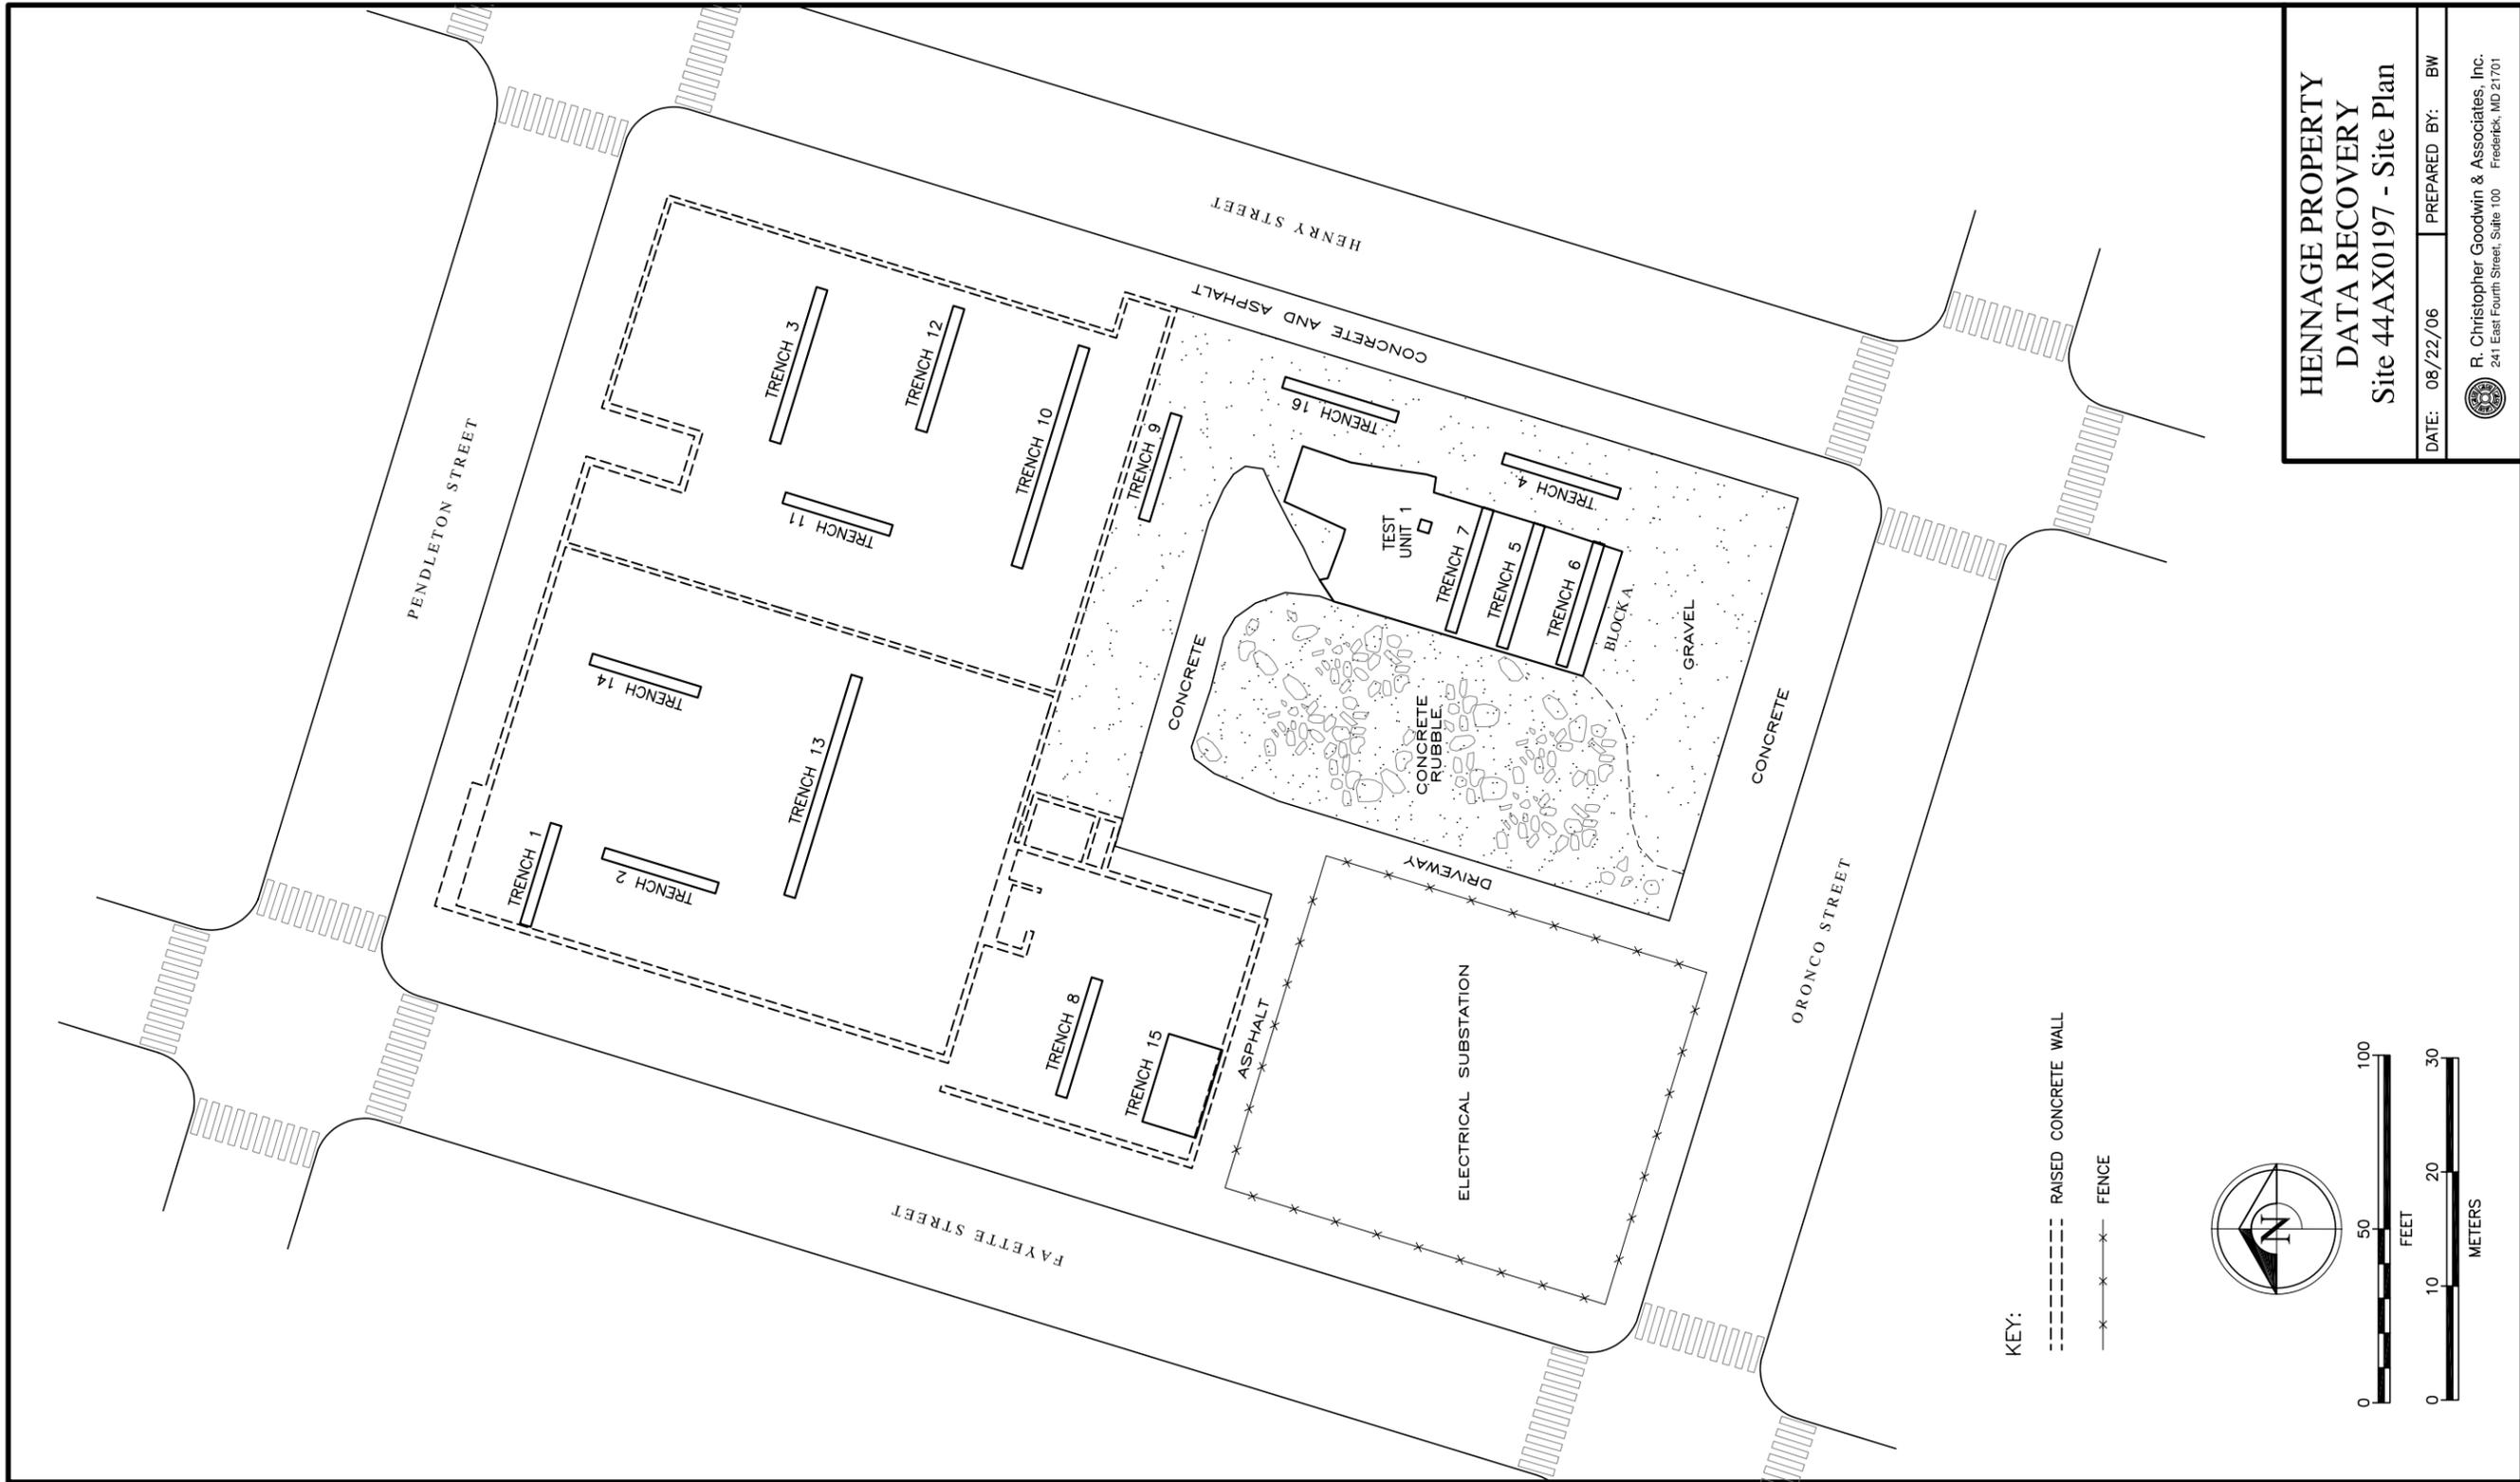
Figure 16. Site plan showing the locations of identified landscape and structural features, test trenches and test units

The northern portion of the block divided further by a north/south running concrete/cinder block foundation wall (Figure 16). The differential modification of the eastern and western portions had affected the archeological record differently. By 1951, the eastern half of the warehouse building had been renovated extensively, and its original wooden beams had been replaced with steel beam construction. Below the concrete pad in the eastern half was a complicated tangle of metal piping that was extremely difficult to extract, even mechanically. In contrast, the western half of the building footprint had been less extensively renovated and did not include any of the piping. The remains of wooden beams were found within the destruction layer, and portions of an intact wooden floor that had been constructed using cut nails were present between the top and bottom layers of the concrete slab (Figure 21).

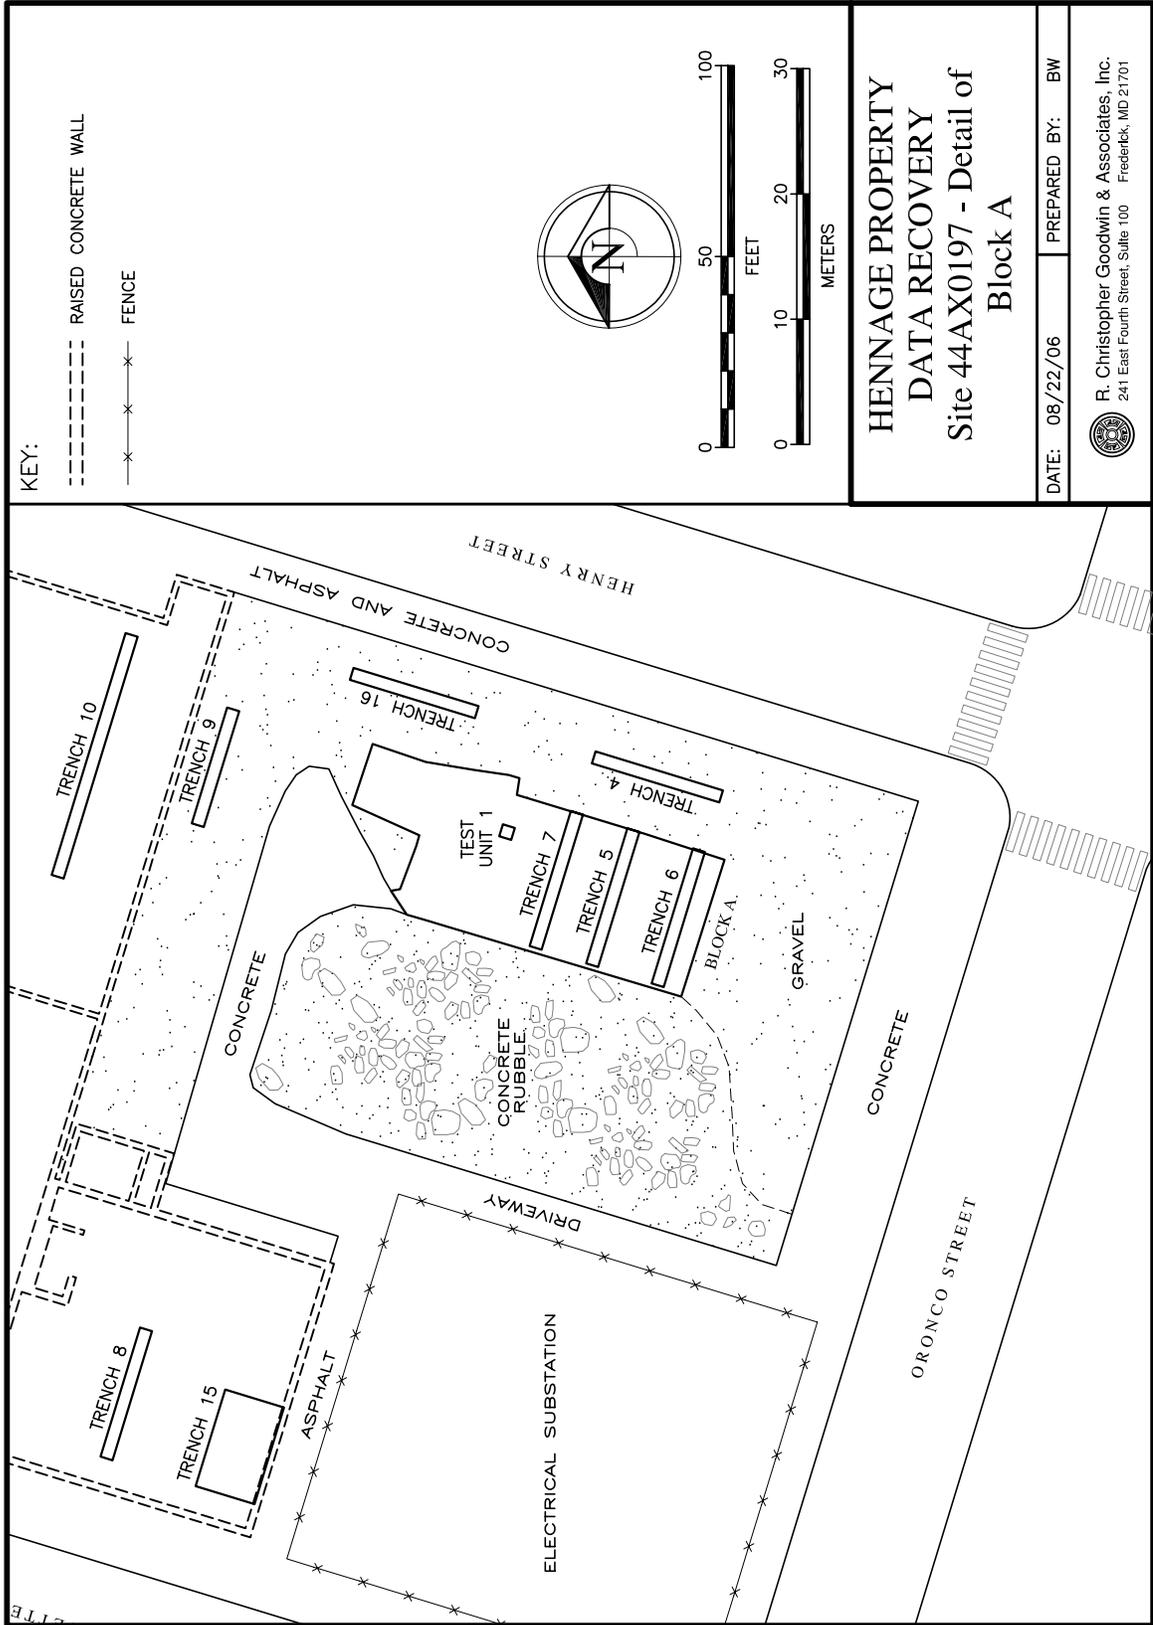
Figure 17. Plan of Block A, showing landscape and structural features, and locations of test trenches and units

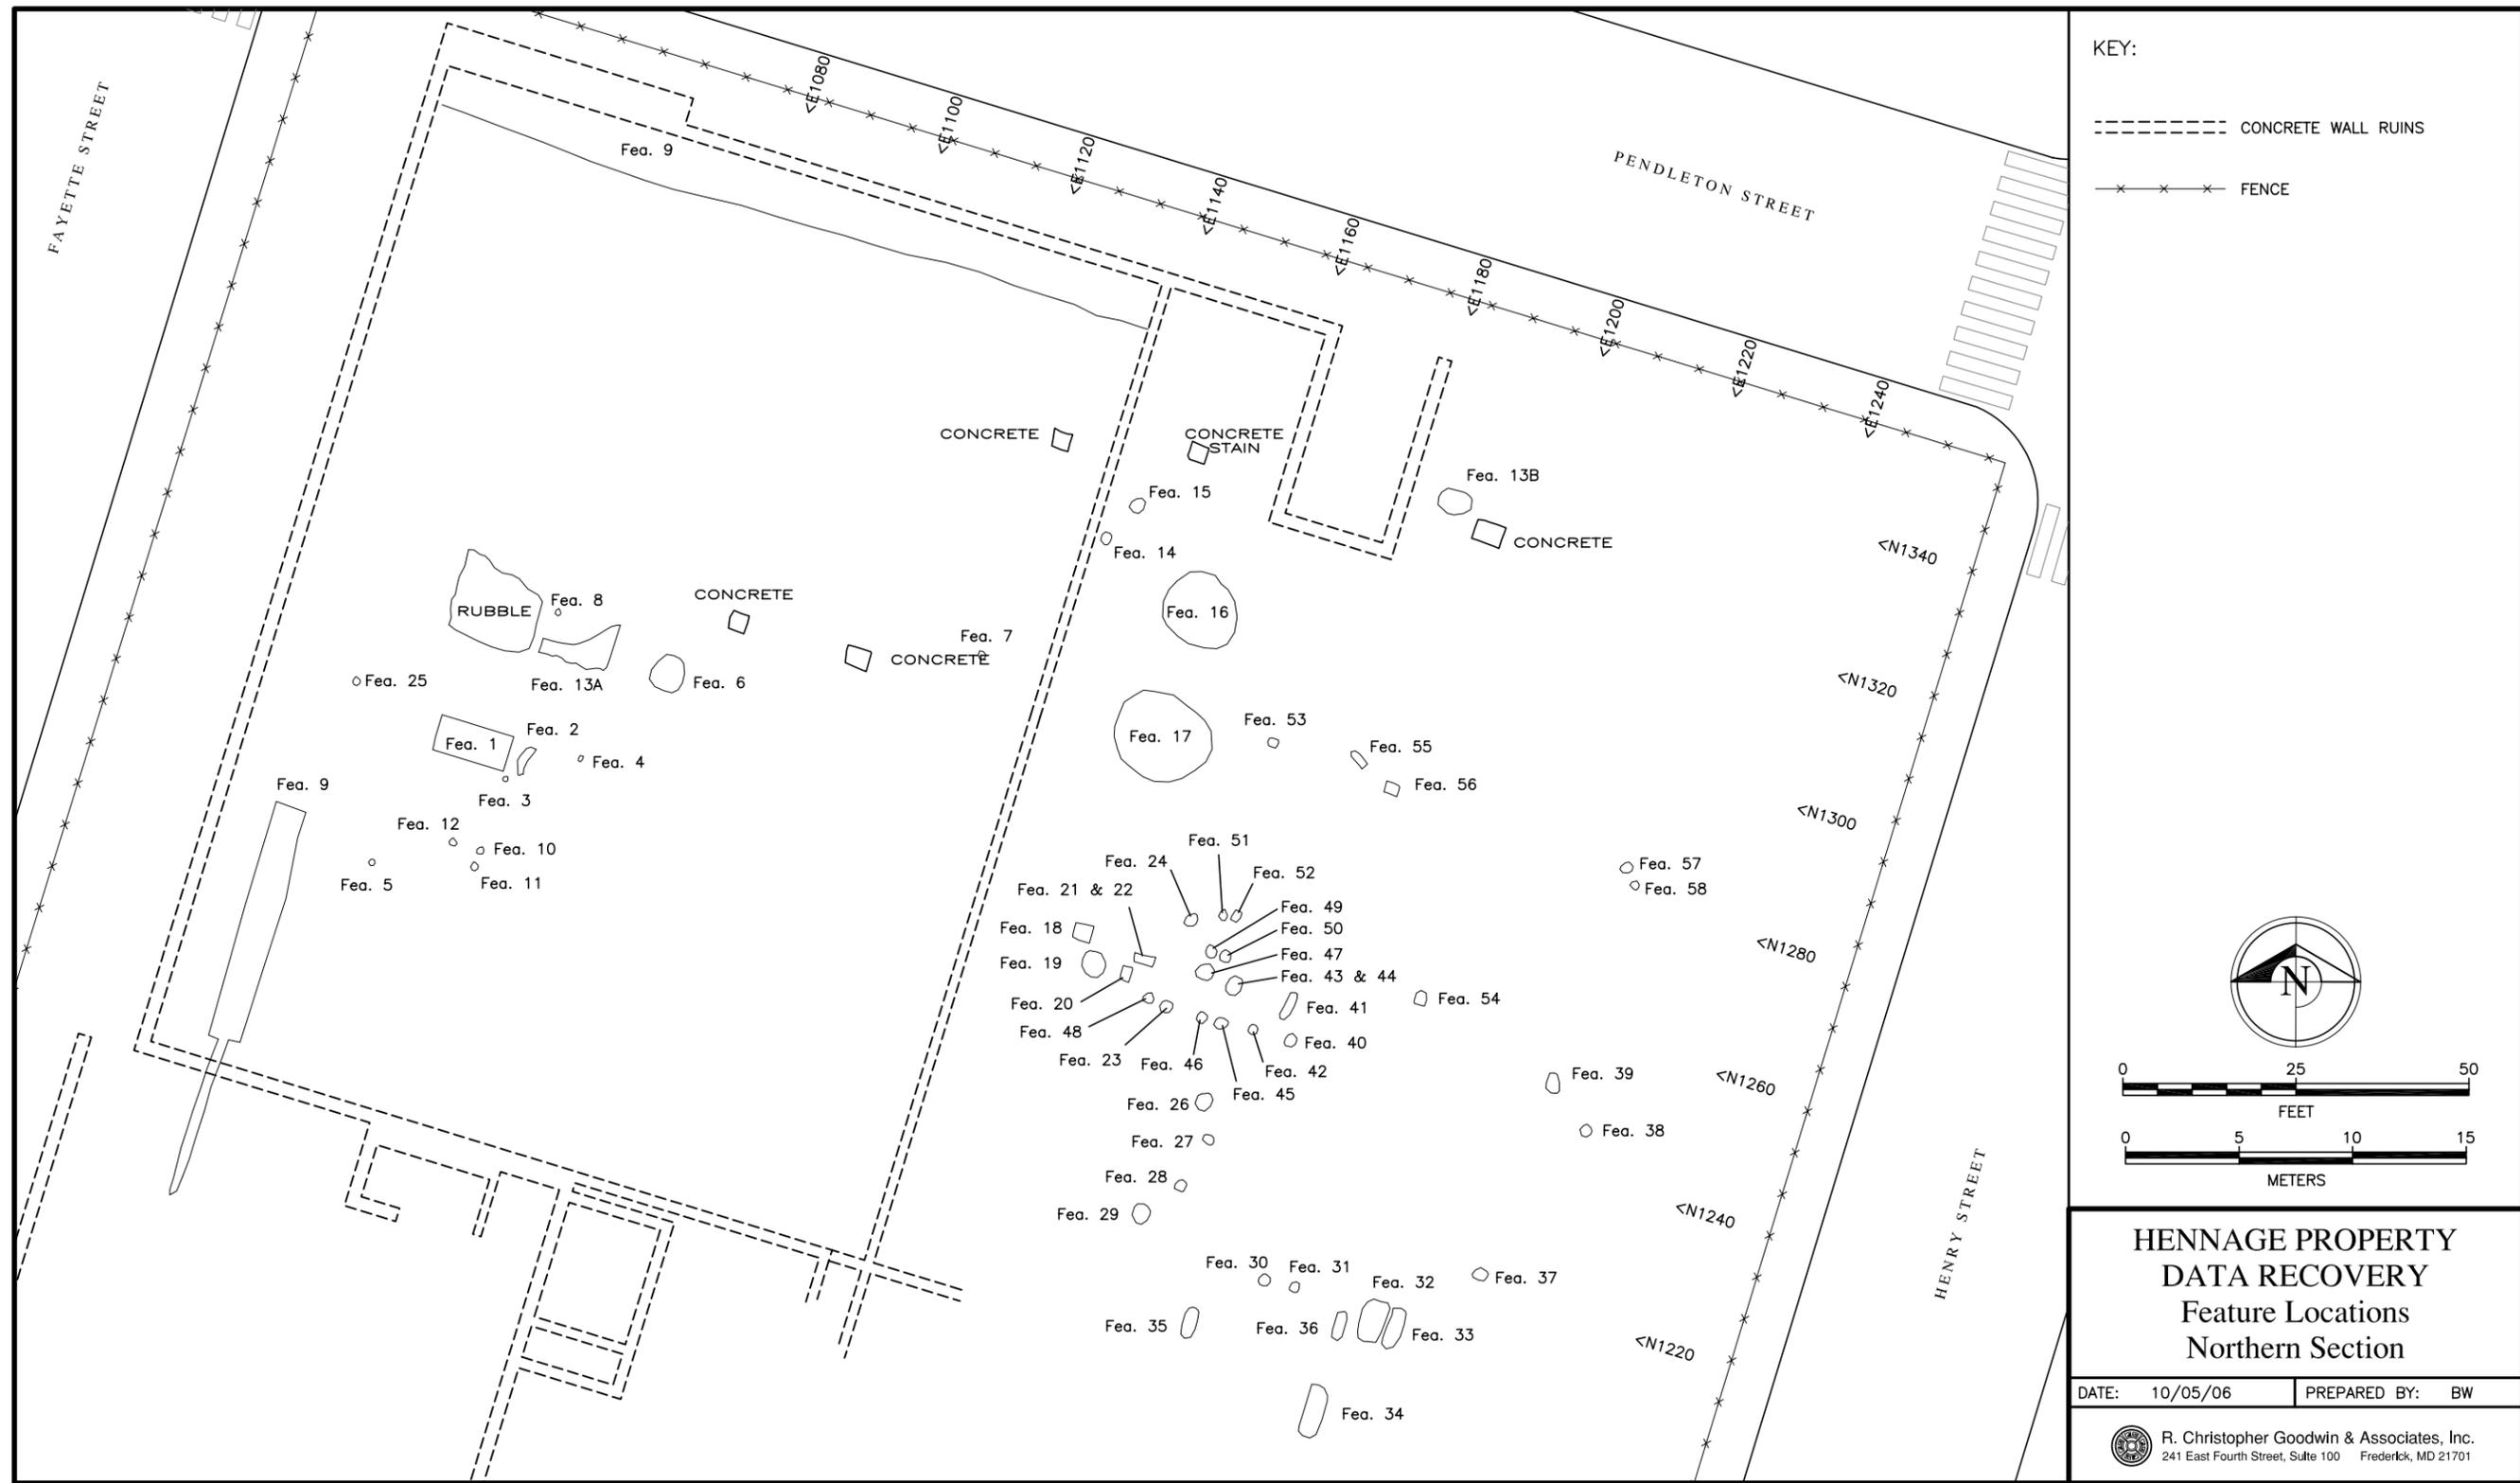
Figure 18. Plan of the northern portion of the block showing the configuration of features

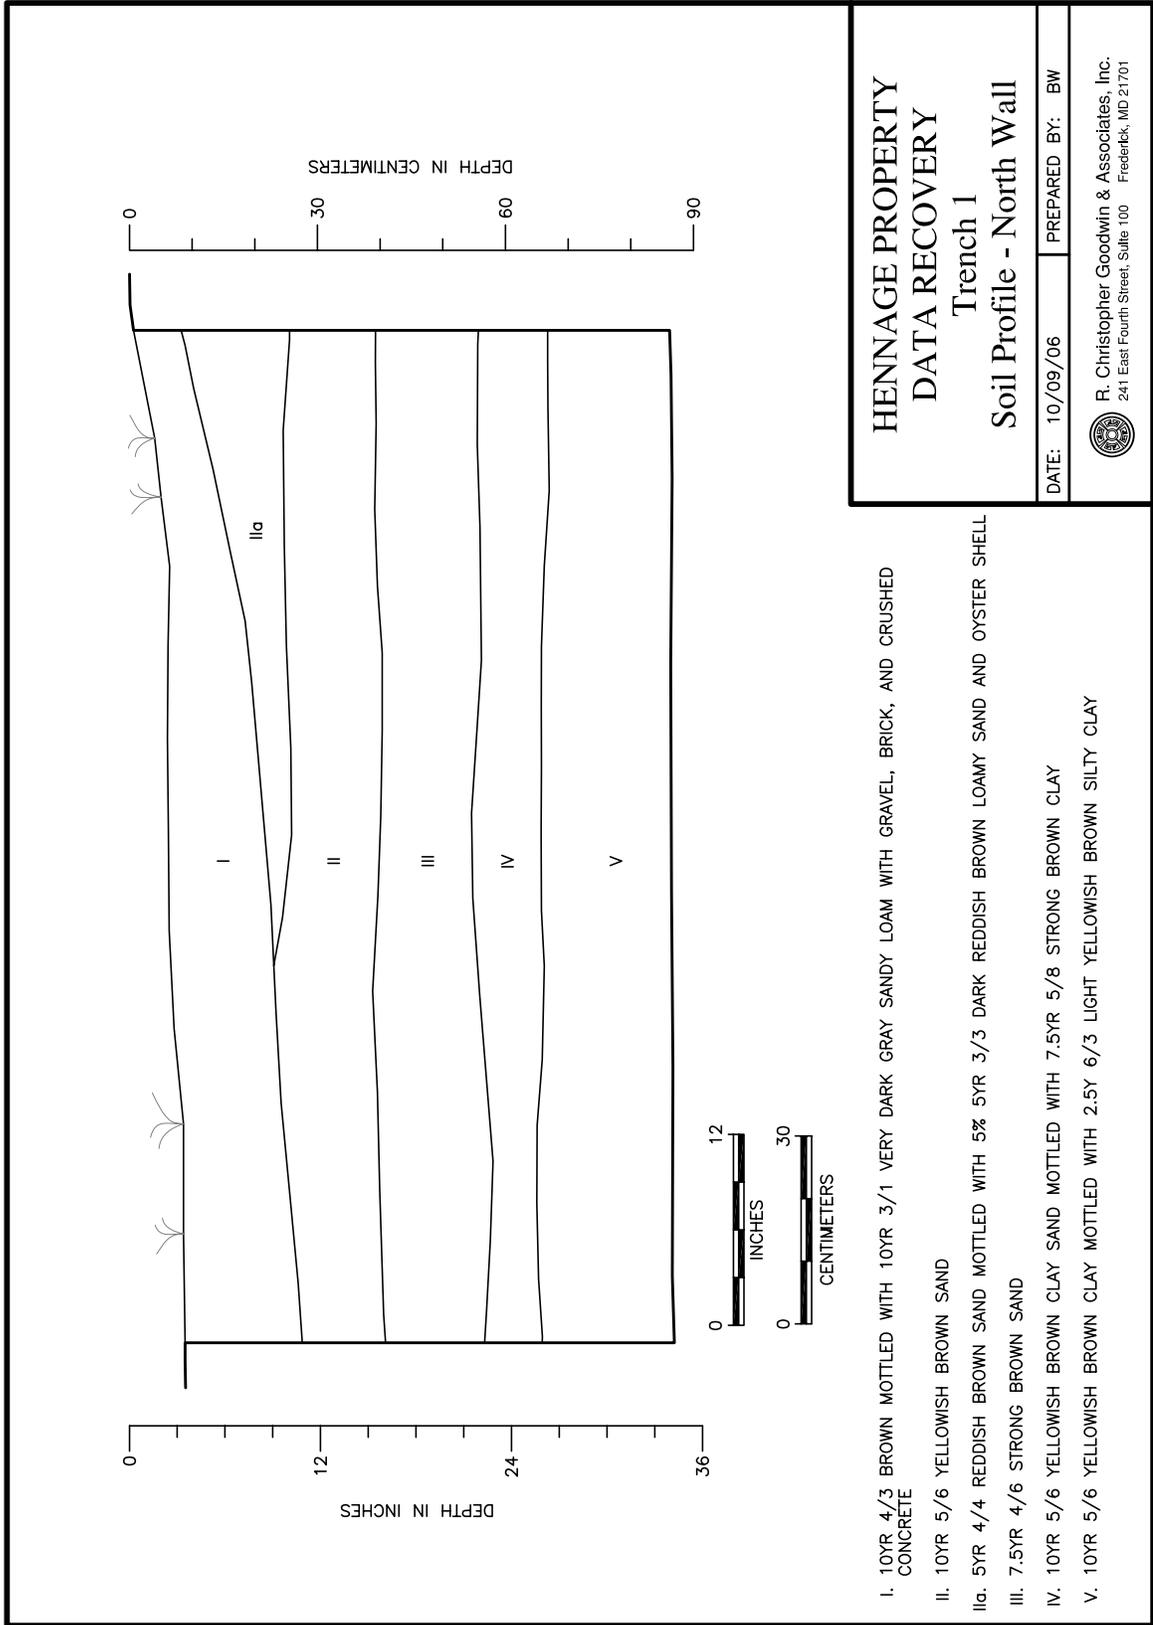
Figure 22a. Profile drawing for Test Trench 1

Trench 1, located in the extreme northwestern corner of the block, was oriented east- west, and paralleled Pendleton Street. Four soil strata were noted above subsoil. The uppermost stratum was an historic debris level; this was underlain by fill material (Strata II and IIa). The underlying strata, below these fill deposits, appeared as naturally occurring, undisturbed horizons. This soil sequence was composed of two strata (Stratum III and Stratum IV) above subsoil. Stratum III was composed of yellowish brown (7.5YR 4/6) sand; Stratum IV was a yellowish brown (10YR 5/6) clayey sand mottled with strong brown (7.5YR 5/8) clay; and subsoil (Stratum V) consisted of yellowish brown (10YR 5/6)

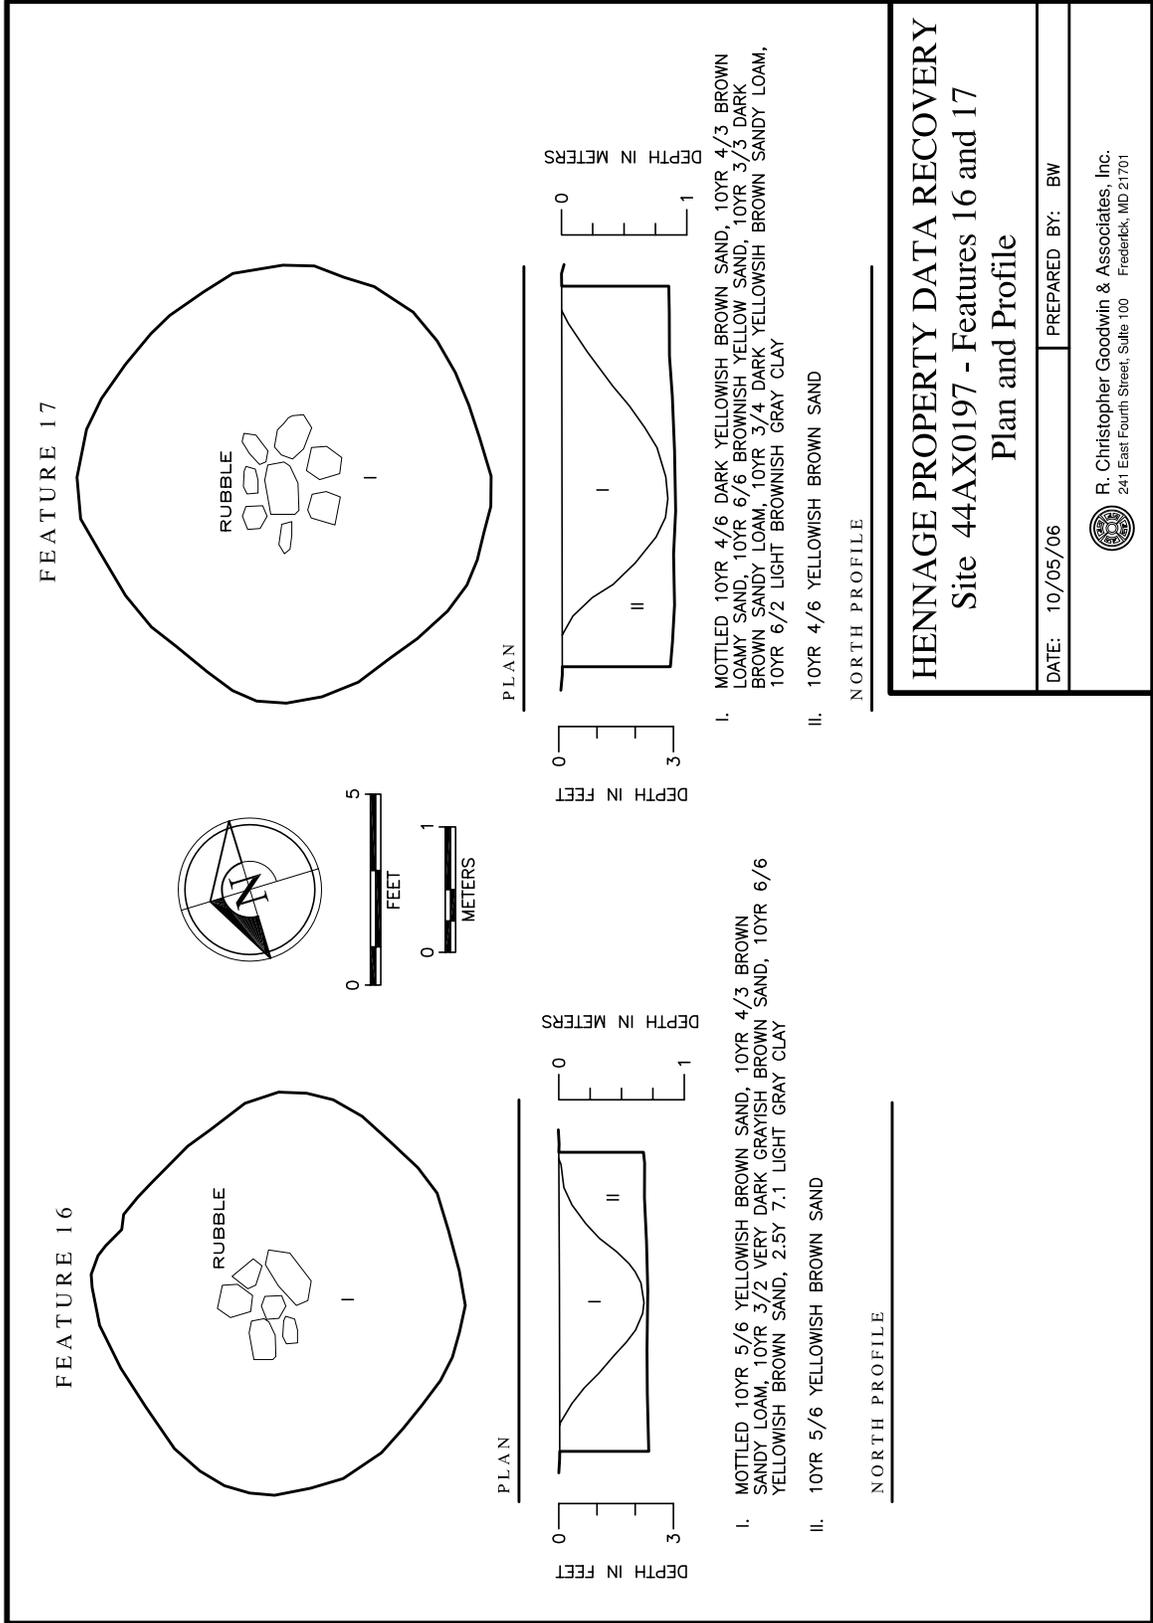
Figure 30. Plan and profile for Posthole Features 16 and 17

Features 16 and 17, spaced approximately 20 feet (6 m) apart, were particularly notable due to their size. These distinct mottled stains were round and approximately 10 feet (3 m) in diameter; they contained concrete and historic artifacts (such as glass insulators) on the surface (Figure 30). Although no structural remains were evident, they were similar in appearance to slumped wells observed elsewhere in Alexandria (Francine Bromberg, personal communication). Because of their size, the features were bisected mechanically. The basin-shaped profiles extended to subsoil, slightly shallower than three feet (Figure 30); the sides and bottoms of the features were fairly regular and 'clean'. The mottled fill contain bottoms of each of the features,

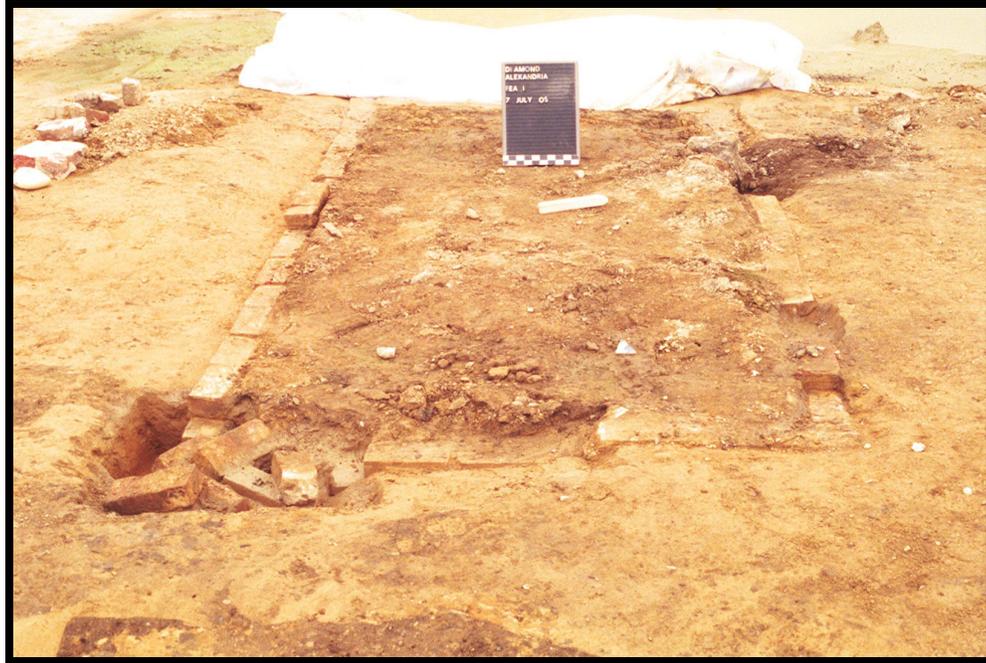
Figure 41. Photograph showing the remnant of the burial vault before hand excavation

The remains of the burial vault (Feature 1) consisted of an 11.3 by 5.8 ft (3.4 by 1.8-m) rectangular brick foundation with walls one brick thick that rested on a concrete footer (Figure 41). Only the lowest four courses of brick remained; there was no floor or paving on the interior, but the inside of the footer

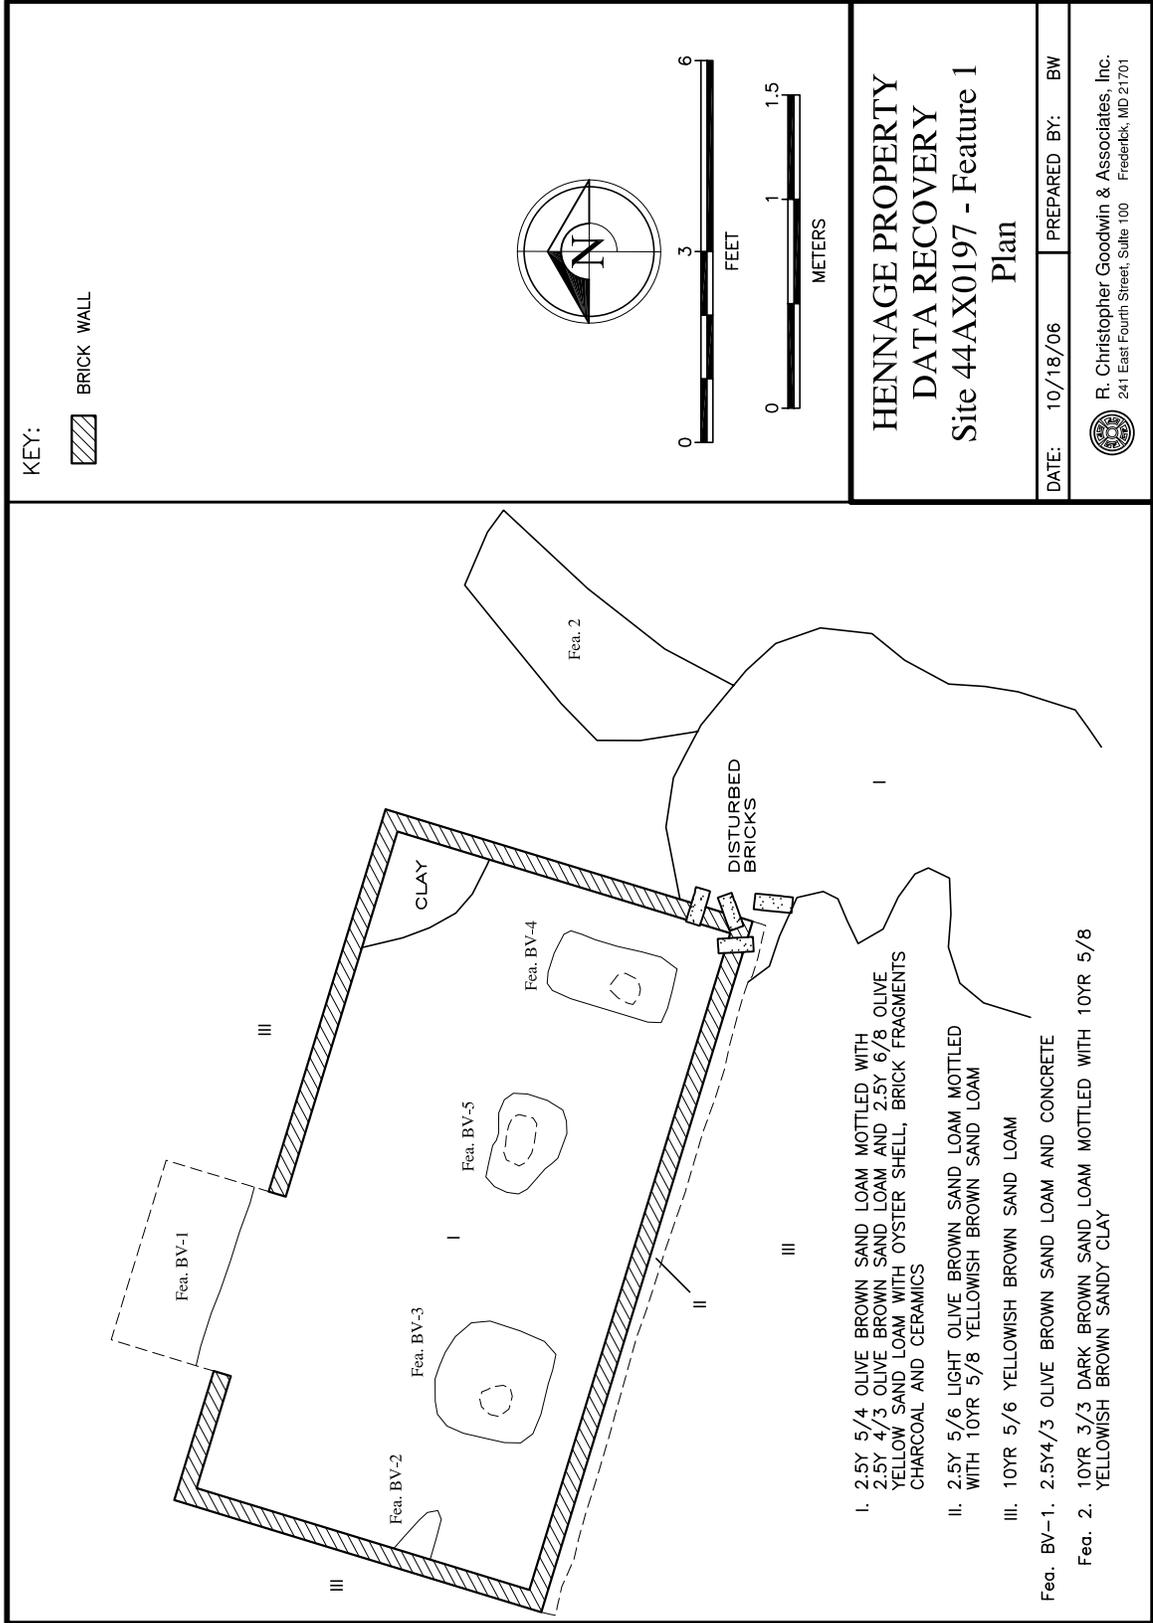
Figure 42. Plan of Feature 1 and Test Unit 2, showing the locations of Features BV-1 - BV-5

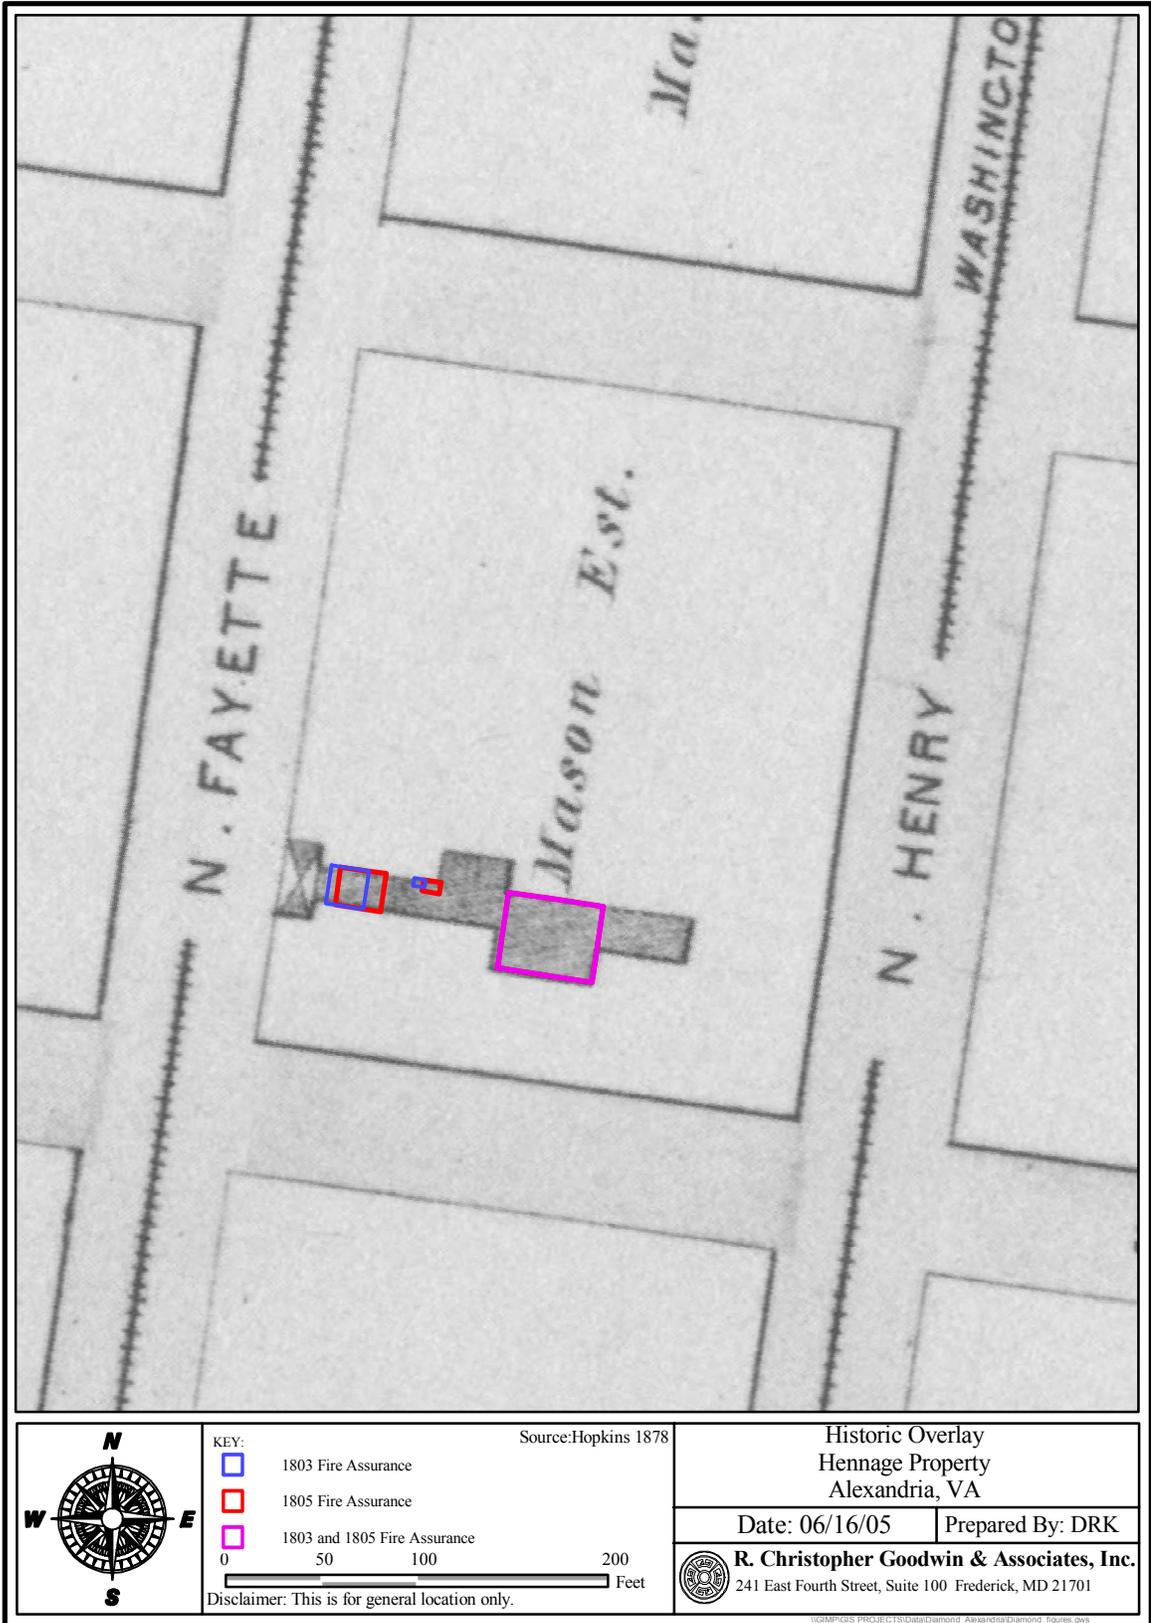
Figure 48. Overlay of historic maps showing the original configuration of the main dwelling and dependencies
