Final Report

Archeological Investigations
of the

COLROSS SITE
(44AX0197)

Alexandria, Virginia

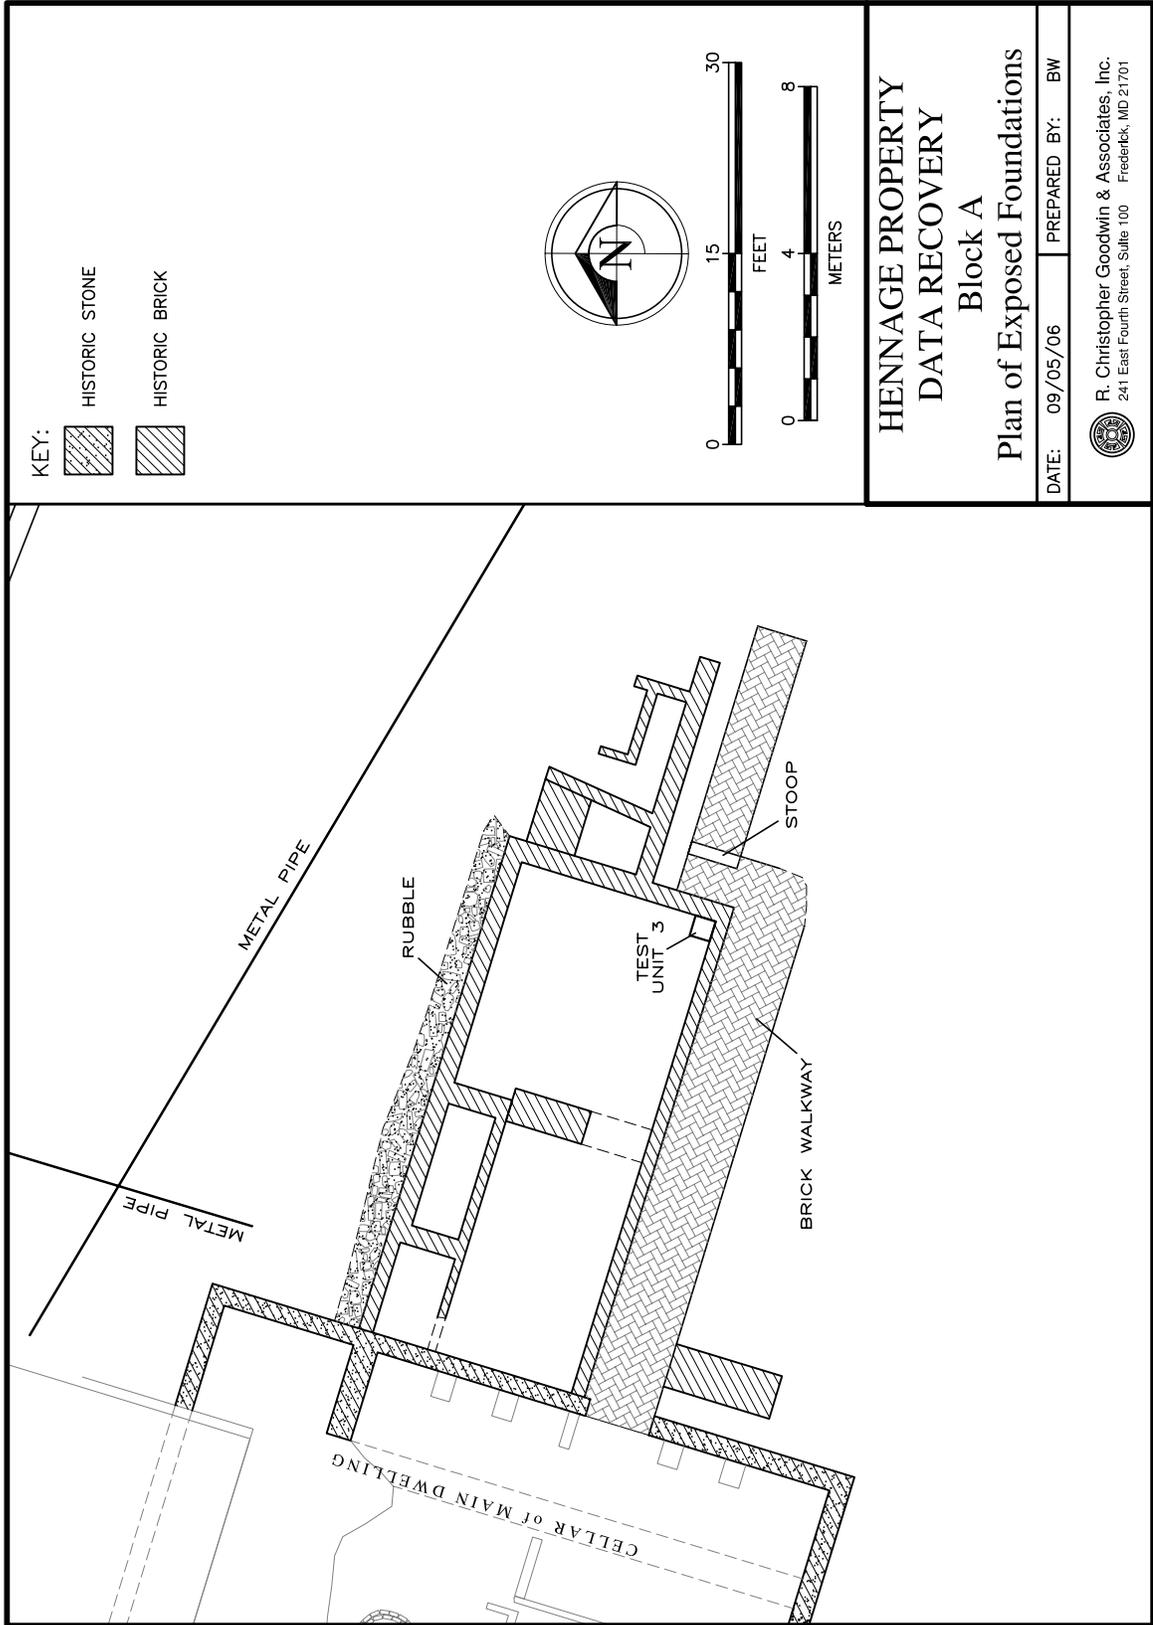
Figure 52. Plan drawing of exposed foundations in Block A

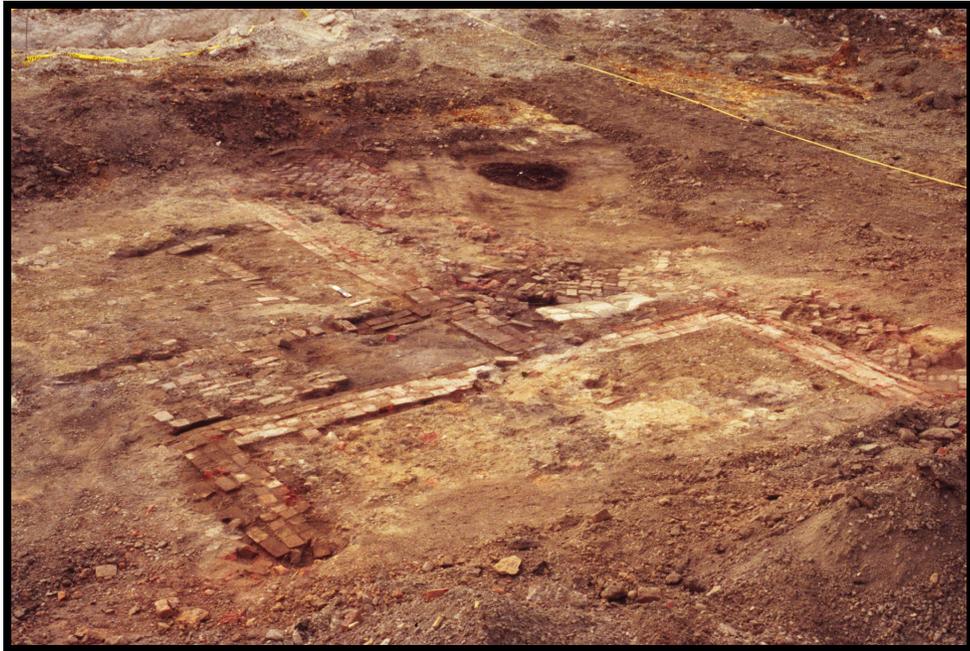
Figure 53. Photograph of the foundation of the eastern wing of Colross

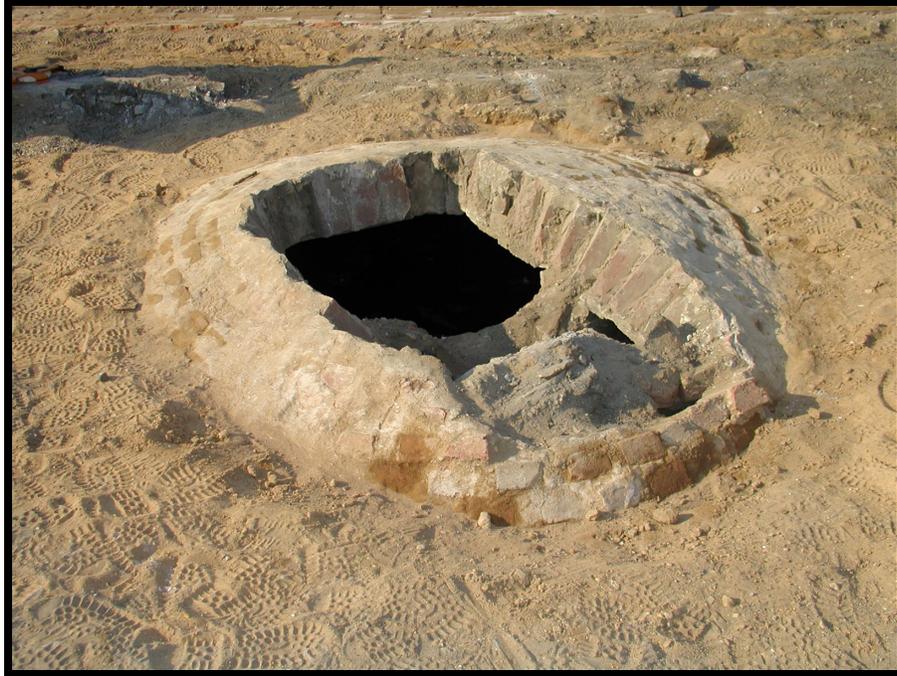
Figure 71. Photograph of the top of the cistern

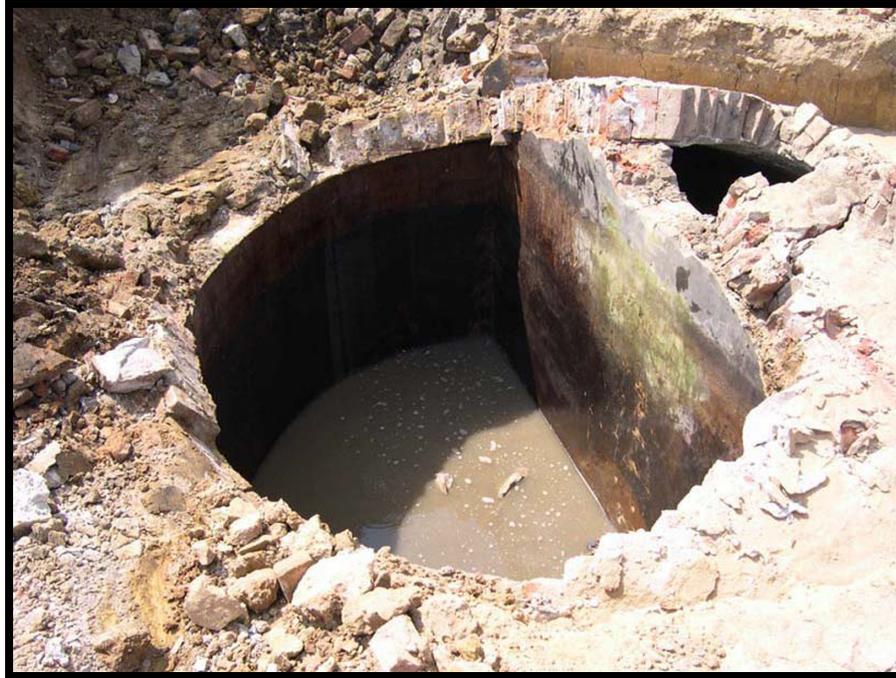
Figure 75. Photograph of the interior dividing wall of the cistern

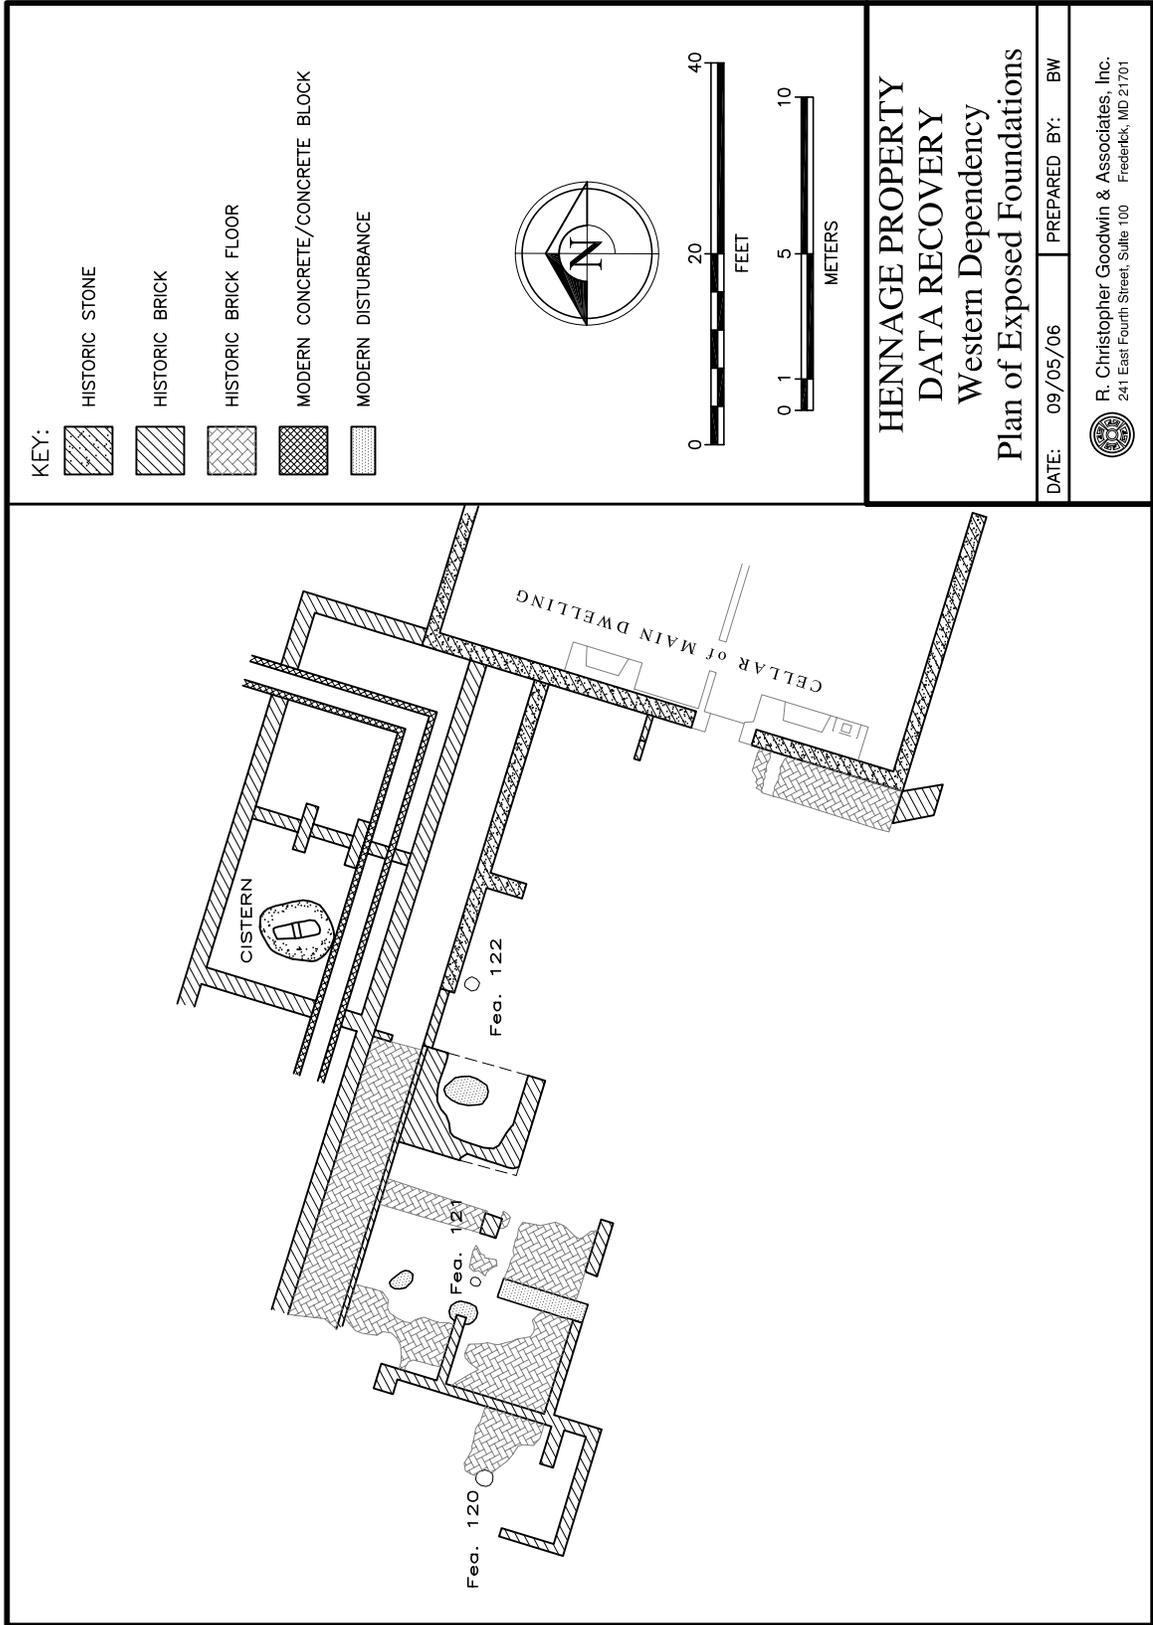
Figure 76. Plan of western dependency foundations and the cistern

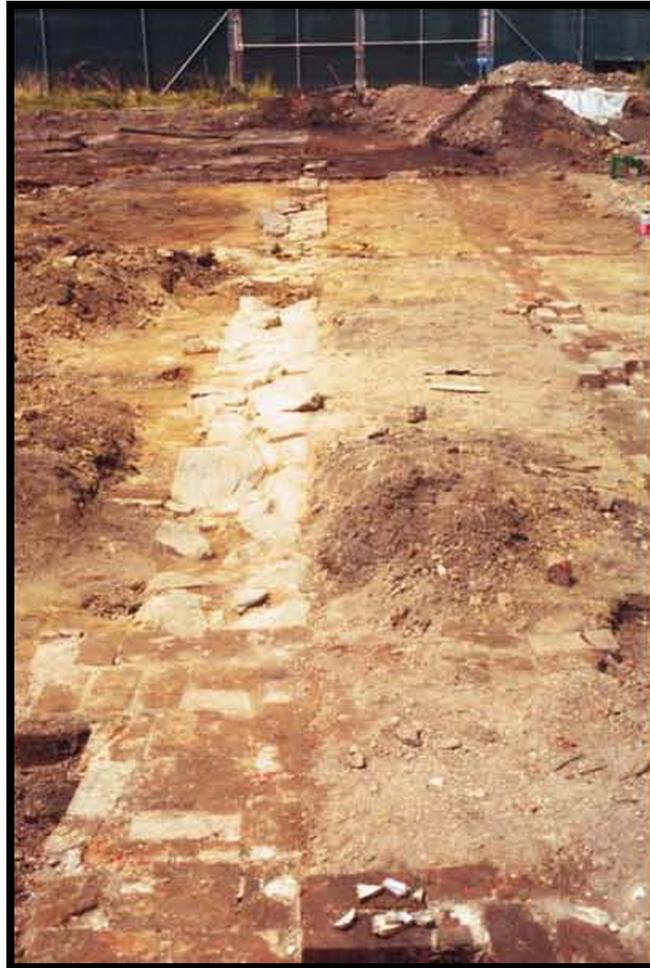
Figure 77. Photograph of the foundations of the dependency buildings

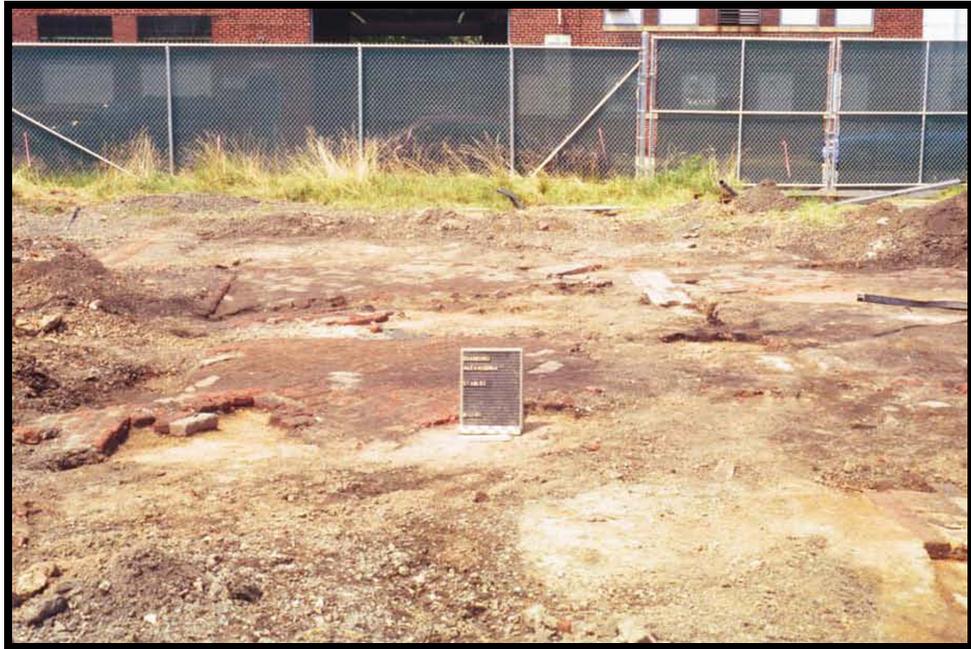
Figure 79. Photograph of the stable foundation

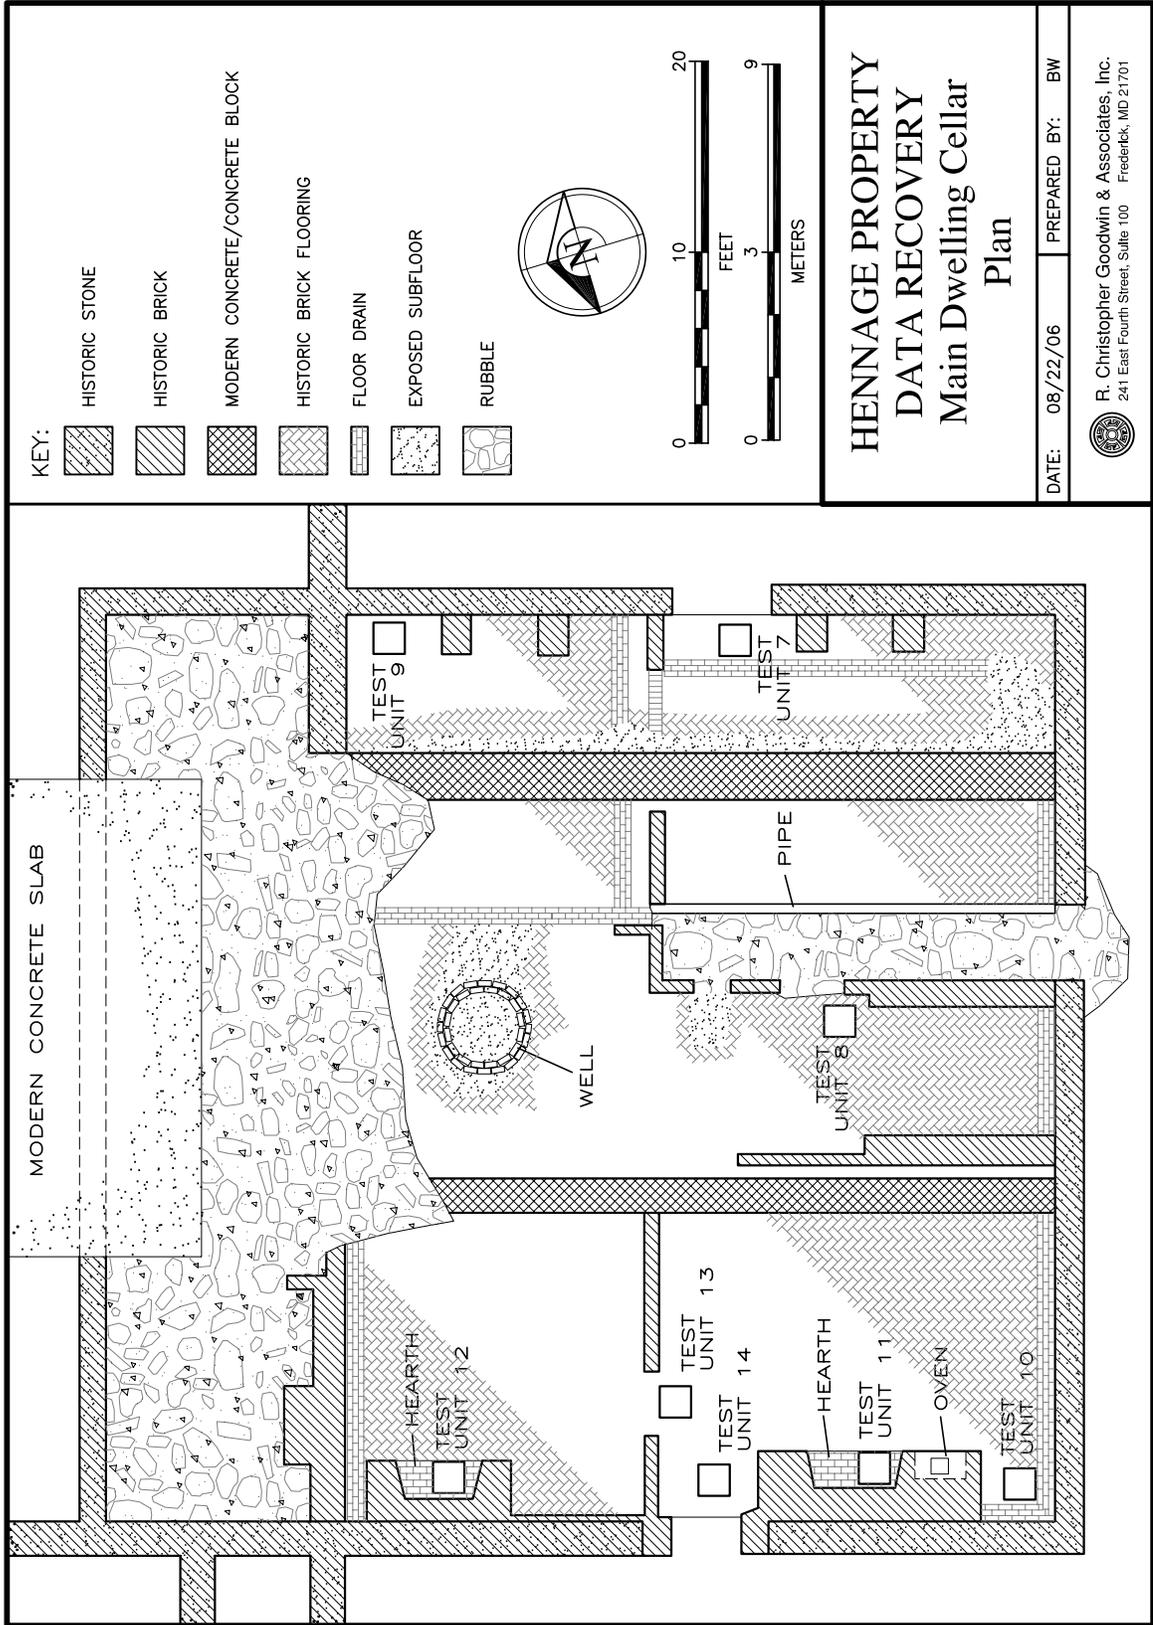
Figure 81. Plan drawing of the cellar of the main dwelling

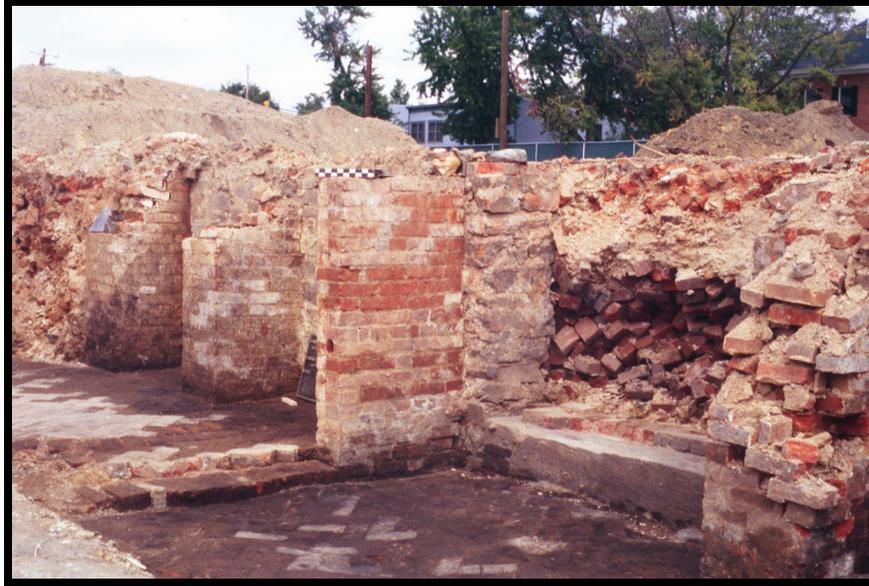
Figure 84. Modification to the eastern cellar wall of the main dwelling

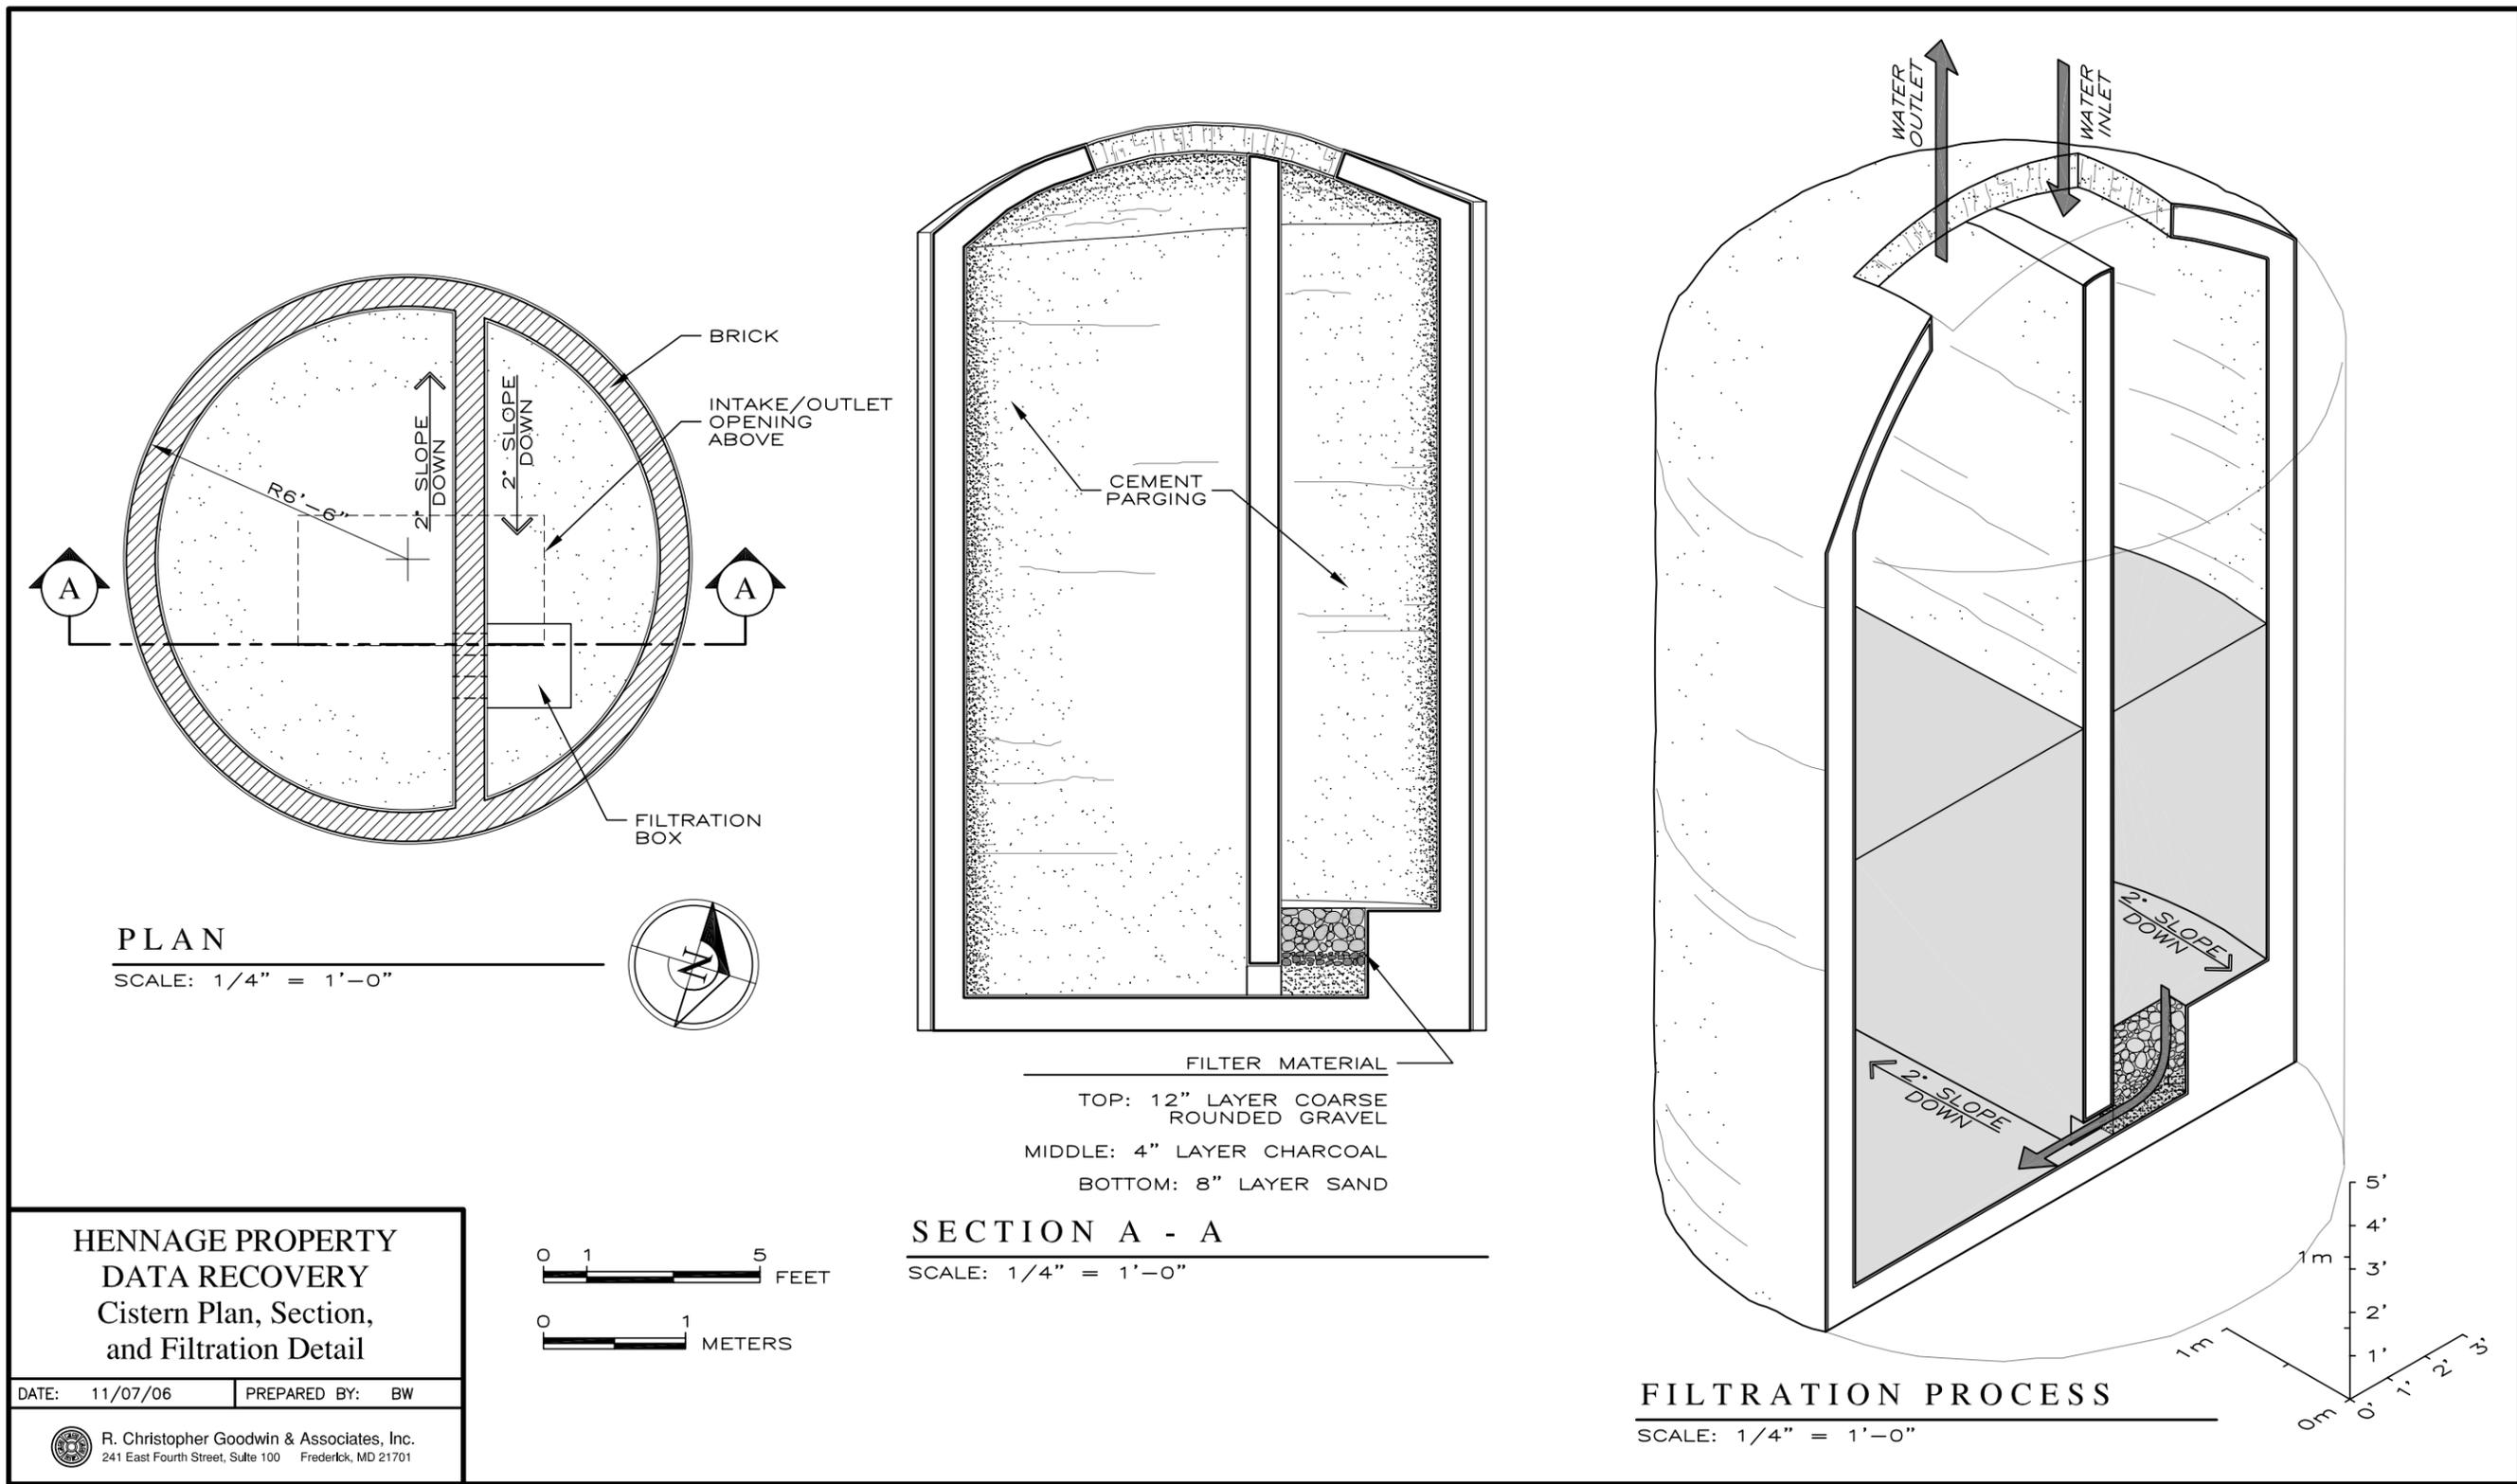
Figure 91. Plan of the filtration box for the cistern

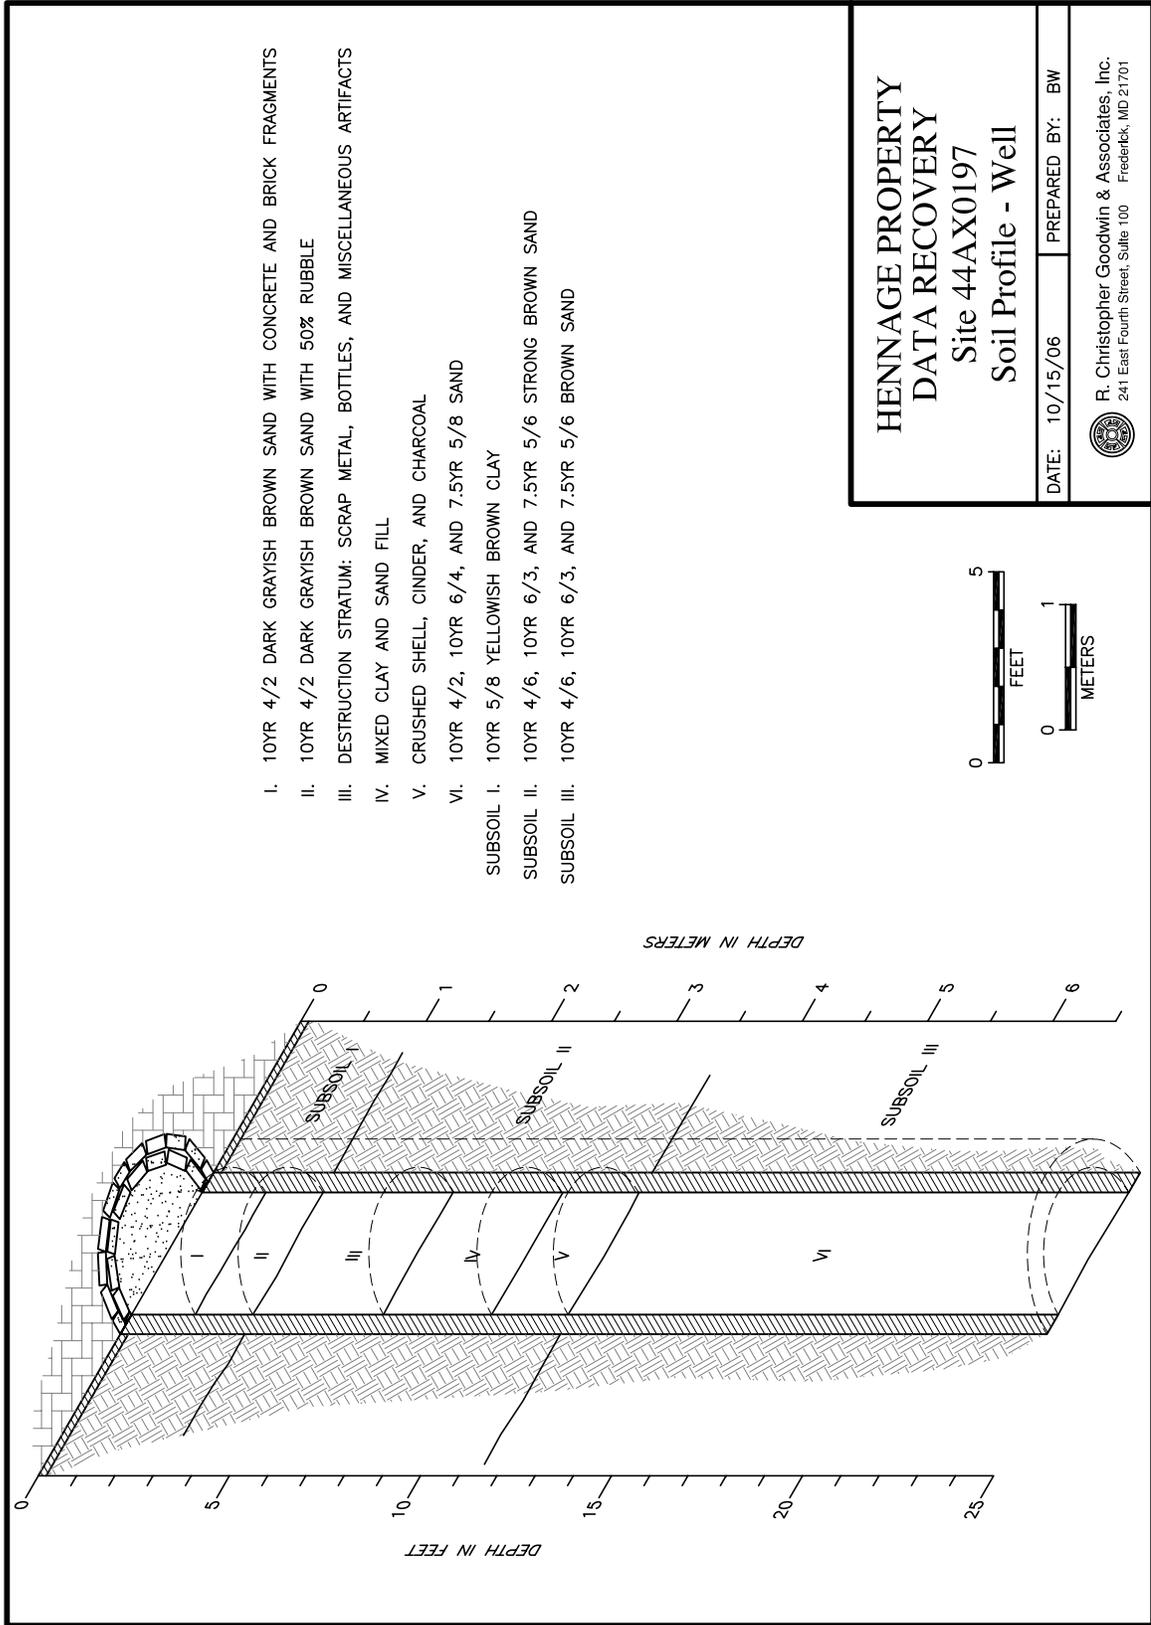
Figure 96. Profile of soil surrounding the brick lined well
