**ROBERT PORTNER BREWERY
(44AX0196)**

INTRODUCTION

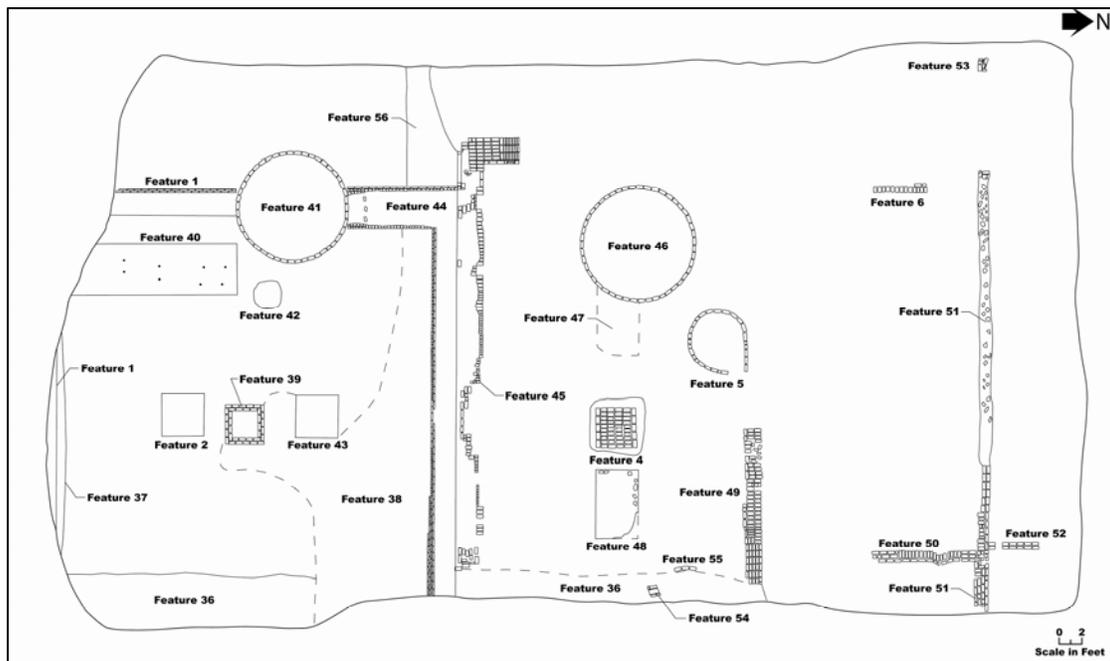
Archaeological Features in the Southern Portion of the Project Area

Additional brick foundations associated with the construction of the new brewhouse in 1894 consisted of exterior walls (Feature 1) and new interior walls (Feature 44) which were slightly skewed from the original wall (Feature 45). A later construction period (pre-1907) is represented by the east wall of the Grain Dryer building (Feature 3).

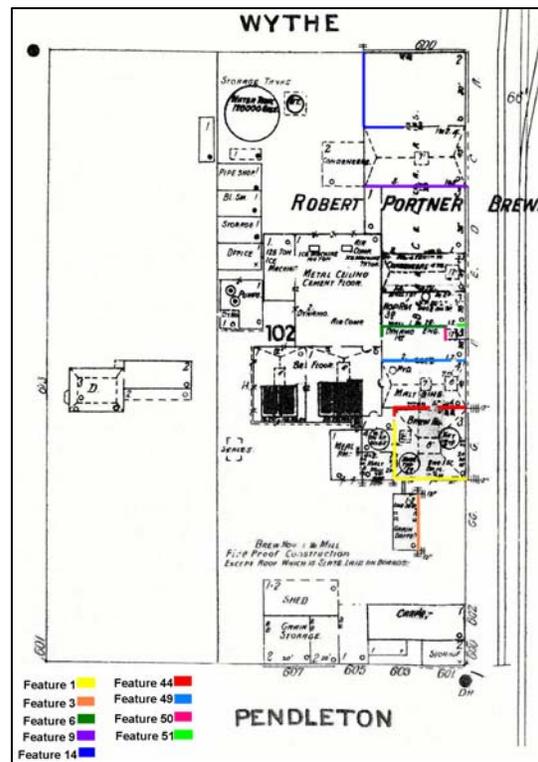
1907 Sanborn Map with Features

have supported the cast iron framework that held up the interior platforms and stairs; *or* the hop jack, which added hops to the wort for flavoring, then strained them out; *or* the receiving tank for the brew on its way to the coolers. But perhaps the most likely alternative, however, was that the stones served as the base for the brewhouse freight elevator, depicted on the 1902, 1907, and 1912 Sanborn maps as being in roughly the same location.
