# Telegraph Road Tunnel

# Holmes Run Trail Tunnel

Existing Conditions and Recommendations Study  
for the City of Alexandria

Prepared by Toole Design Group  
March 2016

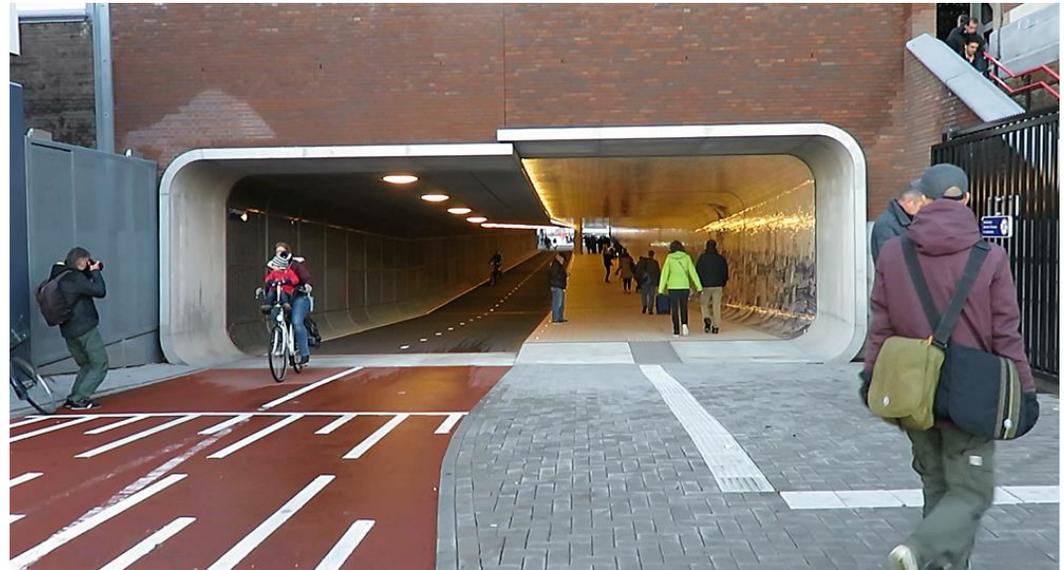
Amsterdam Central Station Tunnel showing separated paths for pedestrians and bicyclists. The tunnel is 110 meters long, 10 meters wide and 3 meters high. Photo, [bicycledutch.wordpress.com](http://bicycledutch.wordpress.com)

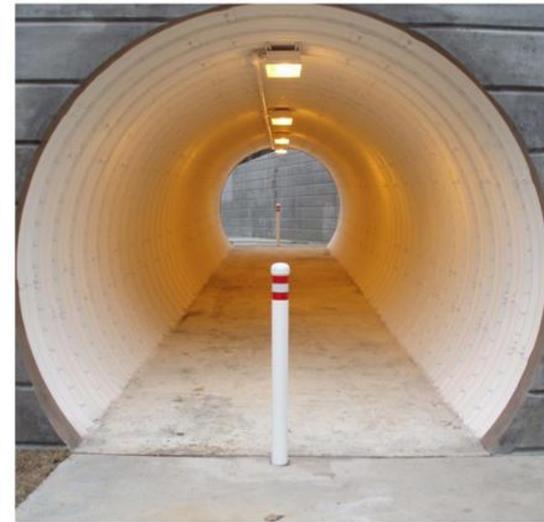
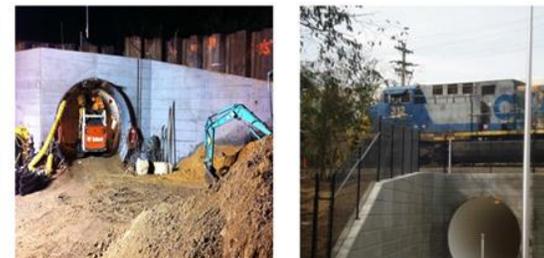
### Lafayette Street Pedestrian Tunnel Tallahassee, FL

Bradshaw Construction built a 55' long hand mine liner plate tunnel for Florida State University to prevent pedestrian overflow onto Lafayette Street after FSU football games. Bradshaw has a long history of building liner plate tunnels; what made this project unique was the active CSX railroad tracks only 6.5' overhead. Trains traveled over the tunnel many times per day during construction. Carrier beams and temporary bulkheads were used to augment the structural integrity of the unfinished tunnel while trains traveled overhead. Construction on this tunnel was conducted around the clock and the tunnel was completed in an expedient manner. The project was "runner-up" for project of the year by the Florida Transportation Builders Association (FTBA) in 2011.

Example of a dug pedestrian tunnel under a roadway.

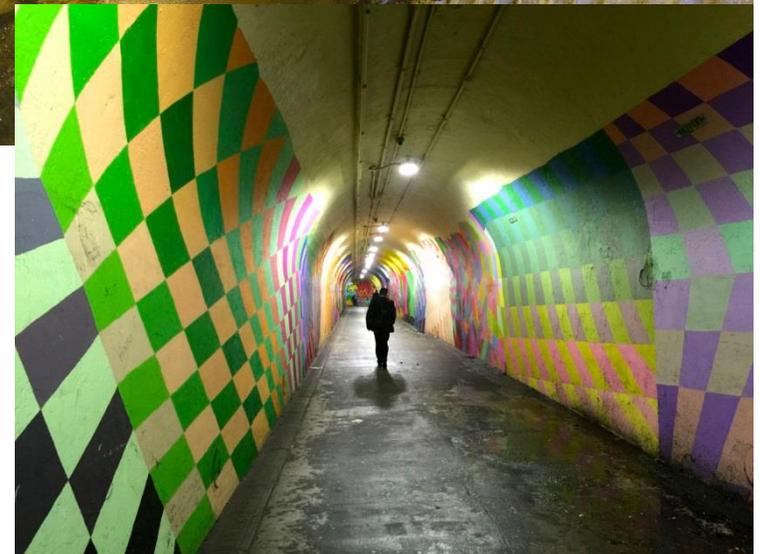
The interior of the Telegraph Road tunnel is of corrugated metal with a concrete floor. The metal has been painted and the paint is visibly peeling. There is a minor amount of graffiti. On the day of the site investigation, water was present on the floor of the tunnel, and there is evidence that continued exposure to moisture has corroded the metal at the base of the tunnel walls.

Although neither tunnel meets national guidelines for width and height, the tunnels are both well used and are not likely to be replaced in the short term. It is recommended that an evaluation be performed to determine whether the corrosion in the tunnel is affecting the tunnel's structural integrity and whether an abrasive means of cleaning the tunnel could be used. Both tunnels would benefit from being cleaned of peeling paint. It is not clear whether the current paint is lead-based. The paint should be tested for lead prior to removal. Once the tunnels are cleaned, it is recommended they be repainted with light, bright, attractive colors, and maintained regularly. Use of lighter colors can also be used to enhance the effectiveness of the tunnel lighting.

Clean tunnels of peeling paint and corrosion (based on findings from structural and lead paint analyses)

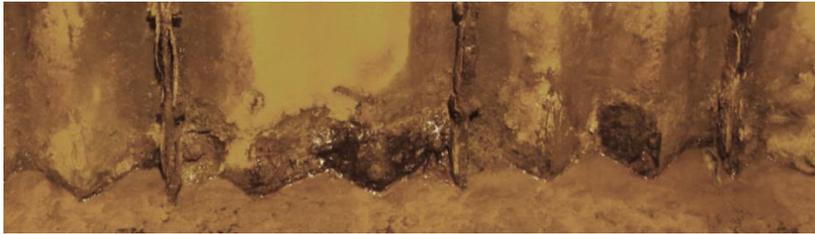
Corrosion at base of the tunnel

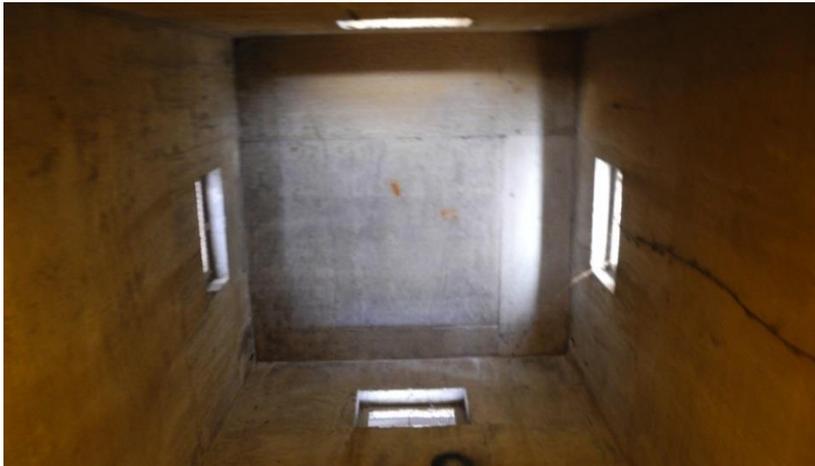
The low point of the tunnel includes a drainage grate inlet on the western side with metal bars in place of the corrugated metal wall. There appears to be a pump in behind the grate, which pumps any water collected to a point outside the south tunnel entrance. The metal bars correspond to a shaft (approximately five feet by five feet) which rises up to the surface and includes four small windows on their exterior sides. It is likely these windows are for ventilation and/or light.

Shaft at the center of the tunnel (looking up)

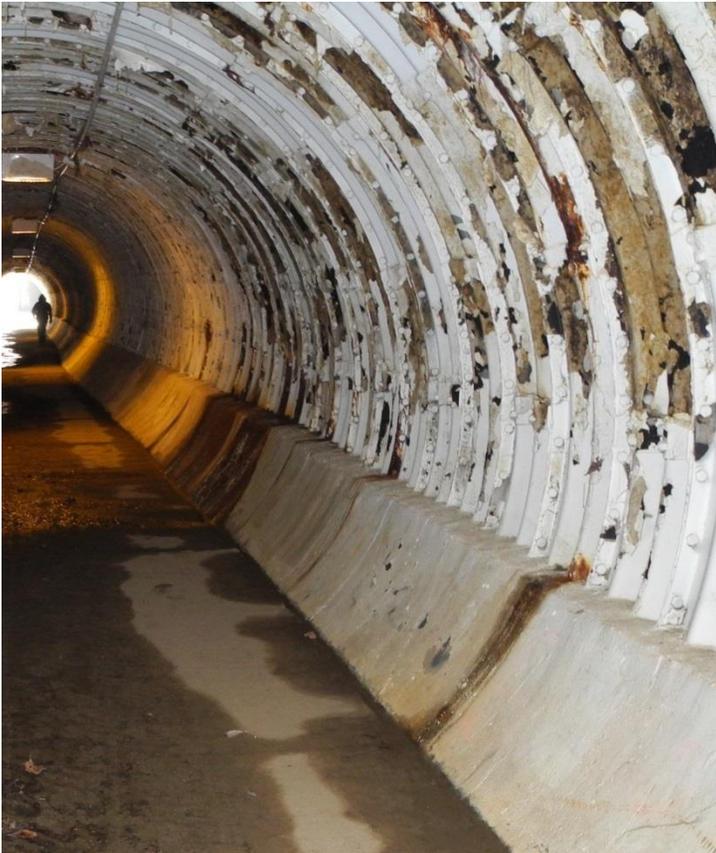
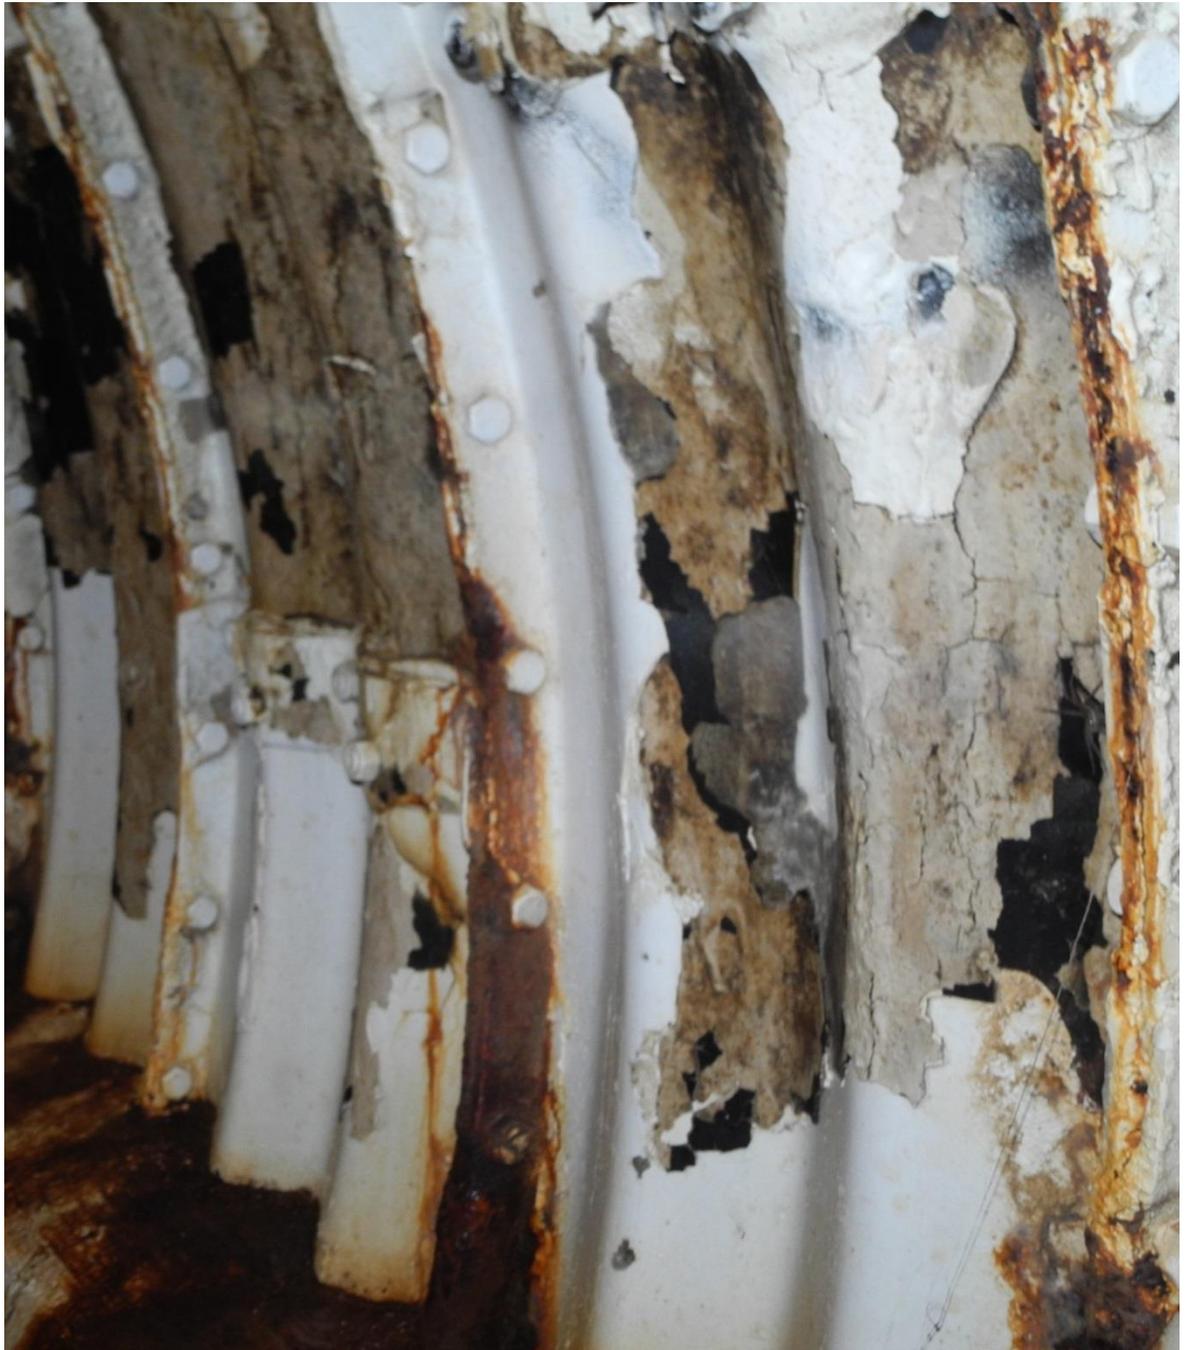
The interior of the Holmes Run Trail tunnel is corrugated metal with cast concrete floor and cast concrete walls up to approximately 2.5 feet in height. . Rust is visible on the metal walls of the tunnel. The depth of the corrosion and the material behind the metal (dirt, cement, etc.) could not be discerned. The corrugated metal has been painted and the paint is visibly peeling.

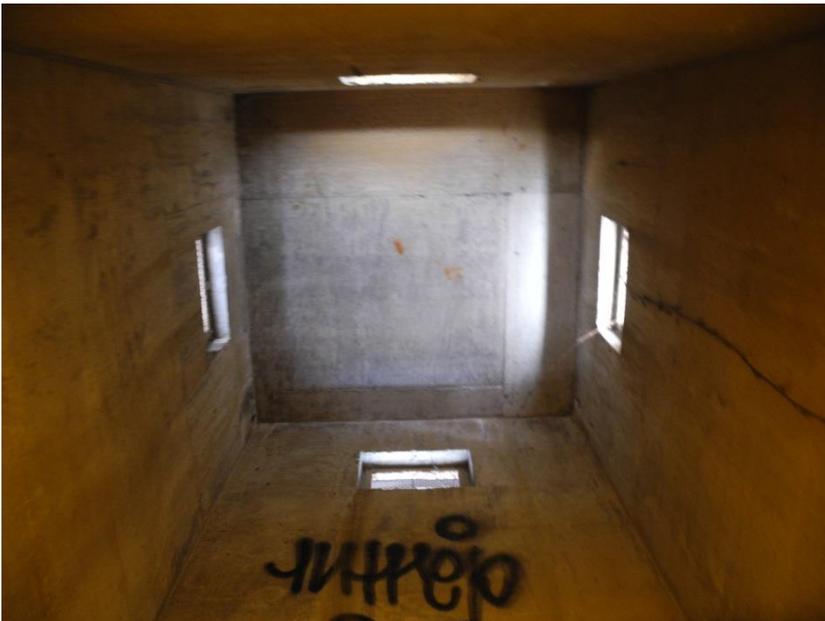
There is poor visibility between one end of the tunnel and the other. There is a shaft at the center of the tunnel with four small windows.

Shaft at center of tunnel with windows and natural light.

- Install new lighting
- Increase the amount of light coming through the Telegraph Road Tunnel shaft
- Use lighting design firm or work with artists to include light as part of a tunnel design project
- Improve tunnel entrance lighting, particularly at north entrance to Telegraph Road tunnel.

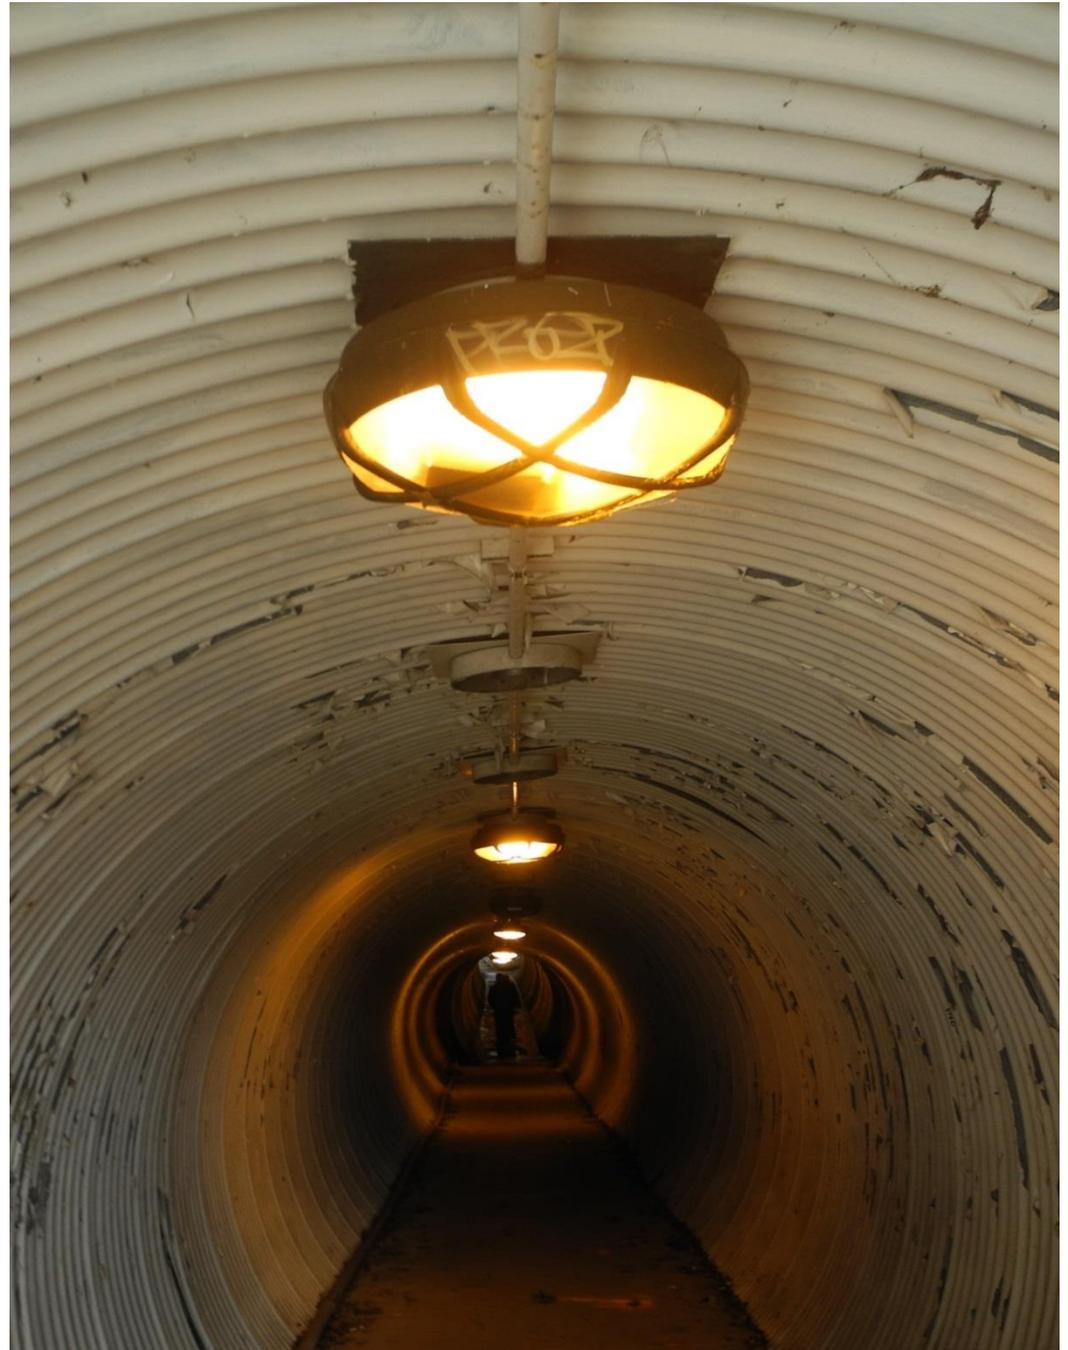
There are currently seventeen lights in the Telegraph Road tunnel approximately 8.5 feet on center, though the spacing of the lights vary. Currently, three lights are not working. The lights are fitted with protective cages. On the southern end there are a series of junction boxes located between the lights.

Typical light with protective cage and junction box in Telegraph Road tunnel.

Although lighting is present and operating at all times in both tunnels, lighting levels could be enhanced. The Maryland *SHA Bicycle and Pedestrian Design Guidelines* recommend at least 10 foot-candles in pedestrian tunnels. This level should be considered in relation to the entranceway lighting to ensure users are able to adapt to the tunnel lighting. For best results, photometric analyses should be performed to determine existing lighting levels and the number, strength, and location of a new lighting system. A lighting designer can further enhance the tunnels. In the Telegraph Road Tunnel, natural light can also be enhanced on the northern end. At this location, vegetation has grown up in front of the tunnel reducing site lines.

- Reduce vegetation overgrowth at Telegraph Road Tunnel north entrance and maintain on a quarterly basis
- Conduct photometric analysis of existing lighting (in tunnel and at entranceways) and determine with lighting specialist the best lighting levels for the tunnel
- Upgrade existing lights with additional lights, brighter luminaires

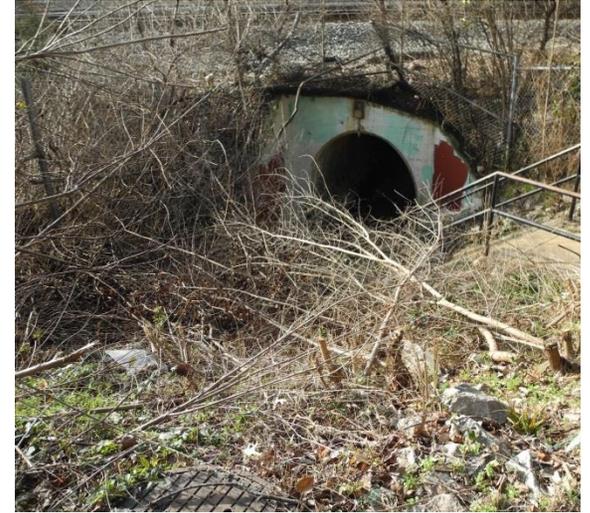
Vegetation at Telegraph Road Tunnel

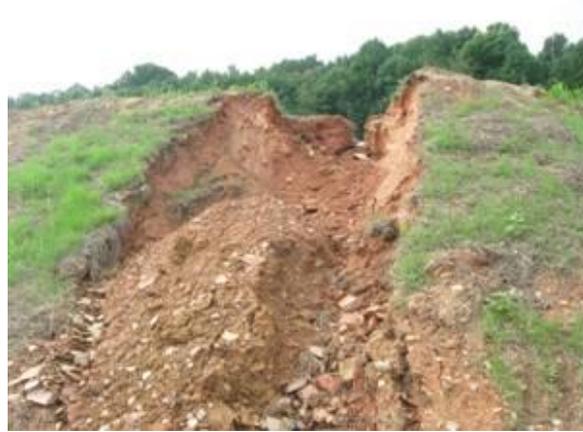
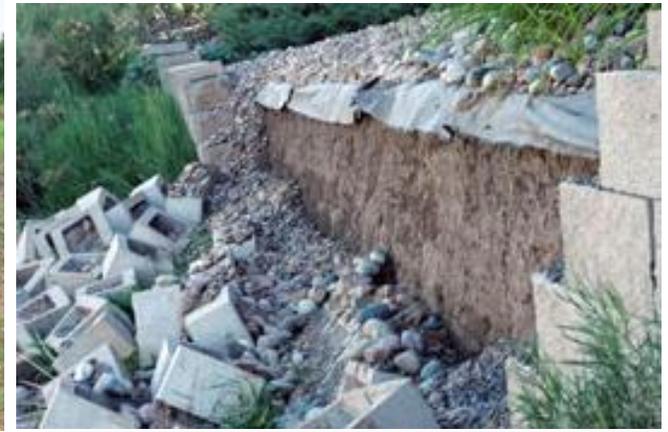
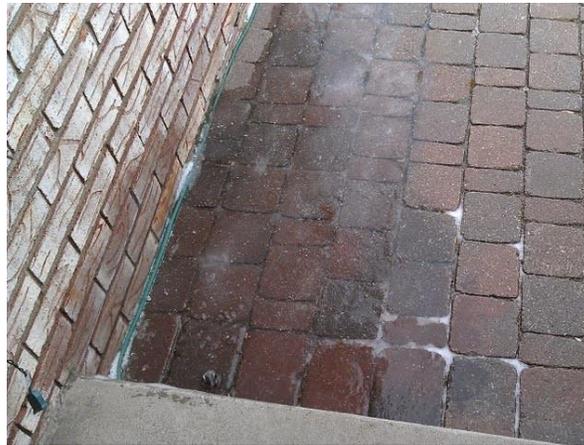
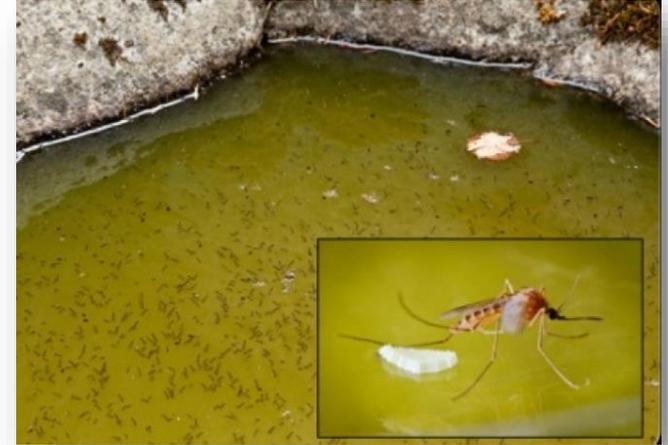
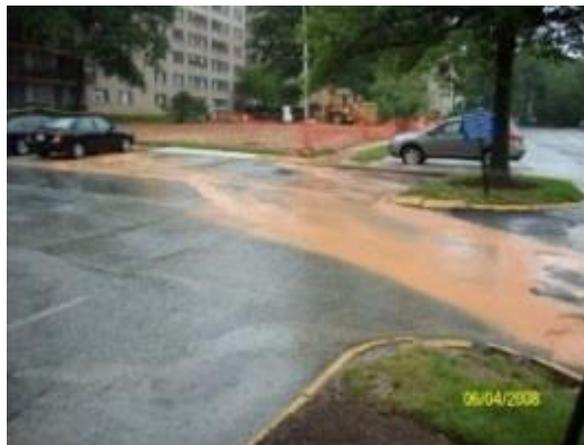
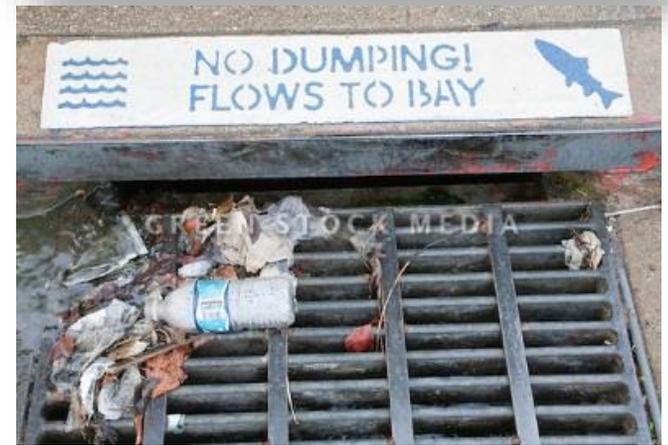
Examples of issues due to poor drainage

In general, the goal is to provide a path for water to drain in both small and large storm events. Water will flow along the path of least resistance and if uncontrolled, will erode surfaces and carry sediment and trash. If a low spot exists, water will pool, collect sediment and trash, deteriorate most surfaces, create icy patches in the winter, and may serve as a breeding ground for pests in the warmer months.

Drainage within a tunnel can be more problematic than other areas due to the difficulty in conveying storm water from an underground location to the storm drain system outside of the tunnel. In addition, pedestrians are unlikely to use a tunnel that appears dirty, wet or deteriorating.

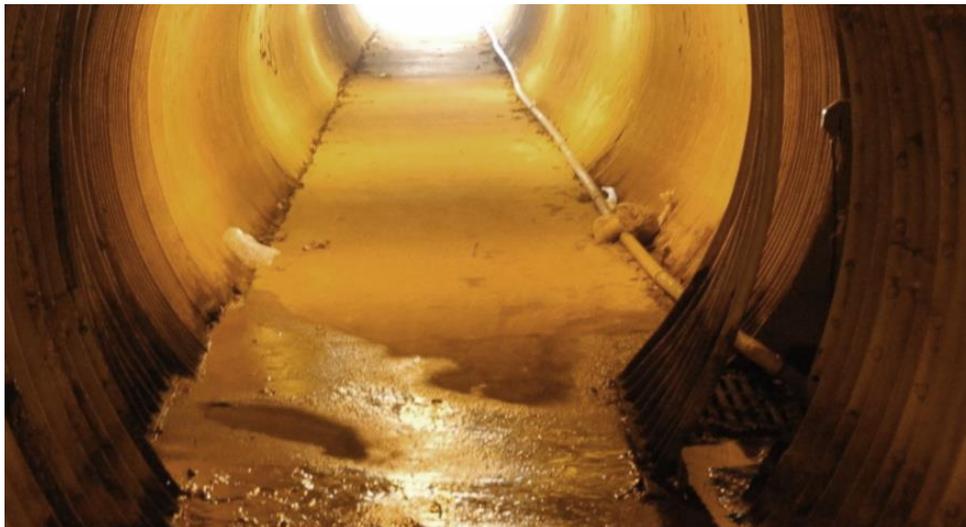
Grate inlet and pipe (looking south)

- If restoration of the tunnels existing drainage system is not possible, replace temporary pump with permanent installation in a manner that is not susceptible to vandalism.

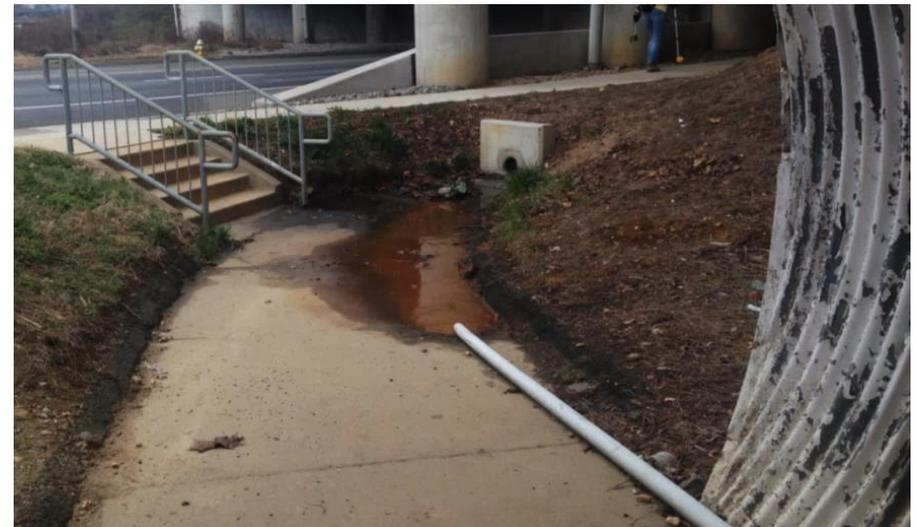
Pipe outfall to culvert (south side of tunnel)

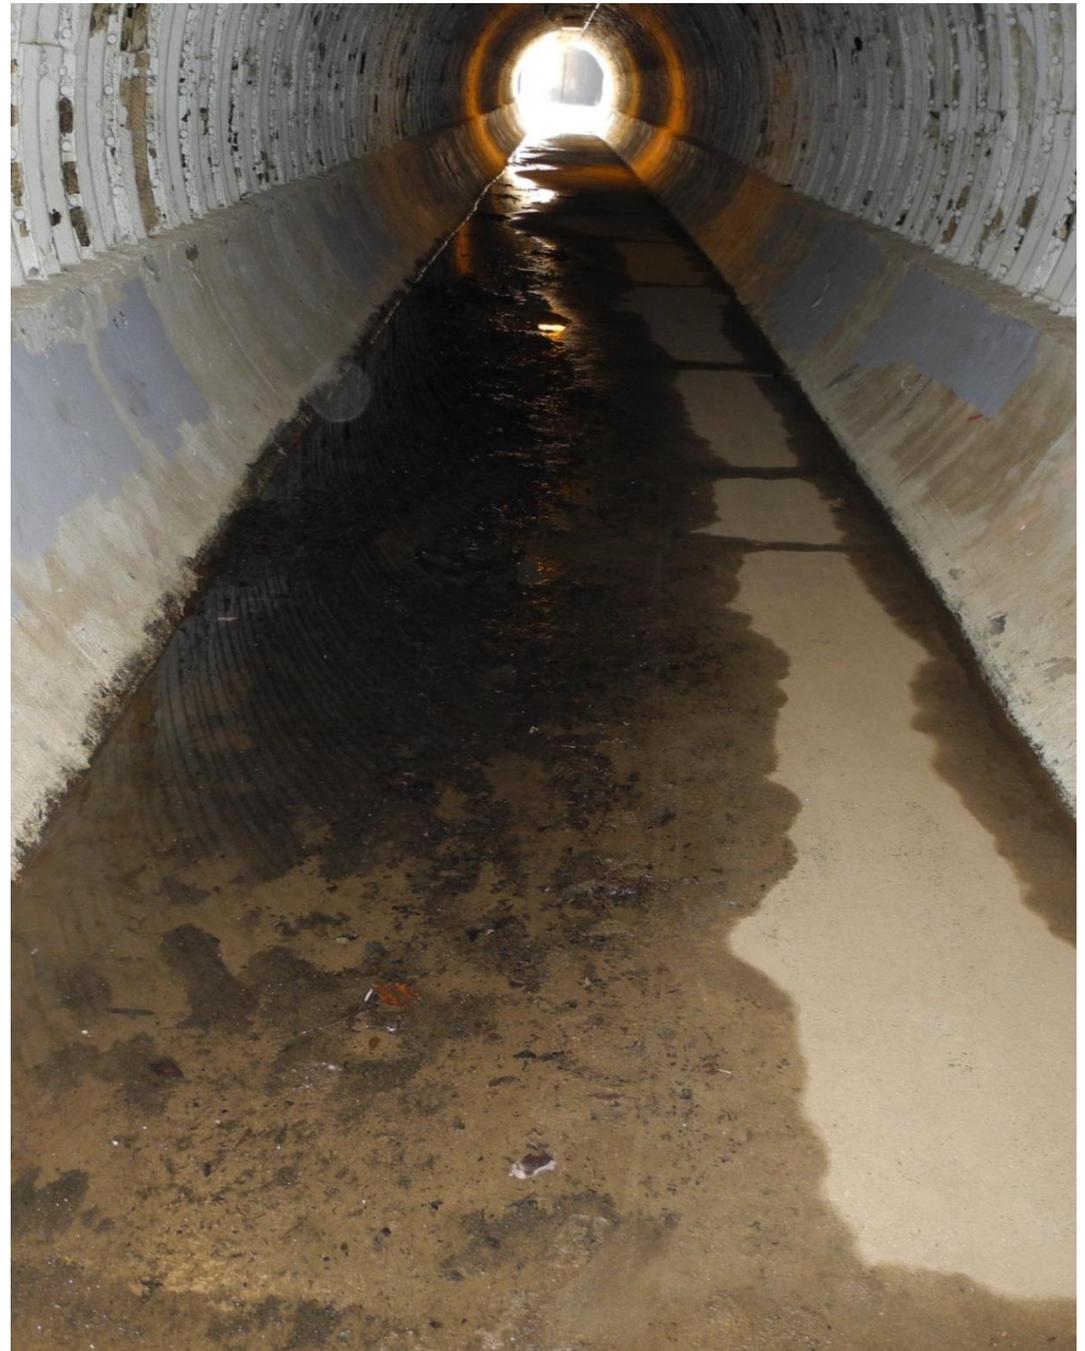
Upstream and downstream of the tunnel, the trail cross-slope generally slopes toward the stream channel, however there appears to be a spot immediately east of the tunnel where the trail surface slopes back toward the stream embankment. There is evidence of sediment and debris deposition at this location, as a result of past flooding. There is a concrete jersey barrier along the trail that may exacerbate this condition. In addition, the longitudinal slope of the tunnel is not steep enough to carry water out of the tunnel, and standing water and debris also collect at the north entrance of the tunnel. There are no visible drainage structures inside the length of the tunnel.

Standing water on north side of Holmes Run Trail Tunnel (facing east)

- Perform quarterly maintenance to remove buildup of sediment and debris at tunnel entrances.

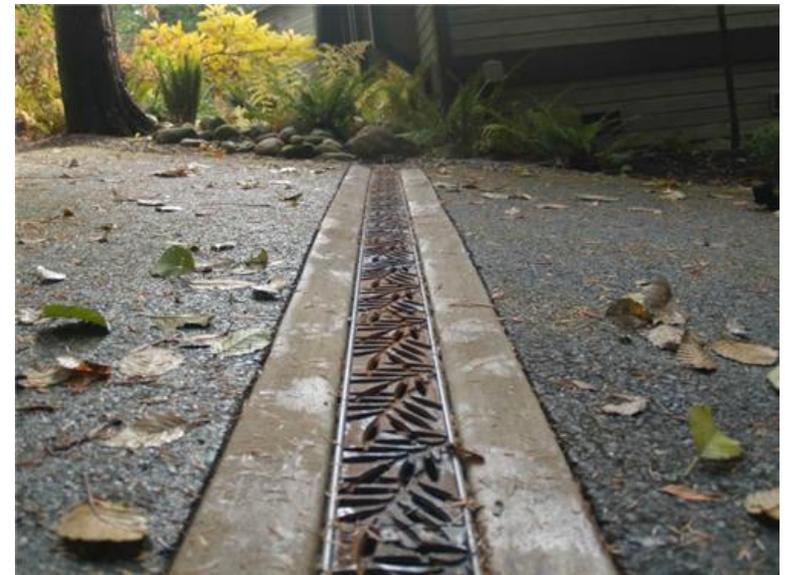
French drain grate. Photo, [www.landscapingnetwork.com](http://www.landscapingnetwork.com)

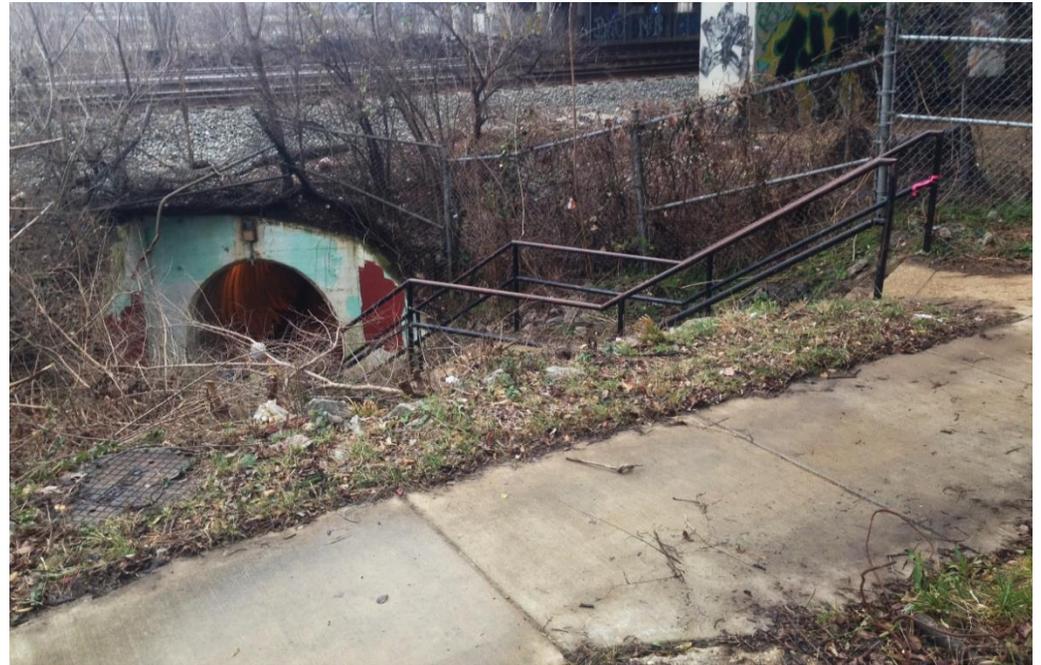
On the north side, the tunnel is connected via a staircase to a trail paralleling Duke Street. The angle of the staircase hides the tunnel entrance from view and the steep slope reduces natural light entering the tunnel. The stair rail is broken. The entrance is not easily accessible to people on bicycles and is not wheelchair accessible. Overgrown foliage further obscures the tunnel entrance and trash is prevalent. The adjacent trail is five feet wide and overgrown with foliage. The usable trail width is further narrowed by fencing immediately adjacent to the trail. A pedestrian desire line is present at the connection to South Dove Street and the chain link fence has been cut to allow access.

North side of tunnel obscured by angle of stair, steep slope and foliage

North entrance: Short term actions should focus on addressing maintenance needs and sight lines. Maintenance needs include landscape maintenance, stair rail repair, regular cleaning of sediment and debris, and painting the tunnel entrance and the staircase. Additional attention should be focused on the trail connecting to the tunnel, which would benefit from clearing vertical objects from the trail edge (the VDOT Road Design Manual, recommends a 3-foot clearance).

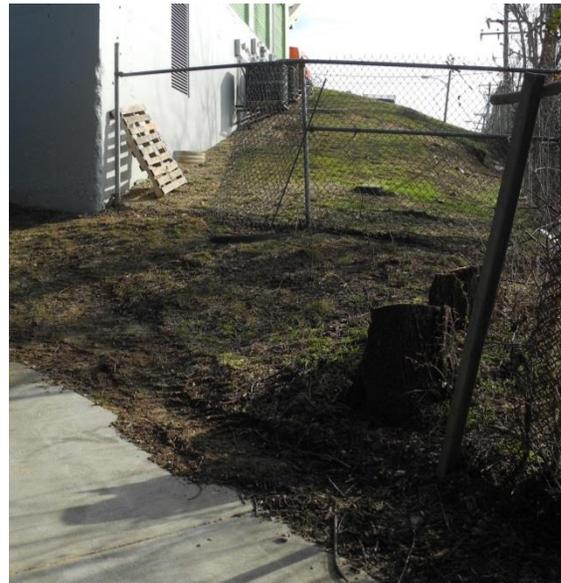
Pedestrian desire line and cut fence connecting to South Dove Street

- Make both entrances accessible for all users: the south side stair should be redesigned with ramp access. The north side connection to South Dove Street should be investigated to determine the feasibility of creating a shared use path connection in conjunction with drainage improvements recommended elsewhere in this report. This could address the steep slopes and allow the entrance to become accessible.
- Redesign access to follow existing desire lines: on both the north and south entrances desire lines are present and should be incorporated into redesigned entrances.
- Work with local community organizations or artists or to enhance the tunnel entrances: the entrance facades, access and landscaping should be holistically addressed with community input and potentially an art element.

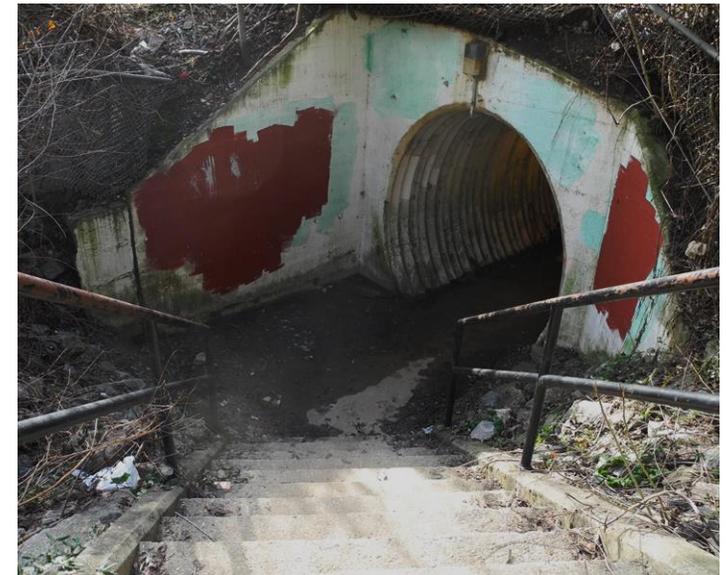
The northern side of the tunnel is lower in elevation than the adjacent trail and must be accessed with stairs. The north side of the tunnel is a local low point and does not have any accommodations for drainage. On the day of the site visit, standing water and debris were observed just outside the north entrance to the tunnel.

Tunnel entrance with water, debris, and trash on the north side

- Reconfigure north tunnel entrance and stairway to allow drainage to escape naturally, and/or provide piped connections to existing storm drains near each end of the tunnel. Improvements at both entrances should also consider drainage coming from above. Provide concrete channels to direct drainage away and prevent runoff from cascading over the upper edges of tunnel entrances. Costs for this item are included in the cost to reconfigure tunnel entrances.

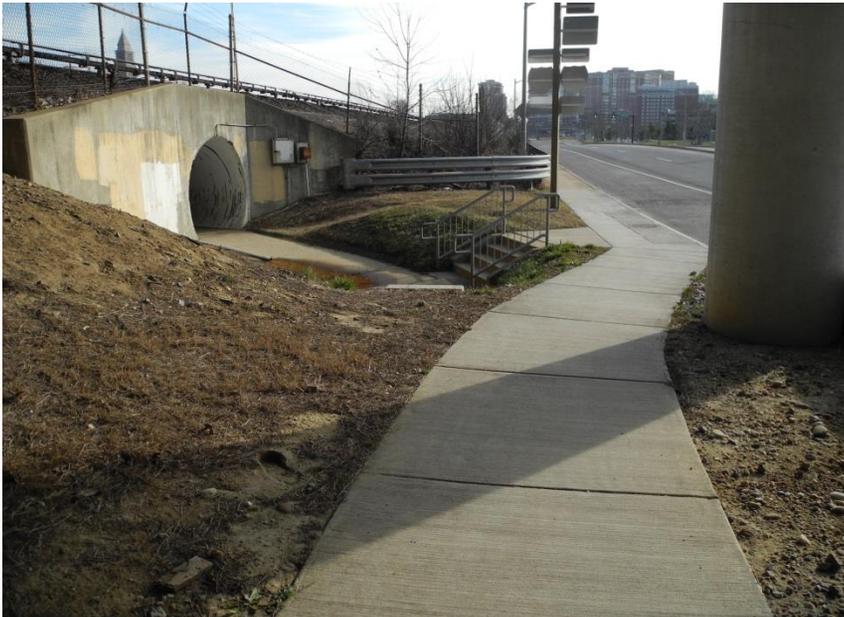
Tunnel entrance from Mill Road (heading east)

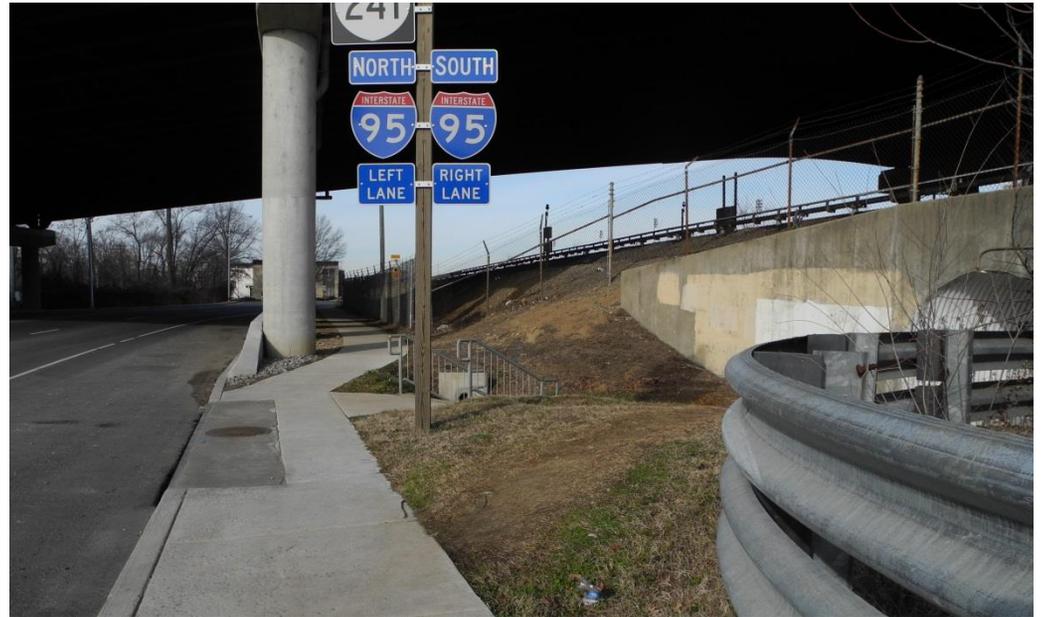
Tunnel entrance from Mill Road (heading west) showing pedestrian desire line

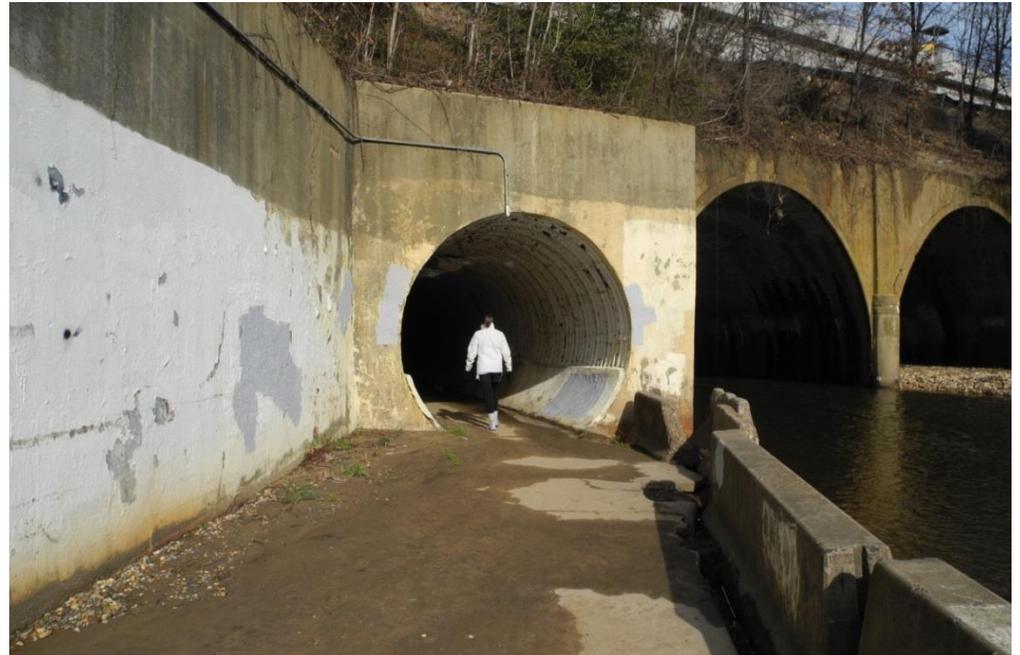
East side

Both entrances showed signs of graffiti which had been painted over.

- Perform routine maintenance quarterly, and after each significant rainfall event. Clear dirt and debris collected on the east and west entrances of the trail.
- Paint both entrances to the tunnel to make them more inviting. Consider reaching out to local artists to create a more enhanced gateway.

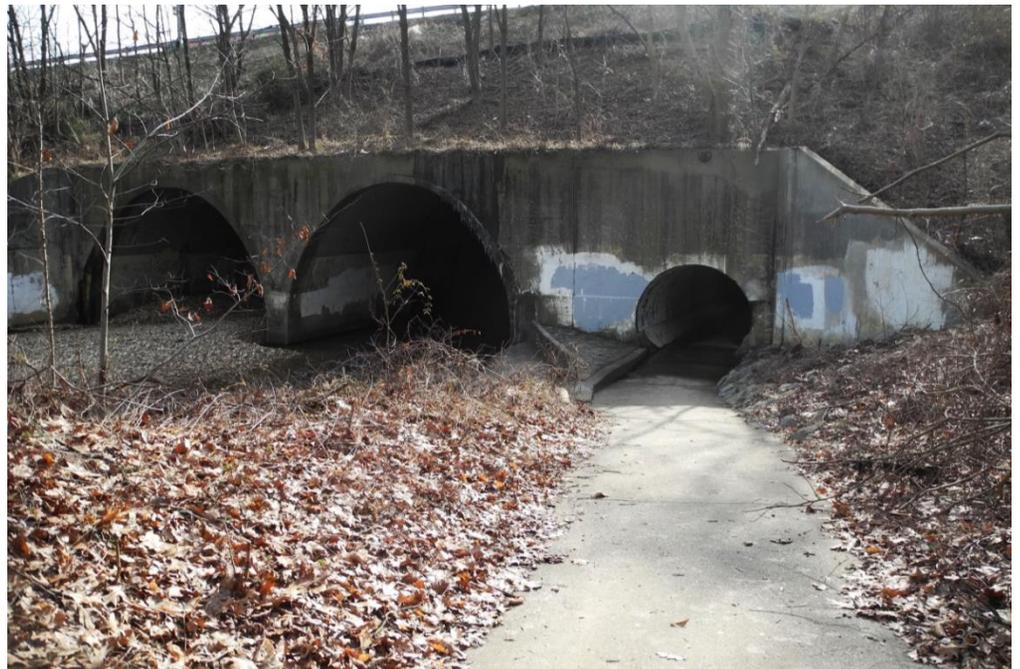
West side

On the west side, debris was noted along the trail and along the northern and southern edge of the tunnel. Debris appears to have come from the adjacent natural hillside. There is also a pedestrian desire line at this location which would connect North Morgan Street to the Holmes Run Trail.
