Study of an Experimental Bike Signal on the Mount Vernon Trail in Alexandria, Virginia

Final Report

Prepared by: Toole Design Group

Prepared for: The City of Alexandria

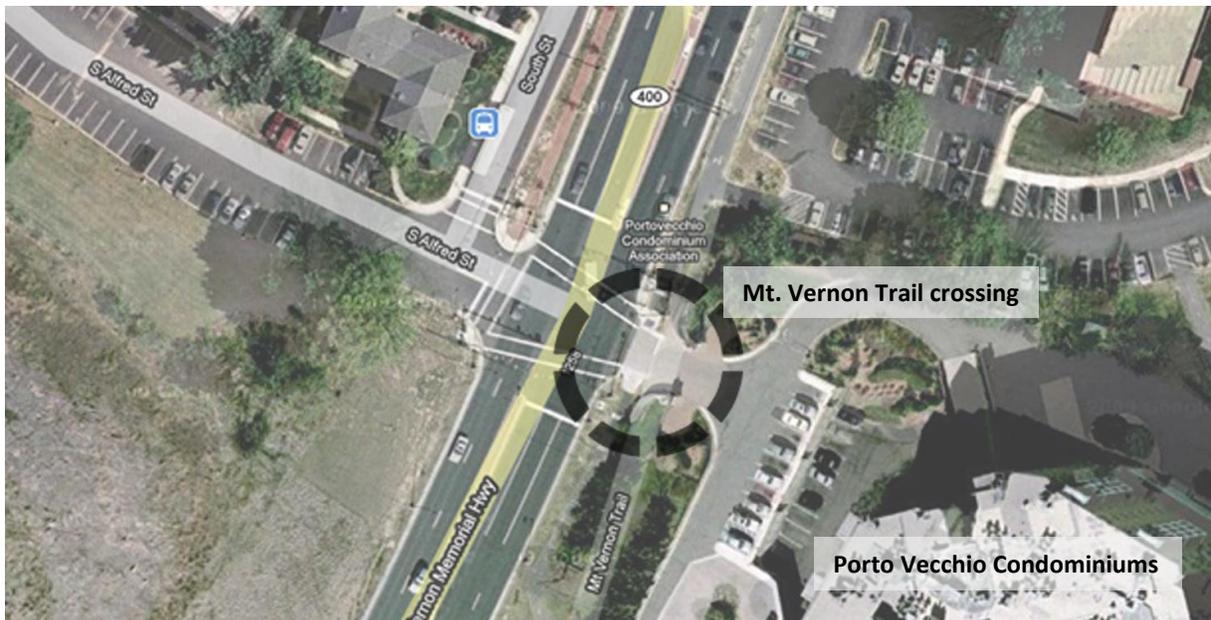
Figure 1 - Intersection of the Porto Vecchio Driveway & Mount Vernon Trail, immediately adjacent to the intersection of South Washington Street & South Alfred Street/Porto Vecchio Driveway

This experiment was located at the Mount Vernon Trail crossing of the Porto Vecchio Condominium driveway, adjacent to the intersection of South Washington Street, also known as the Mt. Vernon Memorial Parkway and the George Washington Memorial Parkway, and South Alfred Street/Porto Vecchio driveway, shown in Figure 1.

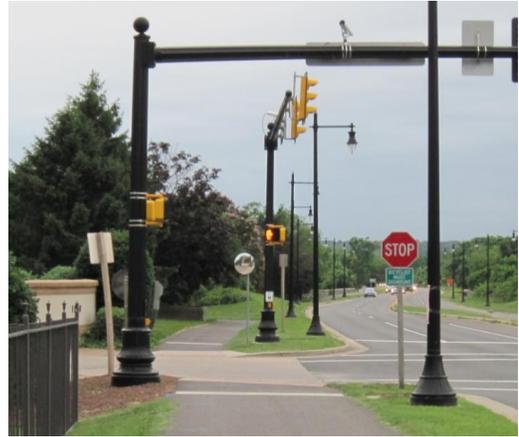
Figure 2 – Southbound Mt. Vernon Trail, July 2010

Field observations found the southbound stop sign was partially obscured by traffic signal pole for the majority of the approach (Figure 2) and the northbound stop sign was partially obscured by vegetation (Figure 3).

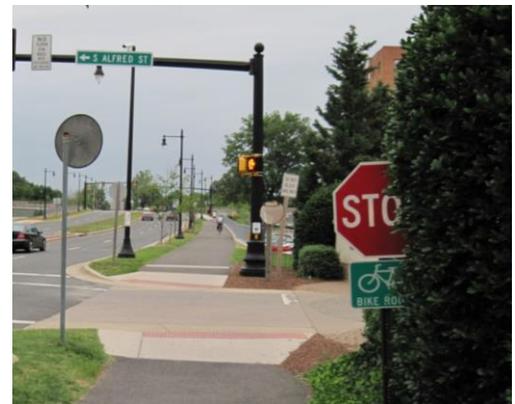
Figure 3 – Northbound Mt. Vernon Trail, July 2010

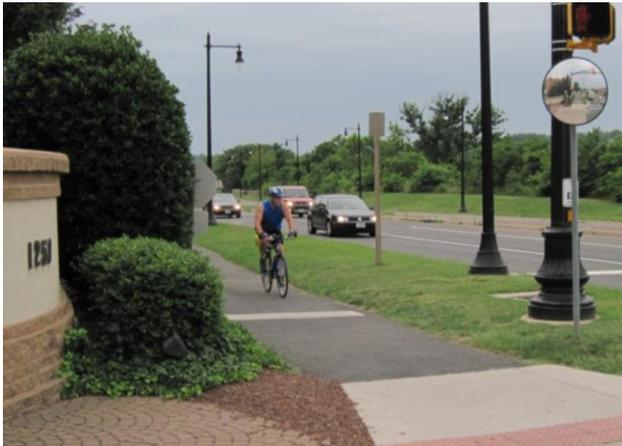
Figure 4 - Porto Vecchio driveway looking south, Aug 2010

The locations of the pedestrian pushbuttons do not meet 2009 MUTCD guidance. Specifically, the traffic signal poles and pushbuttons are located on the left side of the trail relative to the through moving bicyclist who is riding on the right (figures 3 through 6). This layout requires bicyclists to

The decorative walls and vegetation on either side of the driveway restrict the sight distance between Porto Vecchio traffic and the trail. Convex mirrors are installed at the crossing in an attempt to allow trail users and driveway users to see around the sightline obstructions (figures 4 and 5).

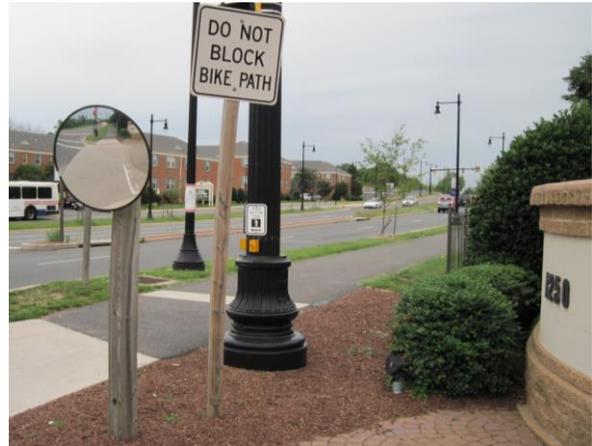
Figure 5 - Porto Vecchio driveway looking north, Aug 2010

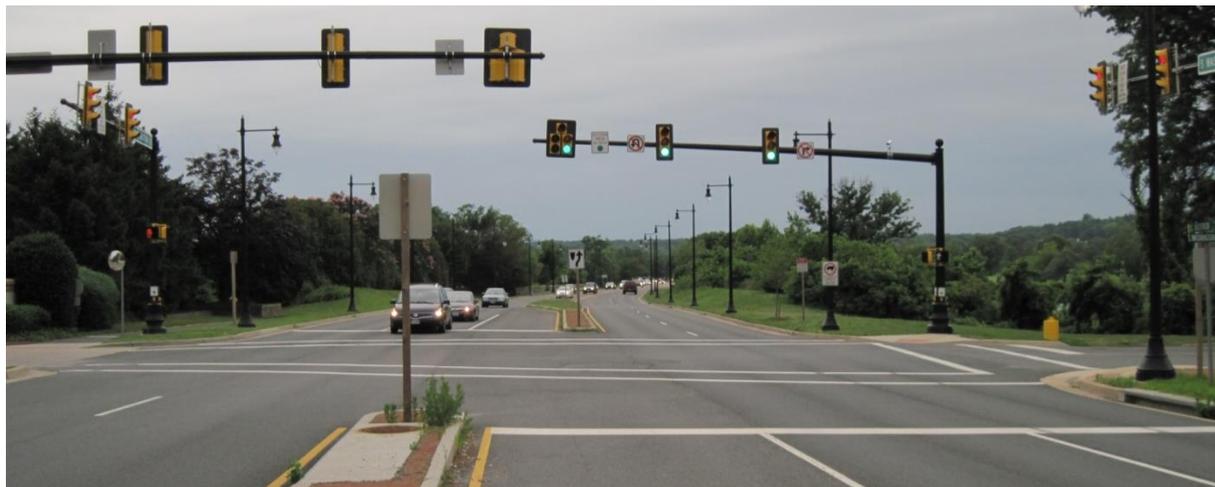
Figure 6 - Southbound view from South Washington Street, August 2010

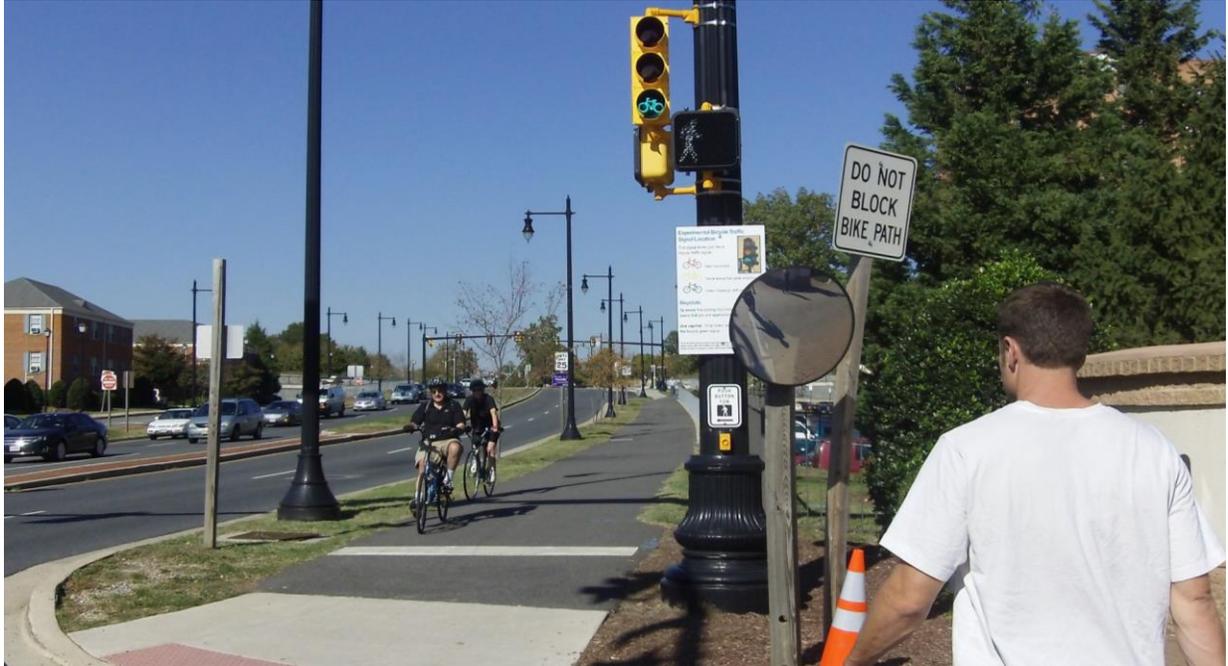
Figure 7 - Phase III Bicycle Signal Operation

- Bicycle signals were added to the south and north approaches of the Mount Vernon Trail crossing of the Porto Vecchio driveway. The bicycle signals were mounted adjacent to the pedestrian signals (Figure7). The bicycle signal timing matches the parallel South Washington Street vehicular movement, maximizing green time for bicyclists on the trail.
- The pedestrian signals for the Mount Vernon Trail crossing of the Porto Vecchio driveway continued to operate in pedestrian recall mode at all times of the day.
- All other traffic controls remained the same as in Phase II.

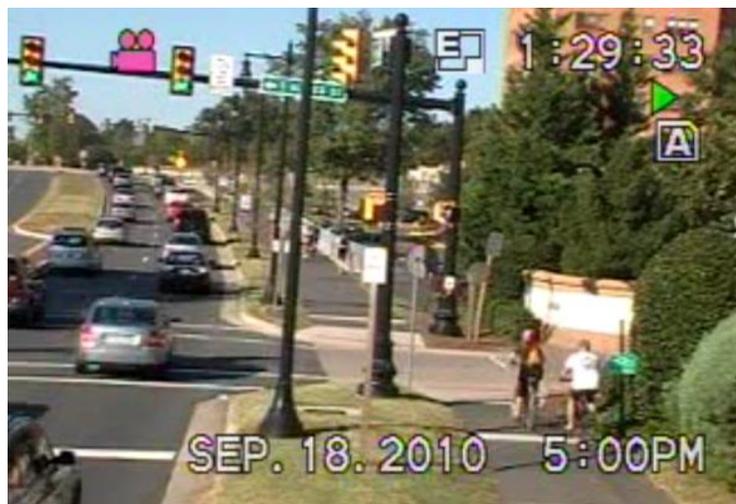
Figure 8 - Example Video from Phase II

The experiment team recorded up to 12 hours of video to capture typical midweek and weekend operations. Video was recorded in August 2010 for Phase I, September 2010 for Phase II, November 2010 for Phase IIIA, and August/ September 2011 for Phase IIIB as detailed in the table in the following section. The video was utilized to determine traffic-control compliance, to monitor for conflicts between various users, and to count
