Beverley Park Slope Stabilization Study

April 14, 2014

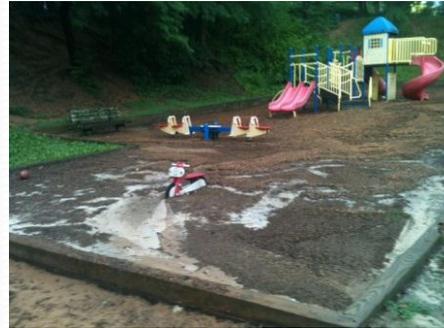
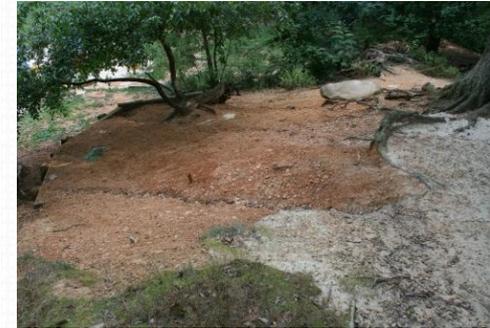
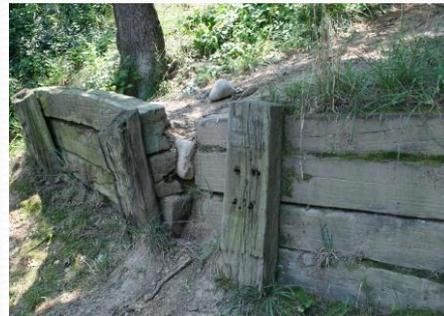
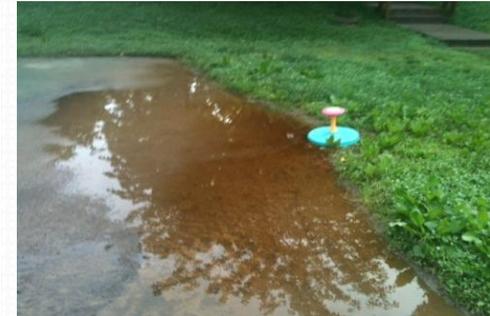
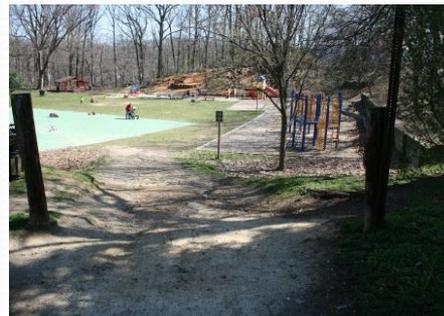
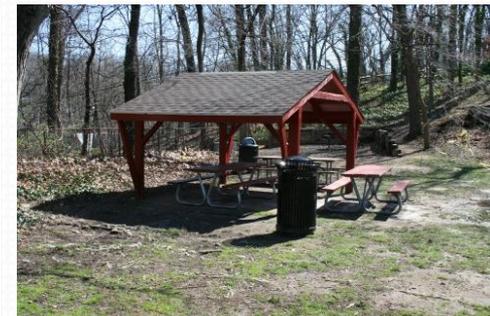
Infrastructure Conditions

- Playground
- Retaining Wall(s)
- Tree Canopy
- Drainage/Slope Erosion
- Shelter
- Accessibility

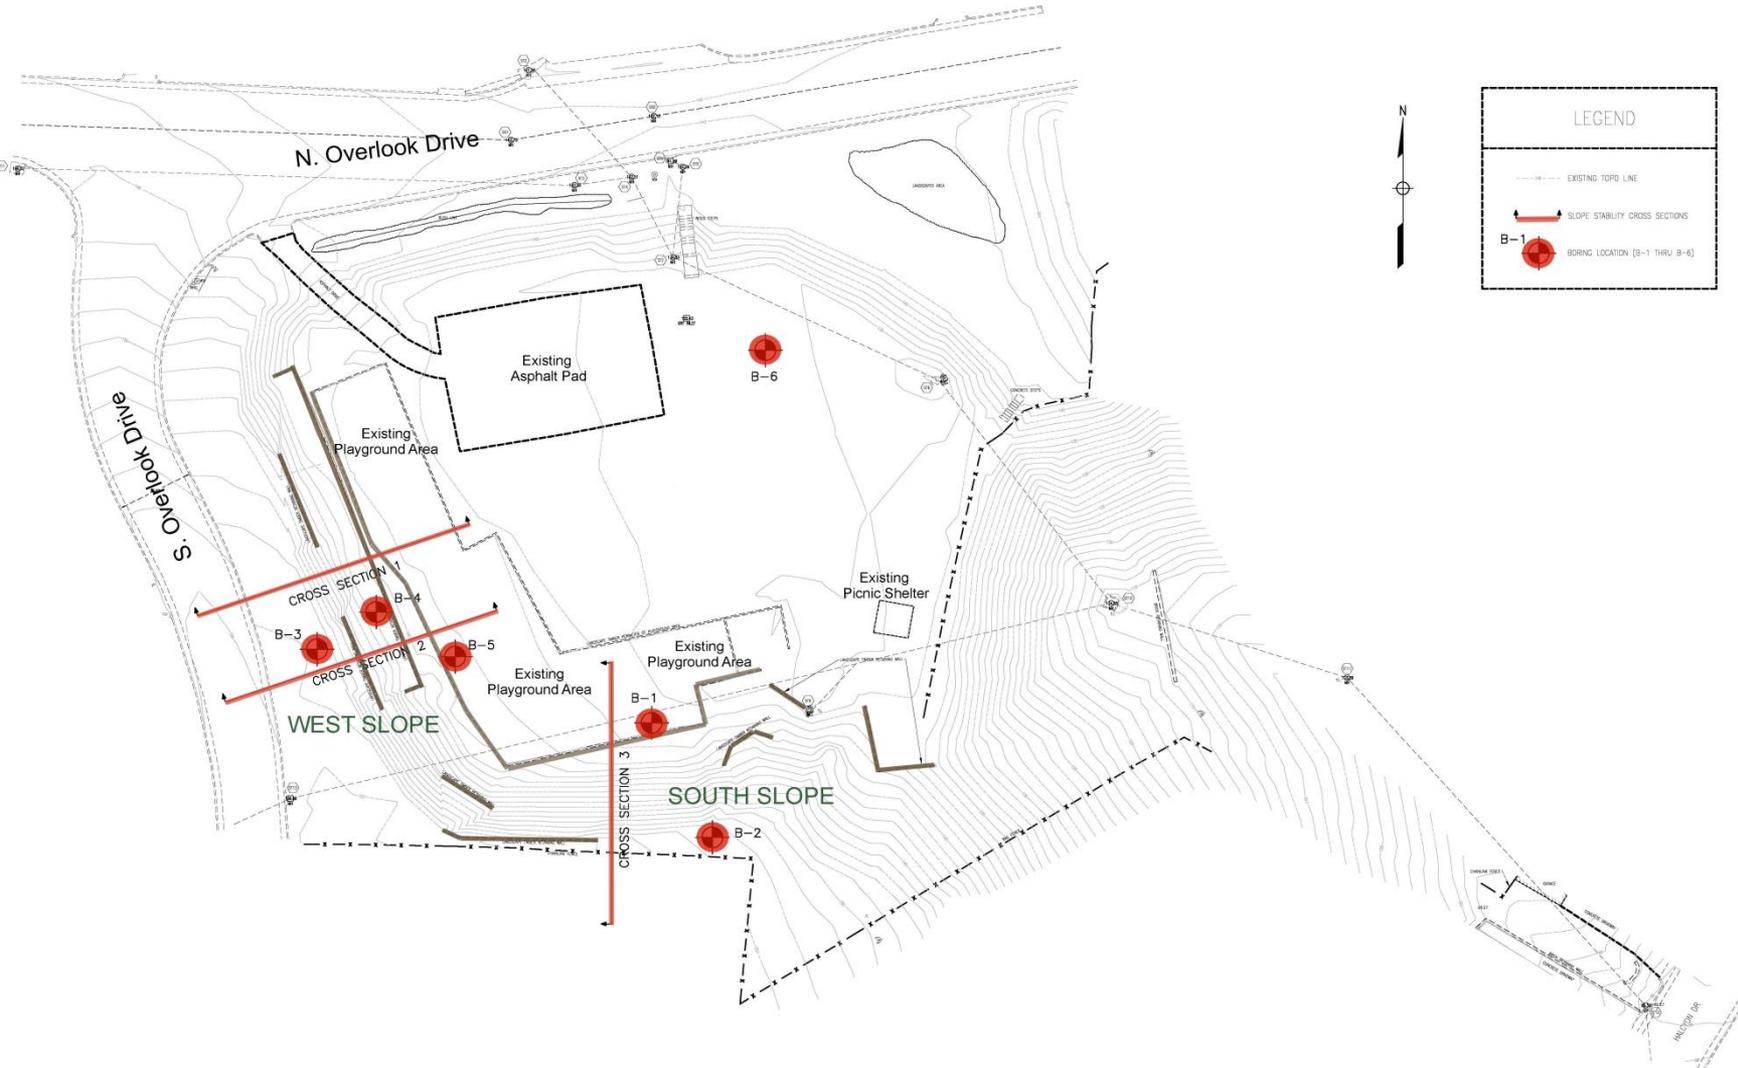
Geotechnical Investigation

- West and south perimeter slopes
- Core sampling at top/middle/bottom of slopes
- Dense sand and clay soil profiles
- Slope stability modelling indicates stable soils
- Future work unlikely to need special techniques

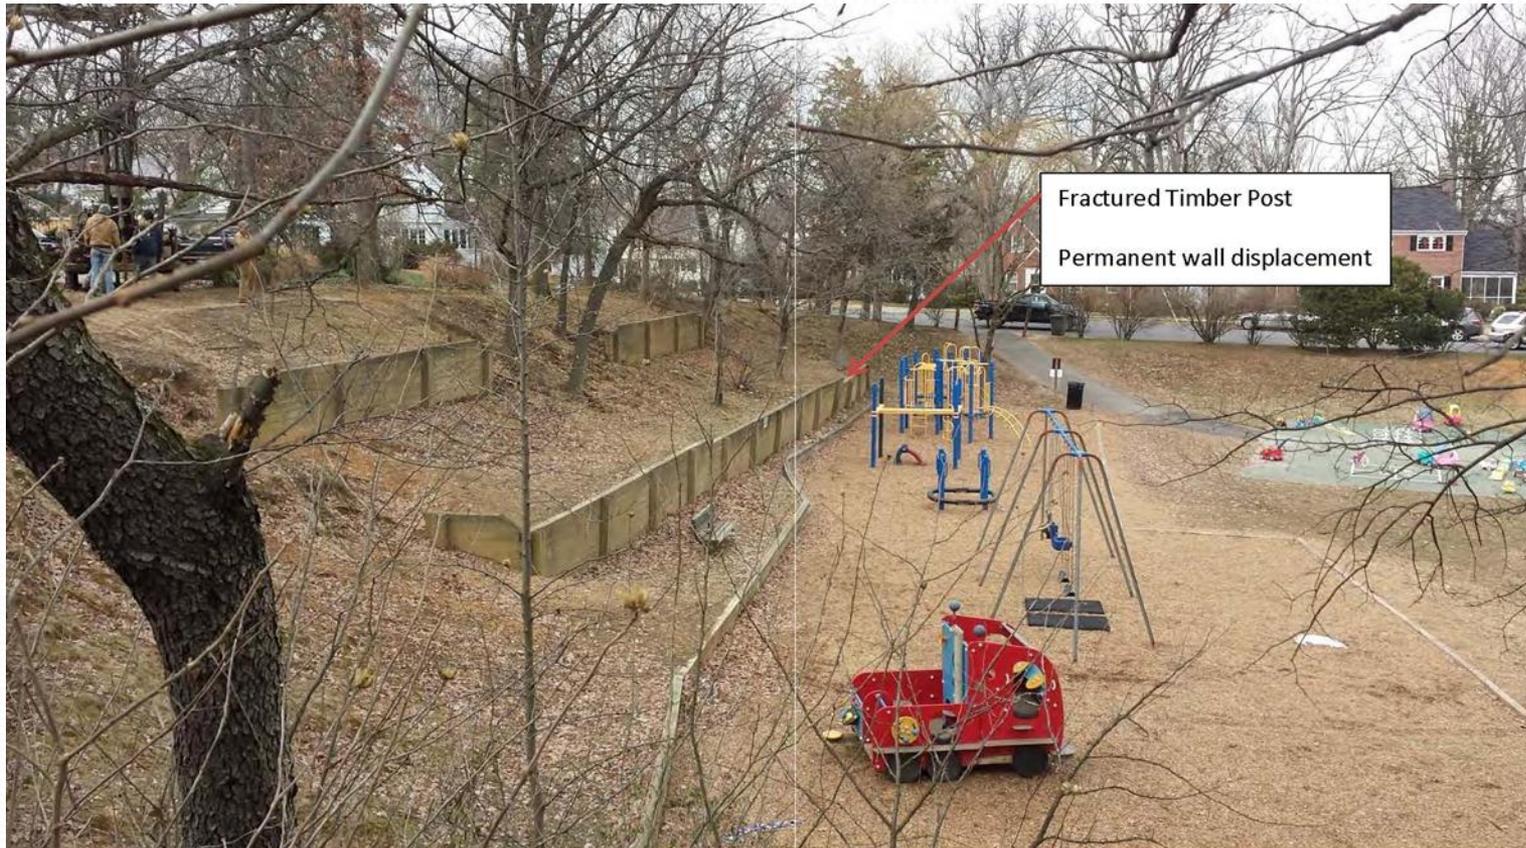
West Slope Retaining walls

- Retaining walls constructed in 1960's-1980's
- Near the end of their useful life
- Exacerbating soil erosion by concentrating water flow
- Remove existing walls

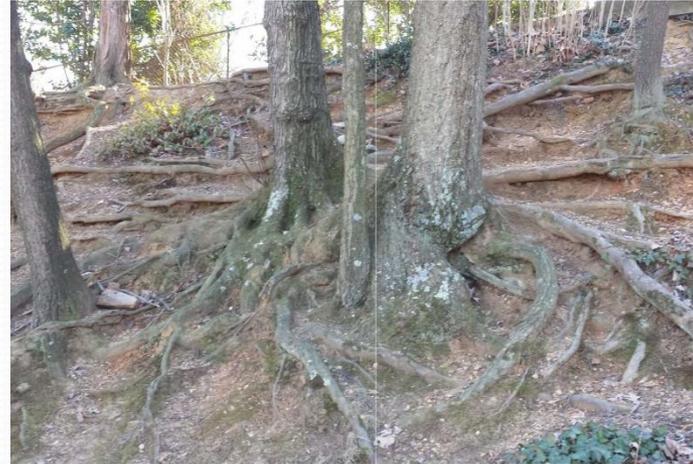
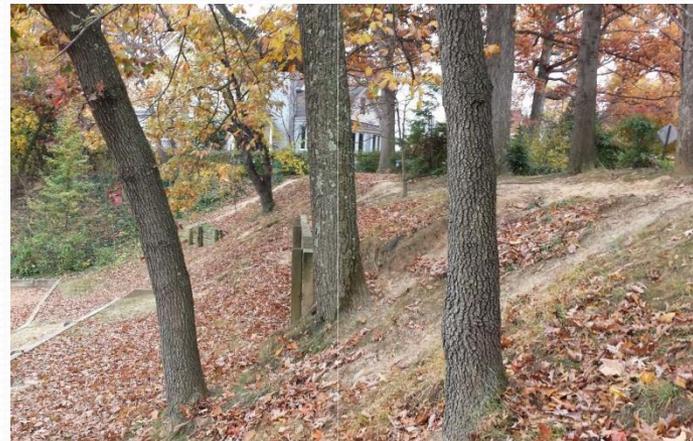
Arboricultural Analysis

- Evaluate condition of 78 trees over 4 inches in caliper
- Best trees are at the top of the slopes
- Trees include native and non-native species

- 3 Trees in need of immediate removal
- Many are unlikely to survive wall reconstruction
- Approximately 25 Trees may be impacted by construction

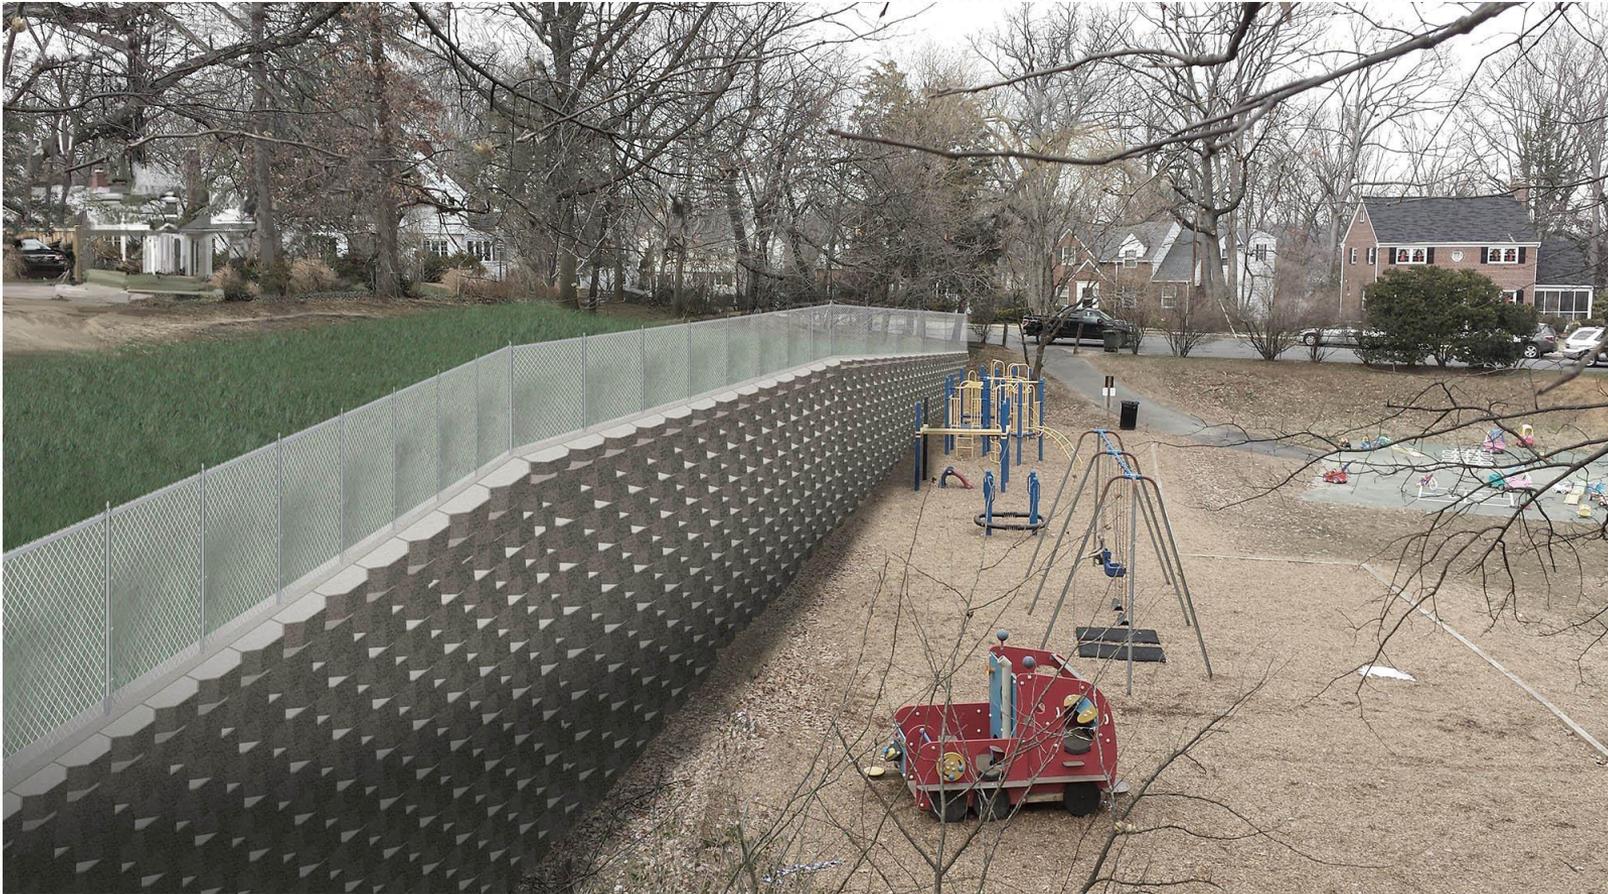
Retaining Wall & Grass Slope

West Slope: 8.5' height retaining wall w/ 3' height handrail

West Slope: 8.5' height retaining wall w/ 3' height handrail
South Slope: Grassed slope with 2H:1V grade, reinforced with erosion control blanket

Tree Removal	Removal of approximately 9 trees. Trees on the south slope to continue decline
Tree/Vegetative restoration	New tree plantings likely to be constrained by wall, erosion control fabric, and steeper slope
Open Space Impact	Playground location stays relatively the same
Drainage	Considerable drainage design for wall and playground
Relative Cost	Higher cost
Constructability	Equipment for wall installation
Long term Sustainability	Potential for vandalism, long term wall maintenance and repairs may be costly

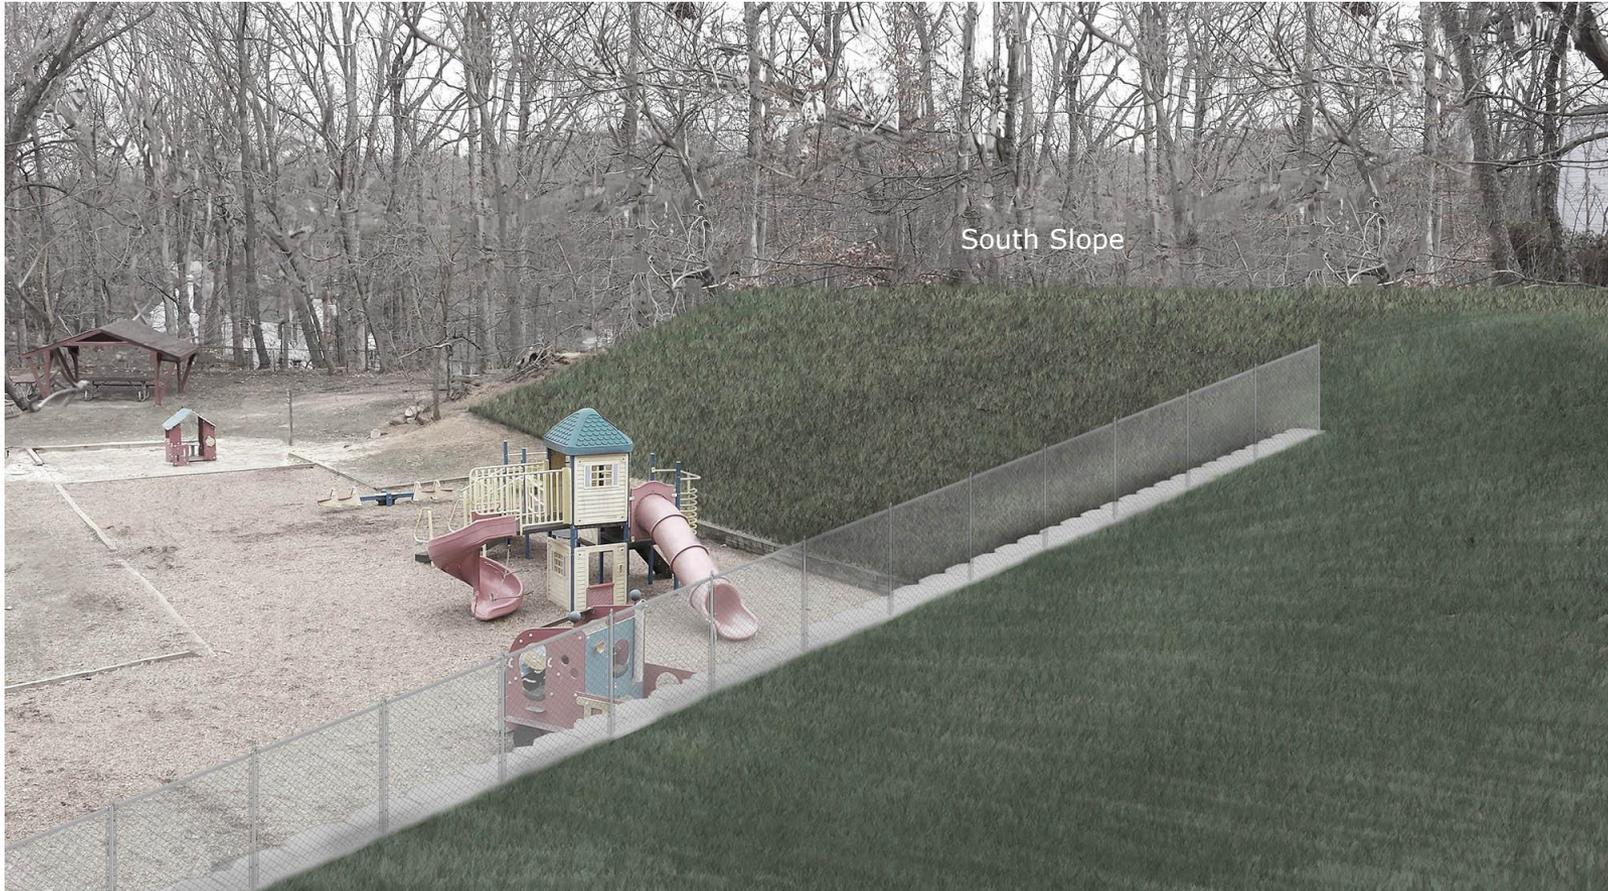
Retaining Wall & Grass Slope

South Slope: Grassed slope with 2H:1V reinforced with erosion control blanket

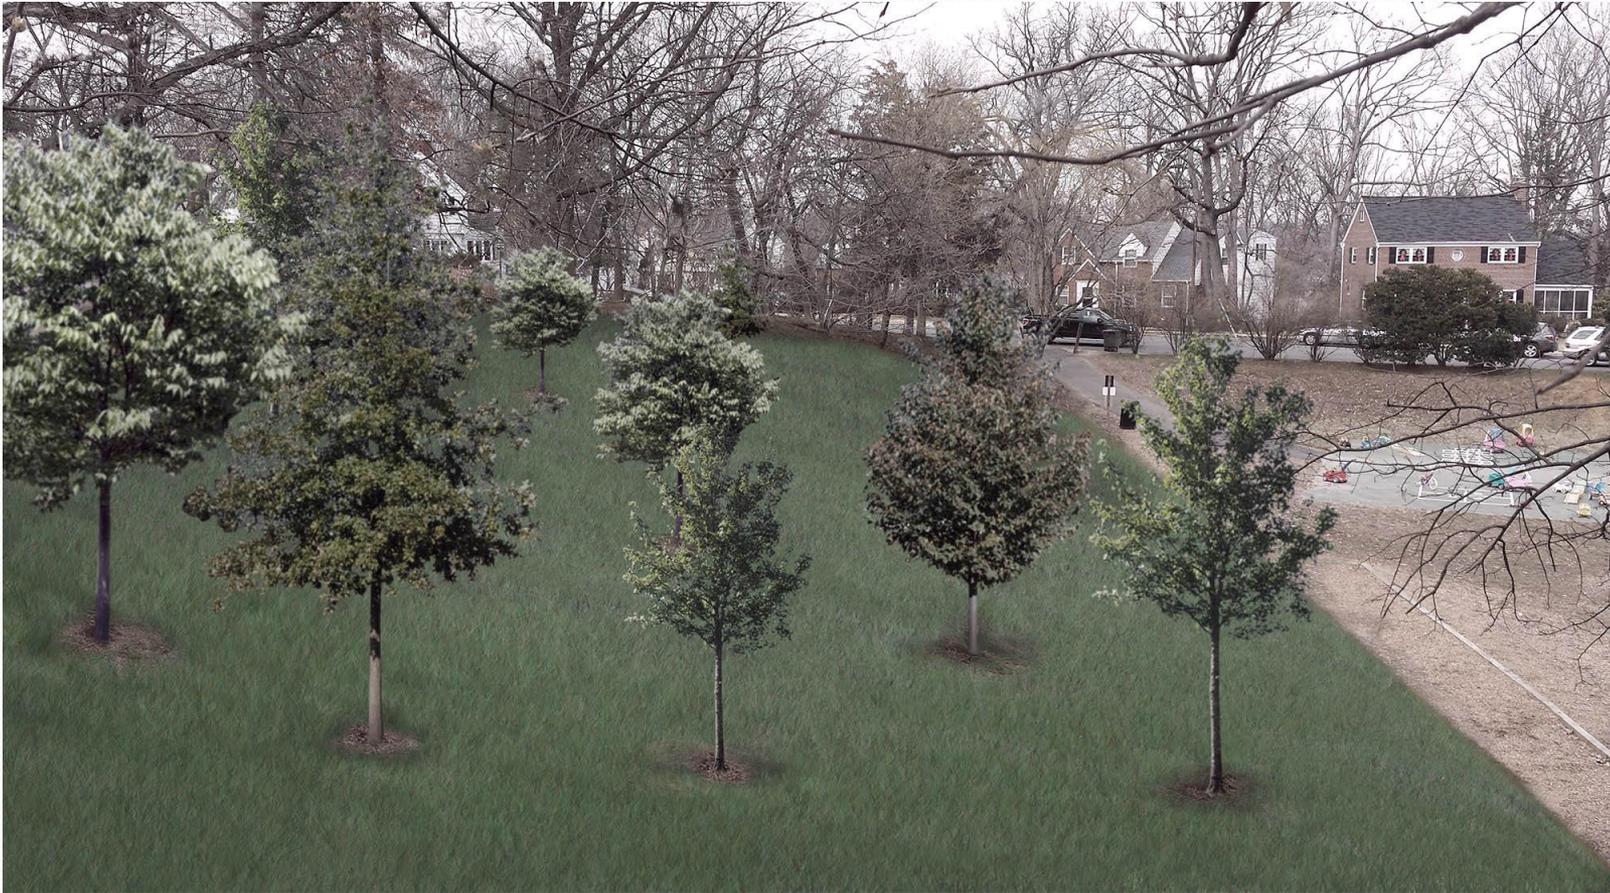
Grass/Natural Slope -No Wall

West Slope: Grassed/Natural Slope, 4H:1V slope

West Slope: Grassed/Natural Slope, 4H:1V slope
South Slope: Grassed/Natural Slope, 4H:1V slope

Tree Removal	Removal of approximately 25 trees
Tree/Vegetative restoration	New tree plantings feasible
Open Space Impact	Playground moves to another location. Slope is useable once vegetation is established.
Drainage	Reduced concentrated runoff and erosion
Relative Cost	Lower cost
Constructability	Large amount of hauling and traffic control
Long term Sustainability	Indefinite life, slopes can be maintained at an optimum level

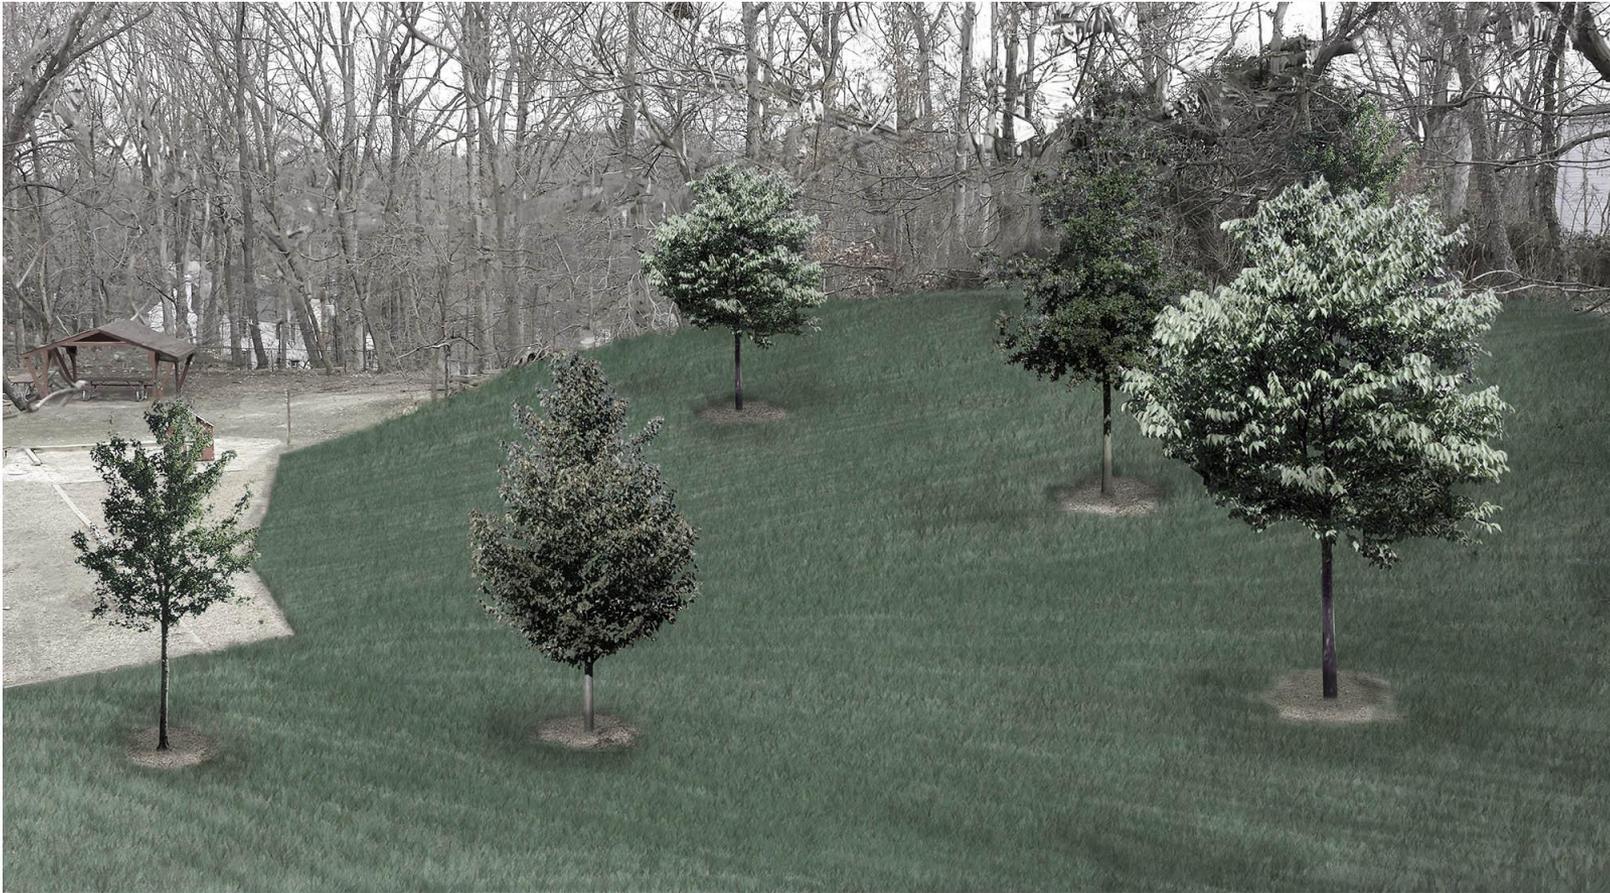
Grass/Natural Slope -No Wall

South Slope: Grassed/Natural Slope, 4H:1V slope
