EASTMOUNT ENVIRONMENTAL SERVICES, LLC
Air Quality Specialists

Collection and Analysis of
Particulate Fallout Samples near
Coal-Fired Power Plant in
Alexandria, VA

Eastmount Environmental Services, LLC
October 13, 2006
Project No.06-082

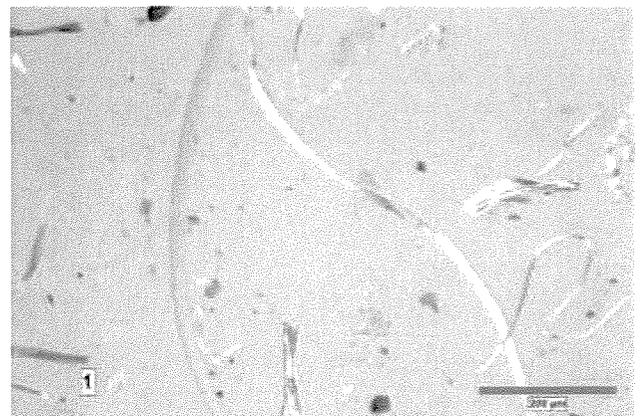
Sample 1 consisted primarily of fibrous material, biological debris and some mineral matter. Industrial soot particles and coal were not detected in this sample. The average composition image and spectra demonstrates both the organic and inorganic content that characterizes this sample.

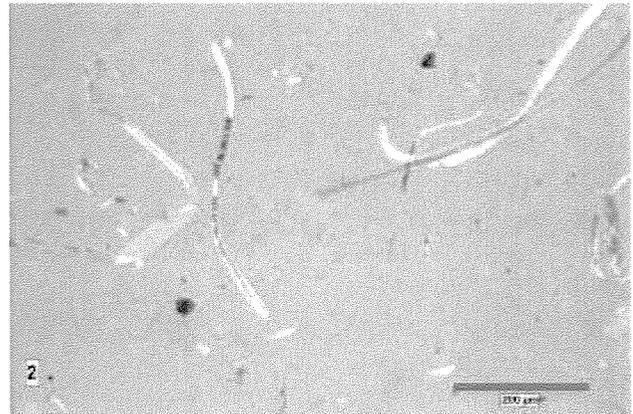
2:

Sample 2 consisted primarily of biological debris, fibrous material and some mineral matter. A few straight glass fibers were found together in one deposit. Particles demonstrating morphology suggestive of combusted soot material and coal were not detected with the PLM.

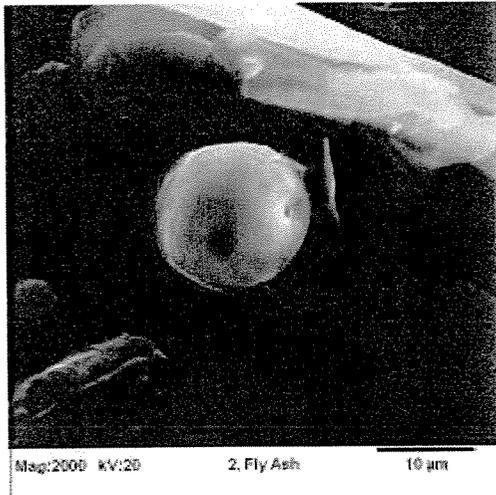
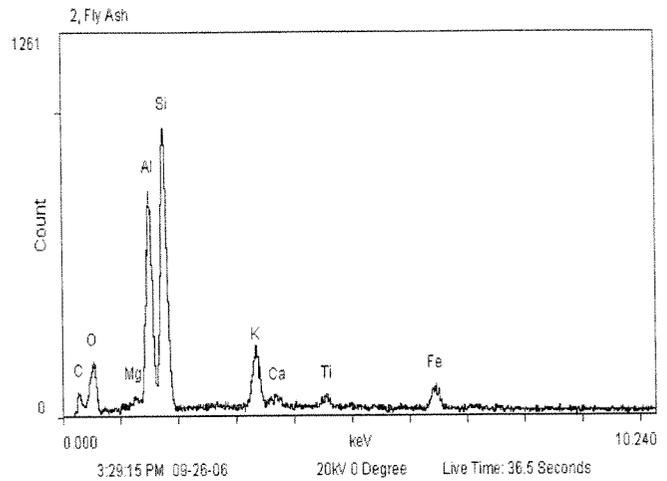
SEM analysis documents the presence of fly ash. No coal particles were detected with the SEM in this sample. The smooth spherical fly ash contains strong peak concentrations of aluminum and silicon with moderately strong to lower peak concentrations of carbon, oxygen, magnesium, potassium, calcium, titanium and iron. No coal was confirmed in this sample.

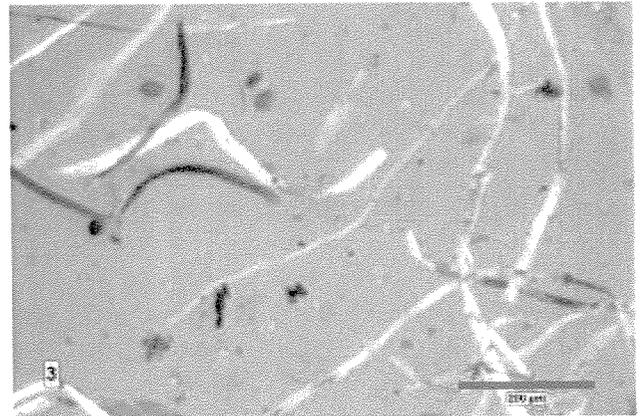
3:

Sample 3 consisted of a noticeable concentration of cellulose fibers with several synthetic fiber strands. A quarter of the sample area was estimated to represent biological debris. Minerals and some particles consistent for paint residue were observed. Particles demonstrating morphology suggestive of combusted soot material and coal were observed with the PLM

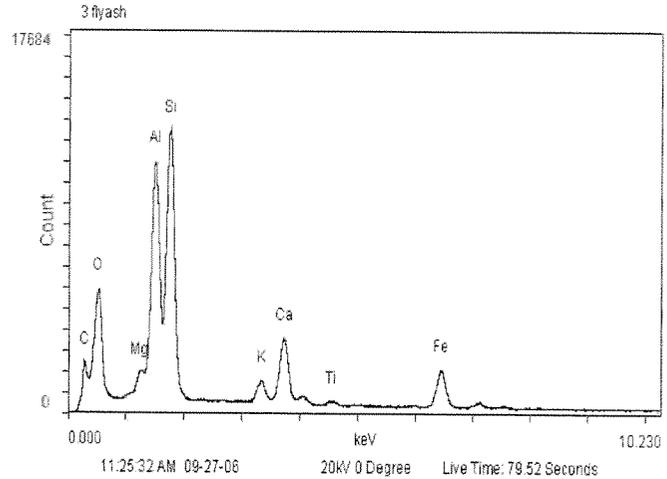
SEM analysis confirms the presence of fly ash. No coal particles were confirmed with the SEM in this sample. The smooth spherical fly ash contains peak concentrations of carbon, oxygen, magnesium, aluminum, silicon, potassium, calcium, titanium and iron. No coal was confirmed in this sample.

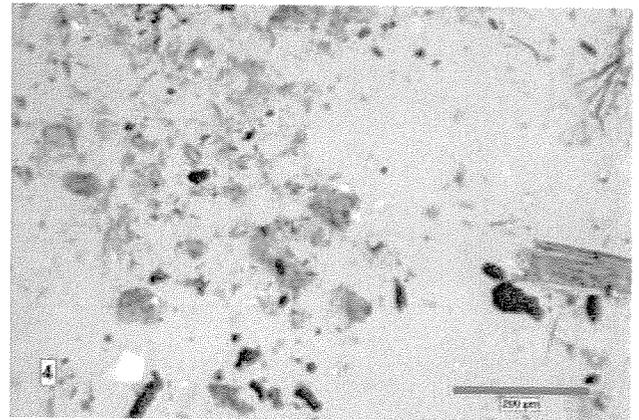
4:

Biological material was estimated to represent over half the sample area in 4 with non-soot dark opaques, mineral grains and aluminum oxide estimated at a third. Particles demonstrating morphology suggestive of combusted soot material and coal were observed with the PLM.

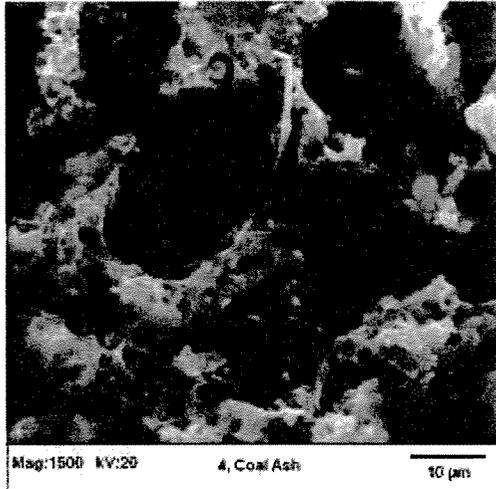
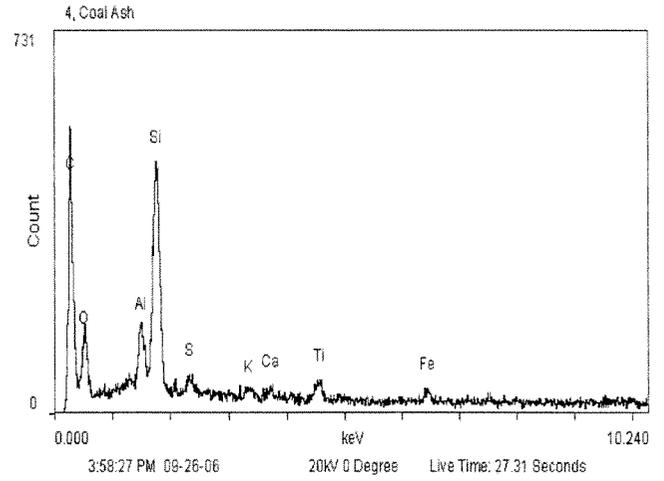
SEM analysis confirms the presence of coal ash and fly ash. No coal was confirmed with the SEM in this sample. The coal ash specimen shows texture laced with numerous pits and craters. The particle is irregular in shape and has several included fly ash spheres. Chemistry from the coal ash shows strong peak concentrations of carbon and silicon with moderately strong to lower peak concentrations of oxygen, aluminum, sulfur, potassium, calcium, titanium and iron.

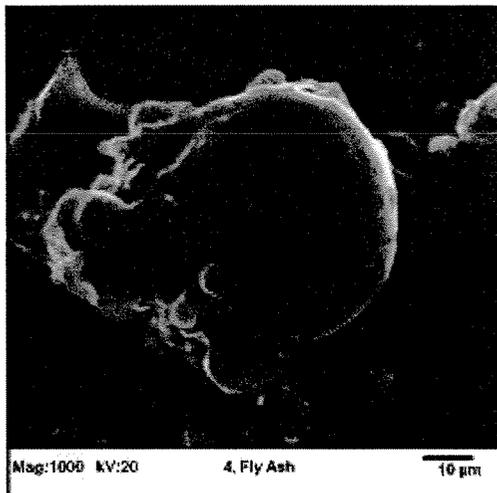
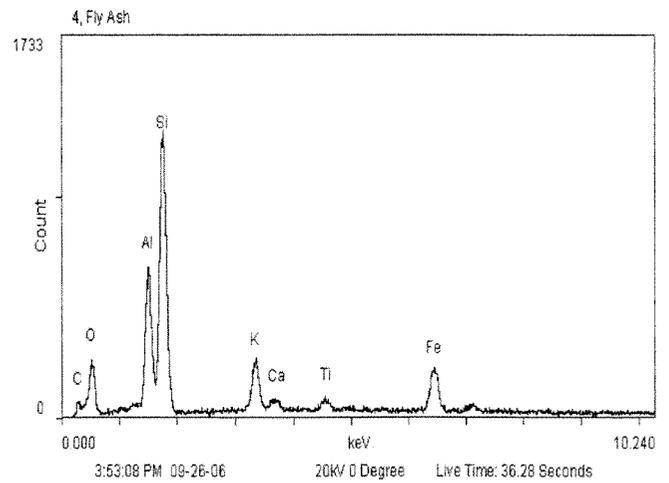
The smooth spherical fly ash is partly embedded in related debris. Other fly ash nodules are seen protruding from the bulk binding material. Chemistry of the fly ash shows strong peak concentrations of aluminum and silicon with lower peak concentrations of carbon, oxygen, potassium, calcium, titanium and iron.

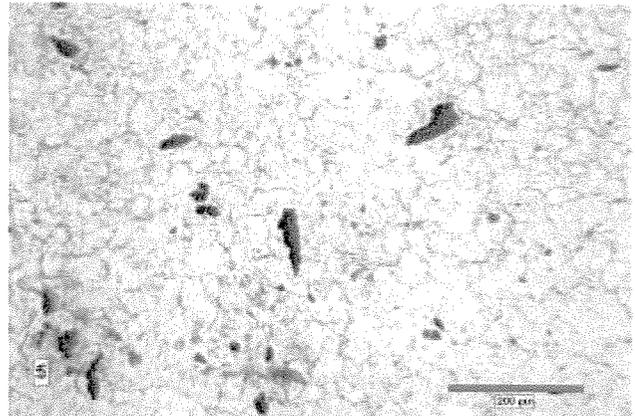
5:

Sample 5 consisted of a noticeable concentration of dark opaques. Fibrous material included one main cellulose fiber deposit, two synthetic fiber strands and two straight glass fibers were observed. Mineral grains and biological particles were also noted. Particles demonstrating morphology suggestive of combusted soot material were observed with the PLM

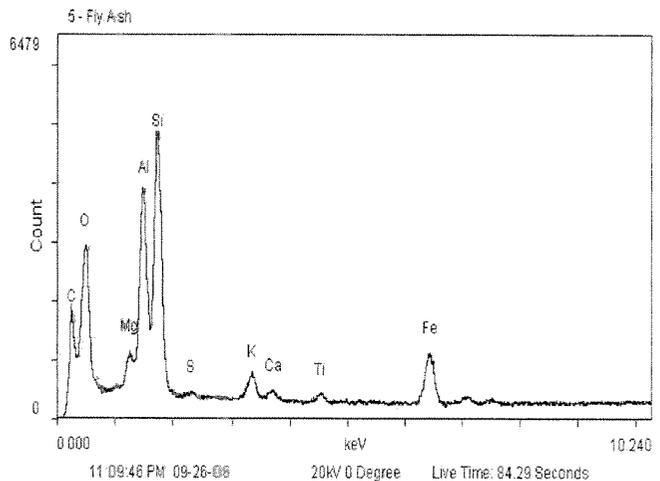
SEM analysis confirms the presence of fly ash, coal ash and oil soot. No coal particles were confirmed with the SEM in this sample. The smooth spherical fly ash contains a strong peak concentrations of carbon, oxygen, aluminum, silicon and iron with magnesium, sulfur, potassium, calcium and titanium.

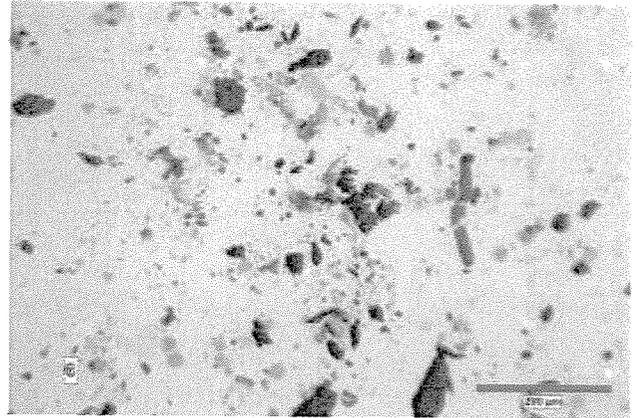
6:

Sample 6 consisted of mineral matter, biological debris and non-soot opaques. Particles demonstrating morphology suggestive of combusted soot material and coal were observed with the PLM.

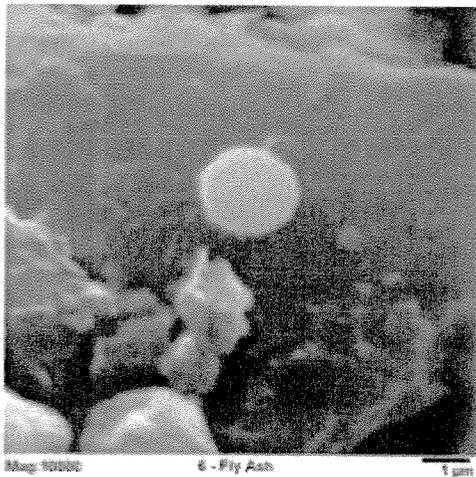
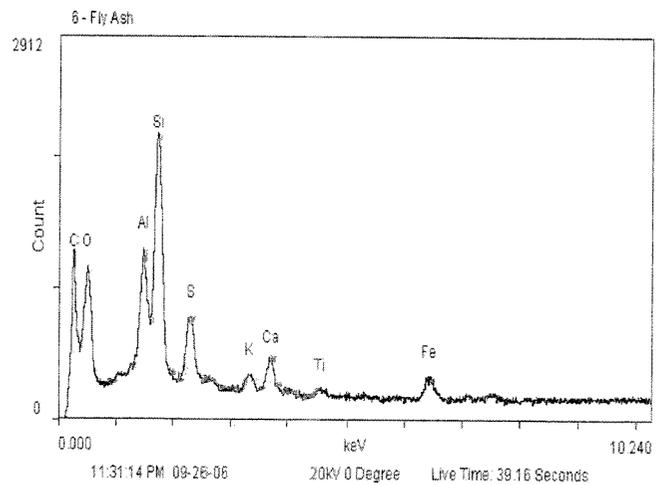
SEM analysis confirms the presence of fly ash and coal ash. No coal fragments were confirmed in this sample. Chemistry from the smooth spherical fly ash particle shows peak concentrations of carbon, oxygen, aluminum, silicon, sulfur, potassium, calcium, titanium and iron.

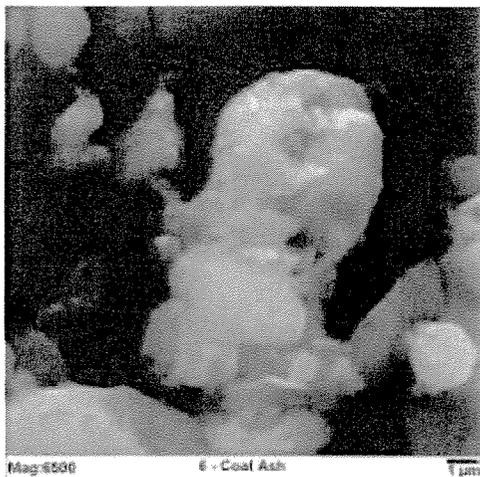
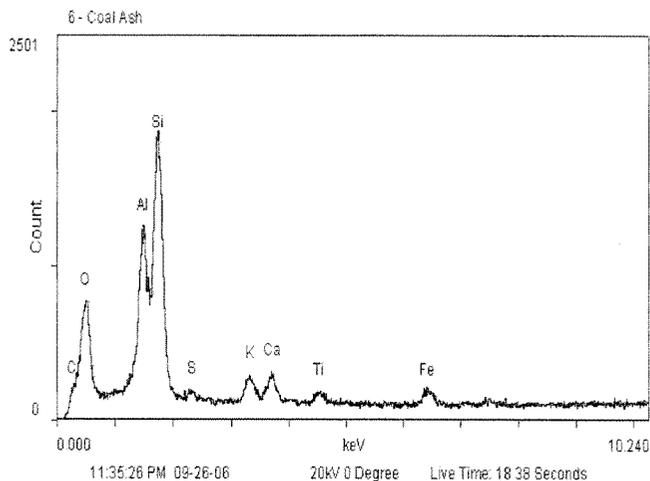
The coal ash specimen is well eroded; showing only rounded contours suggestive of remnant crater form. SEM/EDX of the coal ash shows strong peak concentrations of oxygen, aluminum and silicon with lower peaks of carbon, sulfur, potassium, calcium, titanium and iron.

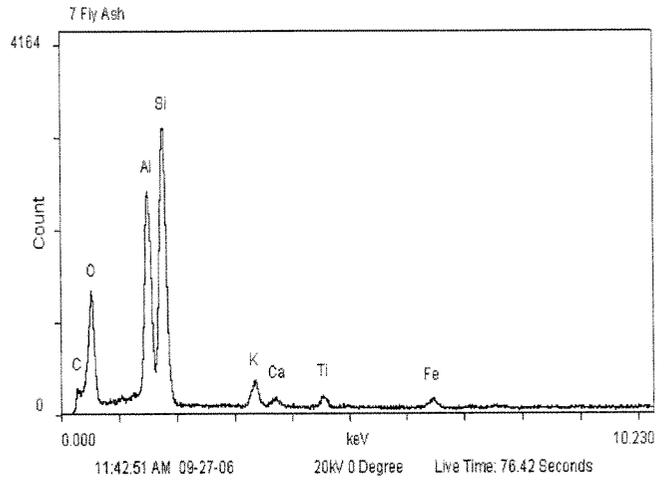
SEM analysis confirms the presence of fly ash and coal ash. No coal fragments were confirmed with the SEM in this sample. The smooth spherical fly ash contains strong peak concentrations of oxygen, aluminum and silicon with lower peak concentrations of carbon, potassium, calcium, titanium and iron.

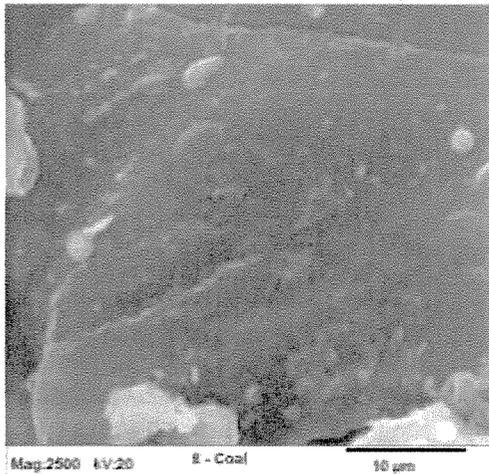
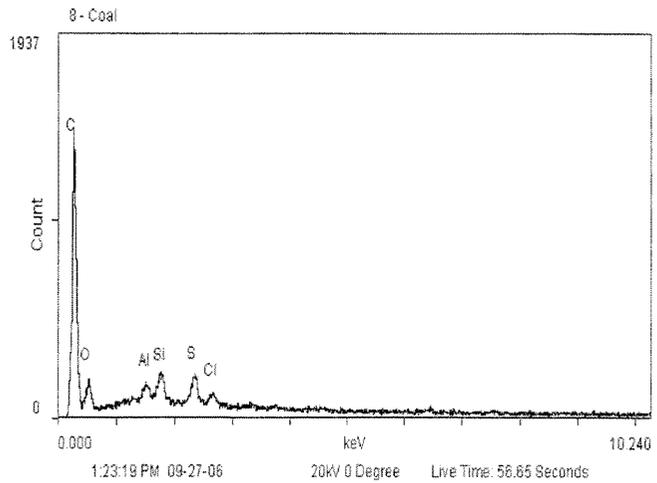
SEM analysis confirms the presence of coal, coal ash, fly ash and wood char. The mineral-like coal particle demonstrates a strong carbon peak with lower peak concentrations of oxygen, aluminum, silicon, sulfur and chlorine.

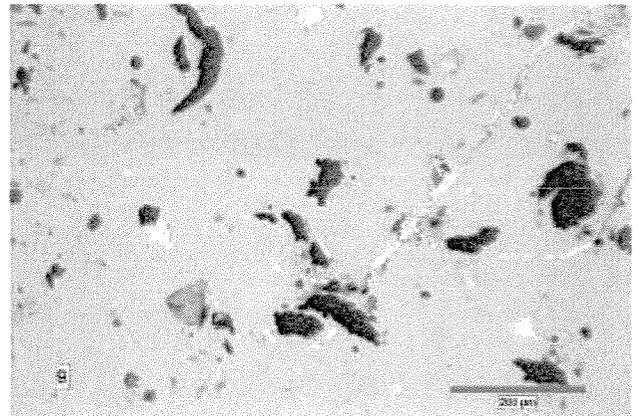
9:

Sample 9 consisted of non-soot opaques, biologicals and mineral grains. Some fibrous material also was observed. Particles demonstrating morphology suggestive of combusted soot material and coal were observed with the PLM.

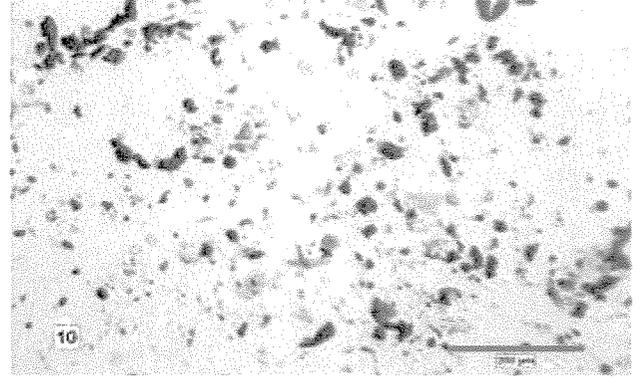
10:

Sample 10 contained a mix of biological matter, mineral grains and non-soot opaque material with some vegetative cellulose fibers. Particles demonstrating morphology suggestive of combusted soot material and coal were observed with the PLM.

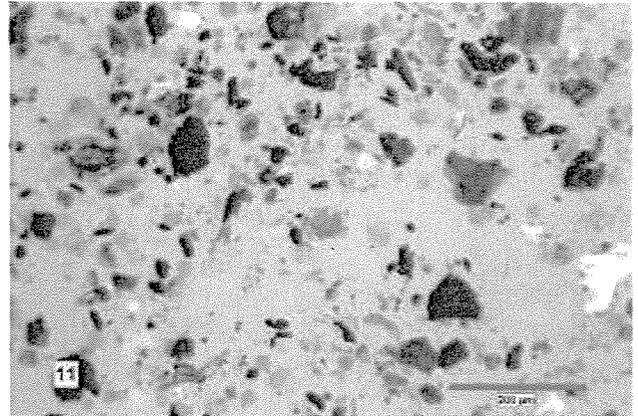
11:

Sample 11 consisted of biological debris and mineral grains with non-soot opaques and fibrous material. Particles demonstrating morphology suggestive of combusted soot material and coal were observed with the PLM.

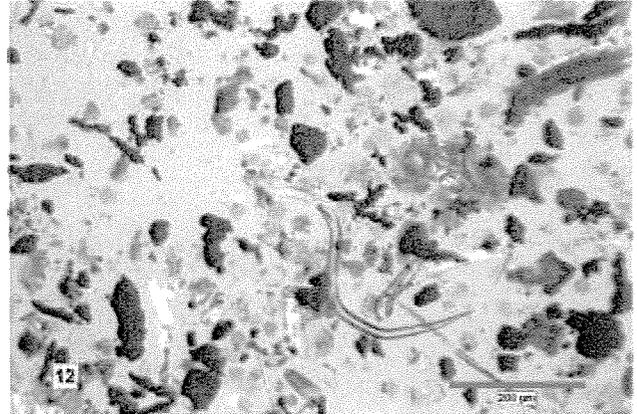
12:

Sample 12 contained a mix of mineral grains, biological debris and non-soot opaques with fibrous material. Particles demonstrating morphology suggestive of combusted soot material were observed with the PLM.

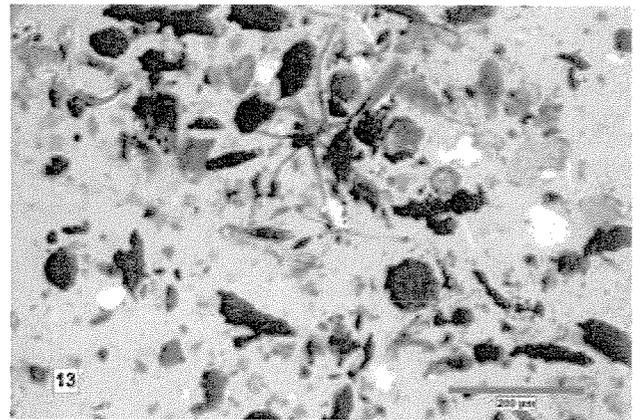
13:

Sample 13 contained a mix of biological debris, mineral grains and non-soot opaque material with some cellulose fibers. Particles demonstrating morphology suggestive of combusted soot material and coal were observed with the PLM

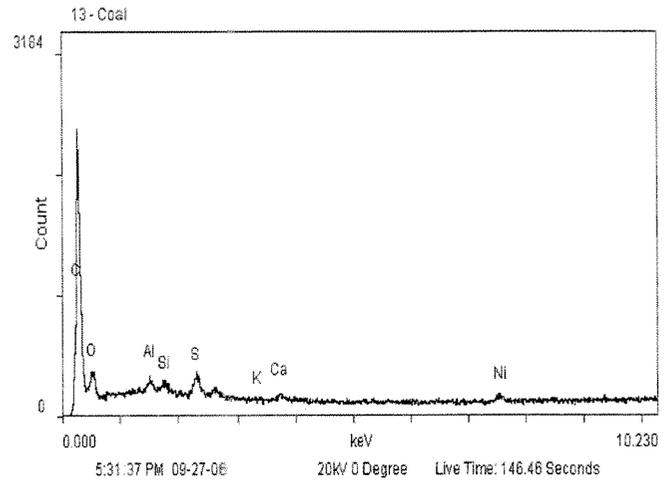
SEM analysis confirms the presence of coal, fly ash and coal ash. The coal particle demonstrates angular mineral-like edges, smooth surface with some light conchoidal fracture lines. Chemistry from the coal particle shows a strong peak concentration of carbon and lower peak concentrations of oxygen, aluminum, silicon, sulfur, potassium, calcium and nickel.

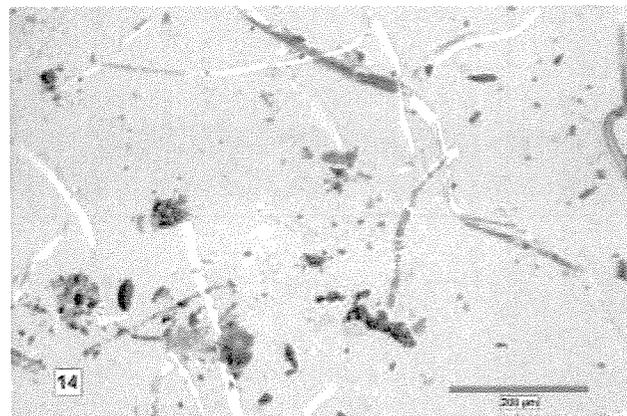
14:

Sample 14 contains mainly biological debris and fibrous material. Also noted were dark non-soot opaques and mineral grains. Particles demonstrating morphology suggestive of combusted soot material and coal were observed with the PLM.

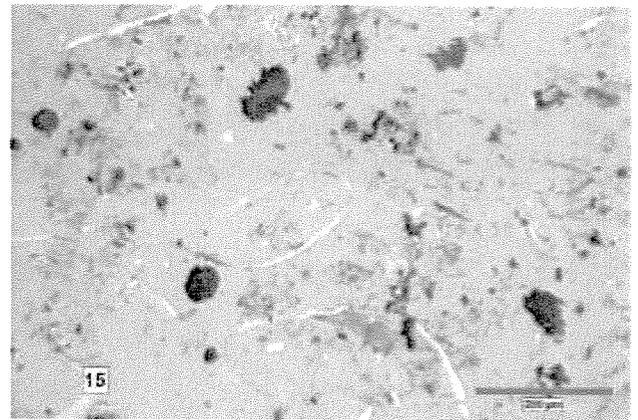
15:

Sample 15 contained a mix of biological debris, fibrous material, mineral grains and dark opaques. Particles demonstrating morphology suggestive of combusted soot material were observed with the PLM

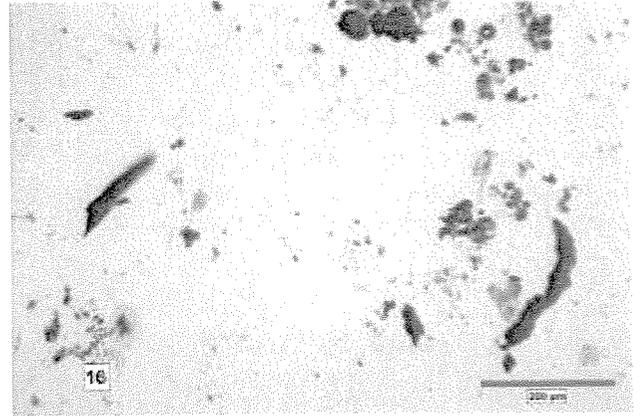
16:

Sample 16 contained a mix of non-soot dark opaques, biologicals, mineral grains and cellulose material. Particles demonstrating morphology suggestive of combusted soot material and coal were observed with the PLM.

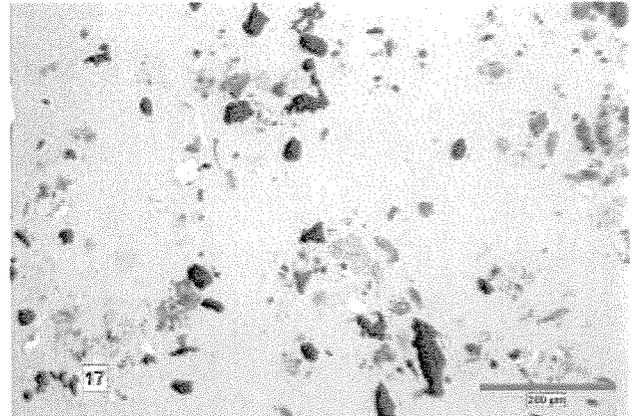
17:

Sample contained a mix of non-soot dark opaque particles, mineral grains and biological material with traces of fibrous material. Particles demonstrating morphology suggestive of combusted soot material and coal were observed with the PLM

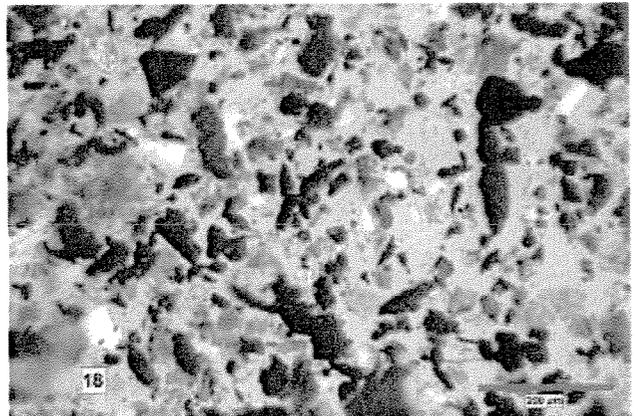
18:

Sample 18 contained a mix of biologicals, mineral grains, cellulose fibers and non-soot dark opaques. Particles demonstrating morphology suggestive of combusted soot material and coal were observed with the PLM

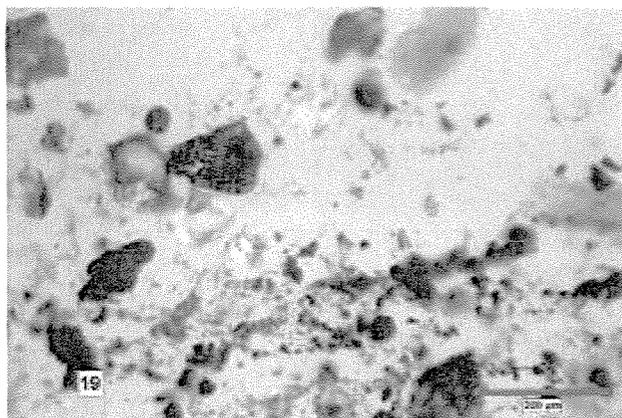
19:

Sample 19 contained minerals, biological debris and non-soot opaques. Particles demonstrating morphology suggestive of combusted soot material were not observed with the PLM

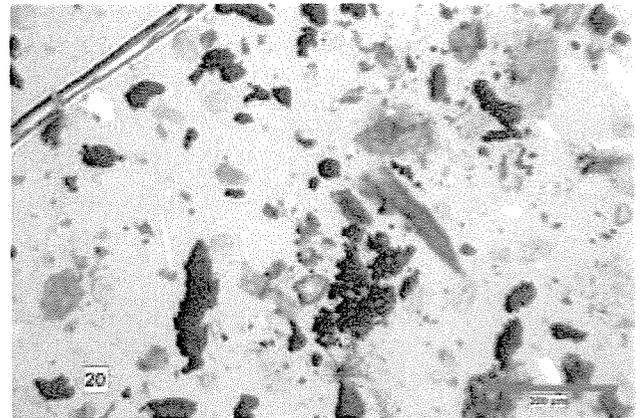
20:

Sample 20 contained a noticeable concentration of biologicals with mineral grains and non-soot opaques. Particles demonstrating morphology suggestive of combusted soot material and coal were observed with the PLM.

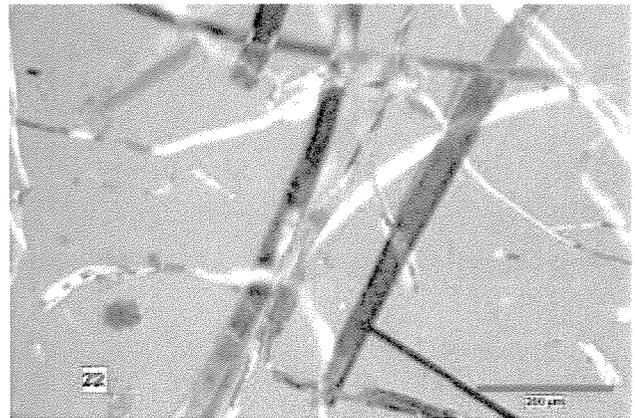
22:

Sample 22 contained fibrous material, biological debris and mineral. Particles demonstrating morphology suggestive of industrial soot material were not observed with the PLM.

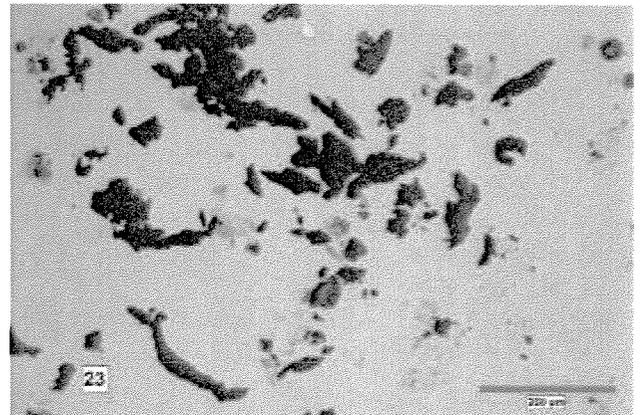
23:

Sample 23 contained a noticeable concentration of non-soot opaques, most of which was classified as vehicle dust. Mineral grains and biological material also were noted in this sample. Particles demonstrating morphology suggestive of combusted soot material and coal were observed with the PLM.

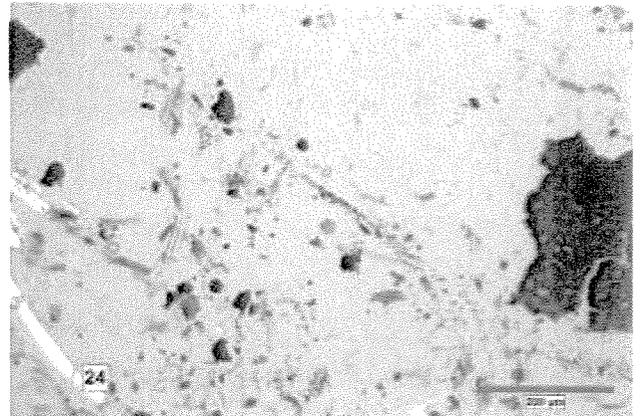
24:

Sample 24 contained a mix of non-soot opaques, fibrous material and biological debris. Particles demonstrating morphology suggestive of coal were observed with the PLM

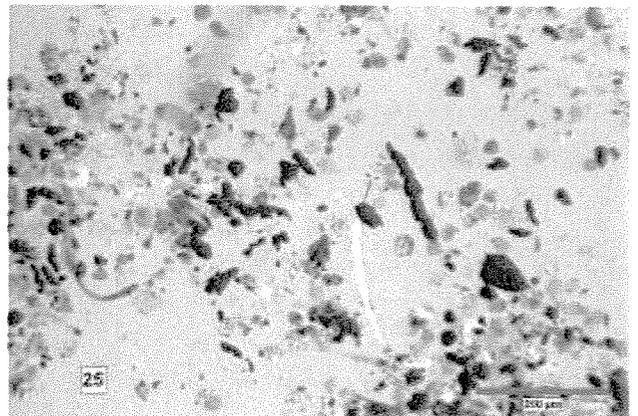
25:

Sample 25 contained primarily mineral grains and biological debris with non-soot opaques. Particles demonstrating morphology suggestive of combusted soot material and coal were observed with the PLM.

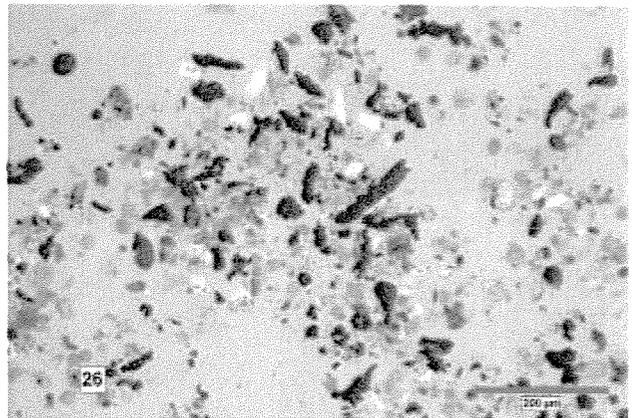
26:

Sample 26 contained minerals grains, biological debris with non-soot opaques. Particles demonstrating morphology suggestive of combusted soot material and coal were observed with the PLM.

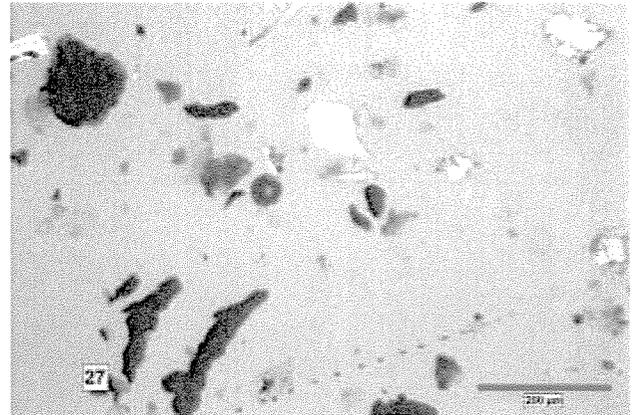
27:

Sample 27 contained a mix of minerals grains, biological debris and non-soot opaques. Particles demonstrating morphology suggestive of combusted soot material and coal were observed with the PLM.
