SITE PHOTOGRAPH LOG

Project Name:		Project No.
Taylor Run Stream Restoration		60742359

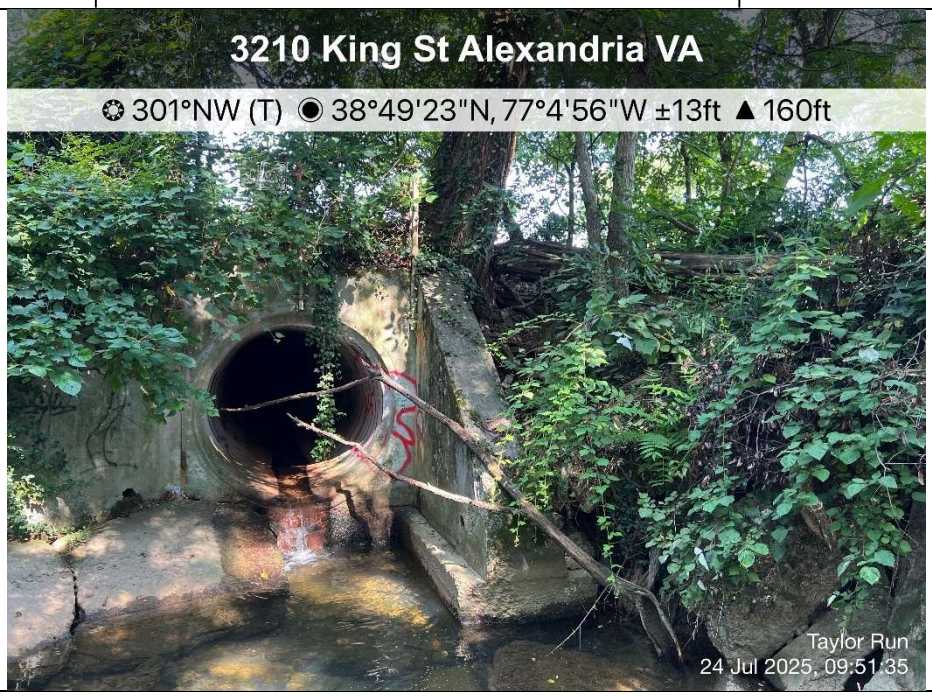
Photo No.	Date:
1	07/24/25

Description:
72-inch outfall condition. Gully next to right wingwall (look upstream) and beginning of plunge pool (Project Area 1)

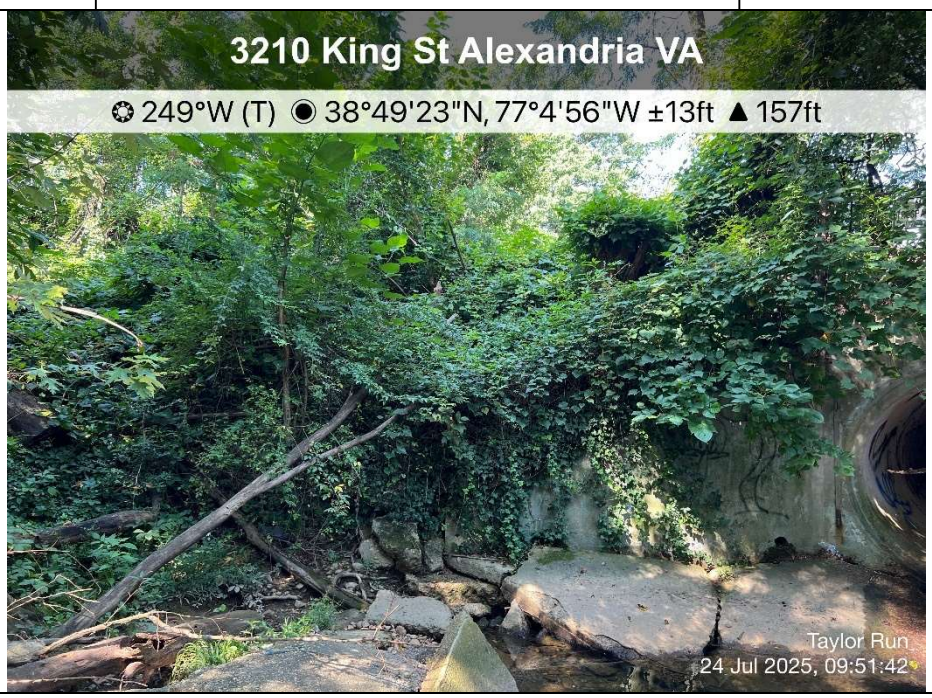
Photo No.	Date:
2	07/24/25

Description:
Left wingwall (looking upstream) condition. (Project Area 1)

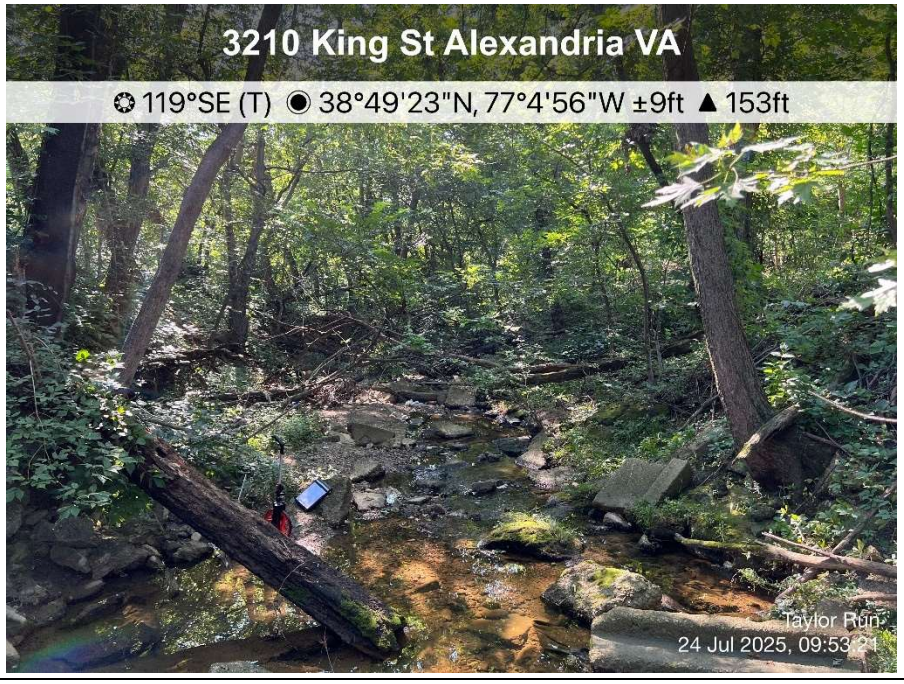
Photo No.	Date:
3	07/24/25

Description:
Downstream condition of stream with concrete debris, unstable (soon to fall) trees, woody debris build up

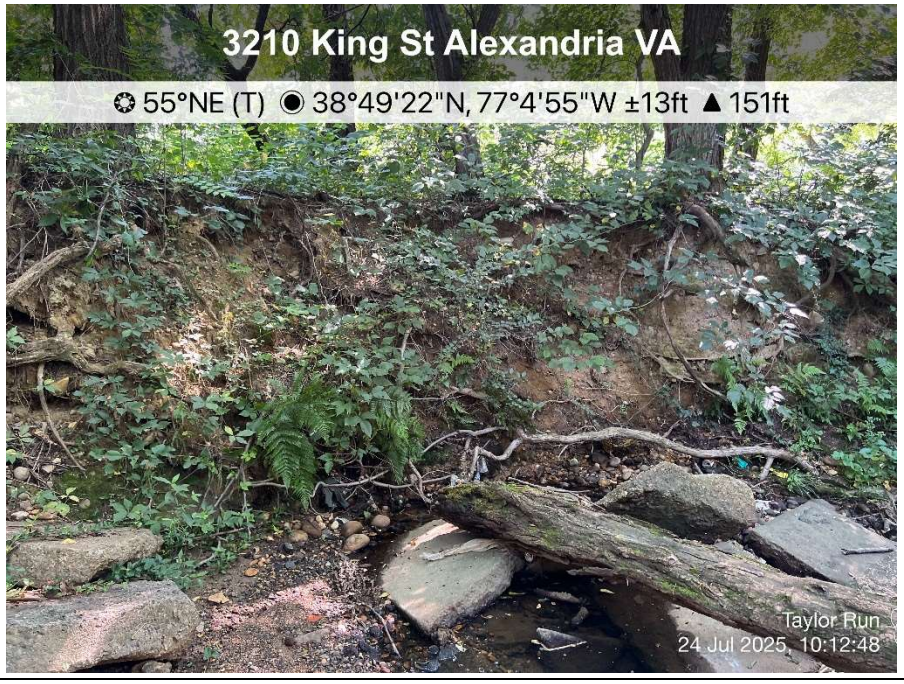
Photo No.	Date:
7	07/24/25

Description:
Eroding channel bank between Project Area 1 and 2

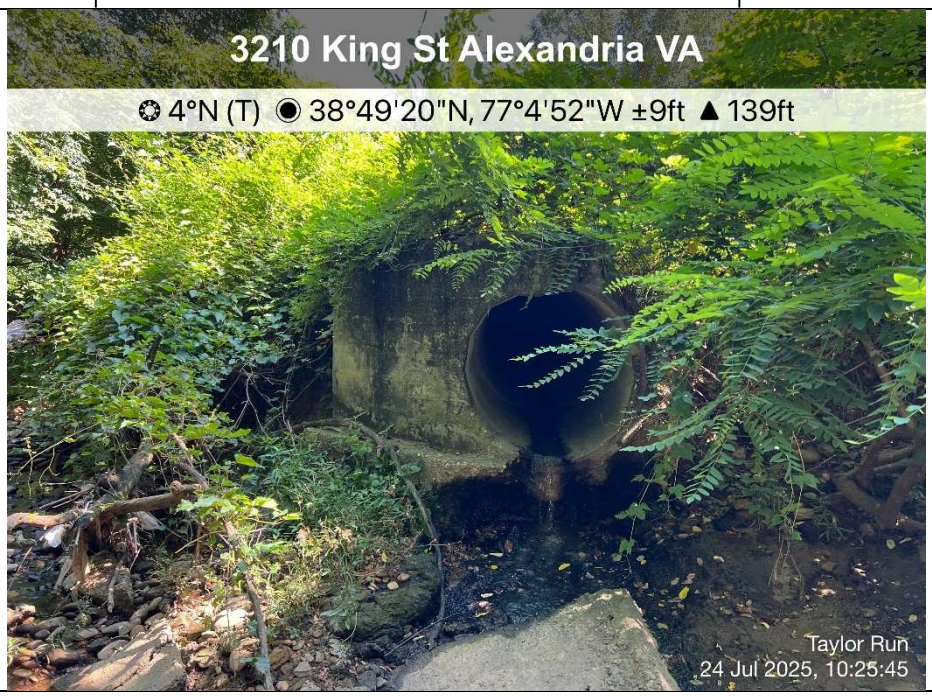
Photo No.	Date:
9	07/24/25

Description:
36-inch outfall showing undercut of headwall and erosion of the left side

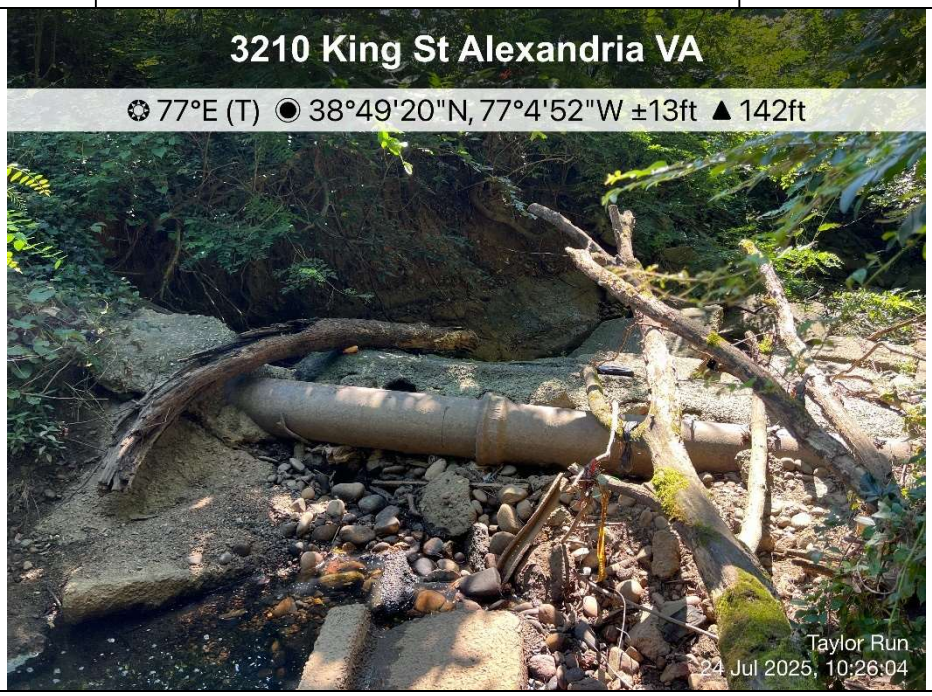
Photo No.	Date:
10	07/24/25

Description:
Exposed sanitary sewer pipe next to 36-inch outfall (Project Area 2)

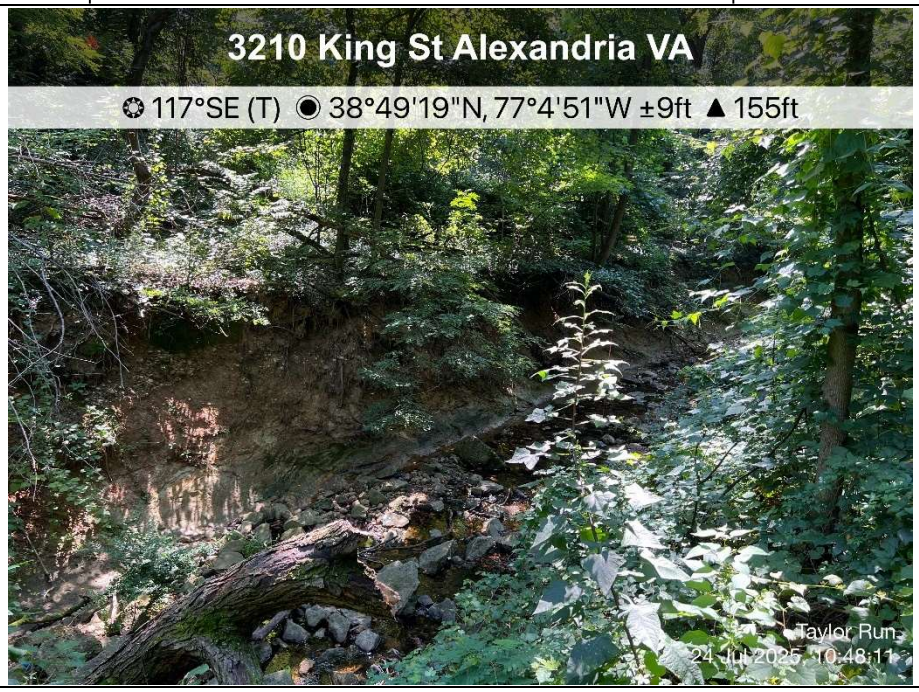
Photo No.	Date:
11	07/24/25

Description:
Severe bank erosion immediately downstream from the 36-inch outfall (Project Area 2)

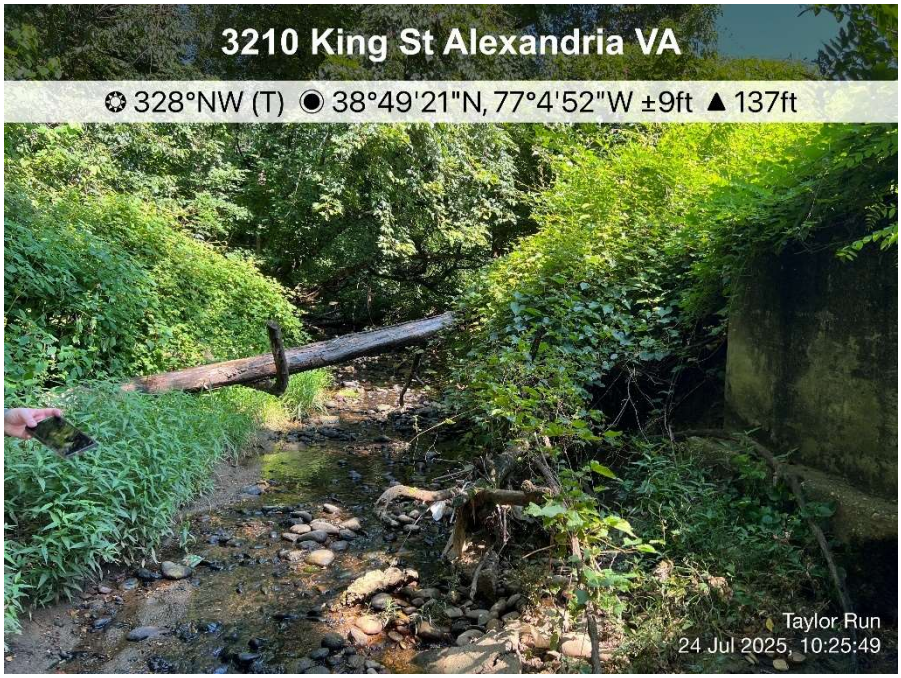
Photo No.	Date:
12	07/24/25

Description:
Upstream stream condition, standing at the 36-inch outfall. Fallen tree(s) due to bank instability (Project Area 2)

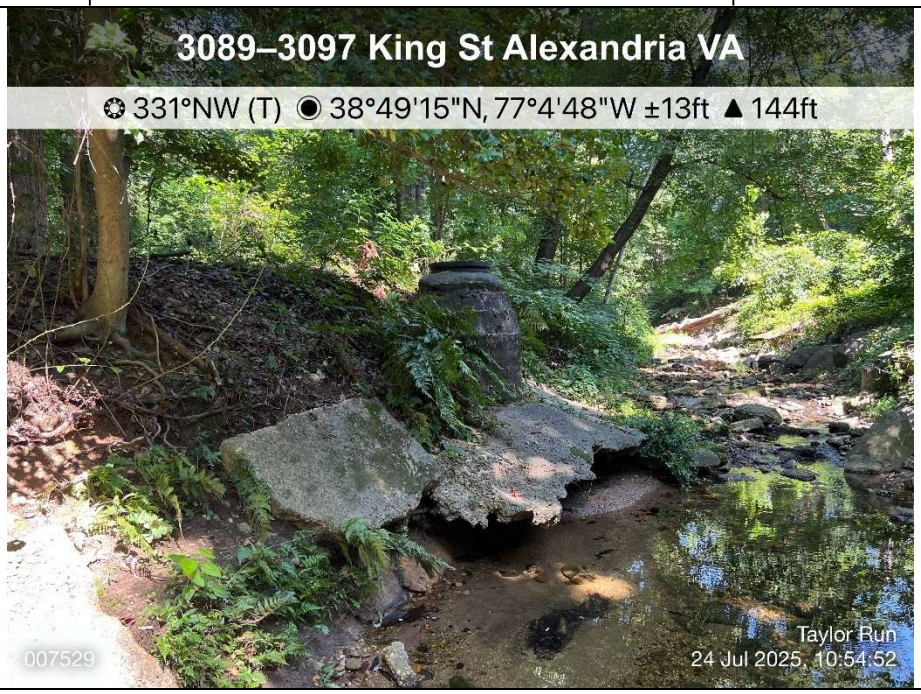
Photo No.	Date:
13	07/24/25

Description:
Exposed sanitary sewer manhole with undercut of concrete skirt

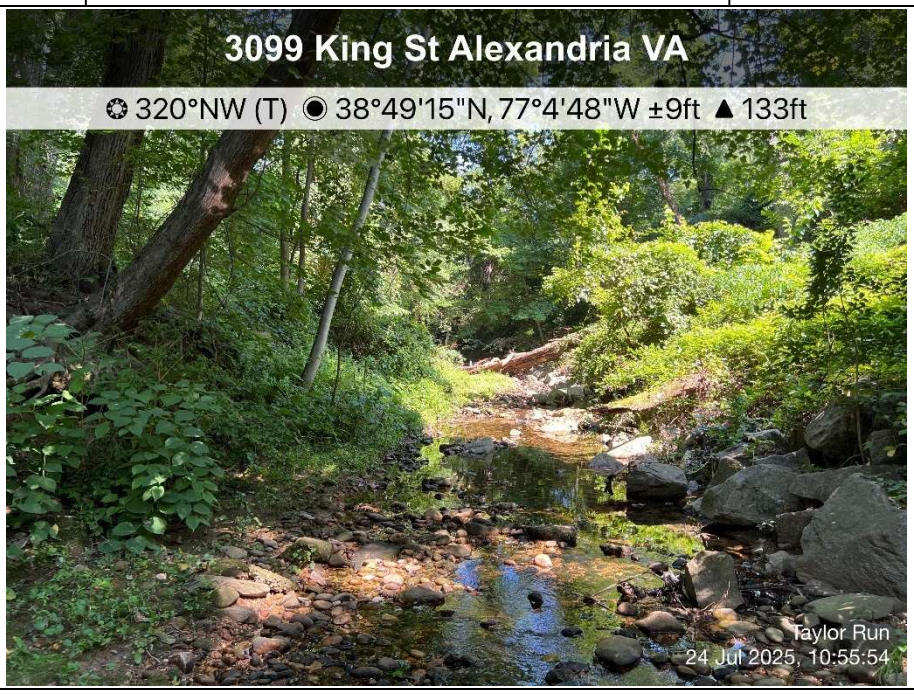
Photo No.	Date:
14	07/24/25

Description:
Upstream stream condition from exposed sanitary sewer manhole (Project Area 3)

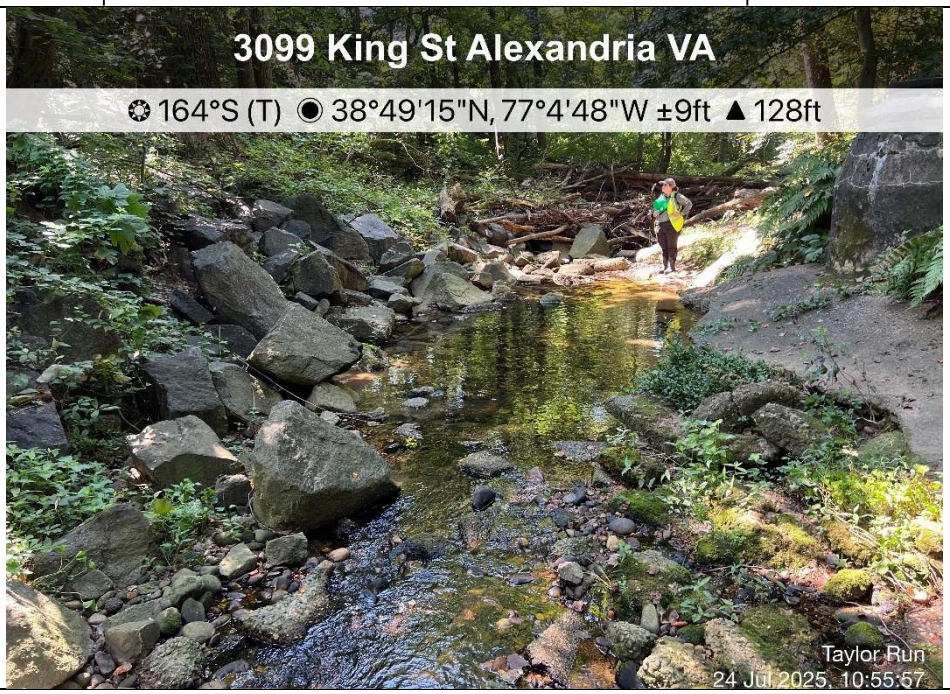
Photo No.	Date:
15	07/24/25

Description:
Downstream conditions of the exposed sanitary sewer manhole. Woody Debris build up in the back. (Project Area 3)

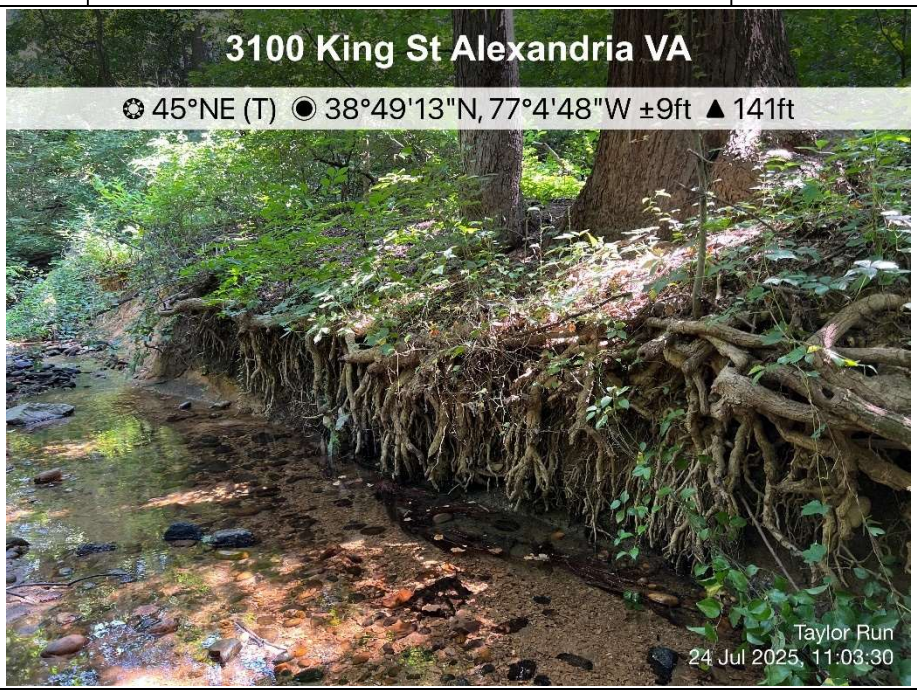
Photo No.	Date:
18	07/24/25

Description:
Horizontal extent of root exposure of the champion tree (Project Area 4)

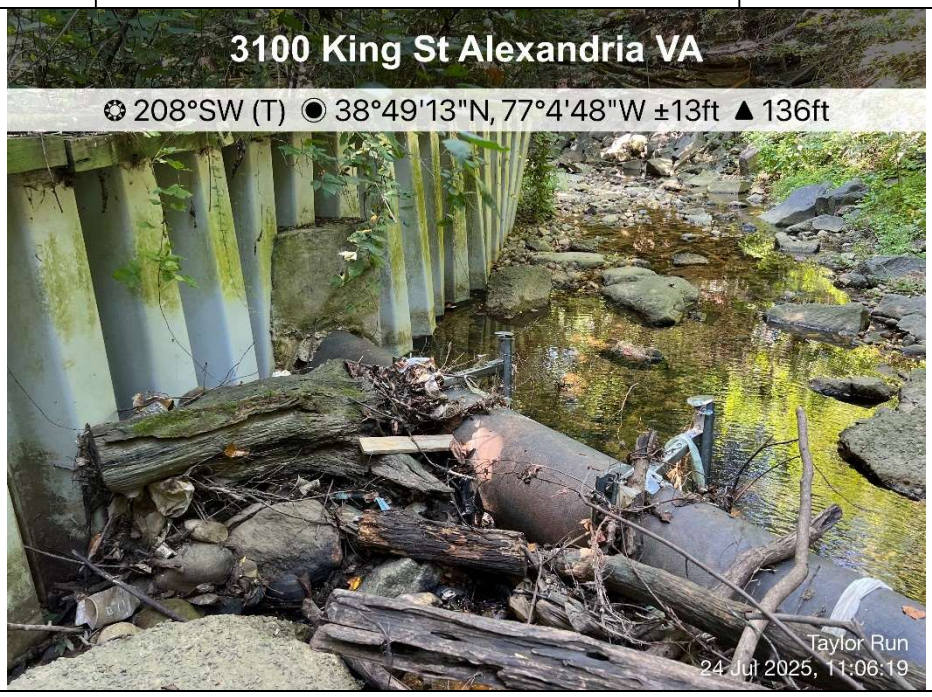
Photo No.	Date:
20	07/24/25

Description:
Exposed sanitary sewer pipe near sheet pile wall (Project Area 4)

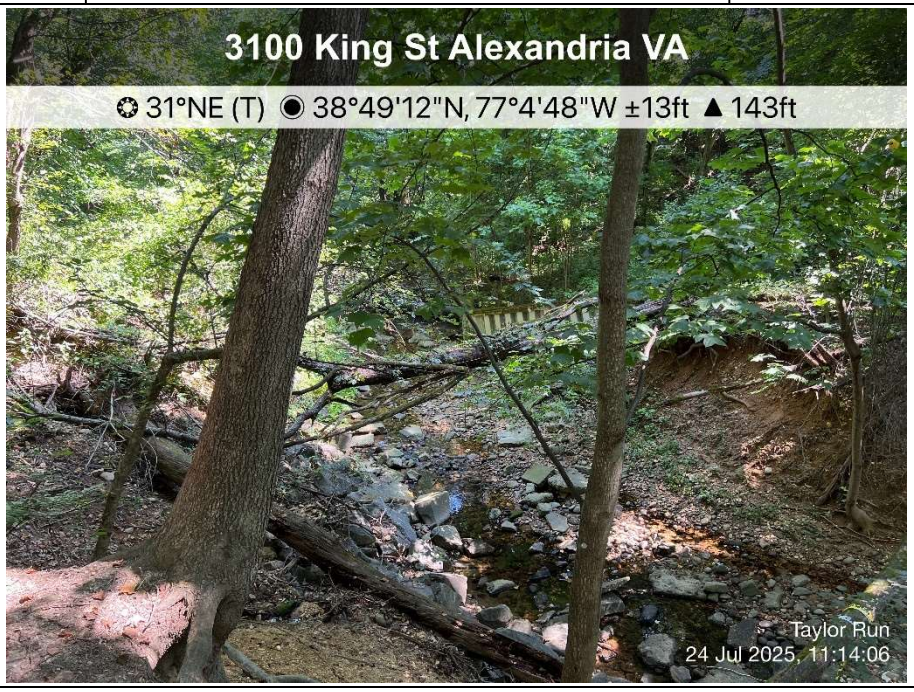
Photo No.	Date:
22	07/24/25

Description:
Condition of right bank, downstream of study extent

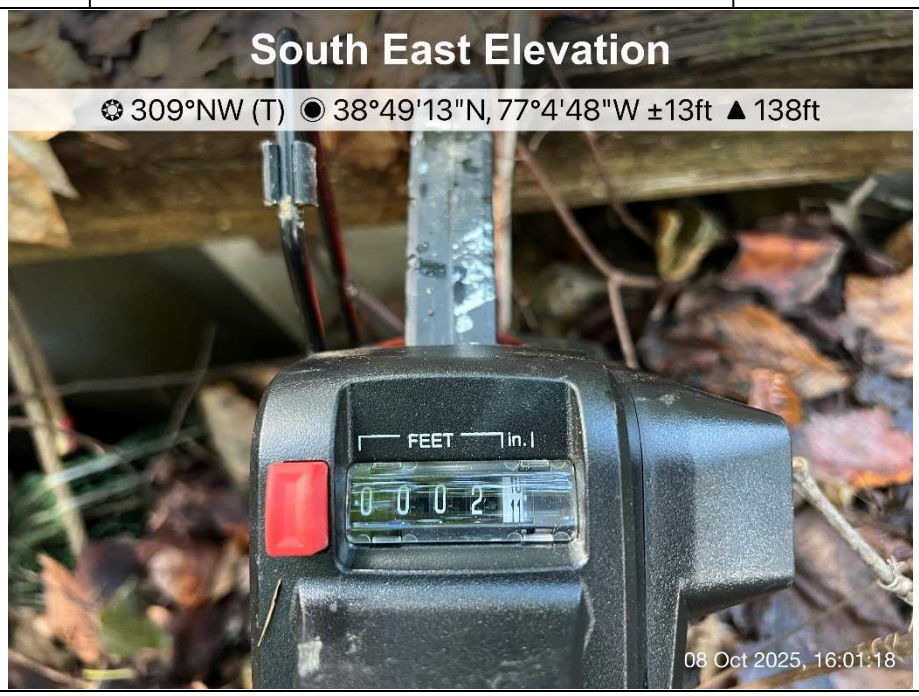
Photo No.	Date:
24	10/08/25

Description:
From center of sanitary manhole it is 2 feet from the sheet pile wall
