# PATRICK HENRY RECREATION CENTER

## FEASIBILITY STUDY - APPENDIX

JUNE 5, 2015

Re: Patrick Henry Elementary School
Limited Building Enclosure Evaluation
WJE No. 2014.6716

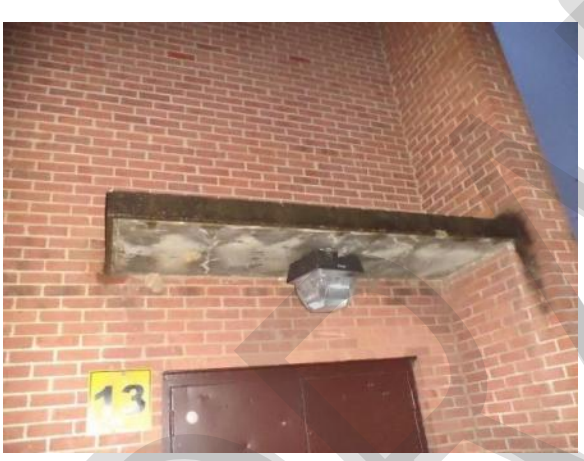
**Figure 7: South Gym Canopy Condition**

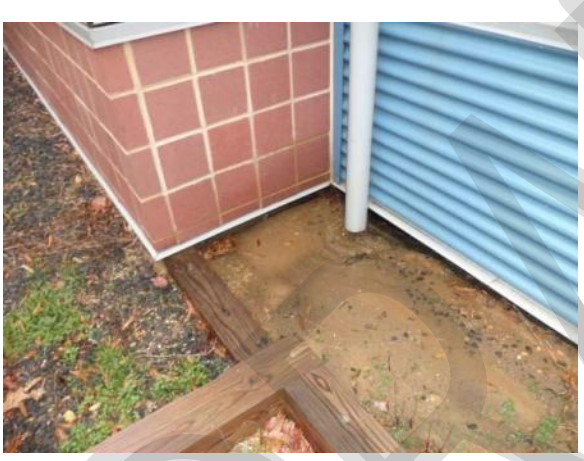
**Figure 9: Pooling of drainage at modular foundation walls (clogged)**

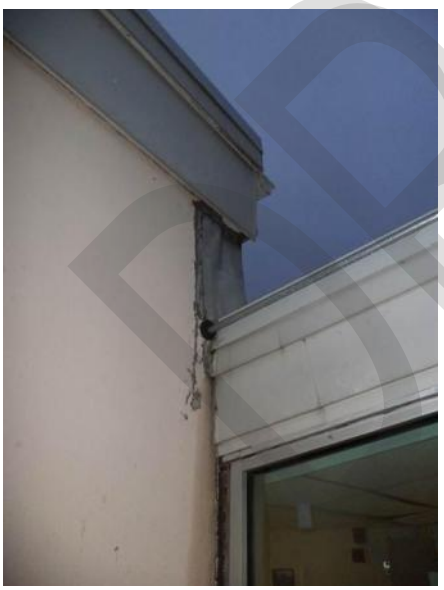
**Figure 17: Deteriorated Flashing at Bldg Return.**

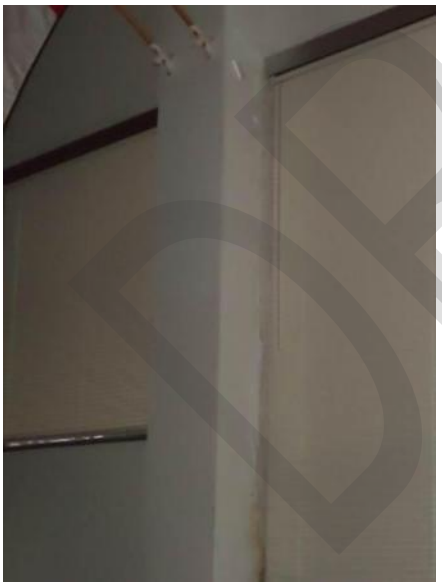
**Figure 23: Signs of moisture infiltration at Auditorium Column.**
