Subject: **Windmill Hill Park**
Bulkhead Inspection Report

WINDMILL HILL PARK

BULKHEAD INSPECTION REPORT

ABOVE WATER INSPECTION OF EXISTING CONCRETE BULKHEAD ALONG THE WINDMILL HILL PARK

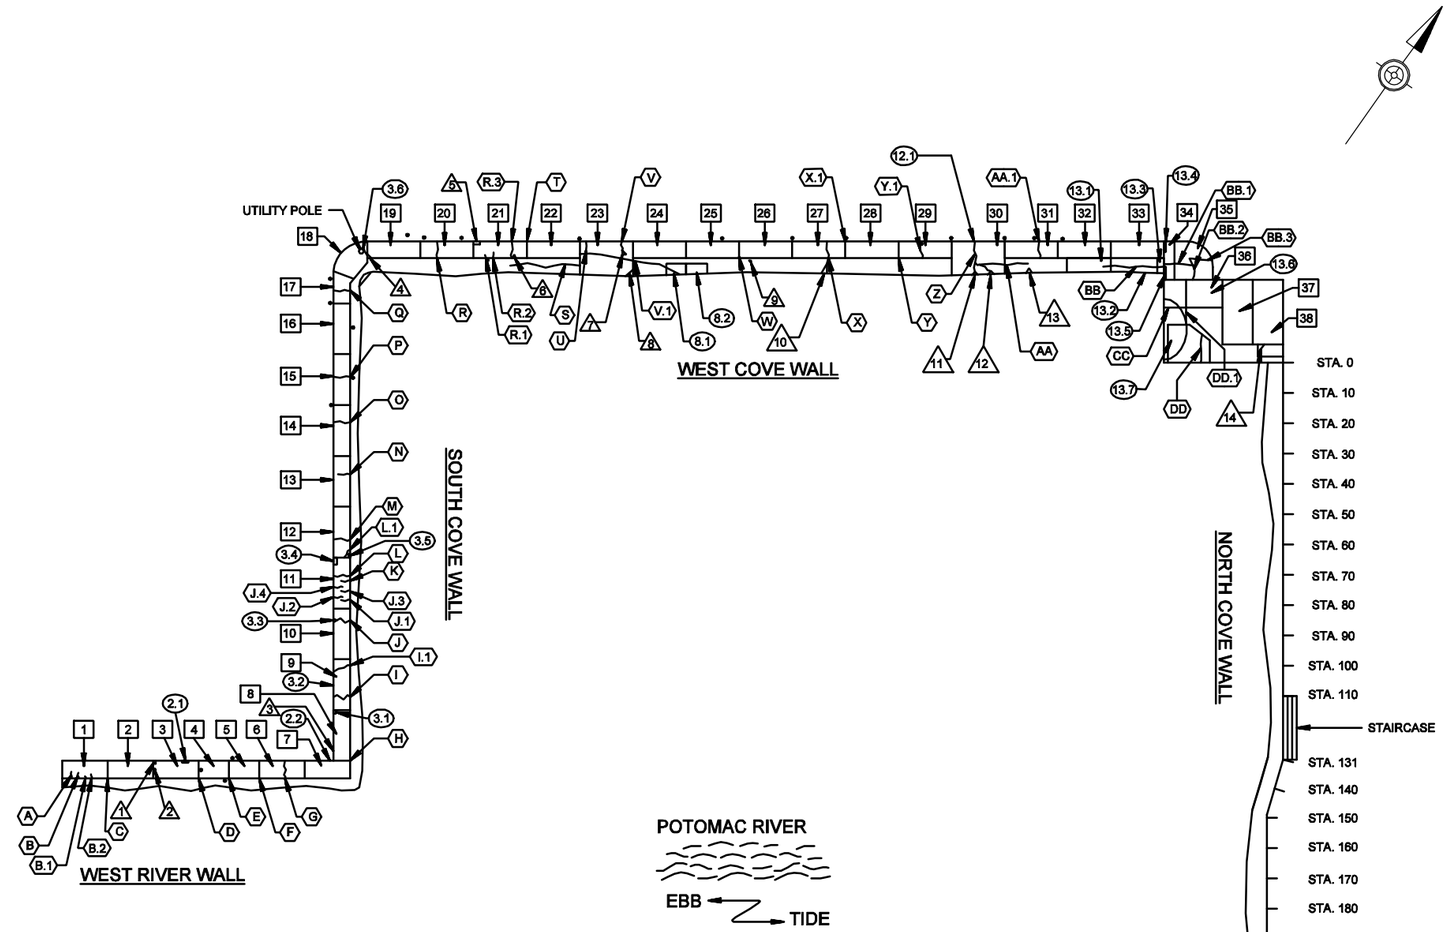
Project Name:
WINDMILL HILL
BULKHEAD INSPECTION
SCHEMATIC

A summary of findings for each segment is presented in this section. For the full defect report, see Appendix B. In addition, the tilt of the walkway slabs were measured using a level and folding rule. These results are produced in Appendix C.
