Strawberry Run Downstream Forensic Investigation

JUNE 27, 2022

Environmental Policy Commission

Presented by: Troy Biggs, PE, PH, D.WRE

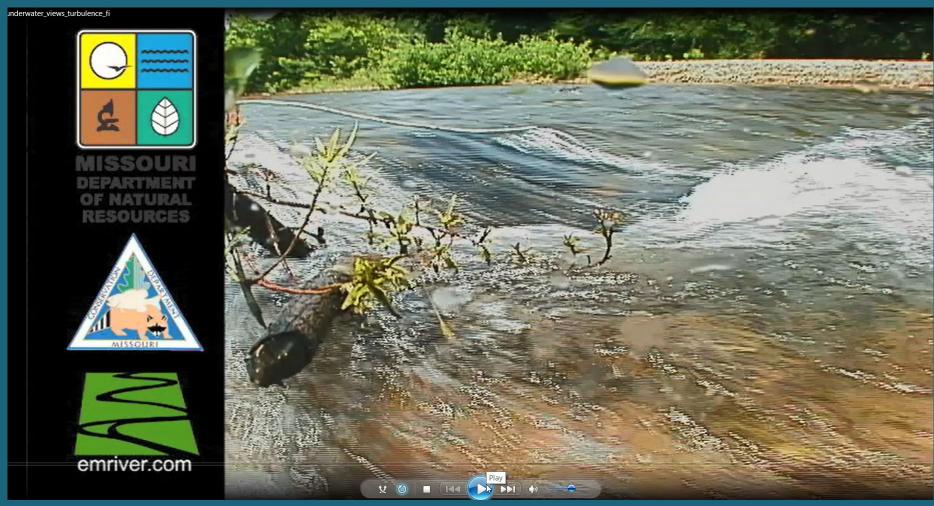
Hydraulics - Shear Stress

A little more than 1 foot of water in the channel nearly mobilizes the entire bed.

The biggest particle found was 110 mm. The 1-yr discharge moves approximately 200 mm particle.

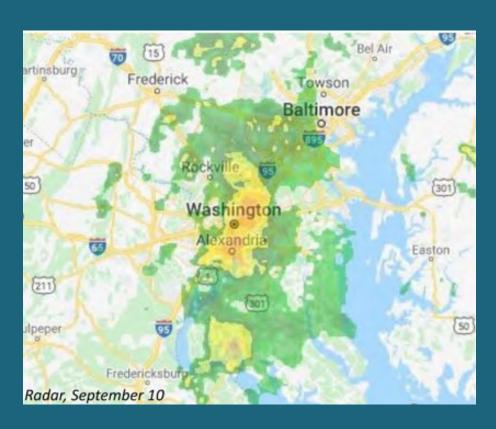
Climate Change: More Frequent, More Intense Storms

- One month post-construction in 2010, a 5-10-Yr storm event occurred
- Flash floods occurred:
 - July 21, 2018
 - July 8, 2019
 - July 23, 2020
 - September 10, 2020
 - August 15, 2021
