Taylor Run Sanitary Sewer Crossings

November 15, 2022

Taylor Run Stream Crossings

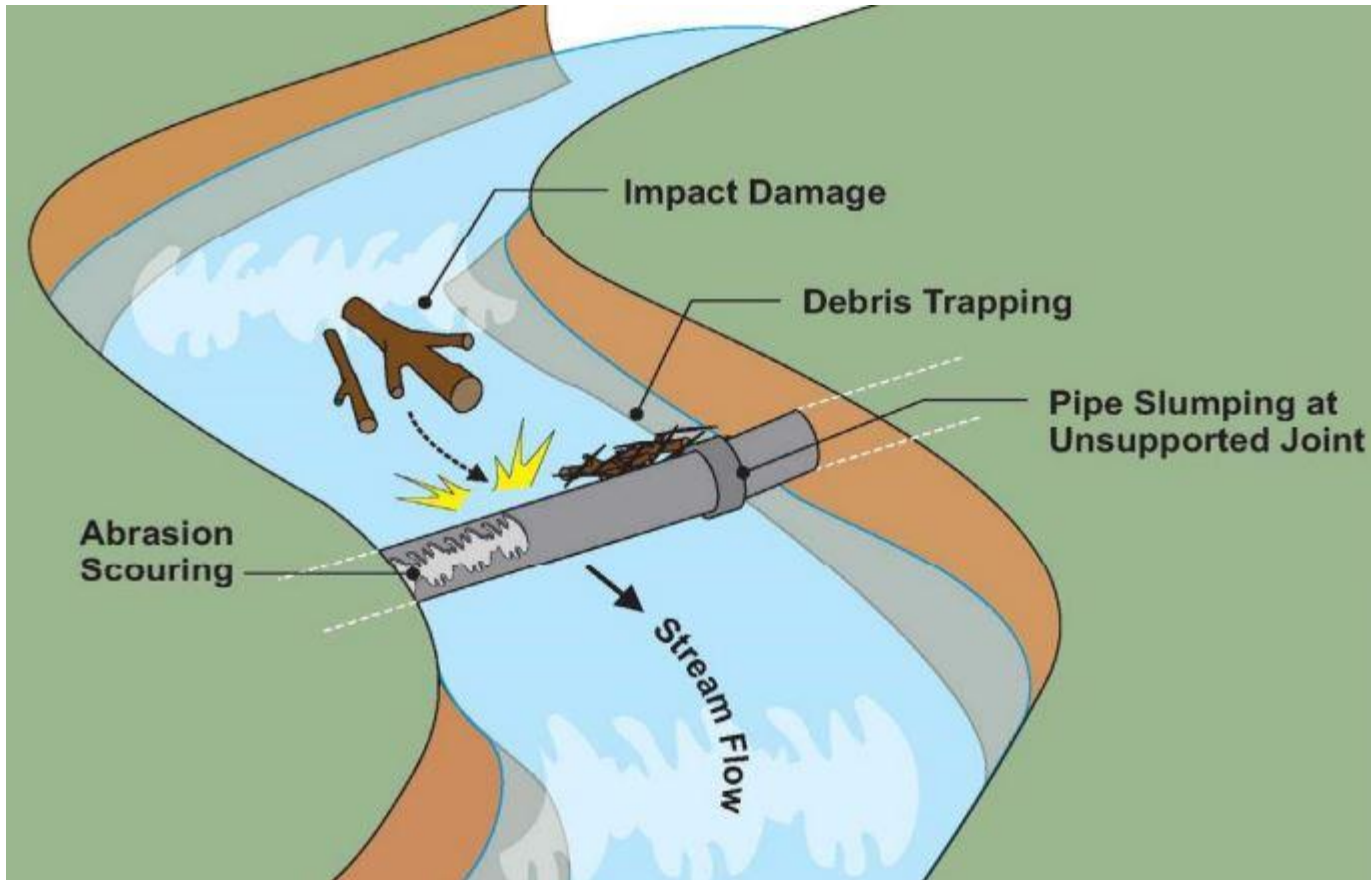
How do stream crossings fail? Consequences?

- Sewage being discharged into stream
- Stream flows in sewer resulting in sewer backups into homes
- Potential fines and/or enforcement action from Virginia Department of Environmental Quality (VDEQ)
- Costly emergency repairs
- Disruption to the community

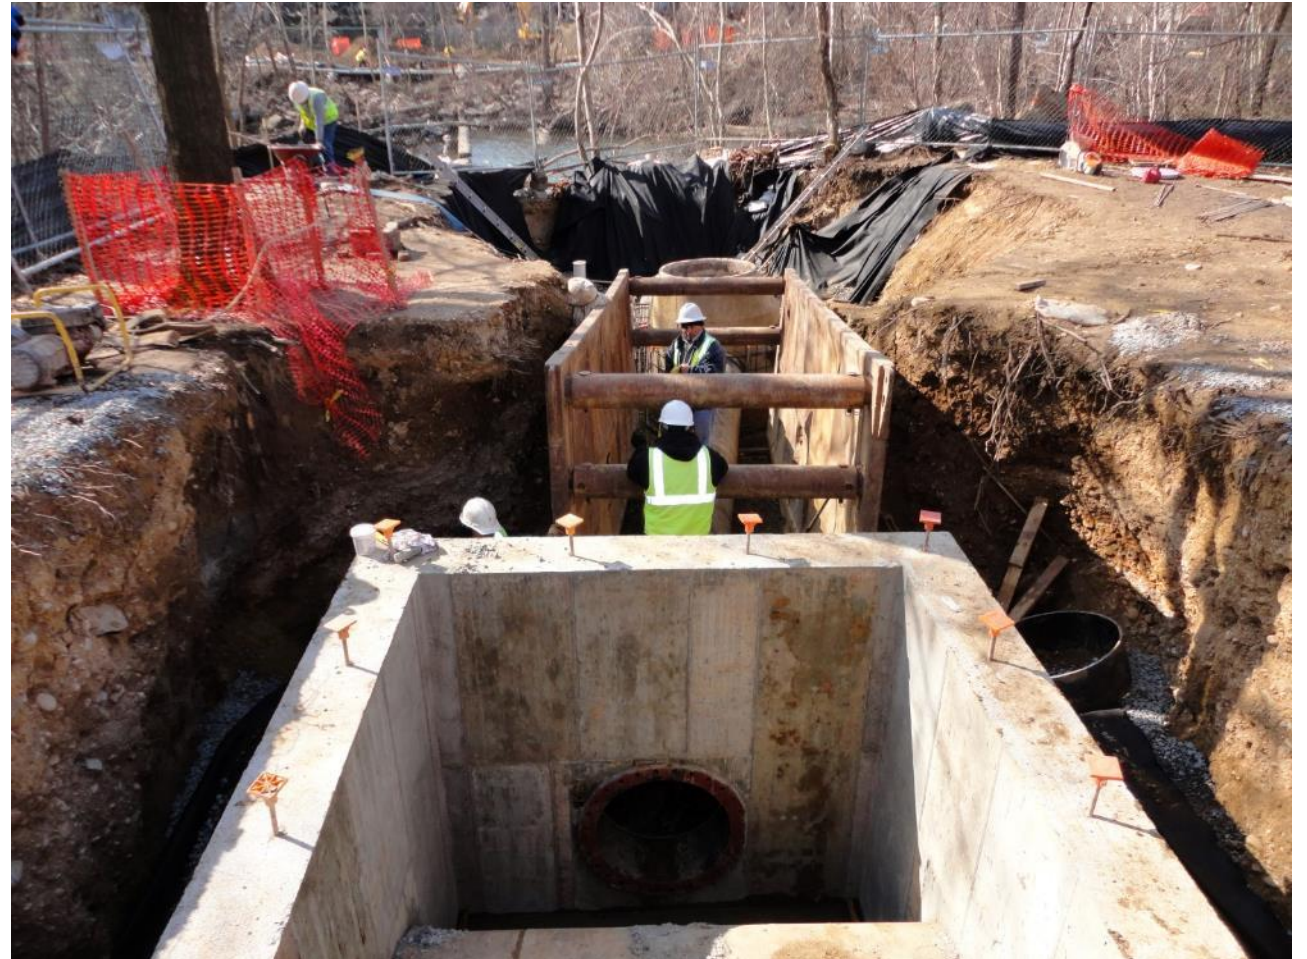
Emergency Repair

- Additional infrastructure was needed to bypass the sewage from entering the stream during construction

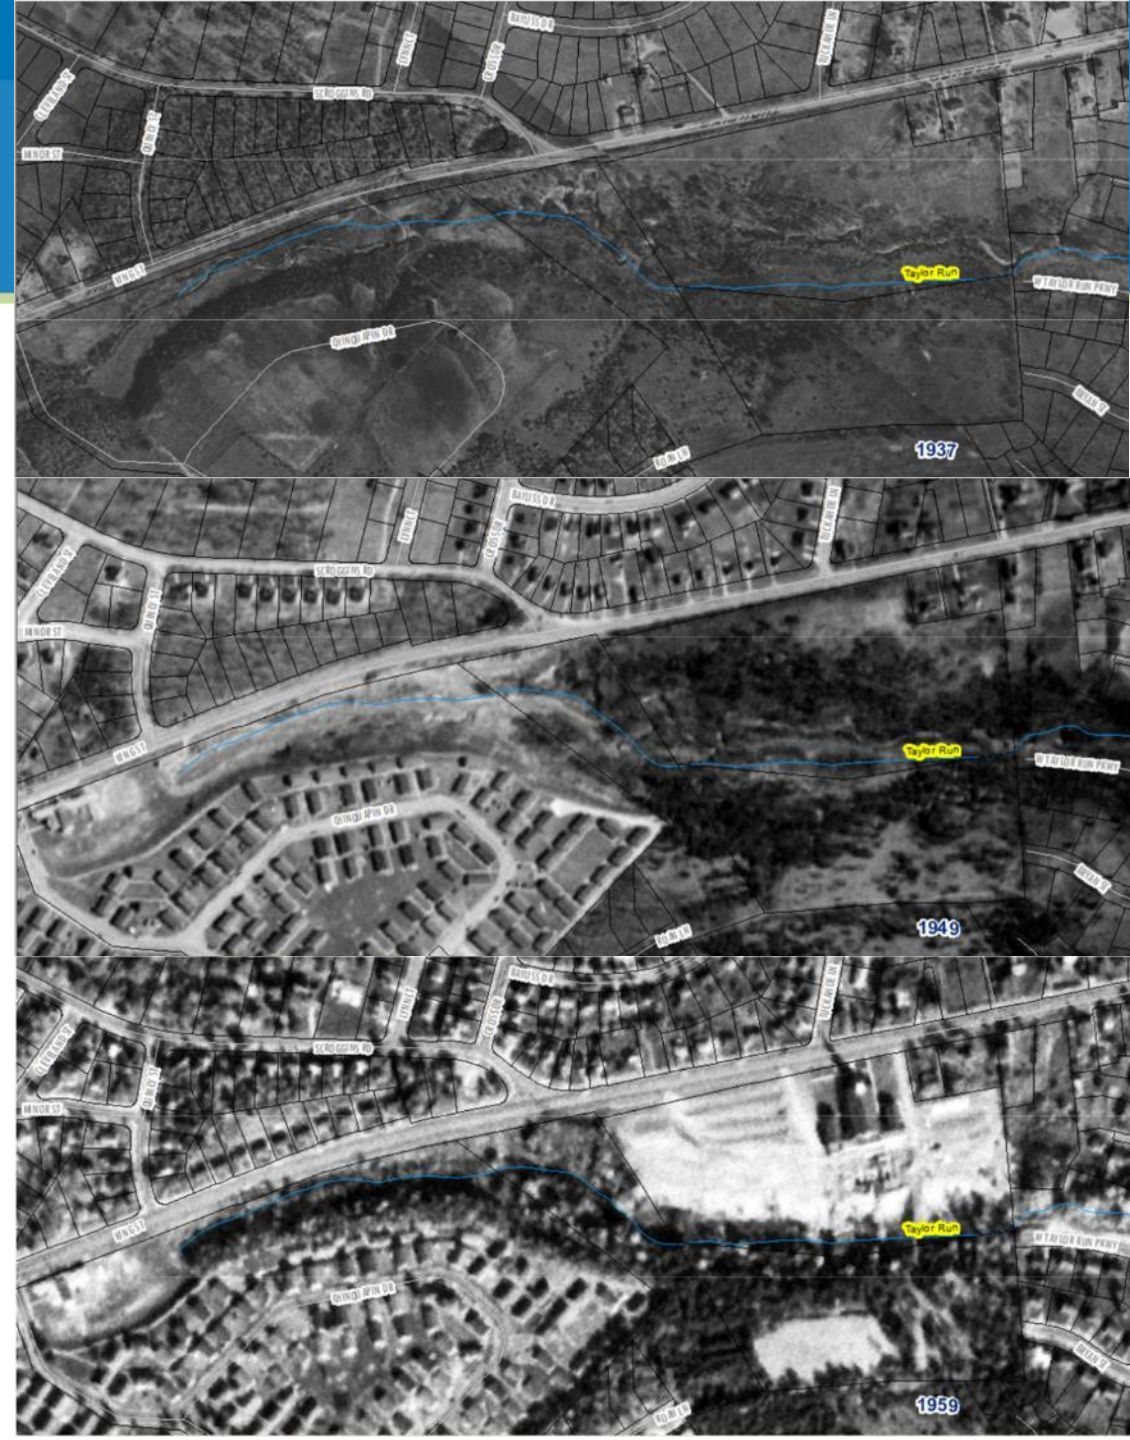
History of Sewer Crossings

- Sewers were constructed in the 1940's
- Rehabilitated with Cured-In-Place Plastic (CIPP) in Aug 2009
- Damage occurred in 2014 that broke the downstream pipe and replacement was required

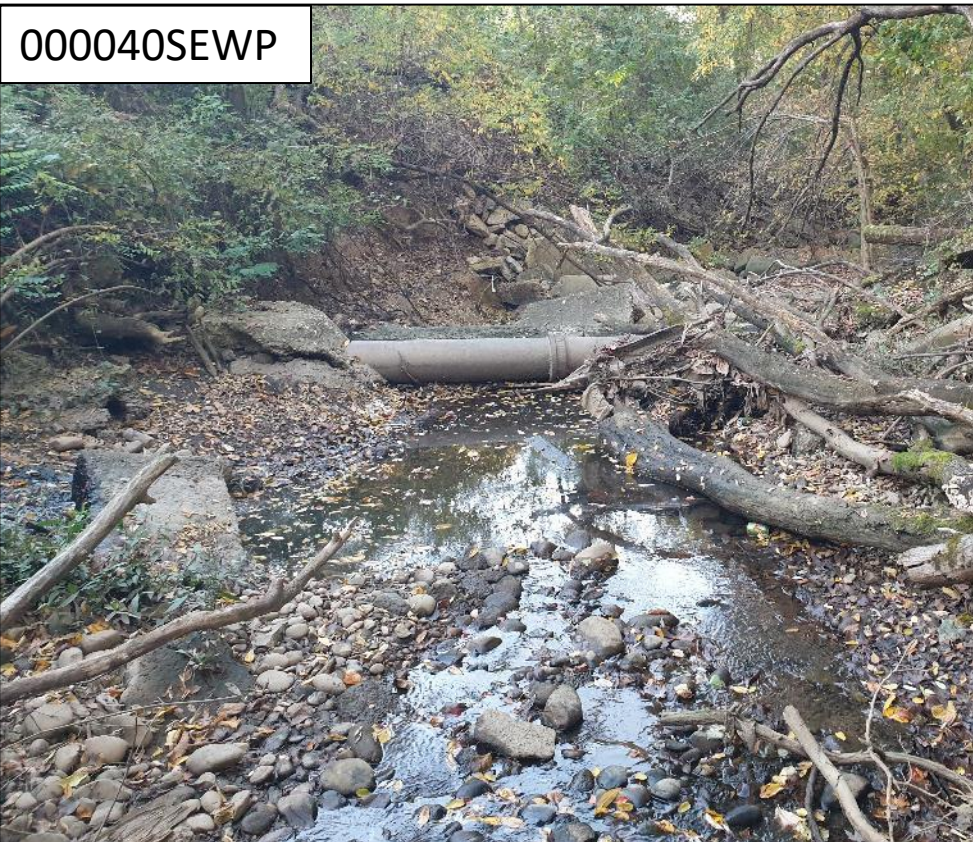
Sewer ID	Pipe Material	Diameter (Inch)	External Risk Factor	Likelihood of Failure (LoF)	Consequence of Failure (CoF)	Overall Risk Score
000040SEWP (Upstream)	CIPP	10	5	2.1	4.80	24.0
009478SEWP (Downstream)	DIP	15	5	1	5.32	26.6

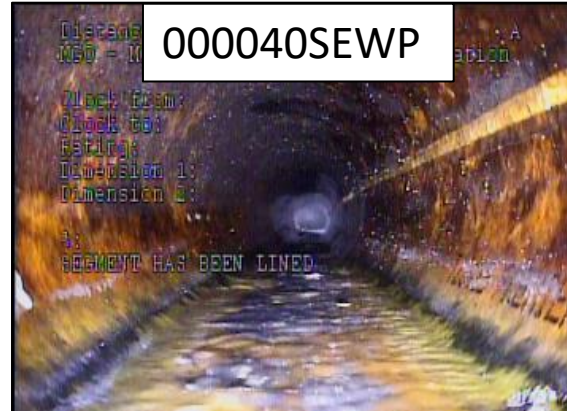
000040SEWP

- There is a joint in the middle of the pipe which is a weak point. Could be a point of failure if struck by debris.
- Support at the north end is eroded and water is now flowing underneath the support. Further erosion may cause the support to fail.
- Concrete and asphalt intended to protect the crossing is beginning to wash out. This is no longer protecting the crossing and shows the power of the stream against the pipe.

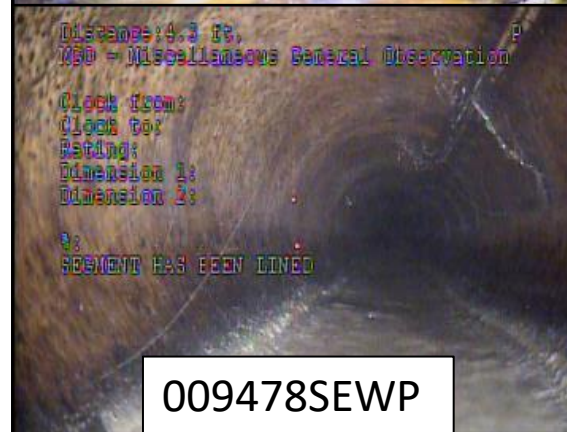
009478SEWP

- Some of the metal supports are beginning to rust
- Debris is building up behind the crossing and acting as a dam. This causes a lot of force to push against the pipe and will continue to increase as more debris builds up and larger storms occur.
