HAZARDOUS MATERIALS SURVEY

BEACHCOMBER BUILDING (Currently Vacant)

**1 – 3 PRINCE STREET
ALEXANDRIA, VIRGINIA 22314**

**SUBJECT: Limited Scope Hazardous Materials Survey for Identification
Of "Suspect" Lead in Paint, "Suspect" Asbestos,
And Miscellaneous Materials**

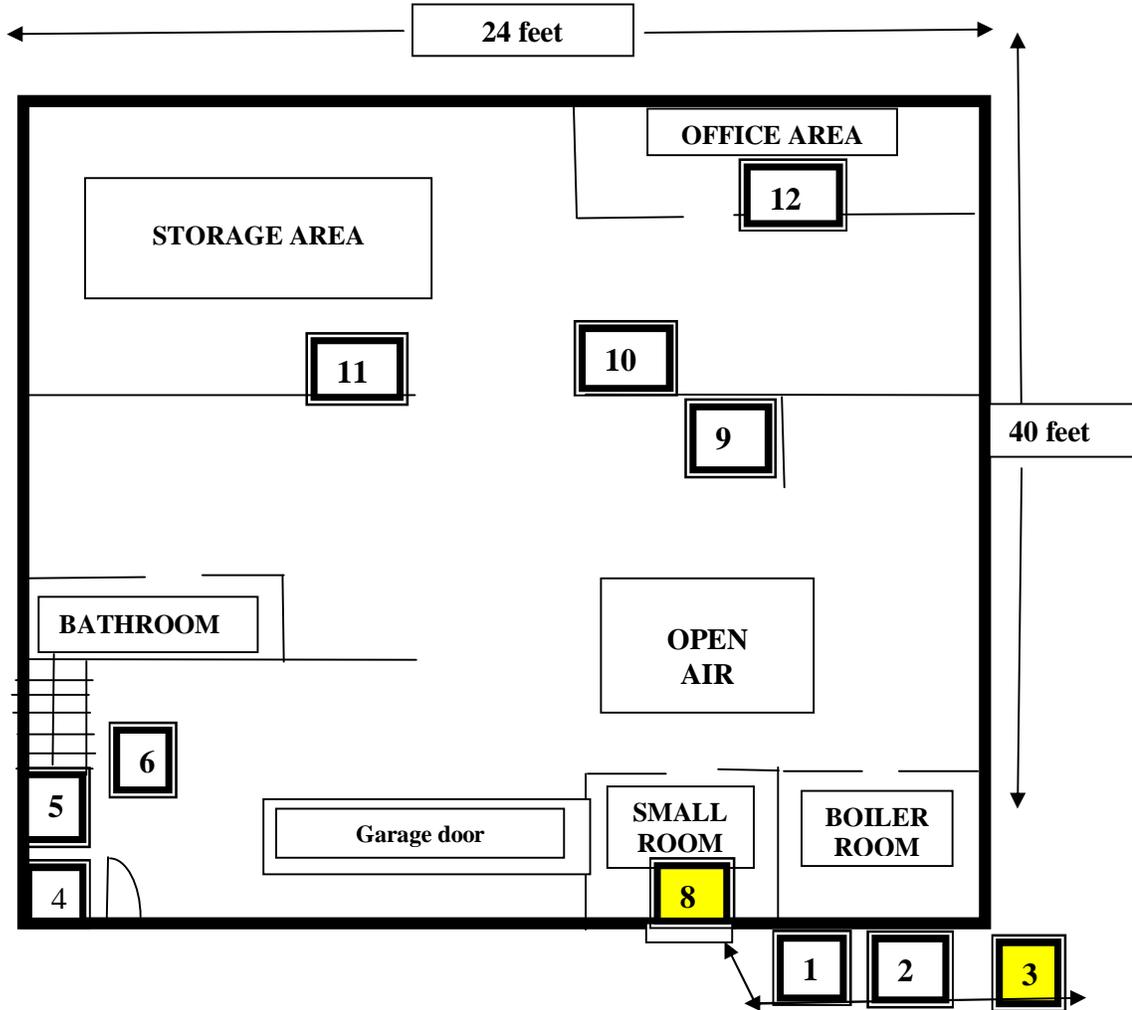
**ASBESTOS BULK SAMPLE COLLECTION LOCATIONS – EXTERIOR & FIRST FLOOR
BEACHCOMBER BUILDING, ALEXANDRIA, VA
INSPECTED: JULY 5, 2012**

Sample #	Area	Description of Material
1	Exterior	Window Glazing
2	Exterior	Window Glazing
3	Exterior	Window Caulking
4	First Floor	Resilient Floor Sheeting at Entry
5	First Floor	9" X 9" Acoustical Ceiling Tile at Stairwell
6	First Floor	Gray Stairwell Tread at Entry
7	First Floor	Wall Plaster at Garage Door
8	First Floor	9" X 9" VAT Beneath Carpet in Small Room
9	First Floor	Underlayment Beneath Carpet
10	First Floor	Wall Plaster in Open Storage Area
11	First Floor	Pegboard
12	First Floor	Green Resilient Floor Sheeting

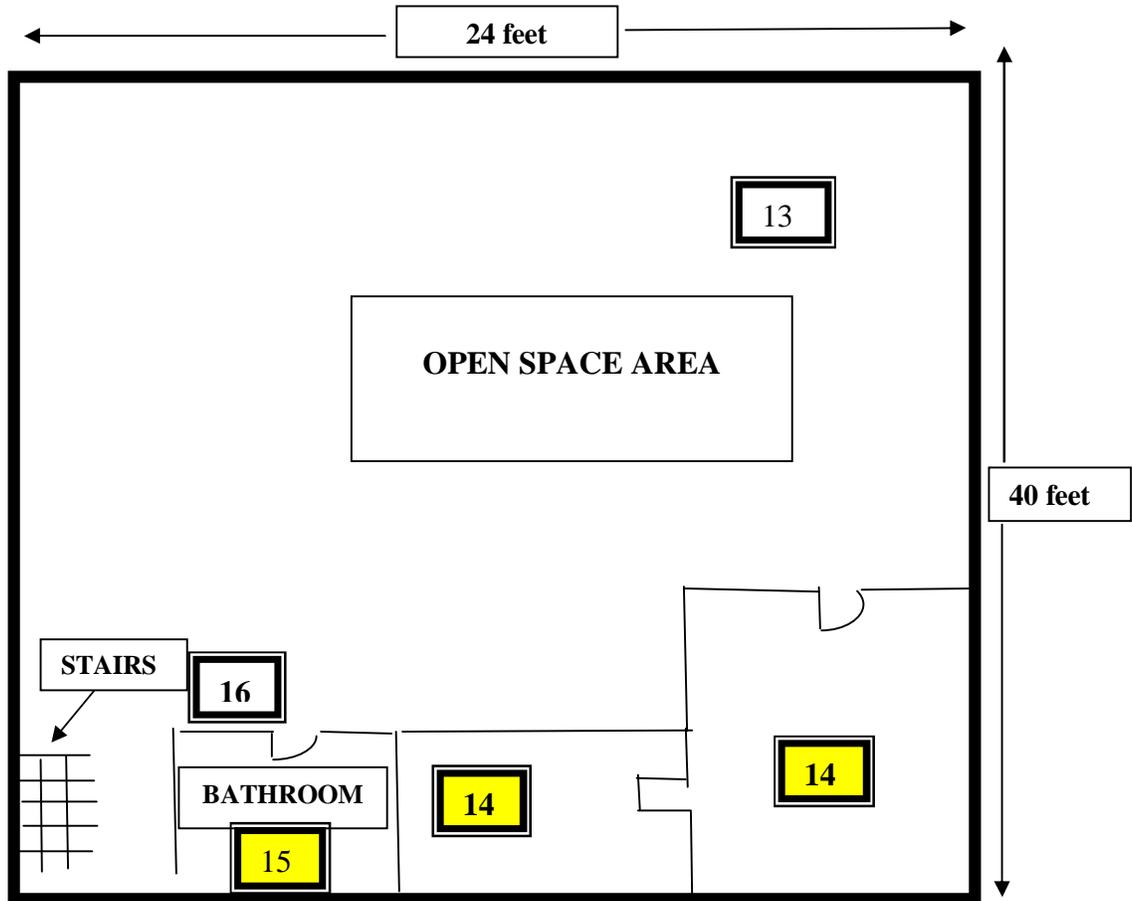
**ASBESTOS BULK SAMPLE COLLECTION LOCATIONS – SECOND FLOOR
BEACHCOMBER BUILDING, ALEXANDRIA, VA
INSPECTED: JULY 5, 2012**

Sample #	Area	Description of Material
13	Second Floor	Insulation Loose Batting / Backing
14	Second Floor	9" X 9" VAT / Gray (2 Rooms Rear)
15	Second Floor	12" X 12" VAT / Gray (Bathroom)
16	Second Floor	Wall Plaster (Above Stairwell Area)
