# TECHNICAL MEMORANDUM

RE: **SITE RECONNAISSANCE AND INVENTORY**

This memorandum documents the site reconnaissance and existing conditions assessment in support of the City of Alexandria waterfront planning efforts. The purpose of this investigation was to obtain an initial understanding of the material type, extent and condition of the shoreline treatment (e.g. steel and timber bulkheads, rip-rap, pavement, “natural” vegetation, etc.) and structures (e.g. piers, wharfs, etc.) along the waterfront. The preliminary observations of existing conditions were based on review of existing data and site investigations performed during the week of May 17 – 23, 2009. This reconnaissance-based rating should not be construed as a structural condition assessment, but rather as a preliminary evaluation.

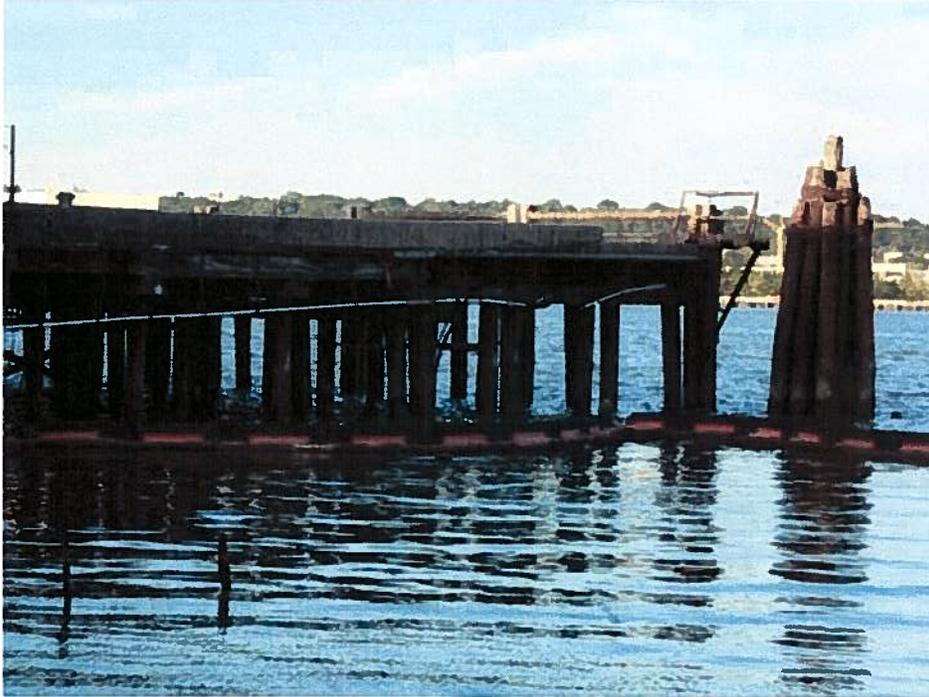
**Figure 7. Timber and steel pile supported pier at Robinson Terminal North**

The timber piles in Area A are in satisfactory condition overall, but are split in some instances at the tops of the piles where they are connected to the timber bent caps (Photo 4-2-203 of Appendix B). This may indicate lateral load overstress at some time during the structure's operation. Minor to moderate corrosion exists on the steel angle cross braces and hardware. The timber bent caps are rotten (Photo 4-2-223 of Appendix B) in many instances and may be susceptible to bearing overstress. Minor corrosion exists on the steel W-Shape stringers and associated bracing and hardware. Some instances of concrete spalling on the underside of the precast concrete panels were noted. The condition of the concrete topping slab was not determined due to limited site access. Overall, the global condition assessment for Area A is considered Poor.

The timber piles in Area B are in satisfactory condition overall. The timber bent caps are rotten in many instances and may be susceptible to bearing overstress. Bearing overstress has already occurred in one location on the South Face of the structure. The concrete deck sags significantly in this location (**Figure 12**). The timber stringers show little visual indication of rot, but it is very possible that rotten stringers are present based on the observed condition of other timber members. Moderate corrosion is evident on the central steel stringer. Some instances of rot were noted on the timber decking under the concrete deck.

The tapered tube steel piles are satisfactory overall, but one instance was noted where a steel pile is split (Photo 4-2-193 of Appendix B). Minor corrosion is evident throughout with a few instances of moderate corrosion. The condition of the concrete topping slab was not able to be determined due to limited site access. Area C is satisfactory.
