# ABOVE WATER INSPECTION OF EXISTING CONCRETE BULKHEAD ALONG THE WINDMILL HILL PARK

**DATE:** January 23, 2009

**LOCATION:** Windmill Hill Park Waterfront  
Alexandria, VA

**INSPECTION TEAM:** Bradford K. Hull, P.E (RK&K)  
Karl Stegmann, P.E. (RK&K)

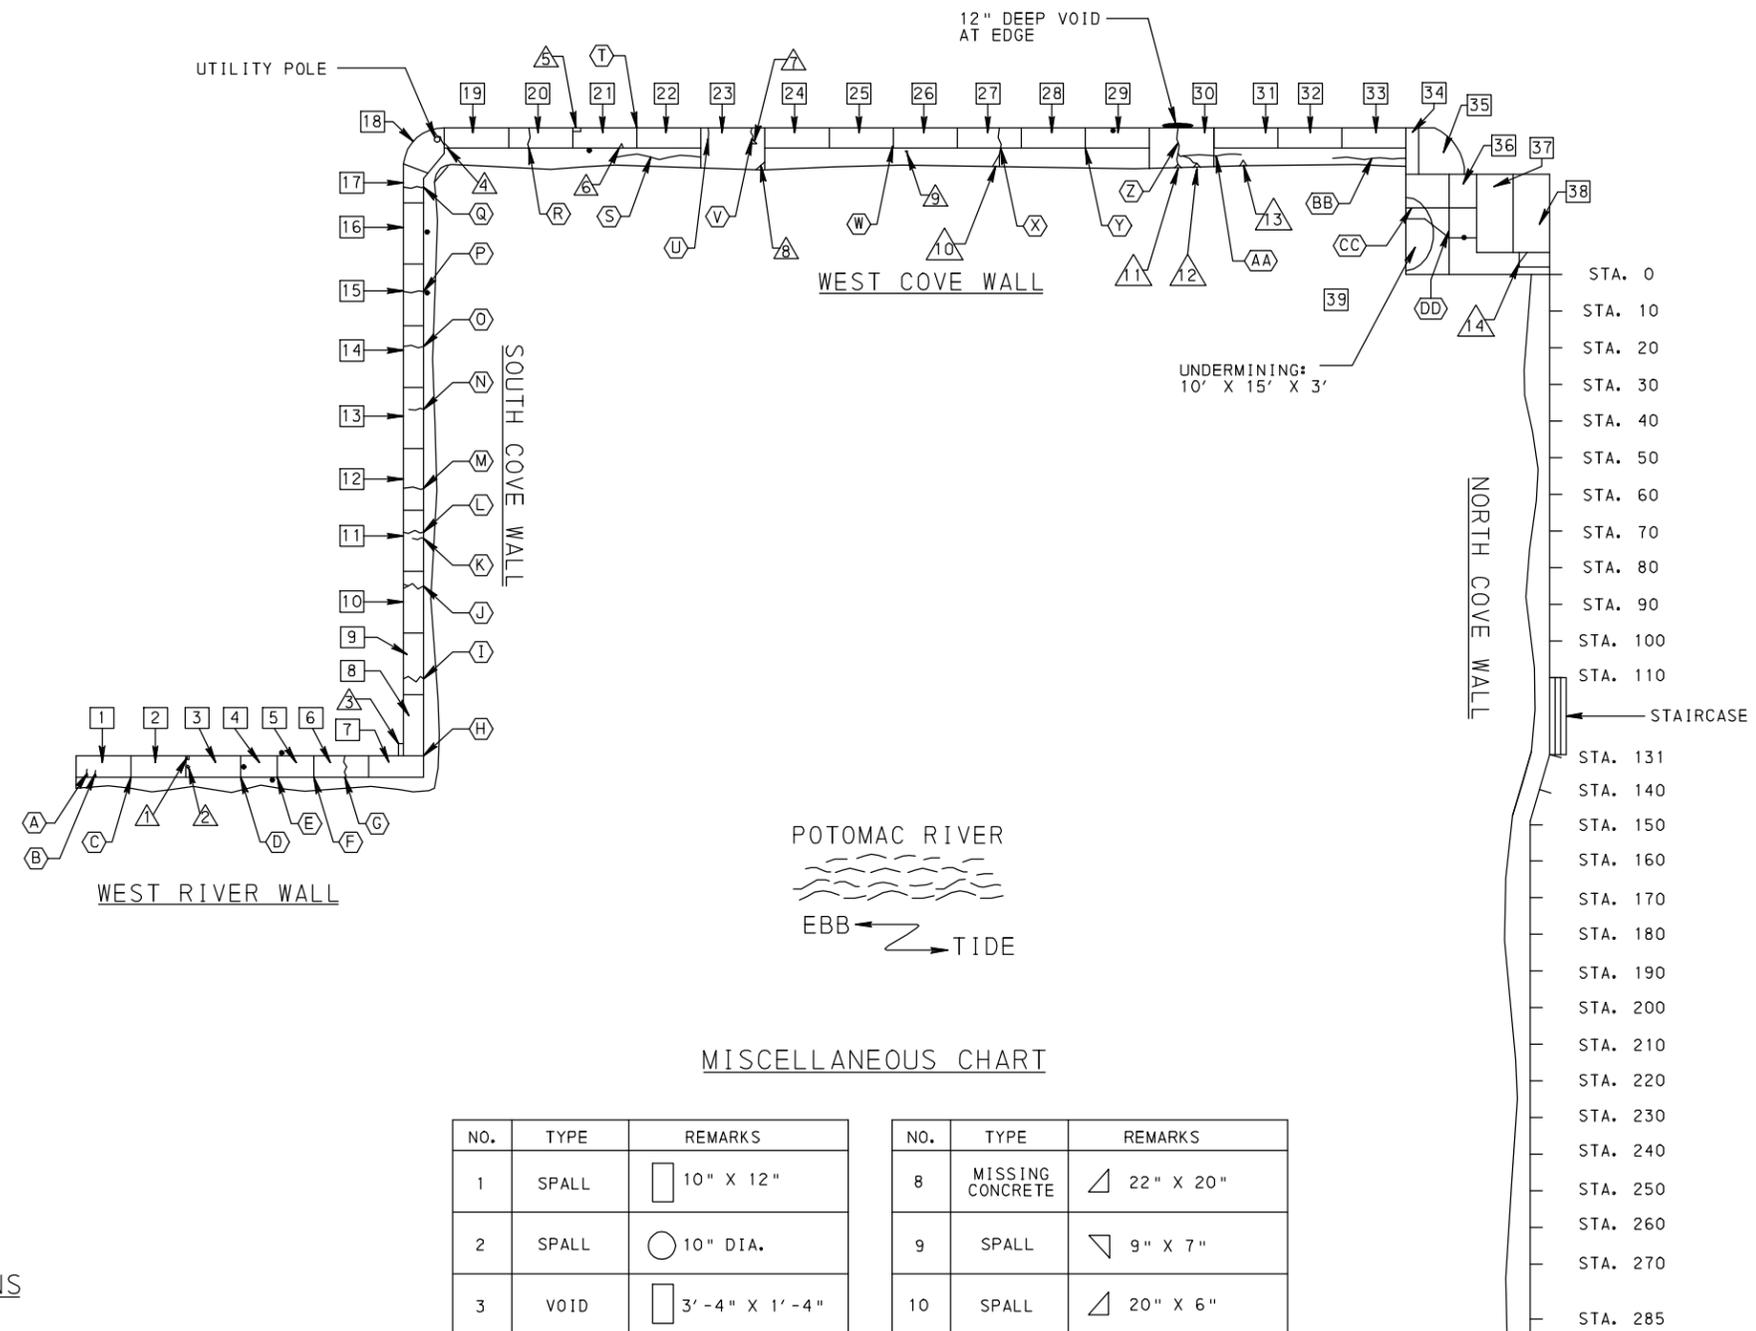
CRACK/SLAB GAPS SIZE CHART

LETTER	LENGTH	GAP	REMARKS
A	26"	MC	
B	22"	MC	
C	GAP	2 1/4"	HORIZONTAL GAP B/W SLAB 1 & 2
D	GAP	1"	HORIZONTAL GAP B/W SLAB 3 & 4
E	GAP	3"	HORIZONTAL GAP B/W SLAB 4 & 5
F	GAP	1"	HORIZONTAL GAP B/W SLAB 5 & 6
G	FW	MC	
H	GAP	4"	HORIZONTAL GAP B/W SLAB 7 & 8
I	FW	1 1/4"	
J	FW	1/4"	13" X 15" SHALLOW SPALL LANDWARD OF CRACK
K	36"	MC	
L	FW	MC	
M	FW	MC	
N	48"	MC	
O	FW	MC	
P	FW	MC	
Q	FW	MC	
R	FW	MC	1" VERTICAL Δ
S	276"	6"-7"	42" VOID UNDER CRACK
T	GAP	-	1 1/2" VERTICAL Δ GAP B/W SLABS 21 & 22
U	36"	1"	
V	36"	1"	
W	GAP	1"	1" VERTICAL Δ GAP B/W SLABS 25 & 26
X	FW	1"	
Y	GAP	-	3/4" VERTICAL Δ GAP B/W SLABS 28 & 29
Z	FW	3"	3" VERTICAL Δ
AA	FW	3"	16" VERTICAL VOID UNDER CRACK
BB	240"	3"	22" VERTICAL VOID UNDER CRACK
CC	GAP	4"	GAP B/W CORNER SLAB
DD	GAP	5"	GAP B/W CORNER SLAB
