Fort Ward Park Master Drainage Plan *Prepared for the City of Alexandria*

Presented by URS Corporation

August 14, 2013

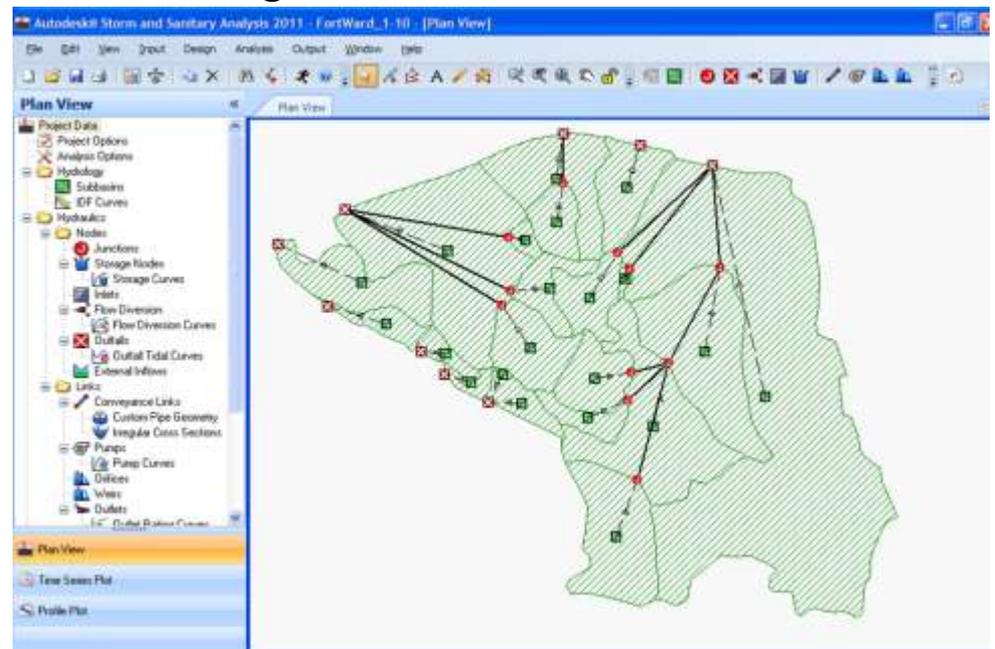
- Developed drainage area map with 21 subbasins
- Hydrologic analyses conducted utilizing available land use, soils information, and drainage areas
- Hydrologic Analyses conducted using Rational Method.
- Estimated capacity of existing culverts using HY-8

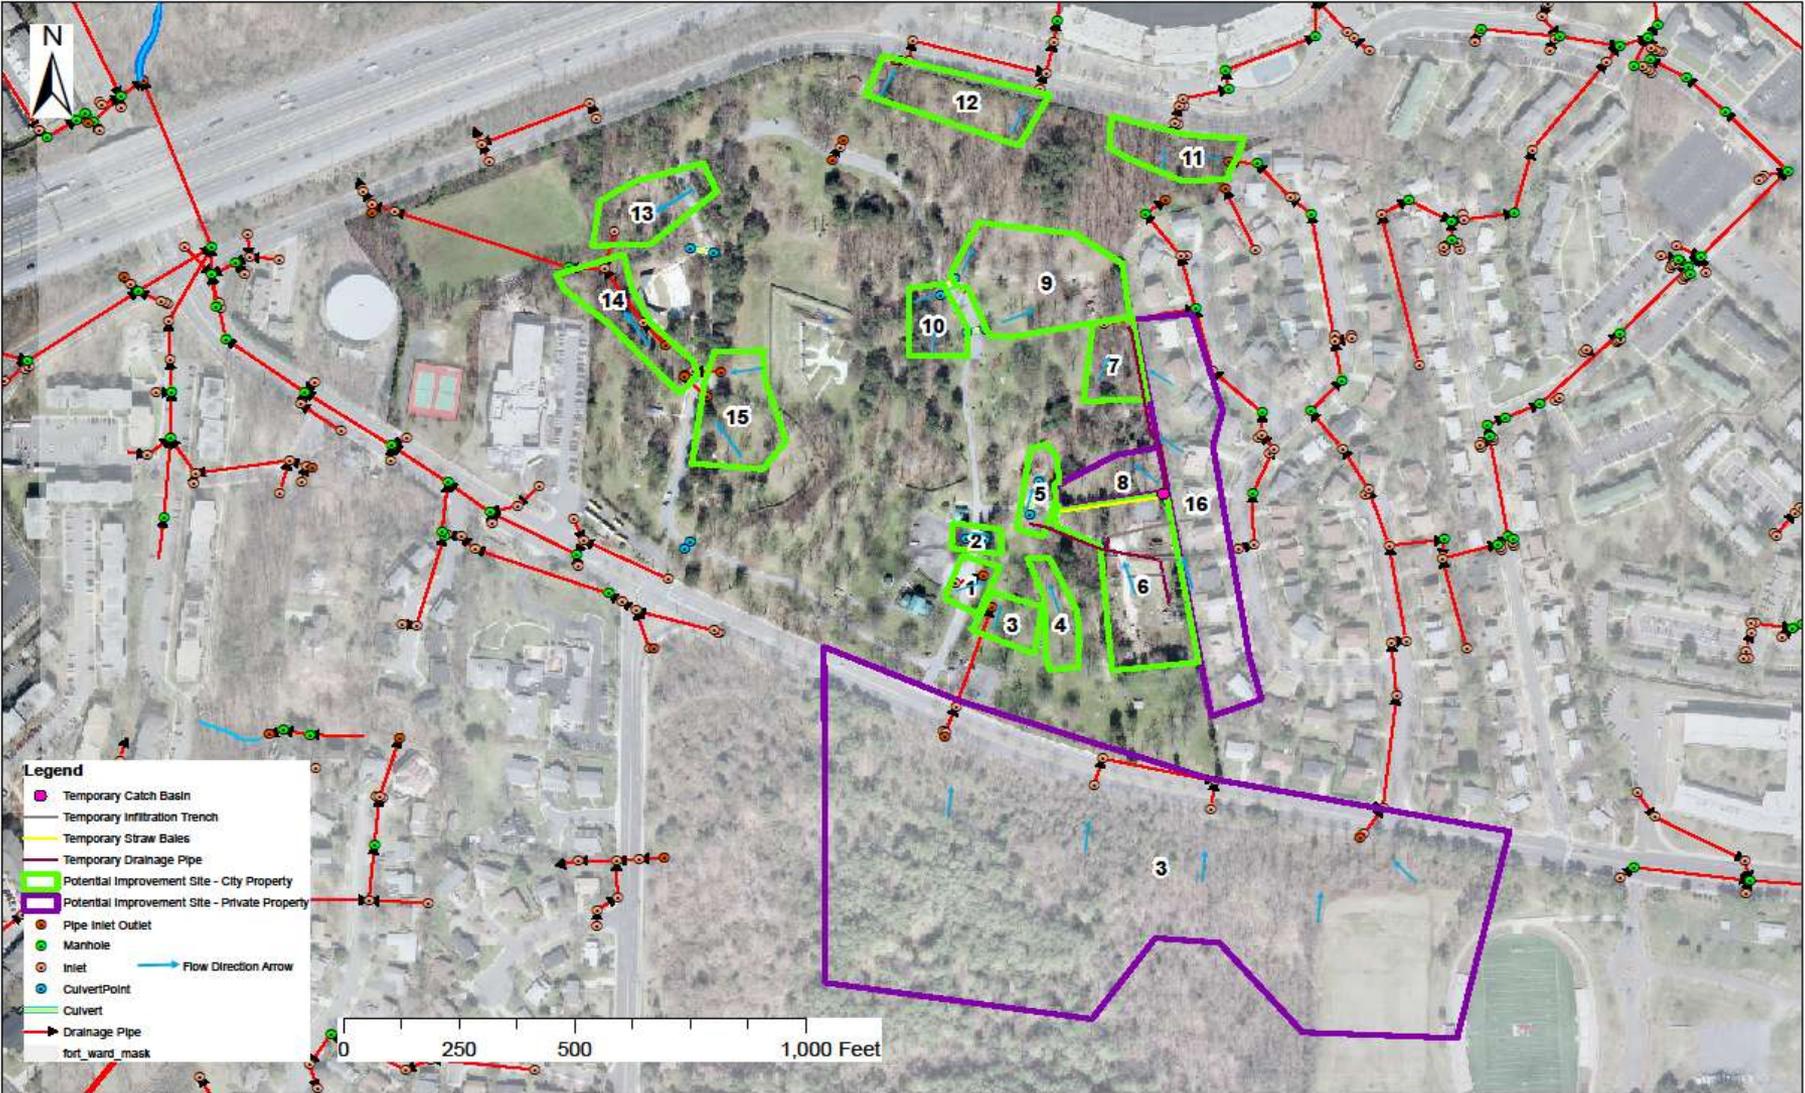
Site Map

- Conducted field visit to assess drainage conditions
- Identified potential drainage improvements
- 16 sites were identified with existing drainage condition problems
