Strawberry Run Forensic Investigation

Prepared for:
Stormwater Management Division Transportation and
Environmental Services

City of Alexandria

June 2022

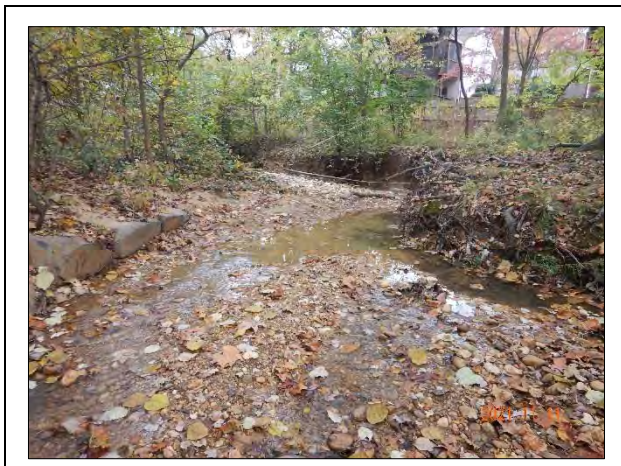
Figure 3. J-Hook Vane #1 – Looking Upstream (Station 1+70)

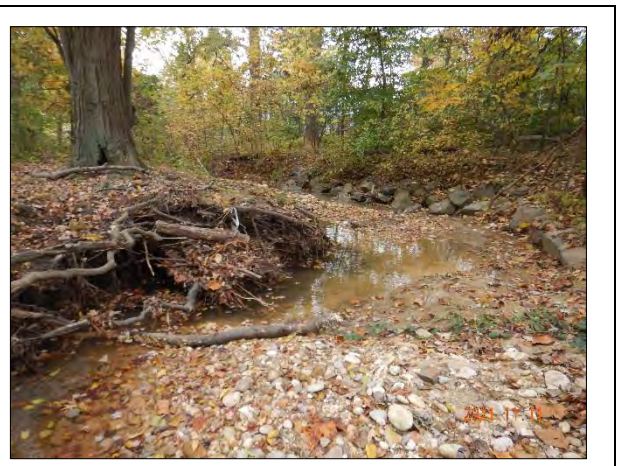
Figure 4. J-Hook Vane #1 – Looking Downstream (Station 2+20)

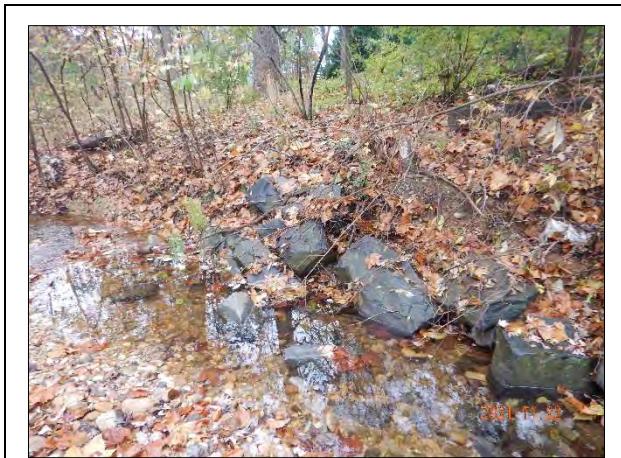
Figure 5. Rock Toe Looking Downstream (Station 1+60)

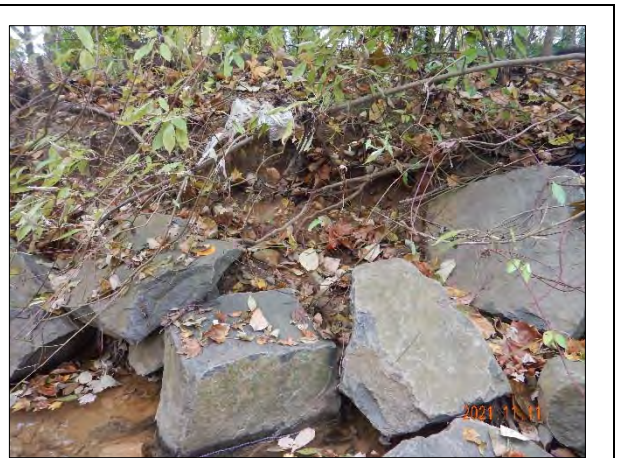
Figure 6. Displaced Rock Toe Material (Station 1+60)

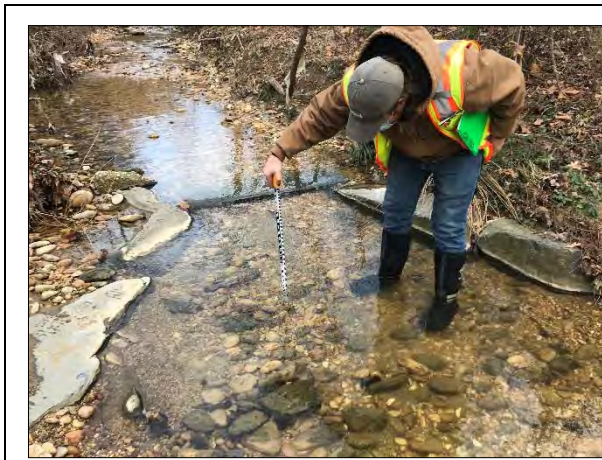
Figure 7. Cross-Vane #1 – Looking Upstream (January 2021, Station 2+40)

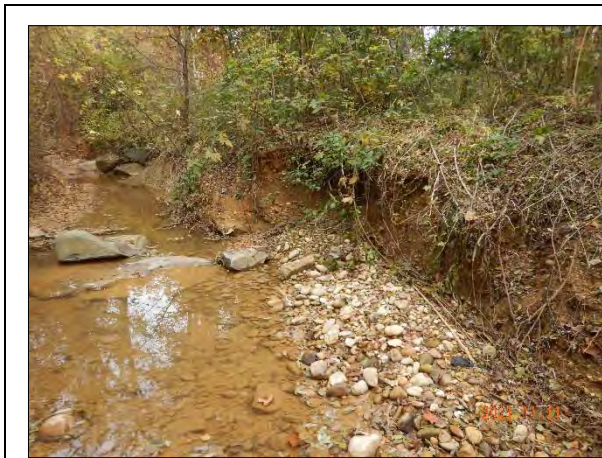
Figure 9. J-Hook Vane #2 – Looking Upstream (Station 3+70)

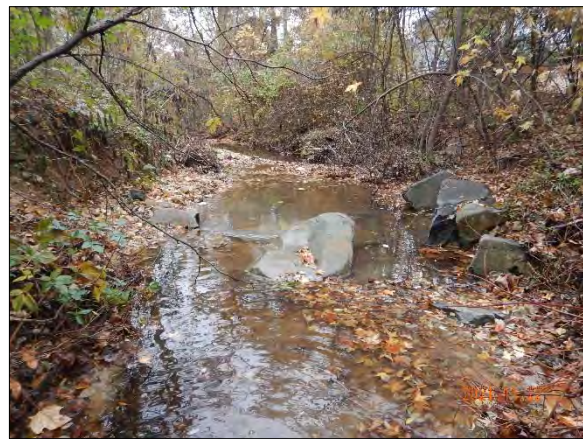
Figure 10. J-Hook Vane #2 – Looking Downstream (Station 3+80)

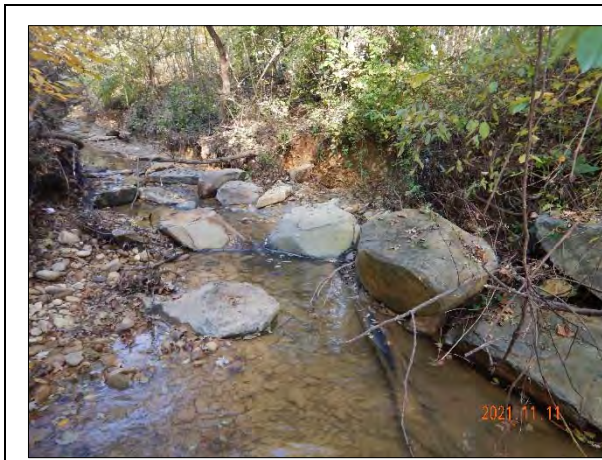
Figure 11. J-Hook Vane #3 – Looking Upstream (Station 4+20)

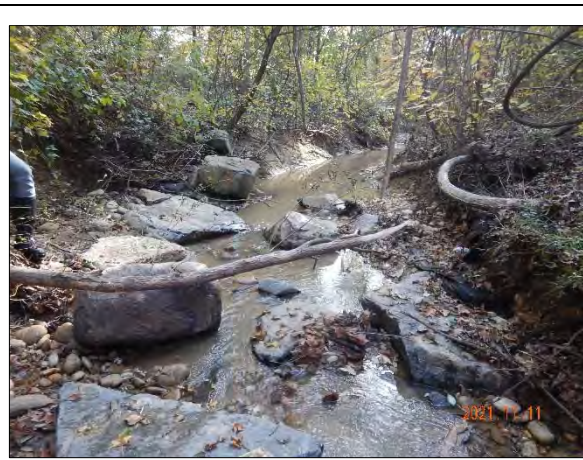
Figure 12. J-Hook Vane #3 – Looking Downstream (Station 4+30)

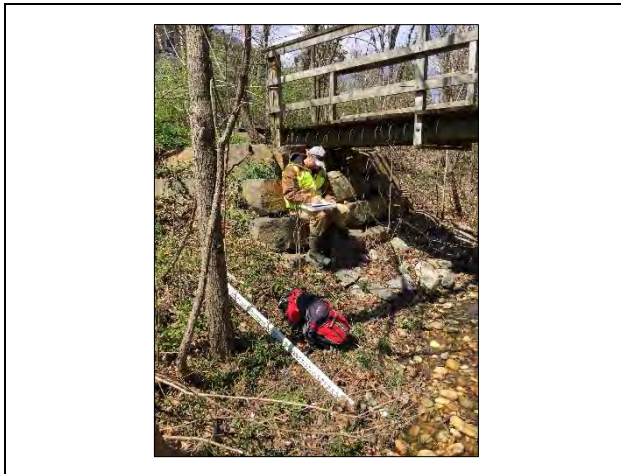
Figure 13. Right Bridge Abutment – Looking Upstream (April 2018, Station 5+00)

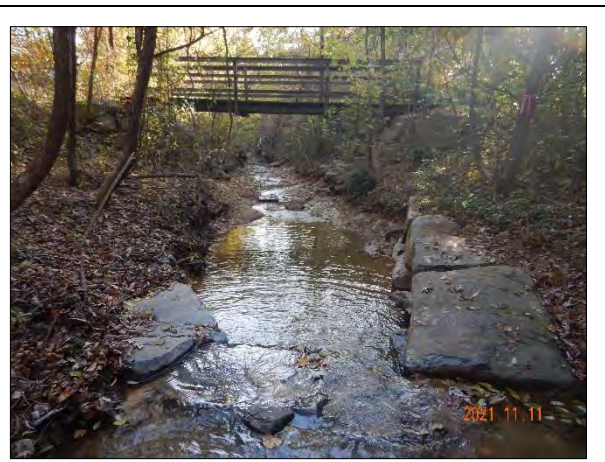
Figure 16. Cross-Vane #2 – Looking Downstream Towards Bridge (Station 5+50)

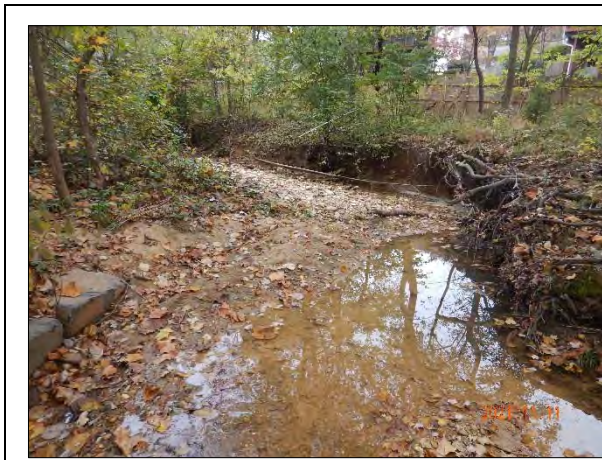
Figure 21. Stream Reach #2 – Looking Upstream (Station 1+90)

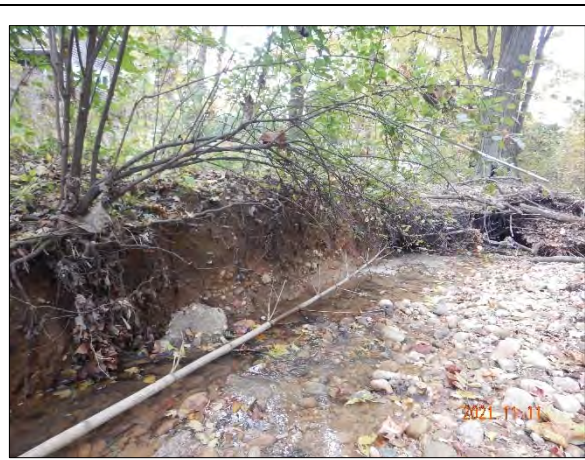
Figure 22. Stream Reach #2 – Looking Downstream (Station 2+20)

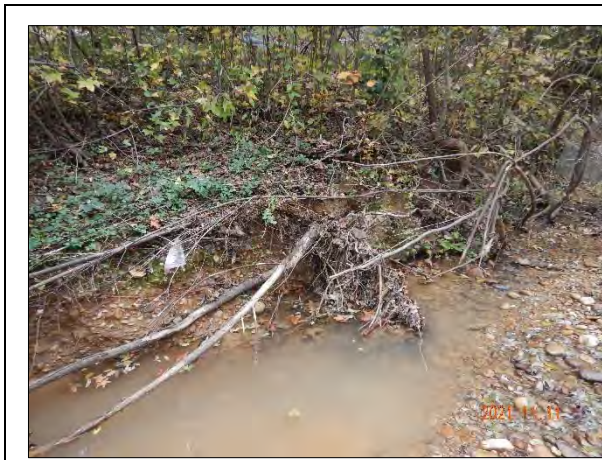
Figure 23. Stream Reach #3 – Looking Upstream Right Streambank (Station 3+30)

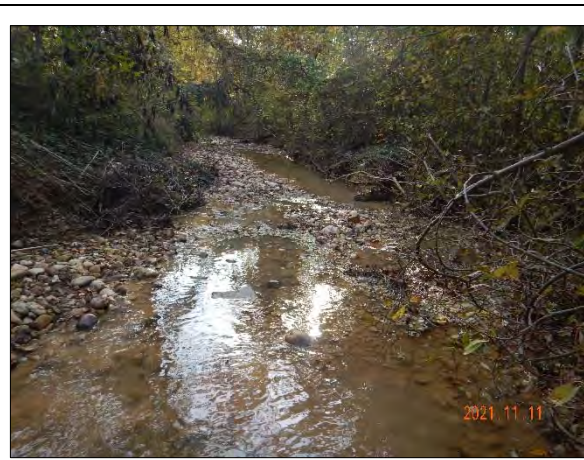
Figure 24. Stream Reach #3 – Looking Downstream (Station 3+40)

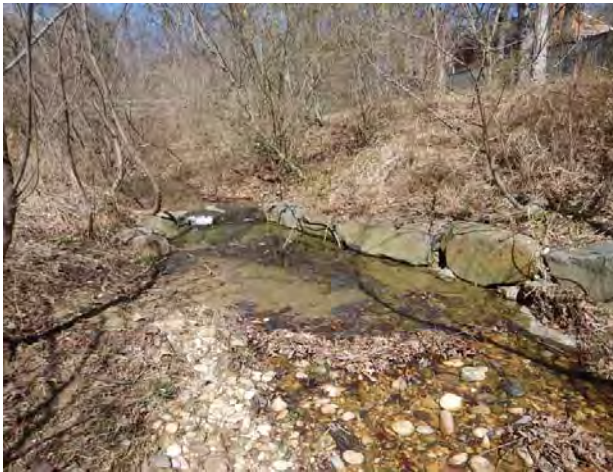
Figure 33. J-Hook Vane #3 (Station 4+20, March 2018)

The lateral and vertical adjustments are symptoms of disequilibrium. The headcutting represents the vertical disequilibrium and the change in stream planform represents the lateral disequilibrium. Figures 33 through 36 document the progression of headcut and subsequent structure failure from March of 2018 to November of 2021. In general, the hydraulic forces exerted on the stream bed and banks during high flows exceed the ability of the channel boundaries to resist erosion in many areas of the restored stream reach.

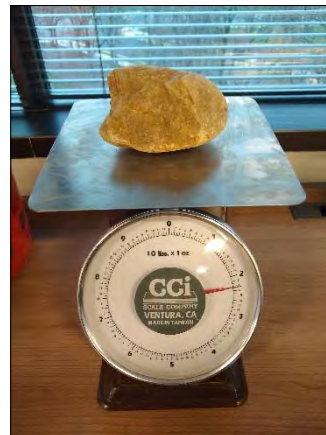
Figure 42. Weighing Largest Point Bar Sample Particle (105 mm)

Additionally, a bar sample was collected along a point bar in the lower section (S1) of the project reach (Figure 38). Point bar material was collected (Figure 43) and wet-sieved to determine the material size-class distribution (Figure 44 - Figure 52). The material size-class distribution represents the range of channel materials subject to transport as “bedload” sediment materials. The point bar material distribution shows that 11% of the sample was finer than the 2 mm sieve (Figure 40). This material passed into the catch bucket and is made up of sands, silts, and clays (Figure 45). The largest particles found on the point bar were 100 mm and 105 mm (Figure 42). The samples were classified as 43% cobble, 46% gravel, and 11% sand (Figure 40).

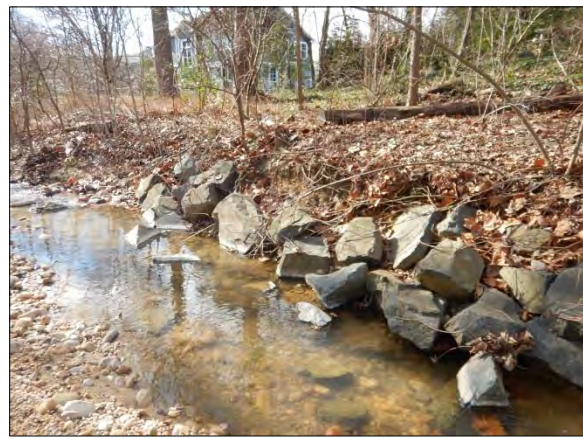
Figure 75. Rock Toe (Station 1+60)

2. Lack of rock toe protection throughout restored reach. Larger material (Figure 75) would have better resisted the applied forces along the channel banks.

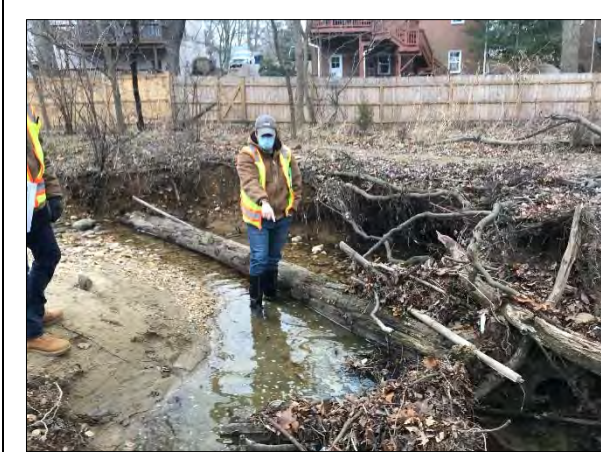
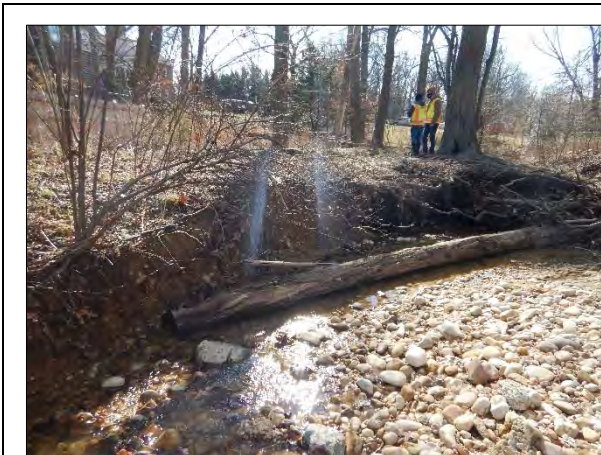
3. Downed trees/channel blockages (Figures 76 and 78). Like excess sediment, channel blockages and debris have the potential to cause local flow accelerations and flow diversions leading to bank erosion and widening. While logs can be useful as bank protection measures, structures need to be securely anchored and placed to prevent washout (Figures 77 and 79).

Figure 76. Downed Tree (January 2021, Station 1+90)

Figure 78. Downed Tree (January 2021, Station 2+20)
