BAR Review Levels

CHIMNEYS + FLUES

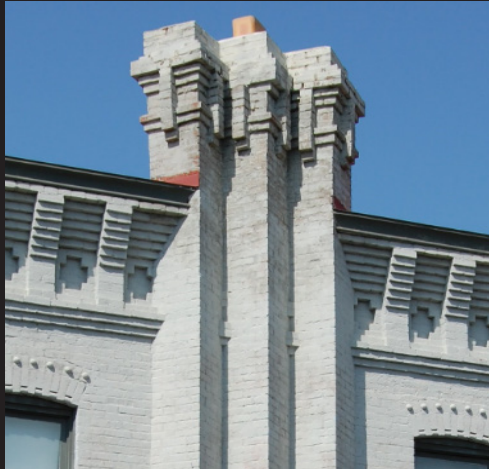
The corbelled brick chimney is a character defining feature of this Queen Anne style residence.

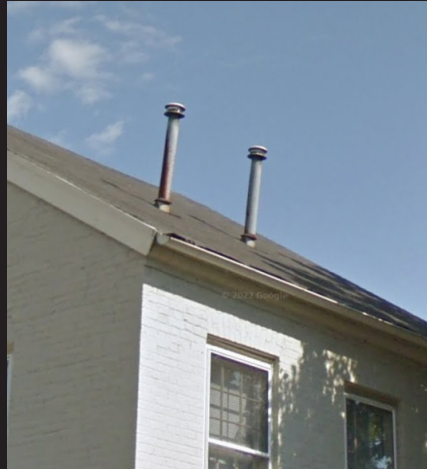
Example of an inappropriate exterior metal flue chimney on a historic building.

- o Existing chimneys should not be removed or reduced in size.
- o New chimneys should be appropriate to the architectural style of the structure.
- o Brick and brick-clad chimneys are appropriate for buildings constructed in the late 18th and 19th Centuries.
- o The Board discourages exposed metal flue chimneys. Metal chimneys on Later (post-1931) commercial and industrial style structures may be appropriate in certain instances.
- o Chimneys should not be clad in siding.
- o Unpainted masonry chimneys on unpainted masonry houses should not be painted.

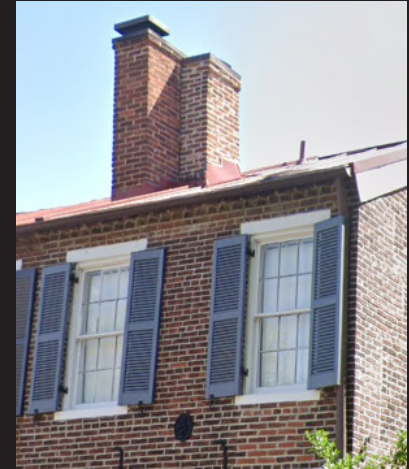
Example of brick chimneys commonly found on historic Old Town residences.
