BAR Review Levels

Introduction

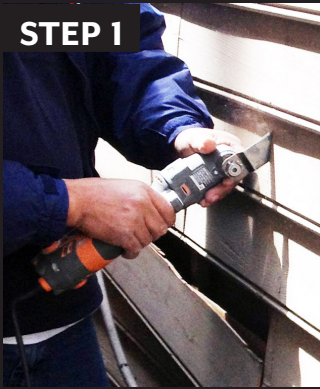
STEP 1

Carefully remove a 2 foot by 2 foot portion of the surface siding.

Intact historic siding may be hidden beneath layers of siding, such as aluminum, vinyl, artificial brick, or stone. To determine if multiple layers of siding exist, remove at least one portion a minimum of 2 feet by 2 feet to reveal the first layer of siding. Staff will inspect the mock-up in the field prior to any approval. The graphic on the following page gives an overview of this process.

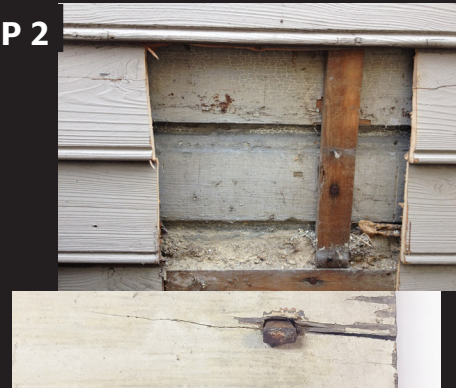
STEP 2

Using clues such as the siding profile and the type of nails used, Staff makes a determination on the age of the siding.

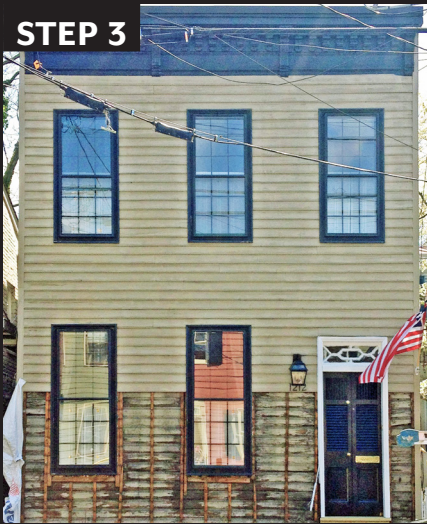
STEP 3

^ BEFORE

More of the historic siding is exposed for Staff to assess its condition. In this case, the historic siding is in very good condition and will be stripped and painted for reuse on this building.

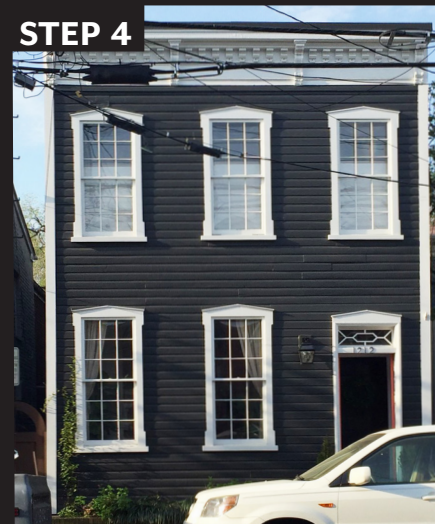
STEP 4

^ AFTER

In this case, removal of the contemporary siding also revealed ghost marks in the old paint from which the original window and door trim was able to be recreated.
