MASONRY

Introduction

PARKER-GRAY DISTRICT CITY OF ALEXANDRIA

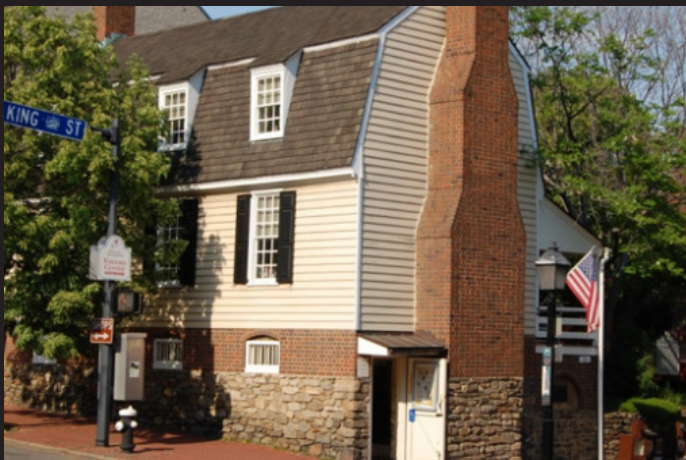
The now-exposed stone foundation of the 18th-century Ramsay House shows the original height before King Street was regraded in the early 19th Century.

The foundations of 18th-century buildings in Alexandria were typically constructed with locally sourced stone. With rare exception, this stone was installed below grade; where it is exposed today, it often indicates the original sidewalk elevation. A notable example of these stone foundations can be seen at the Ramsay House. The Carlyle House is the only building in Alexandria originally constructed of Aquia Creek sandstone, although it was refinished with Indiana limestone in the 1970s. Sandstone, limestone, marble, and granite were commonly used for stoops throughout the 18th and 19th centuries. Precast concrete was not used as a building material until the early 20th century.

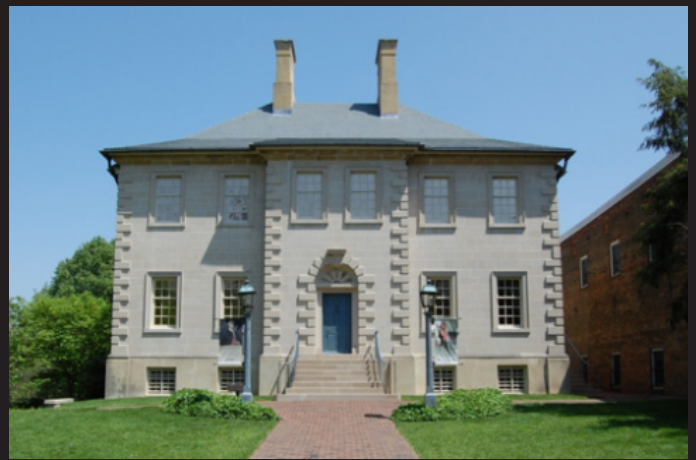
The Carlyle House was originally constructed in the 18th Century with Aquia Creek sandstone.

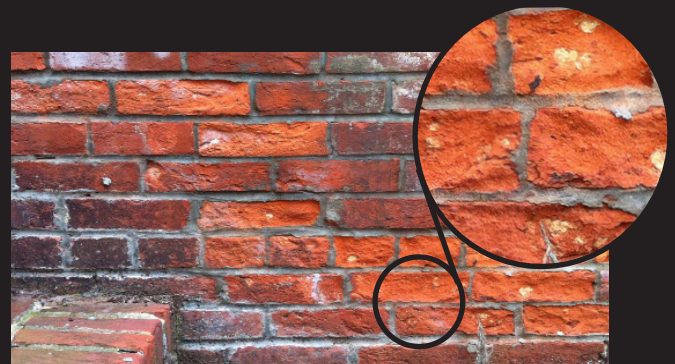
In this example, repointing with a Portland cement mortar has irreversibly damaged the historic brick, causing spalling. Spalling is when the hard-fired face of the brick breaks off due to an impermeable mortar joint.

In masonry walls, mortar is intended to be softer and more porous than the adjacent masonry units. Using mortar that is harder than the surrounding brick or stone prevents the masonry from expanding and contracting as intended. This can cause irreparable damage, resulting in the full or partial loss of individual masonry units. The use of incorrect mortar is considered a form of demolition.

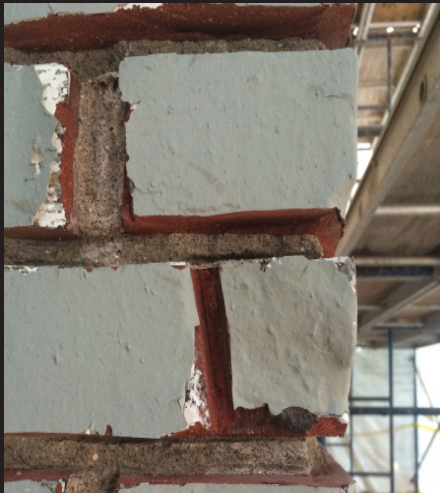
The result of using power tools on mortar joints - the grinders sliced off 1/4 inch sections of brick. The facade is irreversibly damaged, resulting in the loss of the original, handmade bricks. The aesthetic and historic character of the building is lost, as the joints are now twice the original width. In addition, the softer and more absorbant interior of the brick is exposed, leading to future deterioration.

Power tools should be used only to score the center of horizontal joints; the remaining mortar must then be removed using hand tools. Only hand tools should be used on horizontal joints less than 3/8 inch tall and on all vertical joints. Mortar should be removed to a depth of 2½ times the height of the joint. Masonry damaged by improper mortar removal is considered a demolition.

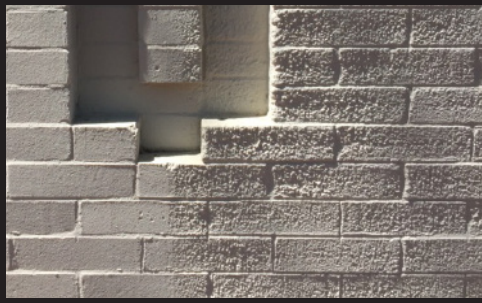
The brick on the right side in the photo has been sandblasted, causing the outer hard fired layer to be removed and making it more susceptible to further damage and destroying its historic architectural character. The Board considers this demolition of the masonry.

Improper paint removal or cleaning can irreversibly damage masonry. Harsh methods—such as sandblasting or power washing—can strip away the hard-fired surface of the brick, exposing its softer core to weathering. Even milder abrasive techniques (e.g., soda or media blasting) may only be approved when a skilled architectural conservator has demonstrated, via a test patch, that it is the safest and most effective option.

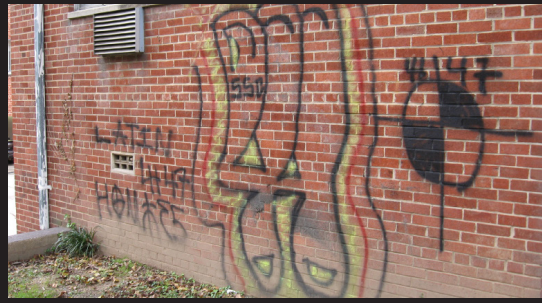
Graffiti should be removed using the same gentle cleaning methods.

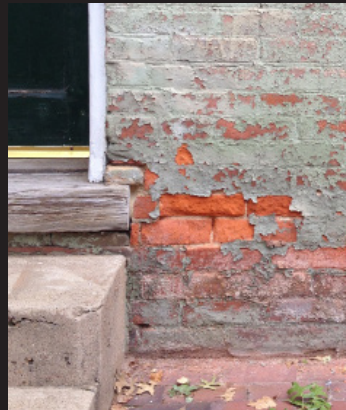
Rising damp (water wicking from below) has caused the face of this early brick to crumble from the freeze-thaw cycle.

Masonry is often damaged by moisture-related issues. Common causes include interior water leaks, faulty air conditioning units, leaking pipes or drains, clogged gutters and downspouts, and rising damp from below grade. Additional damage may occur from drilling into masonry or applying silicone adhesives.

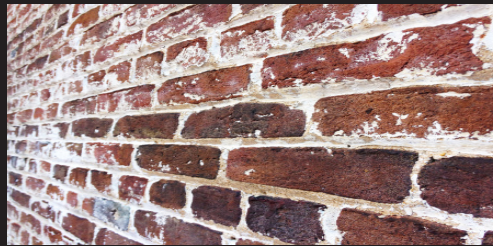
STRUCK JOINT

18th and 19th centuries
Used on secondary facades

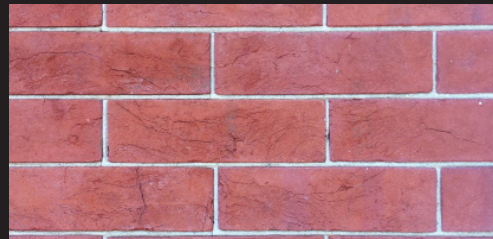
BUTTER JOINT

Mid-19th century
Used on primary facades
3/16-inch lime putty

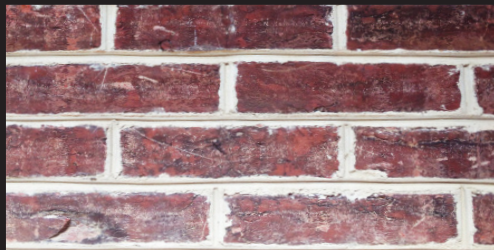
GRAPEVINE JOINT
20th century
Colonial Revival structures

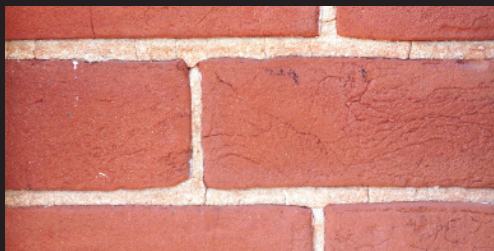
FLUSH JOINT
All years

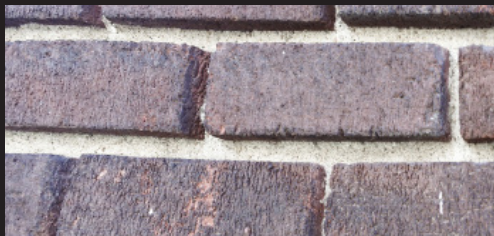
RAKED JOINT
All years
