# Alexandria Times

### Caring for masonry buildings (*part two*)

*Alexandria Times, May 31, 2018*

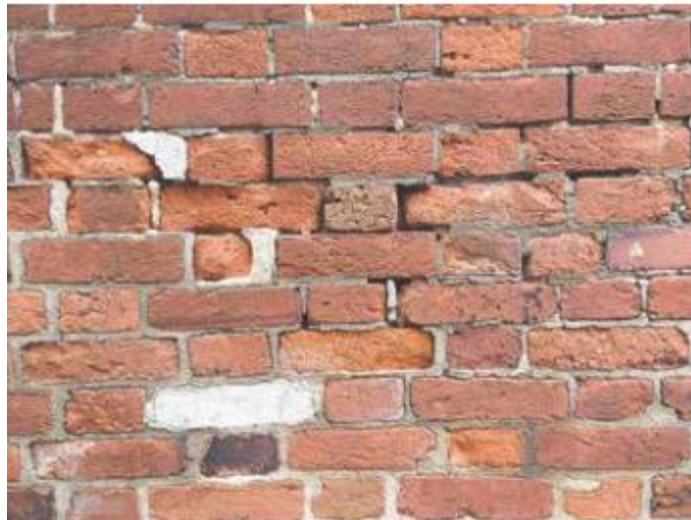
*Image: Hard Portland cement has damaged the face of the soft historic brick. Photo, Al Cox, Office of Historic Preservation.*

Repointing refers to the process by which the existing mortar is removed and replaced. Repointing, sometimes called tuckpointing, should be limited to damaged areas.

On historic buildings, mortar should be removed with hand tools only, as power tools can permanently damage the brick. The mortar should be removed to a depth of 2.5 times the height of the joint. The replacement mortar should match the historic mortar with respect to the color, texture and composition of the ratio of sand, lime and other additives. The historic mortar joint profile on the surface should also be matched. Mortar comprises 15 percent of a masonry wall surface, so a poor repointing job can negatively affect the appearance of a building while also leading to long-term structural issues.
