Out of the Attic

The 1858 Prettyman hose reel carriage

Alexandria Times, April 4, 2019

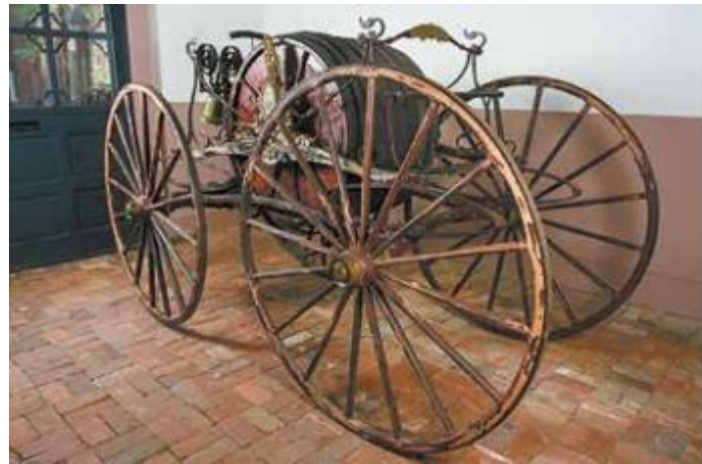
Image: The Prettyman hose reel carriage at Friendship Firehouse Museum. Office of Historic Alexandria.

The Prettyman hose carriage was originally quite colorful. Historic paint analysis has determined the carriage's suspension, steering and chassis were finished with a Prussian blue primer, topped with three layers of high gloss in darker blue.

Analysis has also determined the foliage motifs decorating each side of the reel were gold leaf. The bell springs and sides of the reel drum were black. The wood wheel edging the reel drum and its spokes were painted a bright yellow. The carriage wheels were reddish brown with an outer band of yellow and yellow ray-shaped details that narrowed as they extended outward from the hub.

The carriage was repainted many times over the years, but that finish has been failing for decades now. While the wood and iron components are sound and dry, much of the paint has cracked, peeled and fallen off. The conservation plan calls for a complete documentation of all paint layers on each component before the vehicle is painted to preserve the wood and what remains of its original colors.
