WINDOWS

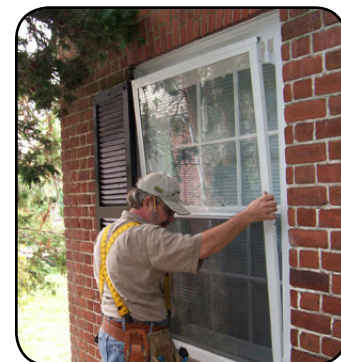
Installation of an exterior storm window.

- Provides a cost-effective and thermally efficient means of energy conservation.
- Can be installed to the exterior or interior.
- Frames should be painted or anodized to match the trim color of the window.
- Glass should be clear and non-reflective.
- Storm windows, because they protect historic windows, are not regulated by the BAR and do not require staff review.
