**Alexandria Commission for the Arts
Special Meeting**

VI. Condition Assessment

1. Presentation and Receiving of Report – The final report for the City's public art conservation assessment done this fall by Evergreene Architectural Arts was shared with the Commission. Diane Ruggiero gave a quick overview of the 76-page report and answered questions. See [Attachment 4](#).

Conservation Solutions, a division of EverGreene Architectural Arts (EverGreene) was contracted by the City of Alexandria, Virginia to carry out condition assessments of the City's public art collection. This survey builds upon a previous assessment completed by Conservation Solutions in 2013, which is part of the City's mandate to assess the collection within a 5-year cycle. The Alexandria Public Art Collection consists of a number of historically significant memorials and contemporary artworks.

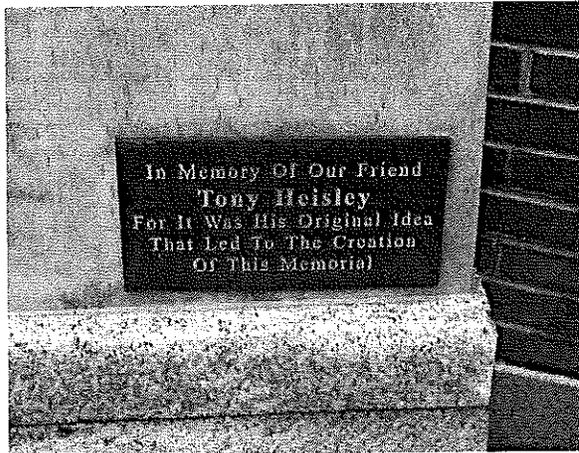
(Left) Figure 7. The dedicatory bronze plaque is in good condition.

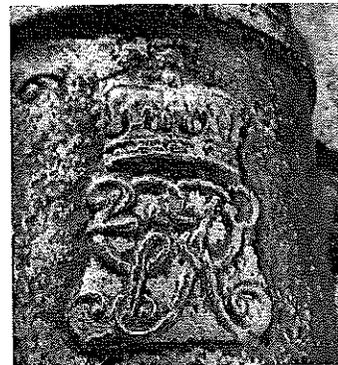
(Right) Figure 4. Emblem on canon.

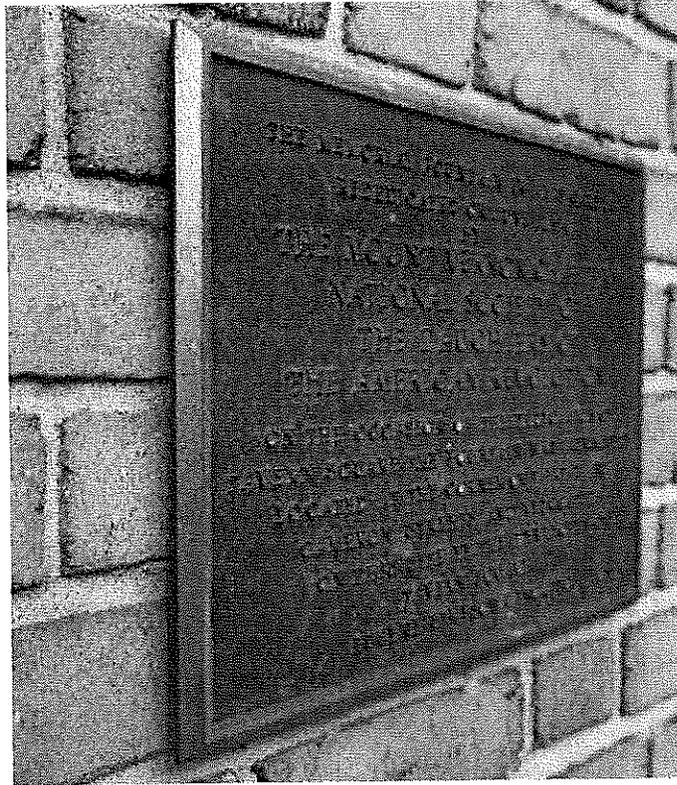
Figure 4. Dedicatory plaque on a wall adjacent to the garden.

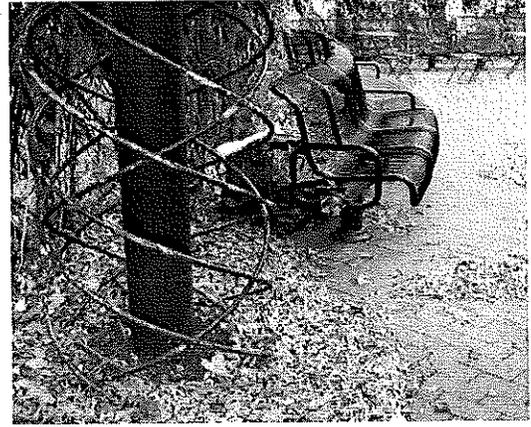
(Right) Figure 10. Typical trellis post encircled by plantings and decorative metal swags.

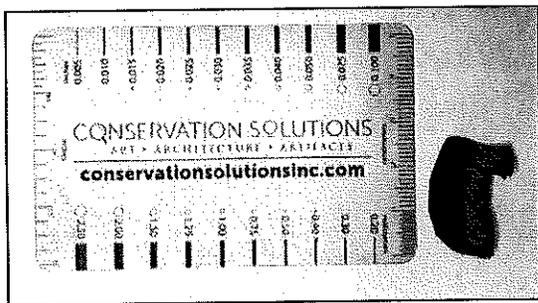
At the request of the client, additional reviews of the existing black paint were reviewed. The sample was obtained during the 2018 conditions assessment performed by Conservation Solutions, a division of EverGreene Architectural Arts in 11/ 2018. The sample represents flakes of paint that had fallen from the substrate to the ground and was not removed directly from the surface. The sample shows that there is no primer, which is confirmed by the exposed patches of the metal substrate from where the paint coat has deteriorated.

Figure 1. King Street Gardens Park, paint sample.

The paint sample was not cast or analyzed but color matched as seen below. The sample was color matched to the standard Benjamin Moore paint swatches, for reference and future color selection for repainting.

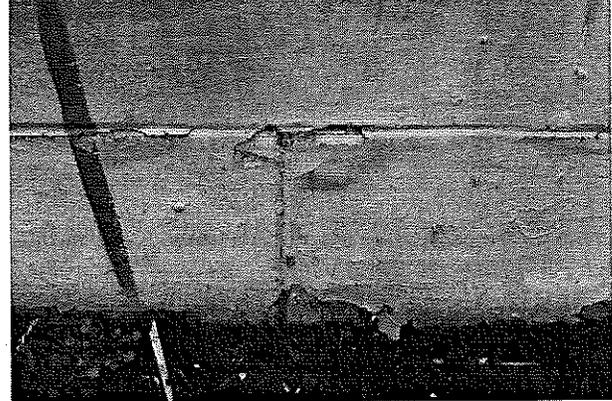
(Left) Figure 1. Overall view of the mural on the north side of the building. **(Right) Figure 2.** Detail of one of the instances of paint blistering and loss.

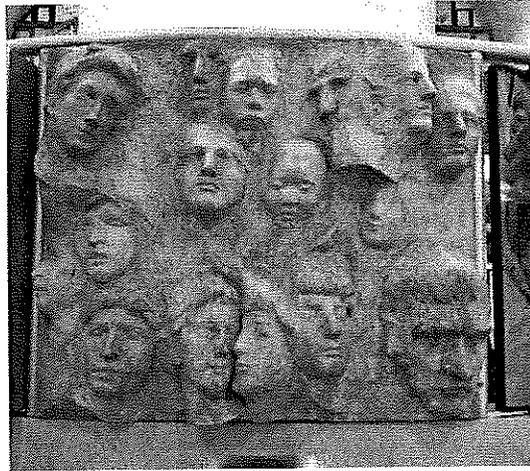
(Left) Figure 3. Fiberglass, face sculpture with epoxy paint by Mirella Belshe.

Located fourth from right, the decorative relief of faces is cast from paper and resin, which have yellowed over time. The resin has failed on some of the raised surfaces of the faces. These areas are creamy compared to the yellow resin. There is a moderate level of soiling on the skyward surface underneath the railing

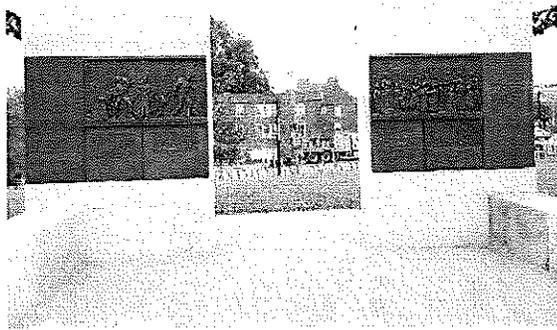
(Left) **Figure 5.** Cemetery entrance; the sandstone pier shows severe iron-staining from the ferrous bolts.
(Right) **Figure 6.** View of the north wall (interior facing) with bronze plaques.
