## APPENDIX D: **Case Study Area Summaries**

# CASE STUDY 1: I-395 / LANDMARK MALL

City of Alexandria

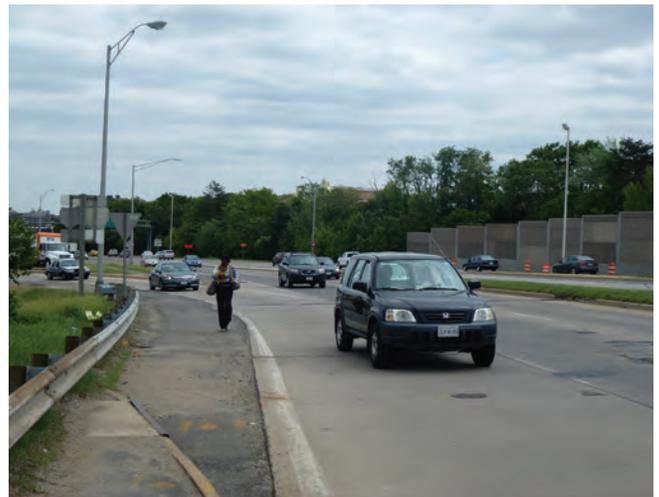
Typical street segment on Duke Street

Within the Case Study Area, the most challenging corridor for pedestrians is along Duke Street between Beauregard Street and South Van Dorn Street. Sidewalks are missing in many locations, and where sidewalks do exist they are in disrepair or are too narrow to create a comfortable walking environment, given the surrounding context and vehicle speeds. Many pedestrians were observed along Duke Street despite the uncomfortable conditions. Worn paths in the dirt/grass were observed in most locations where the sidewalk is discontinuous, demonstrating a need for more permanent infrastructure. The City is currently completing a sidewalk project along Duke Street from Oasis Drive to Walker Lane, which is a step toward addressing the connectivity issues in this area.

New sidewalks and crosswalks are key to the visibility and comfort of pedestrians in this area, particularly near bus stops. Fifteen new crosswalks and eight new sidewalk segments are recommended, primarily along Duke Street. Most of these improvements are already planned for implementation in late 2015 through the Duke Street Pedestrian Improvements project.

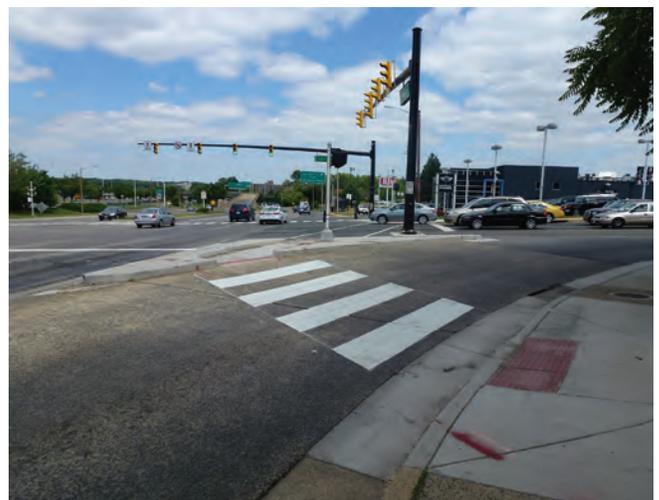
Intersection at Duke Street and South Walker Street

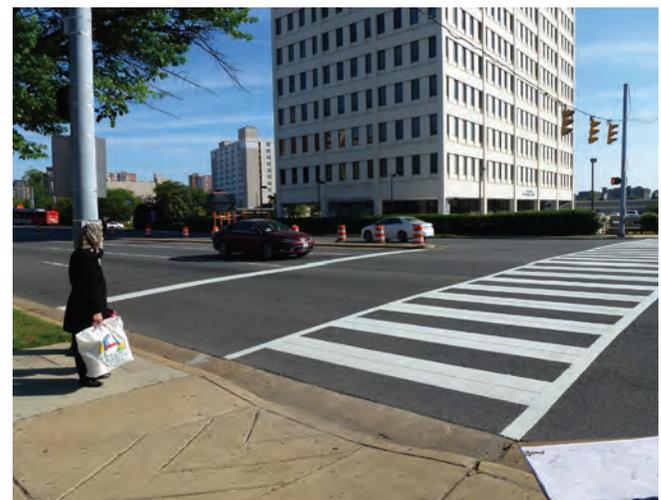
Crosswalk on Seminary Road at Kenmore Avenue near Hammond Middle School

Within the Case Study Area, one of the most challenging locations for pedestrians is the Seminary Road crossing at Kenmore Avenue. During the project field work, numerous pedestrians were observed crossing mid-block on Seminary Road to access the bus stop and shopping centers on Kenmore Avenue and Library Lane. This condition likely results from the concentration of higher density housing to the south of Seminary Road, the commercial development and bus stops to the north, and the long distances between marked crossings in this area.

To help with the issue of people crossing mid-block on Seminary Road at Kenmore Avenue, a near-term recommendation is to consider relocating the bus stop on the north side of the street closer to the signalized intersection of Seminary and Library Lane. Longer term, the City could evaluate the potential for a new traffic signal or pedestrian activated signal at Seminary and Howard; however, the close proximity to the adjacent signal at Library Lane may make this infeasible.

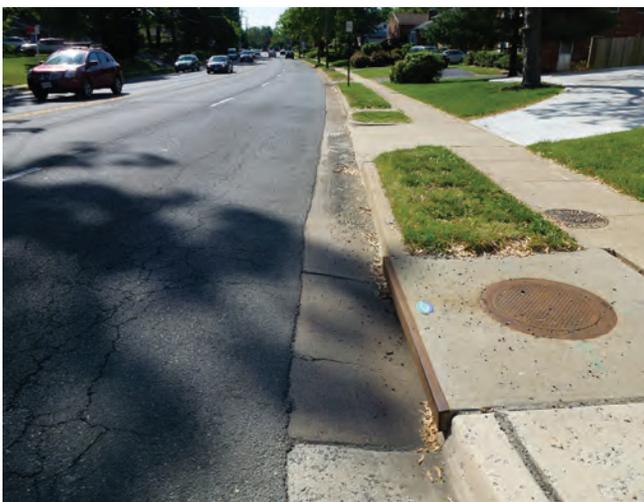
Edge of street conditions on Seminary Road

Finally, bicycle infrastructure is very limited in this area. Bicyclists were observed riding on both the sidewalks and on Seminary Road, though the traffic volumes are too high for most people to be comfortable riding on the street. Also, the edge of the street creates challenges for bicyclists given the prevalence of storm drain grates and unmaintained gutter seams.

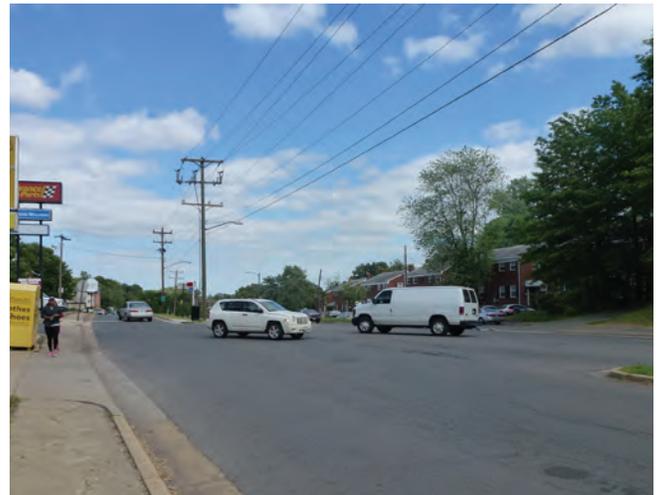
Movement of traffic to and from local access road

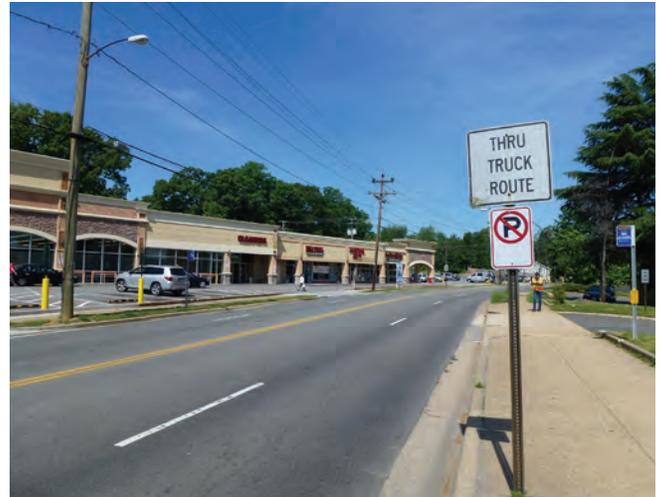
Pedestrian environment near Mount Vernon Avenue at Glebe Road

The intersection of Mount Vernon Avenue at West Glebe Road is recommended for bulb outs in order to shorten crossing distances for pedestrians. Additionally, the study team recommended further study to potentially remove the right turn slip lane on Mount Vernon Avenue at Russell Road, in order to slow vehicle traffic and shorten pedestrian crossing distances.

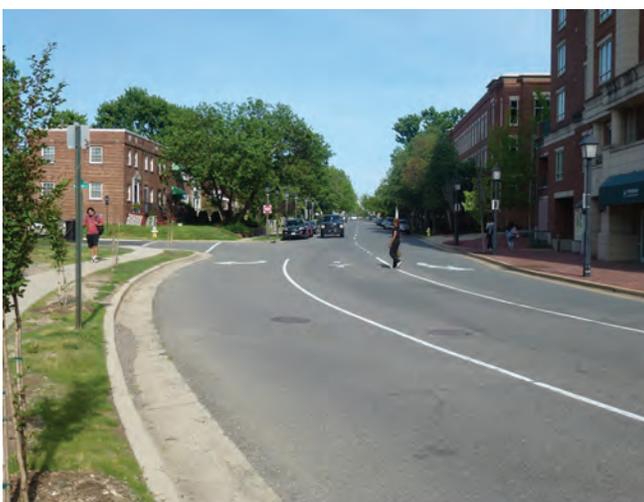
Person crossing Cameron Street to access the walking path

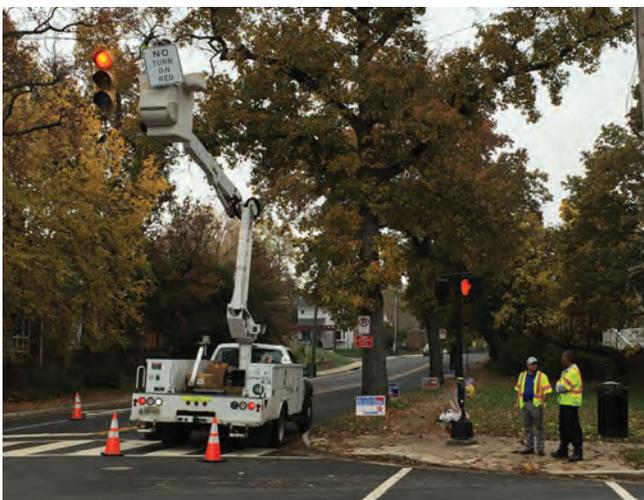
Installing “No Turn on Red” signs

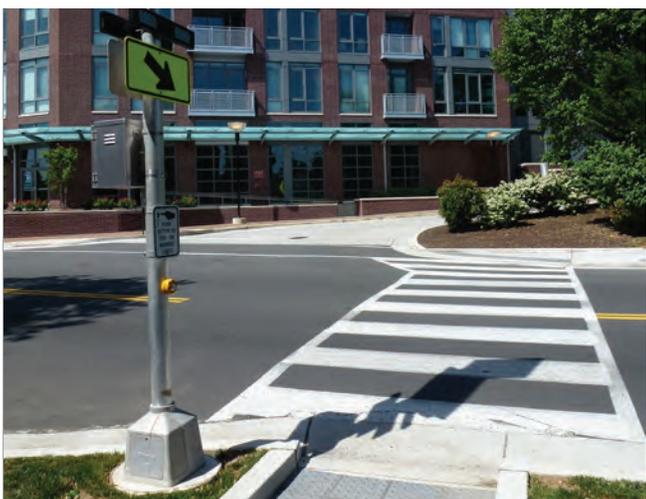
Example of recommended crosswalk and pedestrian signal
